INVENTORY FORM FOR STATE HISTORIC SITES SURVEY

Providence

Mary Brown Farm

QA-104

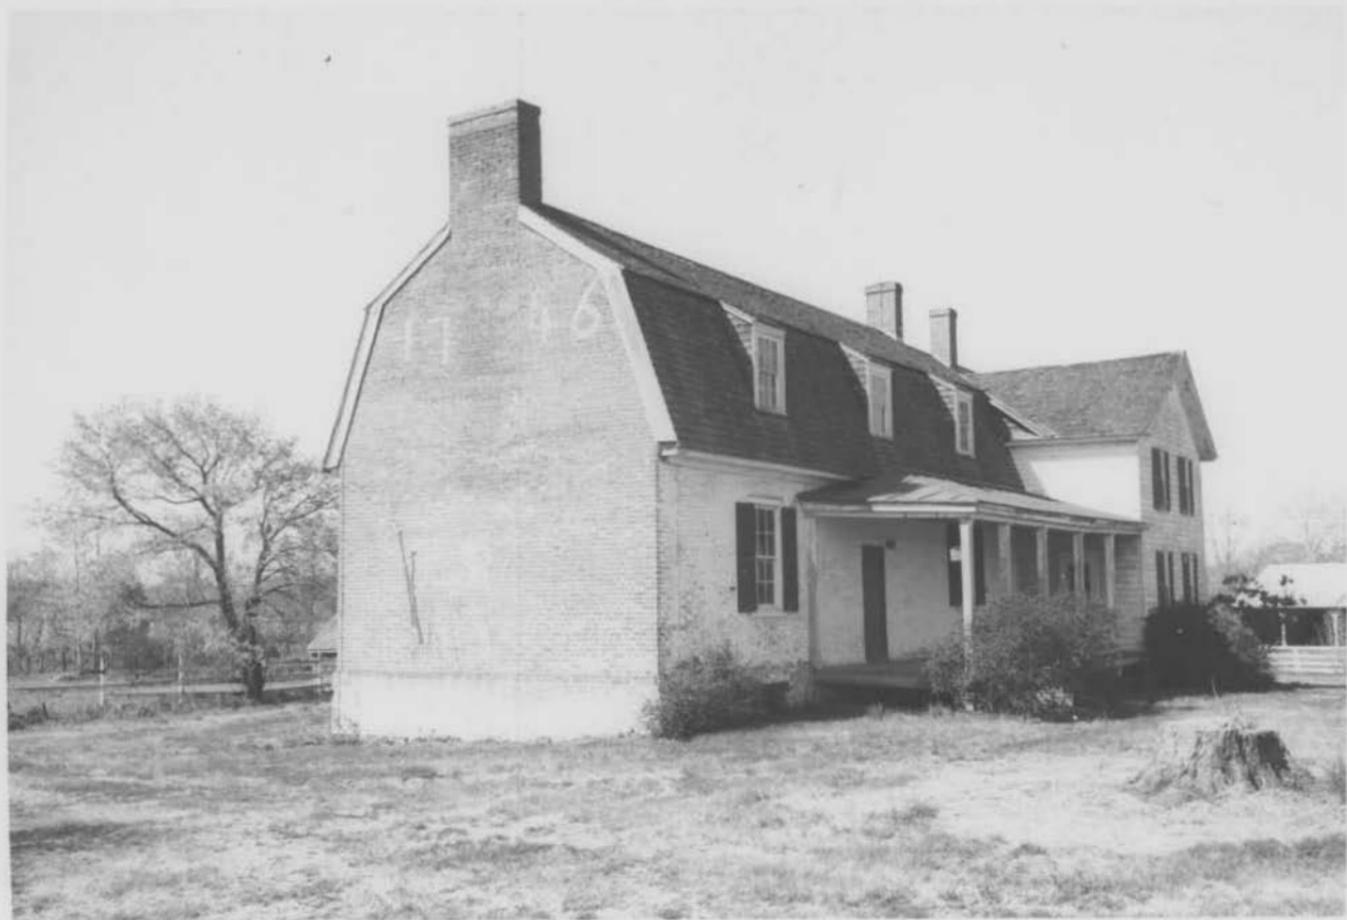
#104

Mary Brown Farm
Centerville vicinity
View from NE

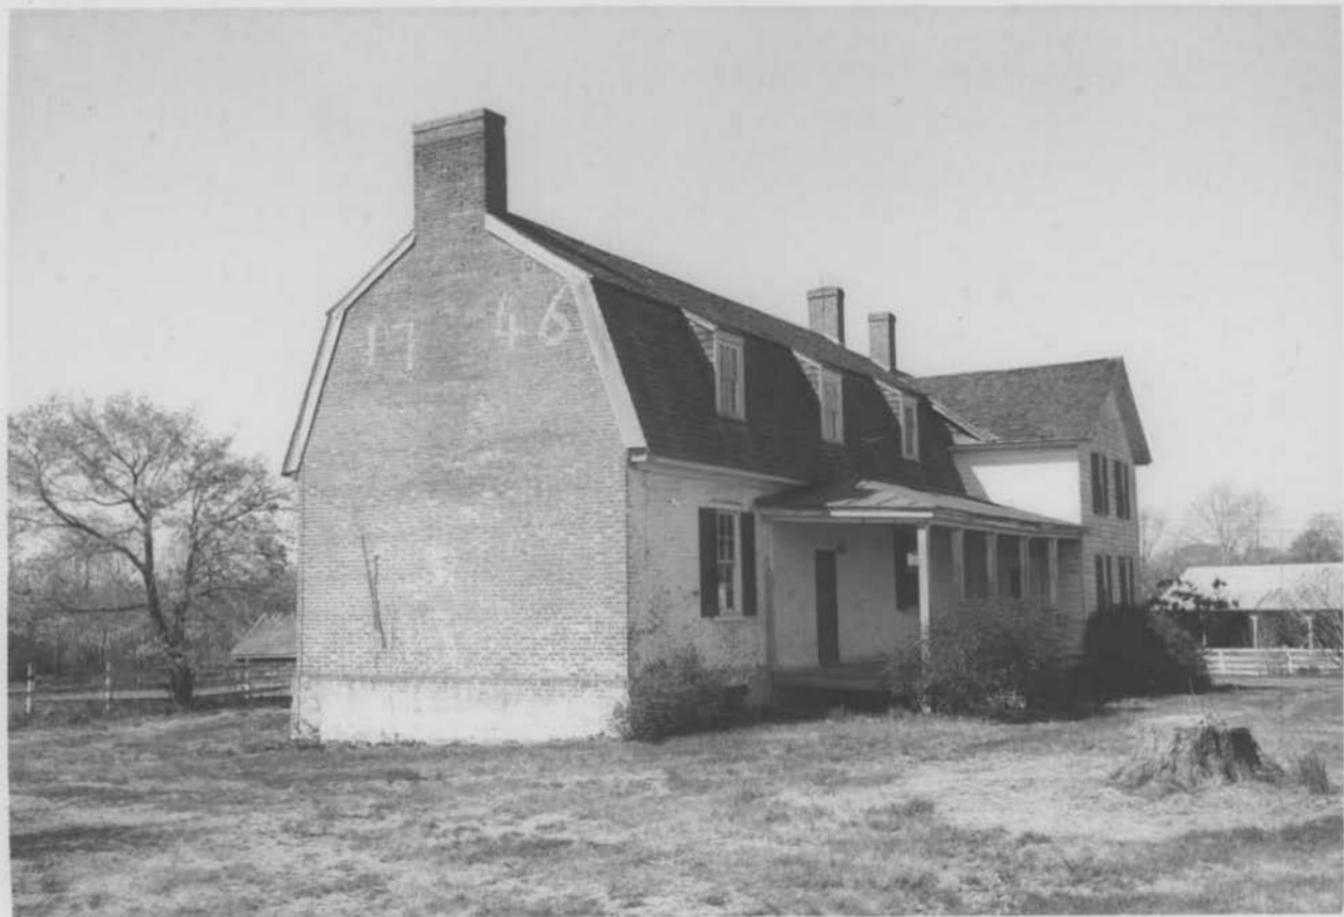
104

Mary Brown Farm
Centerville vicinity
View from NE

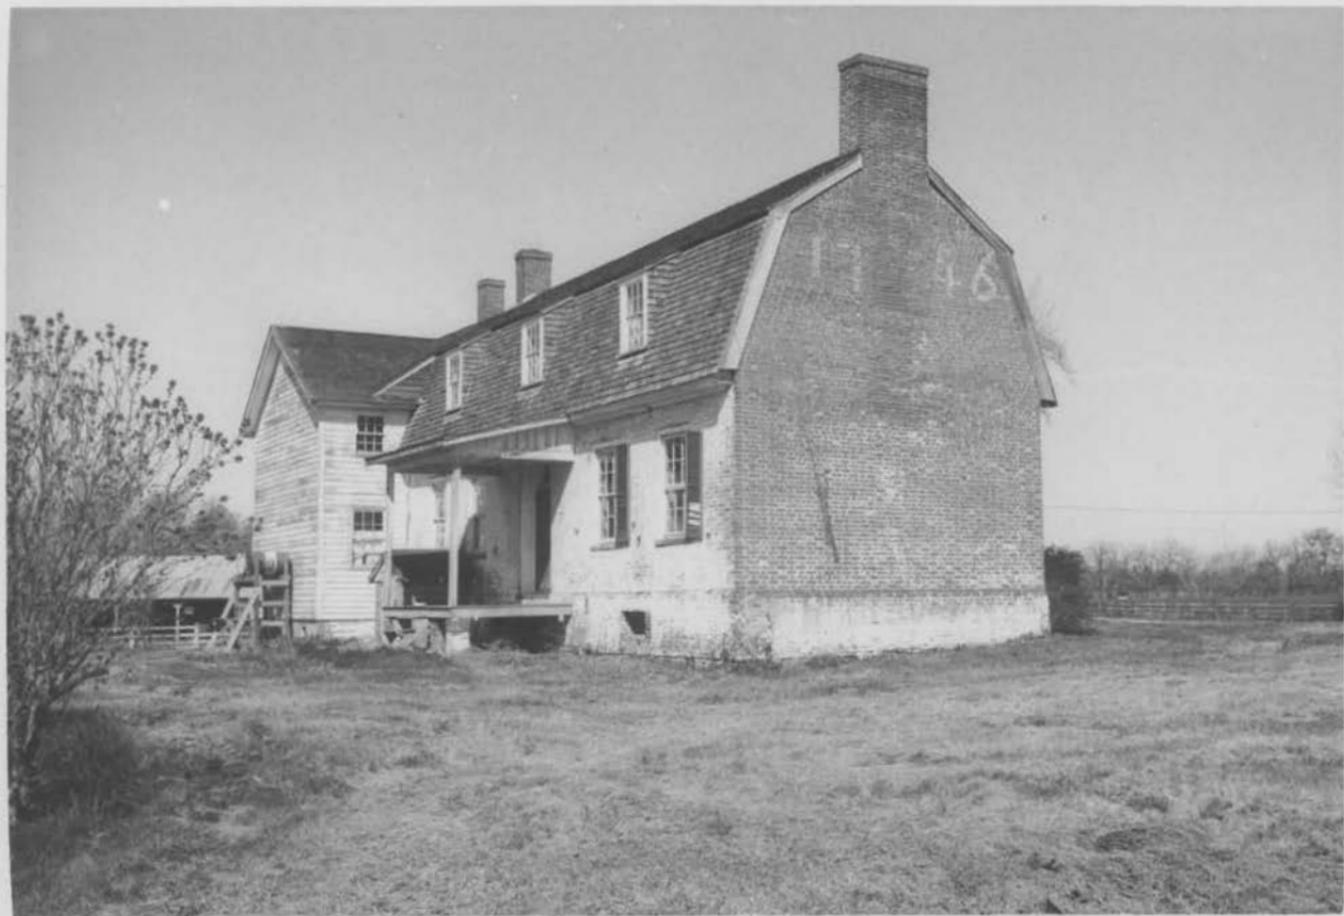
#104

Mary Brown Farm
Centerville vicinity
View from SE

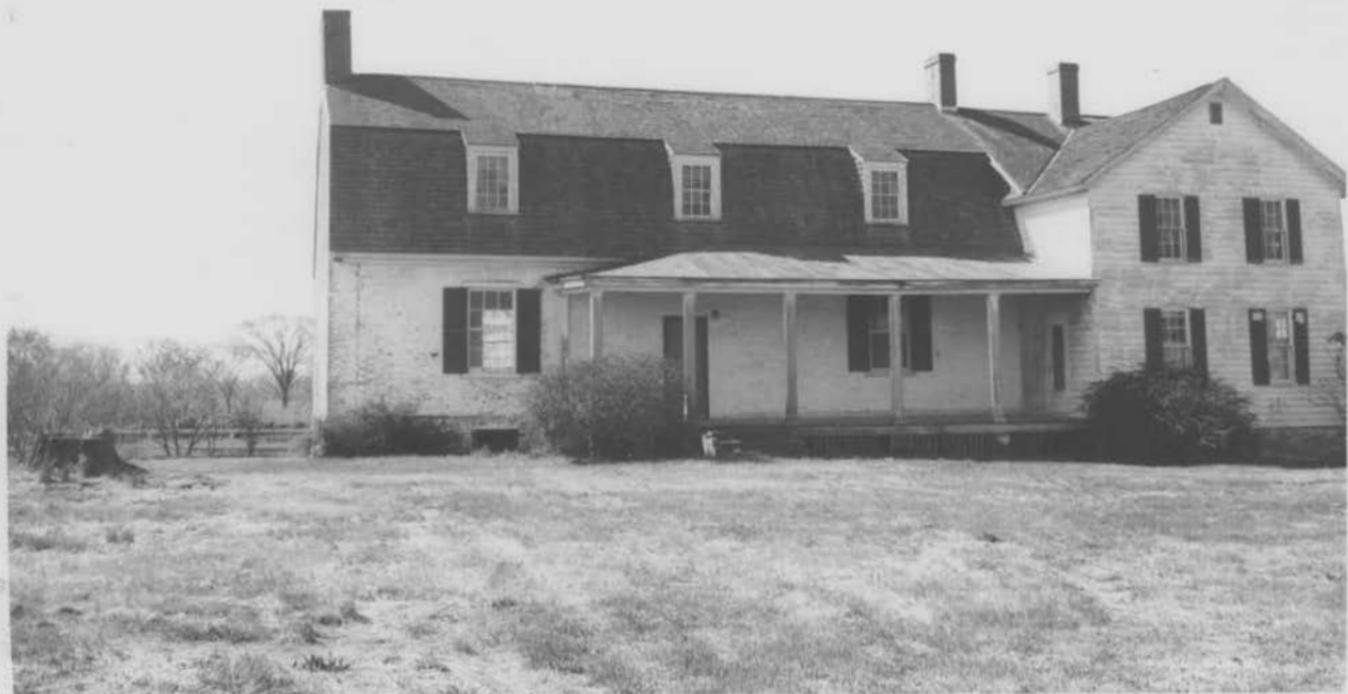
104

On the rear or north facade, the door is offset to left of center, flanked by a single 6/6 window on each side. Three 6/6 shed roof dormer windows are ranged across the second story. The molded water table, segmental brick window openings, molded cornice and shingle roof match the front facade.

Mary Brown Farm
Centerville vicinity
North facade

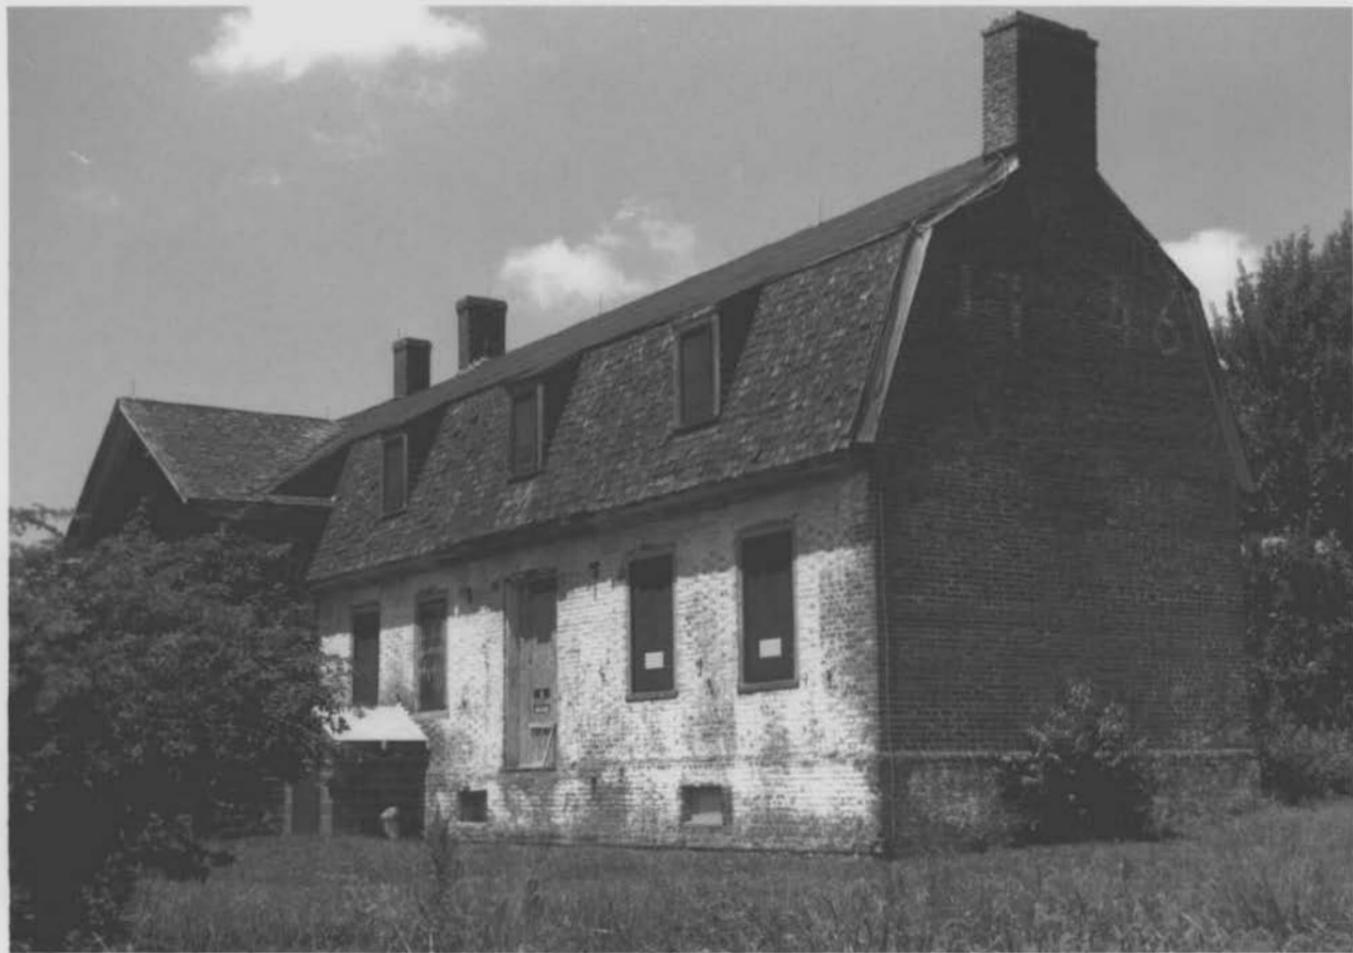
QA-104 Providence (1746)

The front facade of the house faces south, toward the Mill Stream Branch of Corsica Creek. The door is in the center bay flanked by two 6/6 windows on each side. Three 6/6 shed roof dormer windows are ranged across the second story. The brickwork is laid in Flemish bond above a

View from south

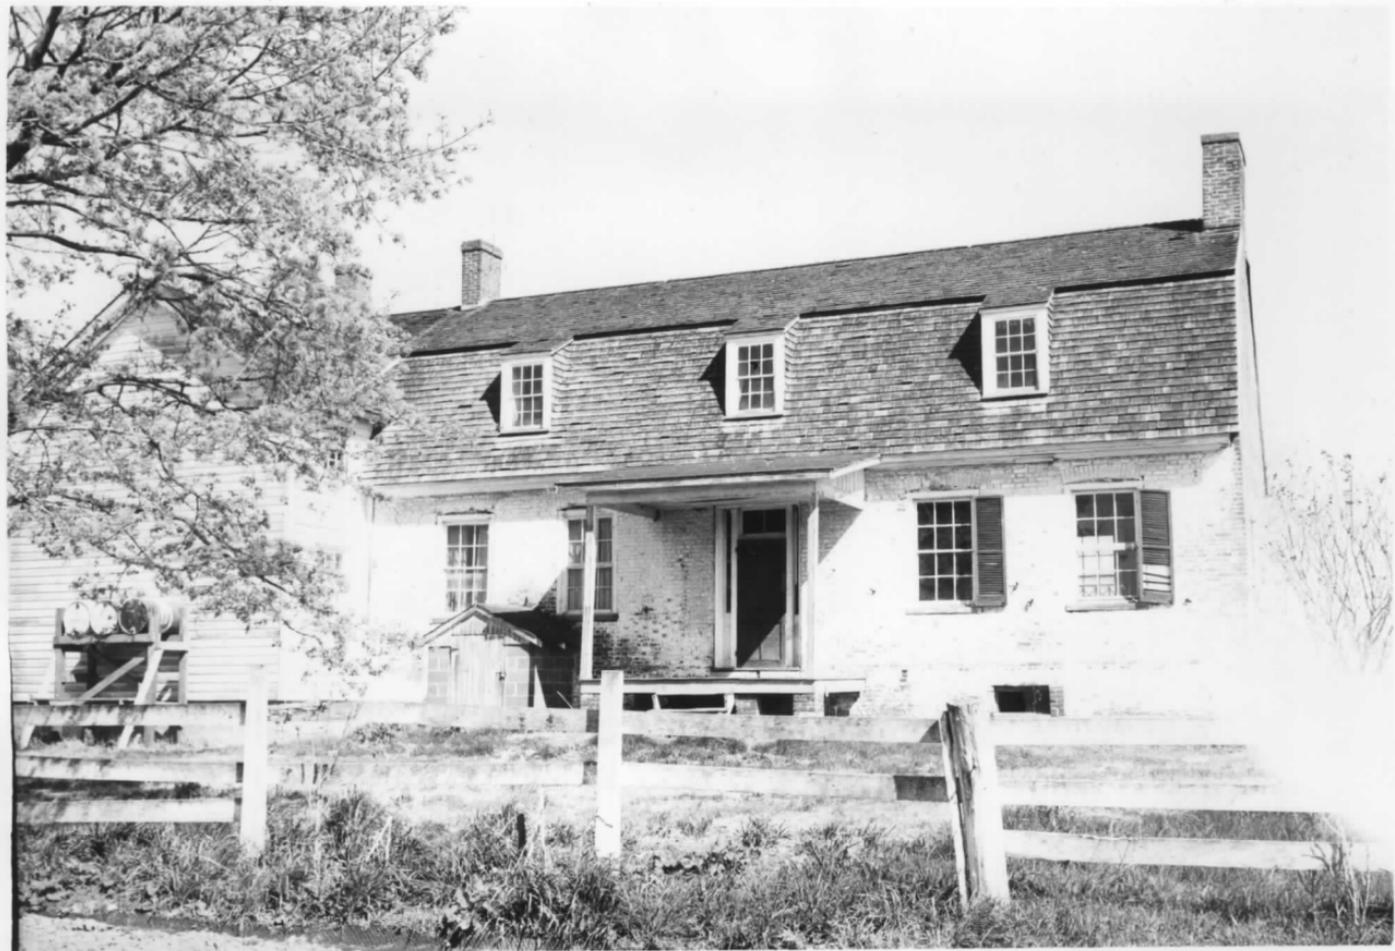
104

molded water table. The window openings have arched brick lintels. The center door is framed with 19th century sidelights and transom. The eaves are boxed in and trimmed with a handsome complex crown mold and bed mold; the roof is covered with wood shingles. A simple entrance porch and concrete block bulkhead cellar entrance have been added in the 20th century.

Mary Brown Farm
Centerville vicinity
South facade

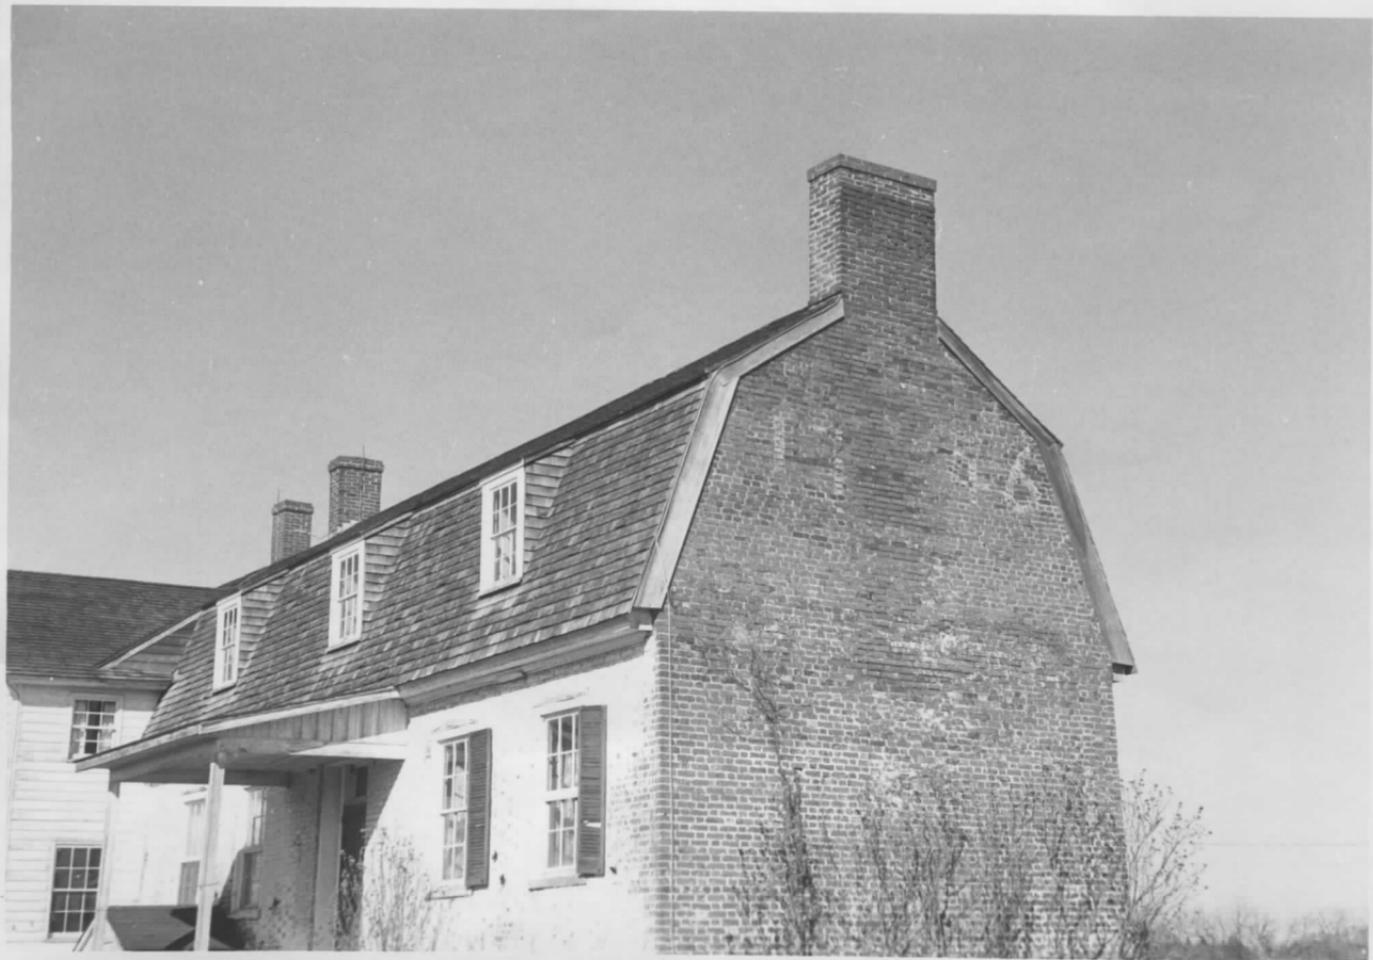
QA 104

View from SE

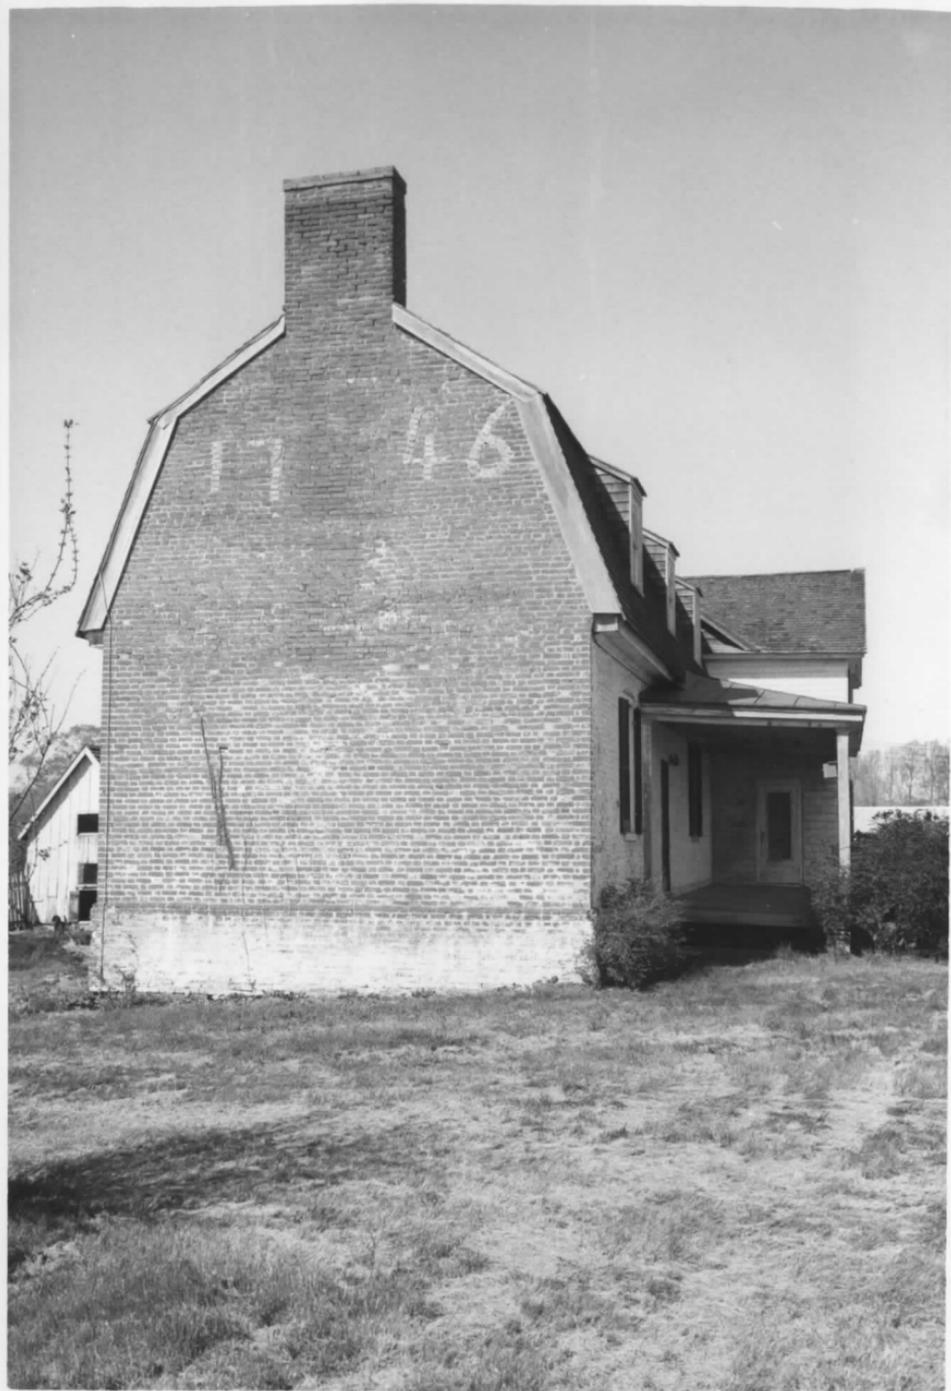
104

There are no openings in the east gable wall. The brickwork is laid in Flemish bond in the first story and English bond in the upper gable above a molded water table and Flemish bond foundation. The date "1746" is incorporated into the upper gable wall using glazed header bricks. The gable rakeboards are replacements.

Mary Brown Farm
Centerville vicinity
East gable w/ date
