INVENTORY FORM FOR STATE HISTORIC SITES SURVEY

Reed Lea

Centreville

QA-112

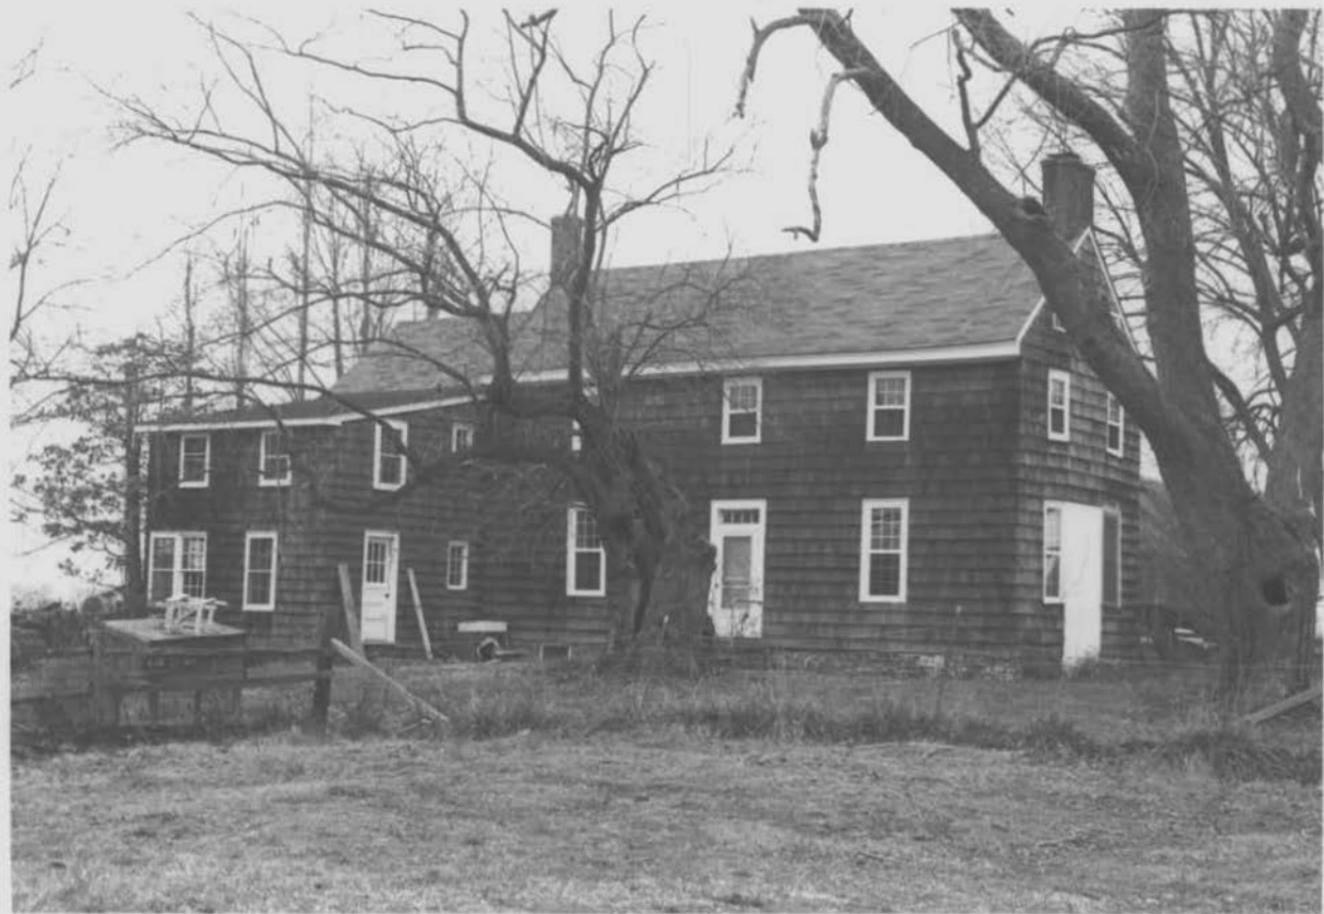
QA-112 Reed Lea
Centreville vicinity
Orlando Ridout V 1981
South facade

south toward the branch that feeds into Reed's Creek. The front door with four-light transom is located in the center bay, flanked by a single 9/9 window on each side. Three 6/6 windows are ranged across the second story. These windows are set in heavy beaded frames with ogee backband trim; the door trim has been replaced. Two small cellar windows to the left of the door provide light to a cellar under the west portion of the house. The eaves are boxed in and trimmed with a replaced crown mold and an original complex bed mold.

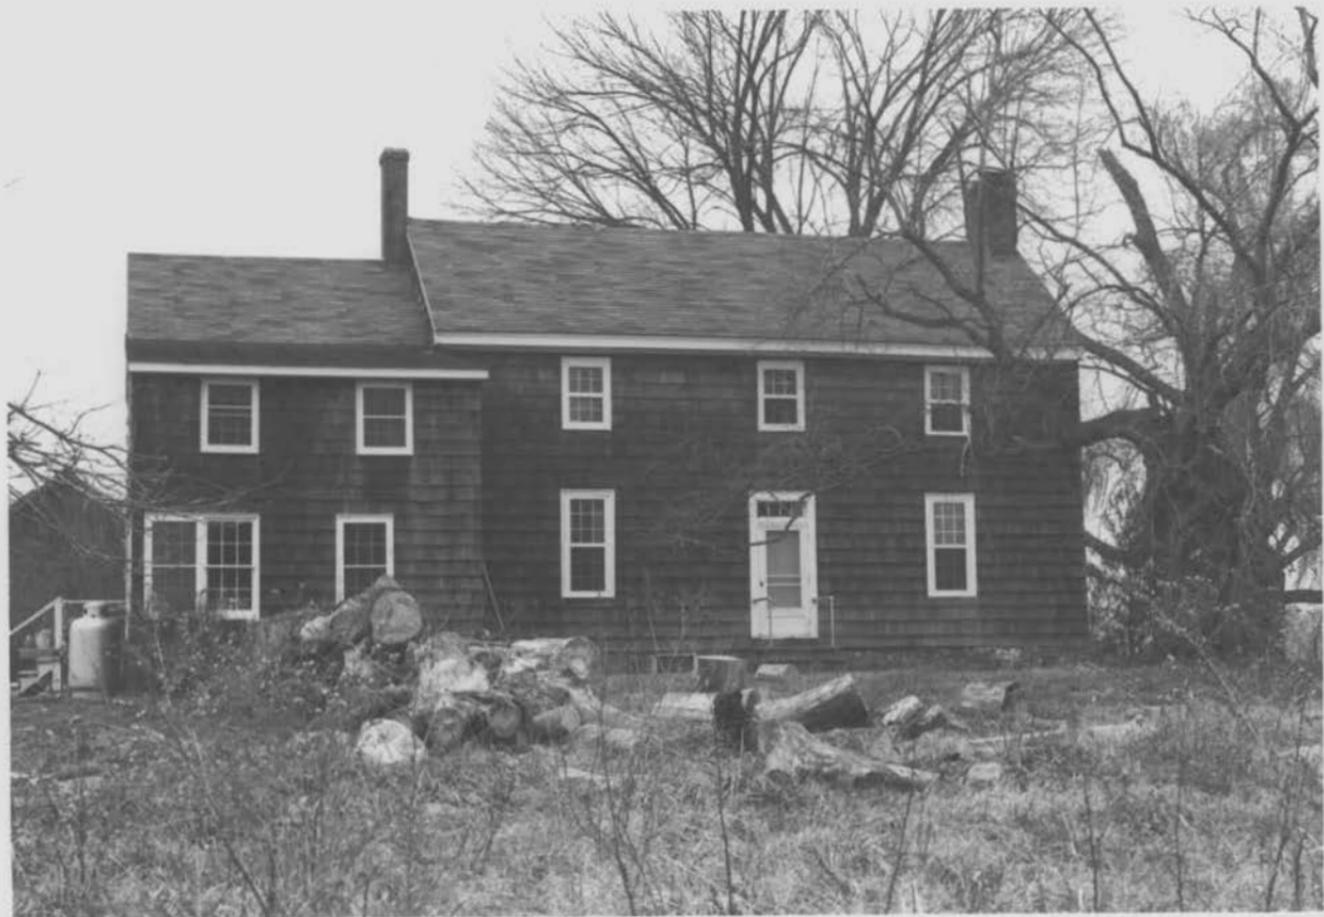
QA-112 Reed Lea
Centreville vicinity
Orlando Ridout V 1981
South facade

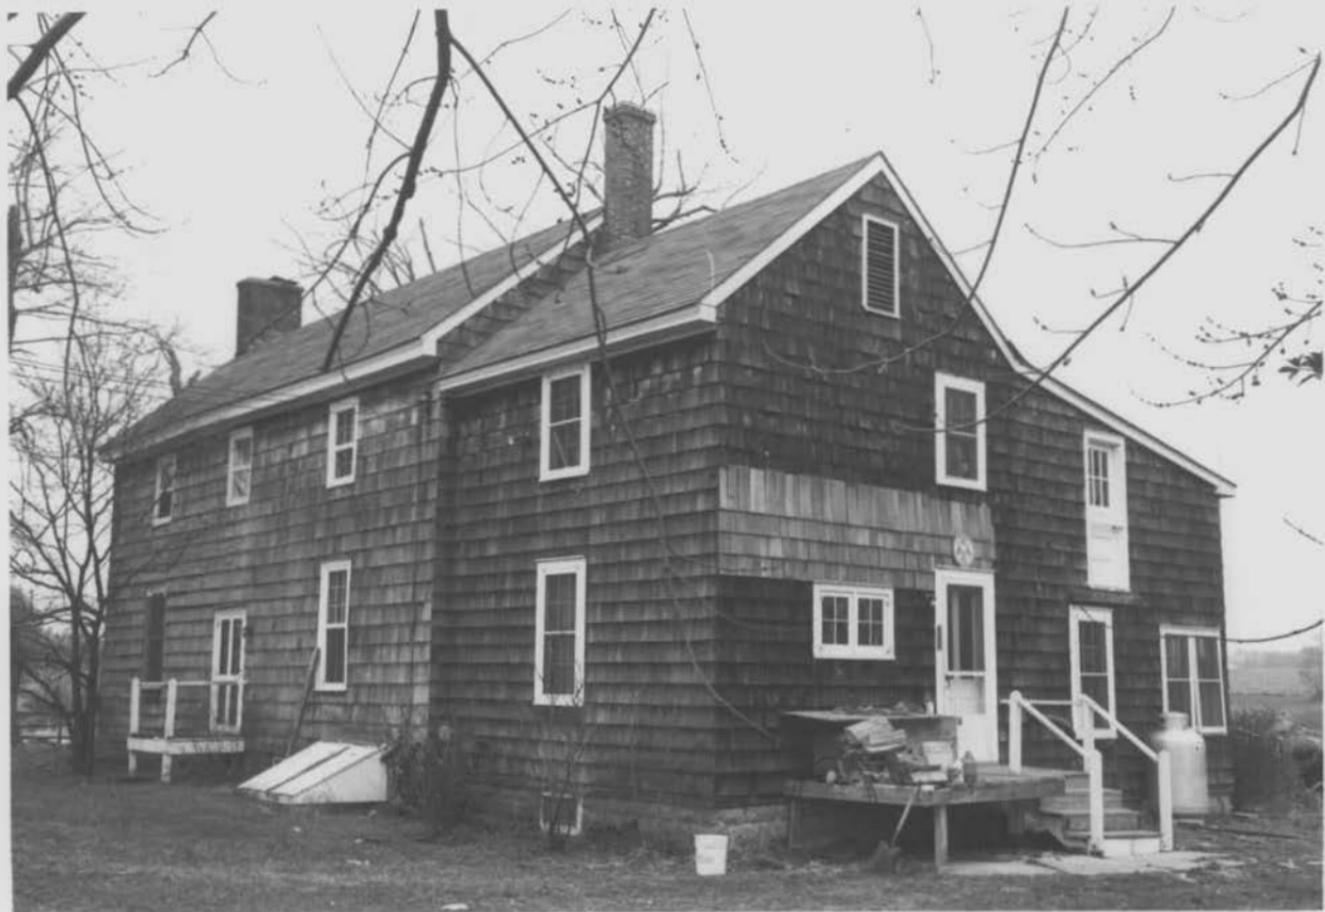
QA-112 Reed Lea
Centreville vicinity
Orlando Ridout V 1981
View from Northwest

The early house known as Reed Lea is of frame construction, two stories high, three bays long and one room deep with a pitched gable roof. Originally there were flush brick chimneys centered on each gable end but the west chimney has been demolished. The building rests on a continuous brick foundation and is covered with wood shingle siding and an asphalt shingle roof. The shingle siding conceals original random-width beaded siding, now visible where it is protected inside the attic of a later wing. The shingle siding has been in use since at least the late 19th century, as hand-split shingles with machine nails also survive in the same gable end. A two story frame wing projects from the west gable wall and extends under a sloping shed roof to the south.

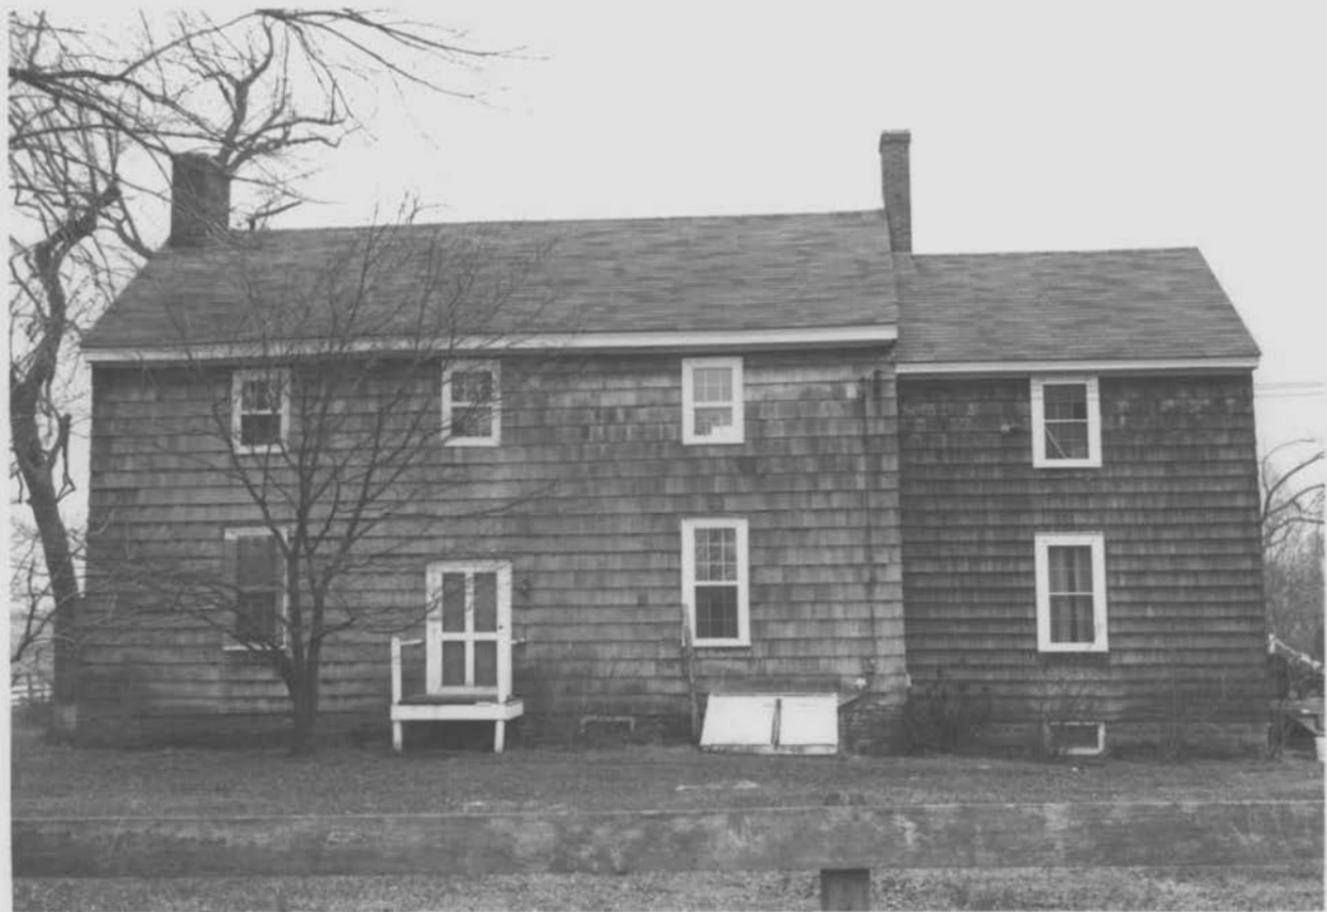
QA-112 Reed Lea
Centreville vicinity
Orlando Ridout V 1981
North facade

The rear facade is virtually identical to the front facade except the center door is lower in height and lacks a transom. A bulkhead cellar entrance is located at the west end of this facade.
