**MARYLAND HISTORICAL TRUST  
DETERMINATION OF ELIGIBILITY FORM**

Property Name: Carpenters Square (May Turpin Farm) Inventory Number: QA-131  
 Address: Wye Mills Centreville Road (MD 213) (west side) Historic district: yes  no  
 City: Wye Mills/Queenstown Zip Code: \_\_\_\_\_ County: Queen Annes  
 USGS Quadrangle(s): Wye Mills  
 Property Owner: \_\_\_\_\_ Tax Account ID Number: \_\_\_\_\_  
 Tax Map Parcel Number(s): \_\_\_\_\_ Tax Map Number: \_\_\_\_\_  
 Project: \_\_\_\_\_ Agency: \_\_\_\_\_  
 Agency Prepared By: DOT/FHWA/E. Elinsky  
 Preparer's Name: \_\_\_\_\_ Date Prepared: 12/3/1979  
 Documentation is presented in: \_\_\_\_\_  
 Preparer's Eligibility Recommendation:  Eligibility recommended  Eligibility not recommended  
 Criteria:  A  B  C  D Considerations:  A  B  C  D  E  F  G  
*Complete if the property is a contributing or non-contributing resource to a NR district/property:*  
 Name of the District/Property: \_\_\_\_\_  
 Inventory Number: \_\_\_\_\_ Eligible:  yes  no Listed:  yes  no

QA-131  
May Turpin Farm  
Wye Mills vicinity  
Private

INVENTORY FORM FOR STATE HISTORIC SITES SURVEY

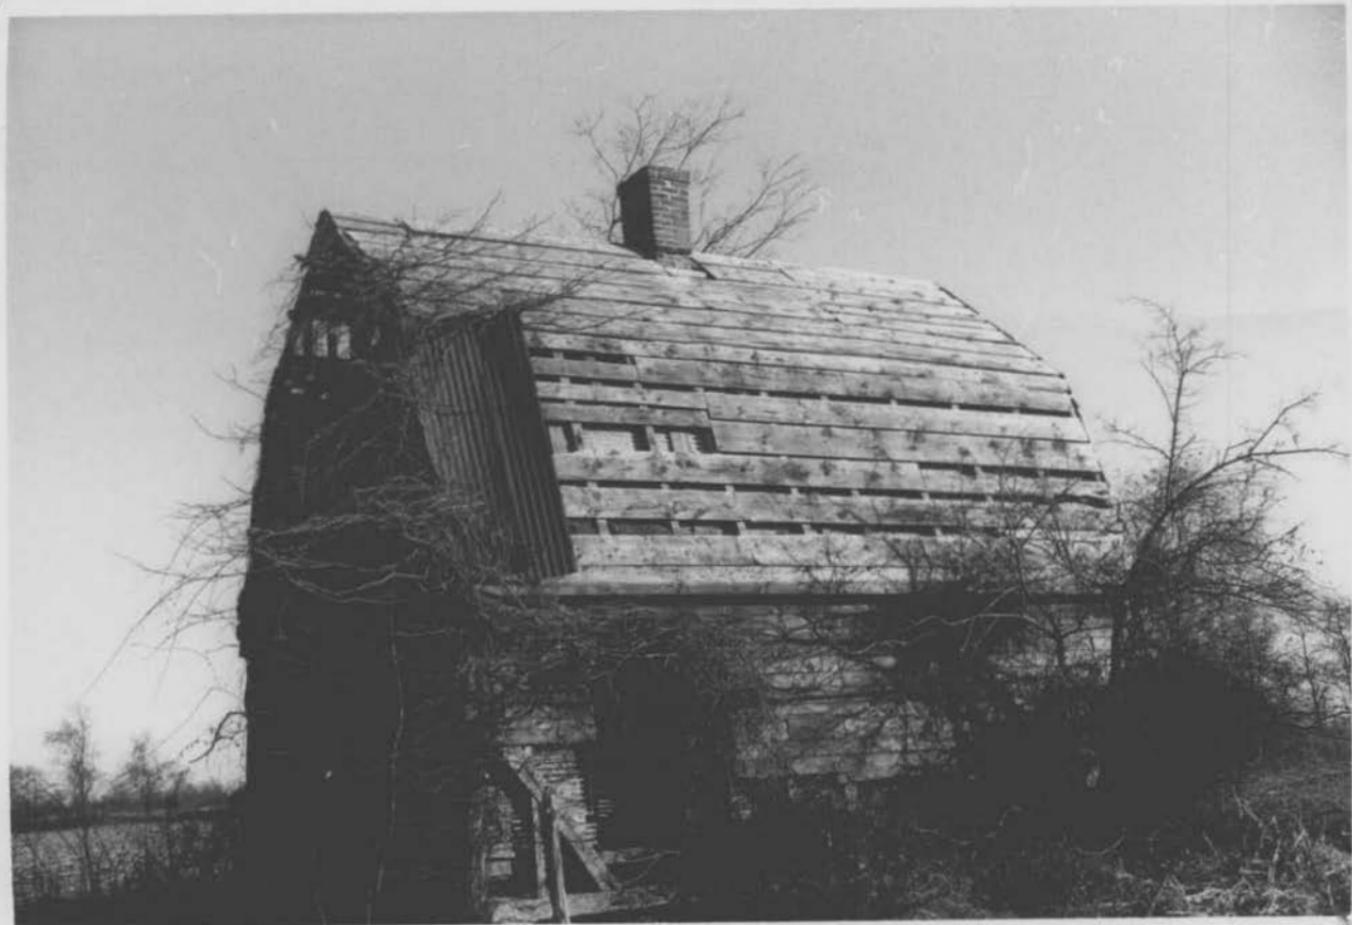
QA-131 May Turpin Farm

Building to rear of house  
(since destroyed)

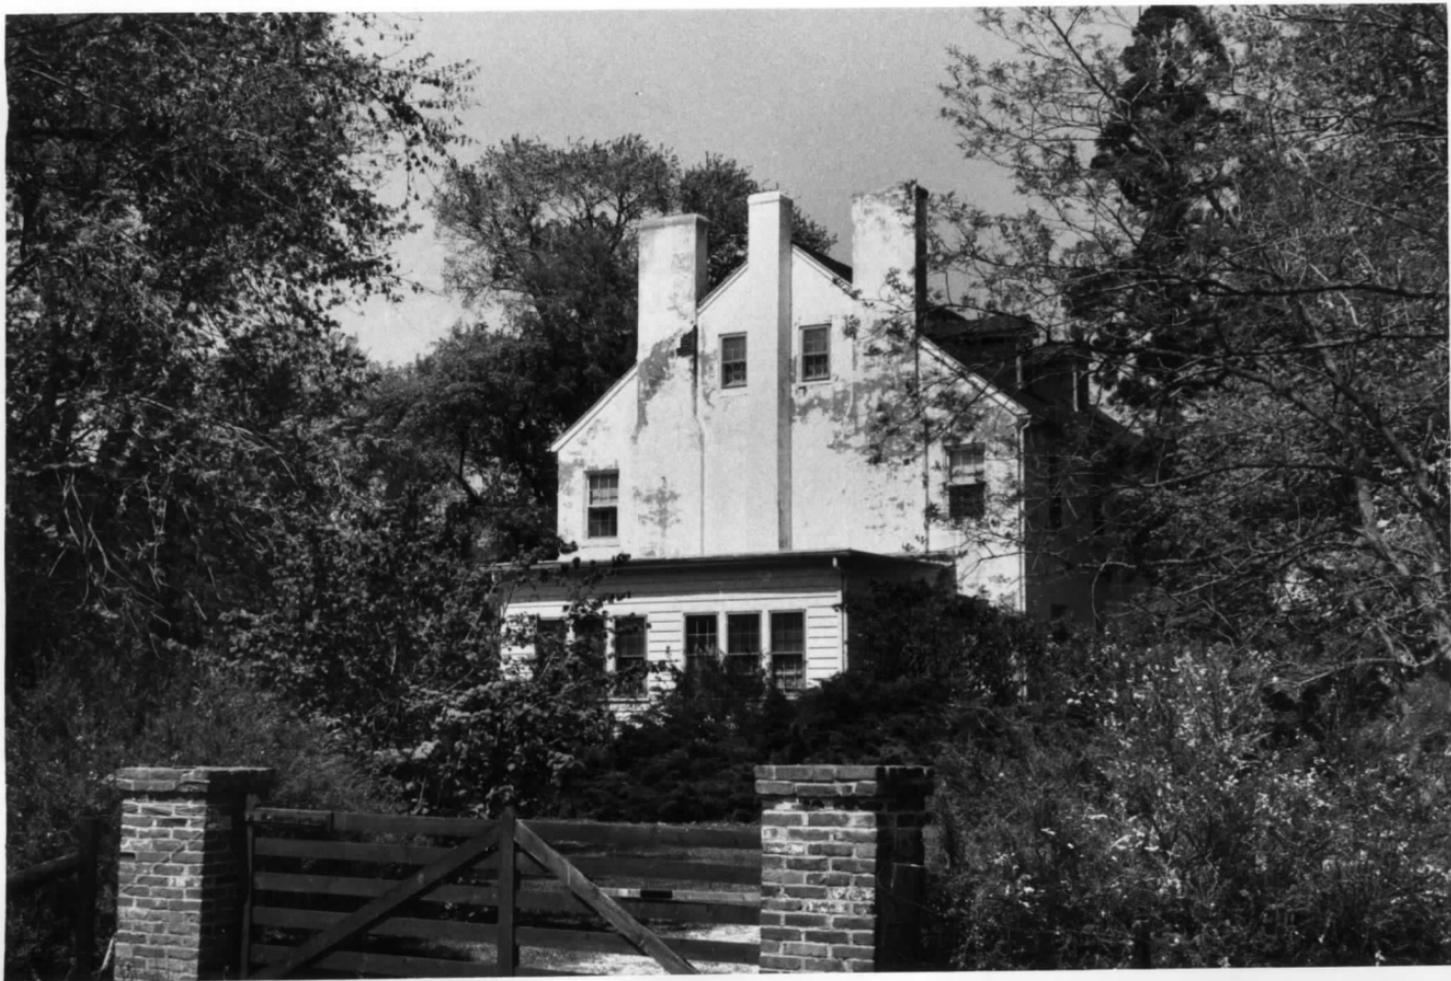
QA-131

May Turpin Farm  
Wye Mills vicinity  
Rita Suffness, 1979  
South Gable

The south gable wall is now partially concealed by a modern one story frame addition. The gable facade of the early house is dominated by the paired brick chimneys which protrude approximately five inches from the wall surface, and are shouldered at the second floor eave level. A modern single-flue chimney has been added against this wall, rising between the original chimneys. There are six-over-six windows in the east and west bays on the first and second floor, and two small six-over-six windows between the original chimneys in the upper gable. Cellar windows remain below each first floor window, and the west cellar

window is still fitted with three-over-three sash and a wood frame with diamond-section horizontal bars. The gable eaves are finished with beaded and tapered rakeboards.

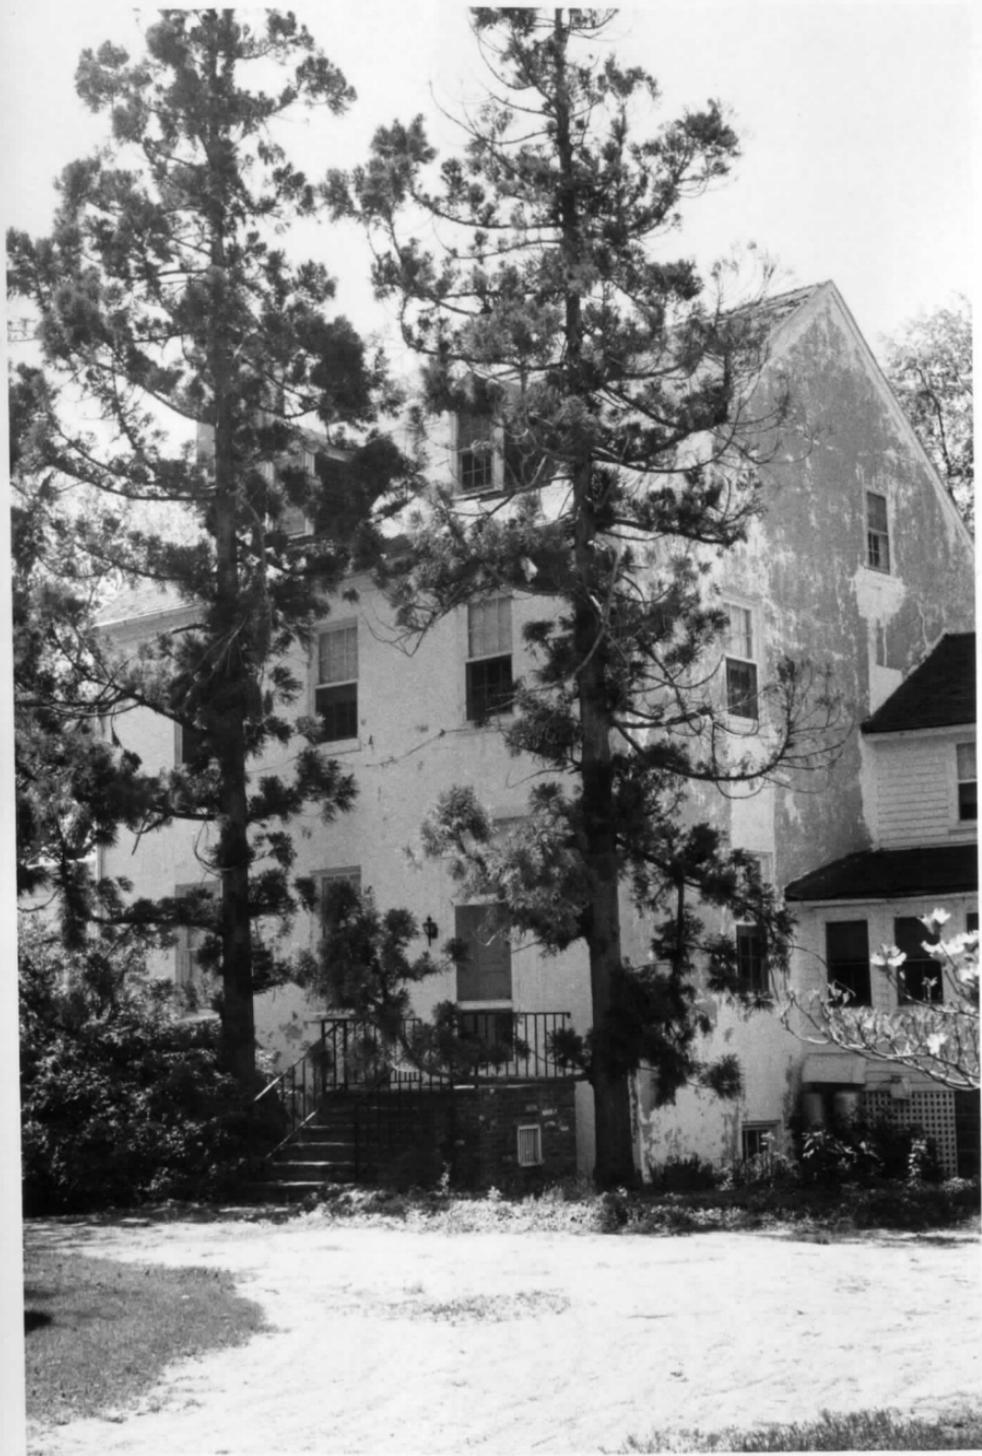
QA-131

May Turpin Farm  
Wye Mills vicinity  
Rita Suffness, 1979  
Front facade from east

The front facade faces east, toward Route 213. The principal entrance is located in the north bay of this facade, with two six-over-six windows to the left, three six-over-six windows ranged across the second floor, and a pair of pitched roof six-over-six dormers on the third floor. Small cellar windows that were once fitted with three-over-three sash are positioned directly

below each first floor window. The door opening has a paneled soffit and jambs, and the paneled door is set off by a three-light transom. The present door surround has a Federal flavor to it, but may be a modern feature. Traces of an entrance porch remain visible in the stucco rendering, which has been scored on this facade to suggest rustication. No evidence remains visible to identify the bonding pattern of the brickwork, and there is no watertable or belt course. The cornice is corbeled in brick and stuccoed, while the roof is covered with asphalt shingles.

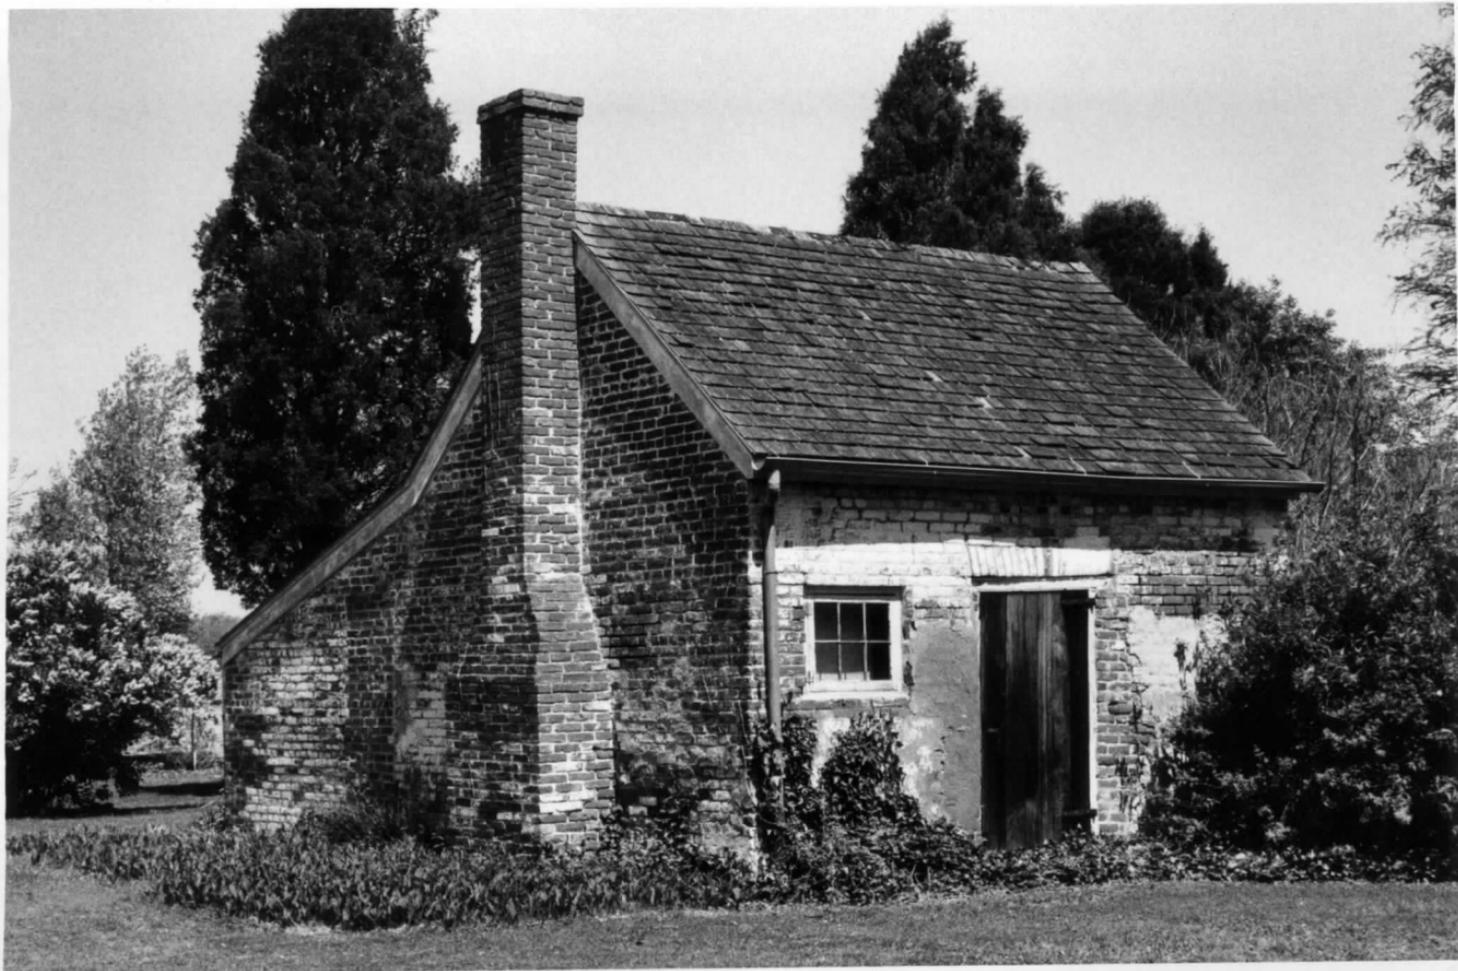
QA-131

May Turpin Farm  
Wye Mills vicinity  
Rita Suffness, 1979  
Quarter/Outbuilding

Immediately to the north of the large brick house on the Turpin farm is a small brick outbuilding. Although the original use of this building cannot be positively ascertained, architectural evidence strongly suggests it was either a slave quarter or a combined kitchen and quarter.

The building is of rather unusual form, with a pitched-roof front section that measures approximately 16 feet wide and 14 feet deep, and an original outshut that stretches an additional 11½ feet to the rear. The brickwork is laid in five course bond without a watertable. The roof has been rebuilt but copies the original roof in form and pitch. A one-flue exterior chimney has been added to the west gable of the front section, replacing the original chimney located in the center of the building.

The front facade faces south, with a door located in the center bay and a small six-light sash window to the left of the door mounted on side hinges to serve as a casement. A large six-over-six window is centered on the east gable of the front section, while simple doors in both the east and west walls of the rear

The interior is divided into a single room in the front section with an open loft and a slightly smaller room in the rear outshut. There is no interior access between the two rooms, but seams in the brick partition wall indicate the location of an original shared chimney stack that has been demolished. This projected out into the front room, with fireplaces in both the front and rear rooms. A small fireplace in the west wall of the front room was cut in when the original chimney was demolished. Both rooms clearly had dirt floors, and the rear room had whitewashed brick walls, while traces of plaster remain on two of the walls in the front room. The loft in the front room was apparently always open, as there is no evidence of flooring nails on the top face of the joists, though boards were sometimes laid across the joists without being nailed down. The existing joists all appear to be original, as they are bedded in the masonry of the front and rear wall. Two of these are clearly pit sawn, while a third is obviously circular sawn, suggesting a date of construction of circa 1840.
