QA-164
Great Neck
Stevensville vicinity
Private

INVENTORY FORM FOR STATE HISTORIC SITES SURVEY

Great Neck, Hopkins House

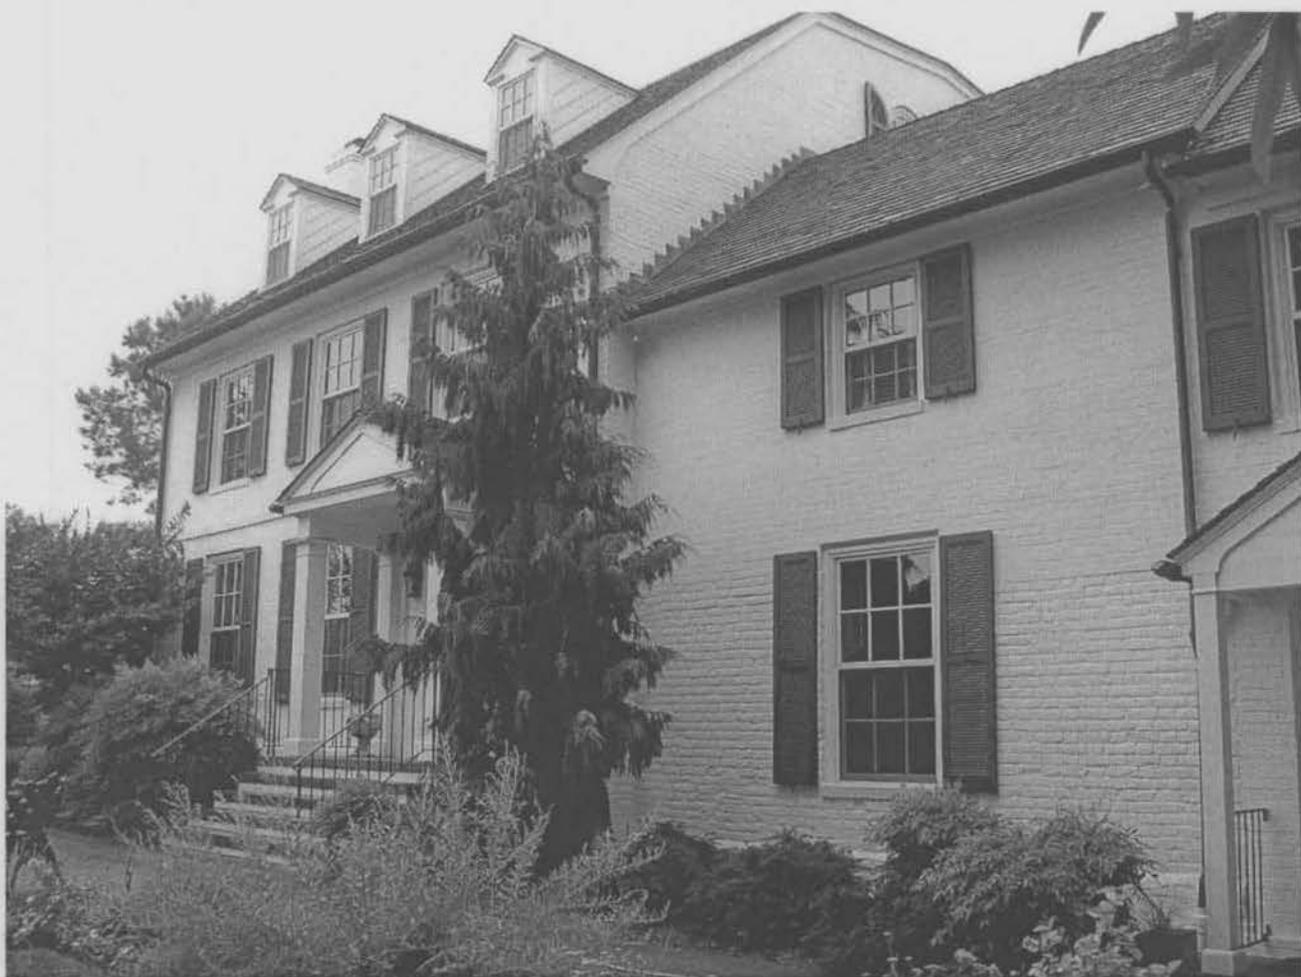
QA-164
Great Neck

Mary McCarthy
Spring/Summer 2003
Digital color photo on file at MHT

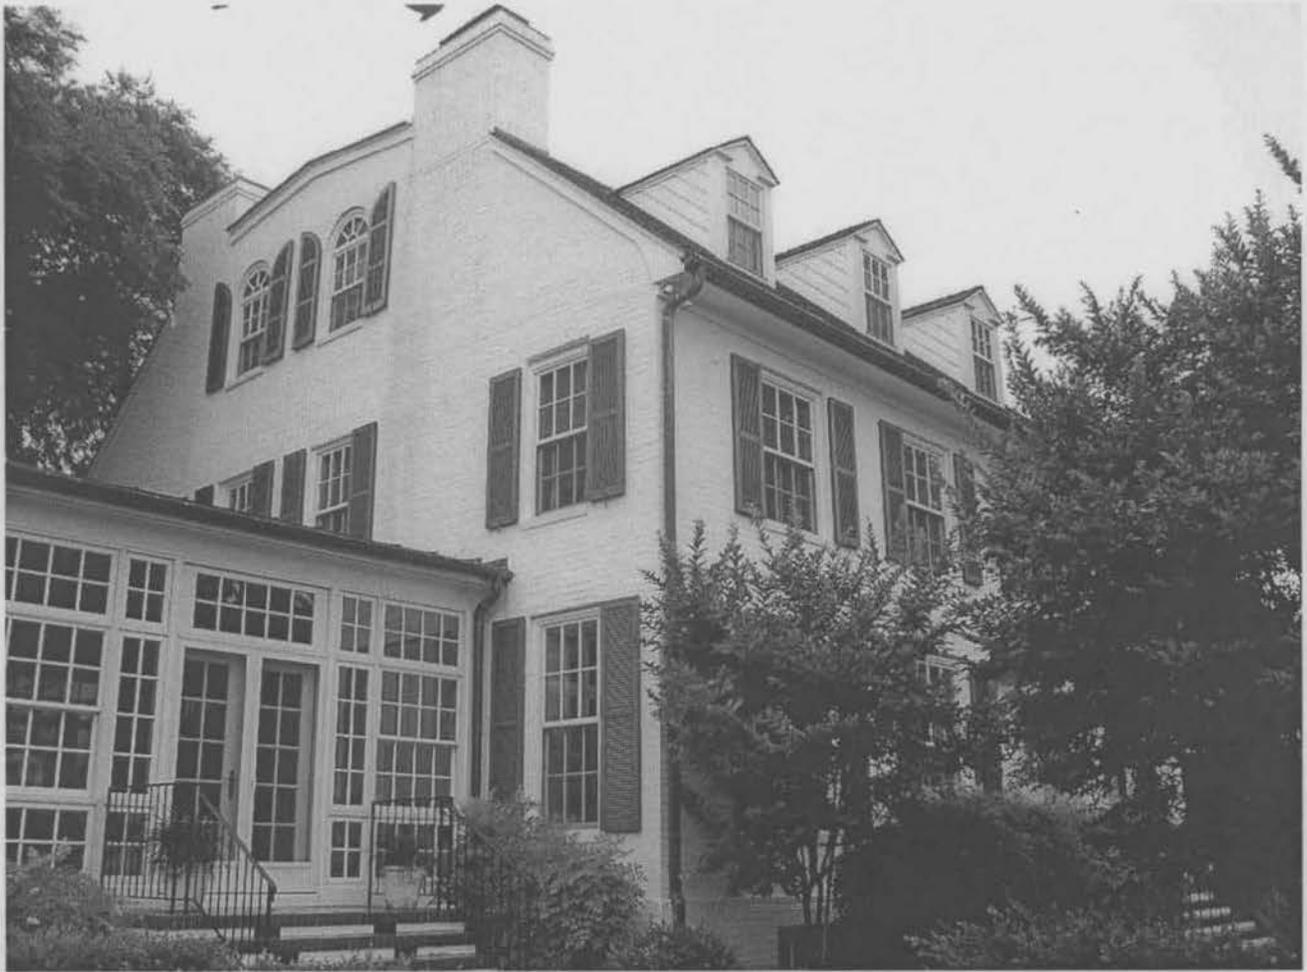
QA-164
Great Neck

Mary McCarthy
Spring/Summer 2003
Digital color photo on file at MHT

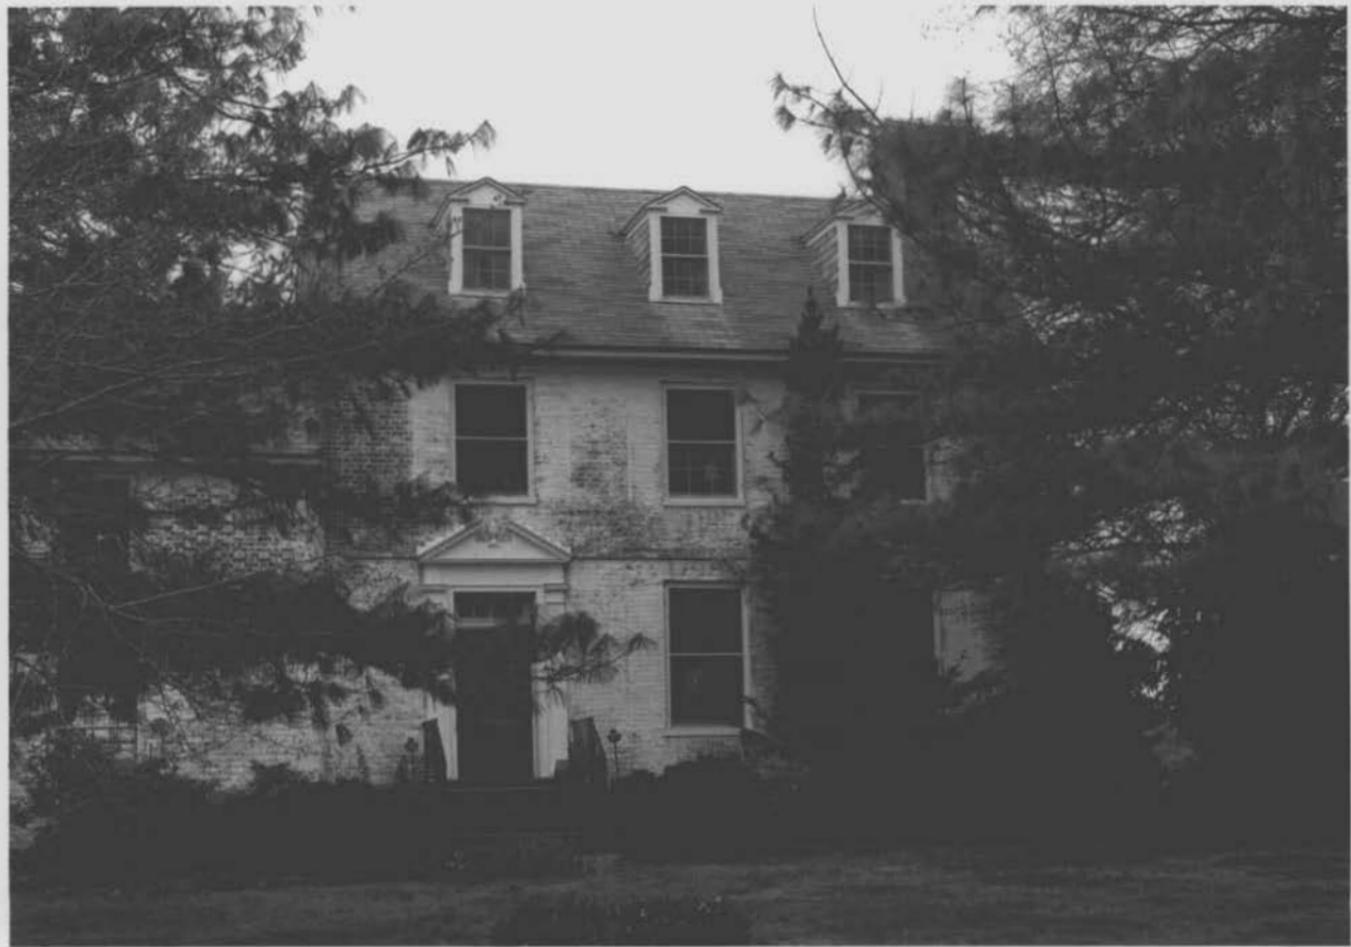
QA-164

The brickwork and fenestration on the south facade, facing the creek, match the north facade except that the east bay is offset slightly on all three floors to accommodate the stair. The door is fitted with a 20th century surround with reeded pilasters. There is no transom, but this may be due to an alteration. The eaves are finished with a deep box cornice, a complex crown mold and a small bed mold.

South facade

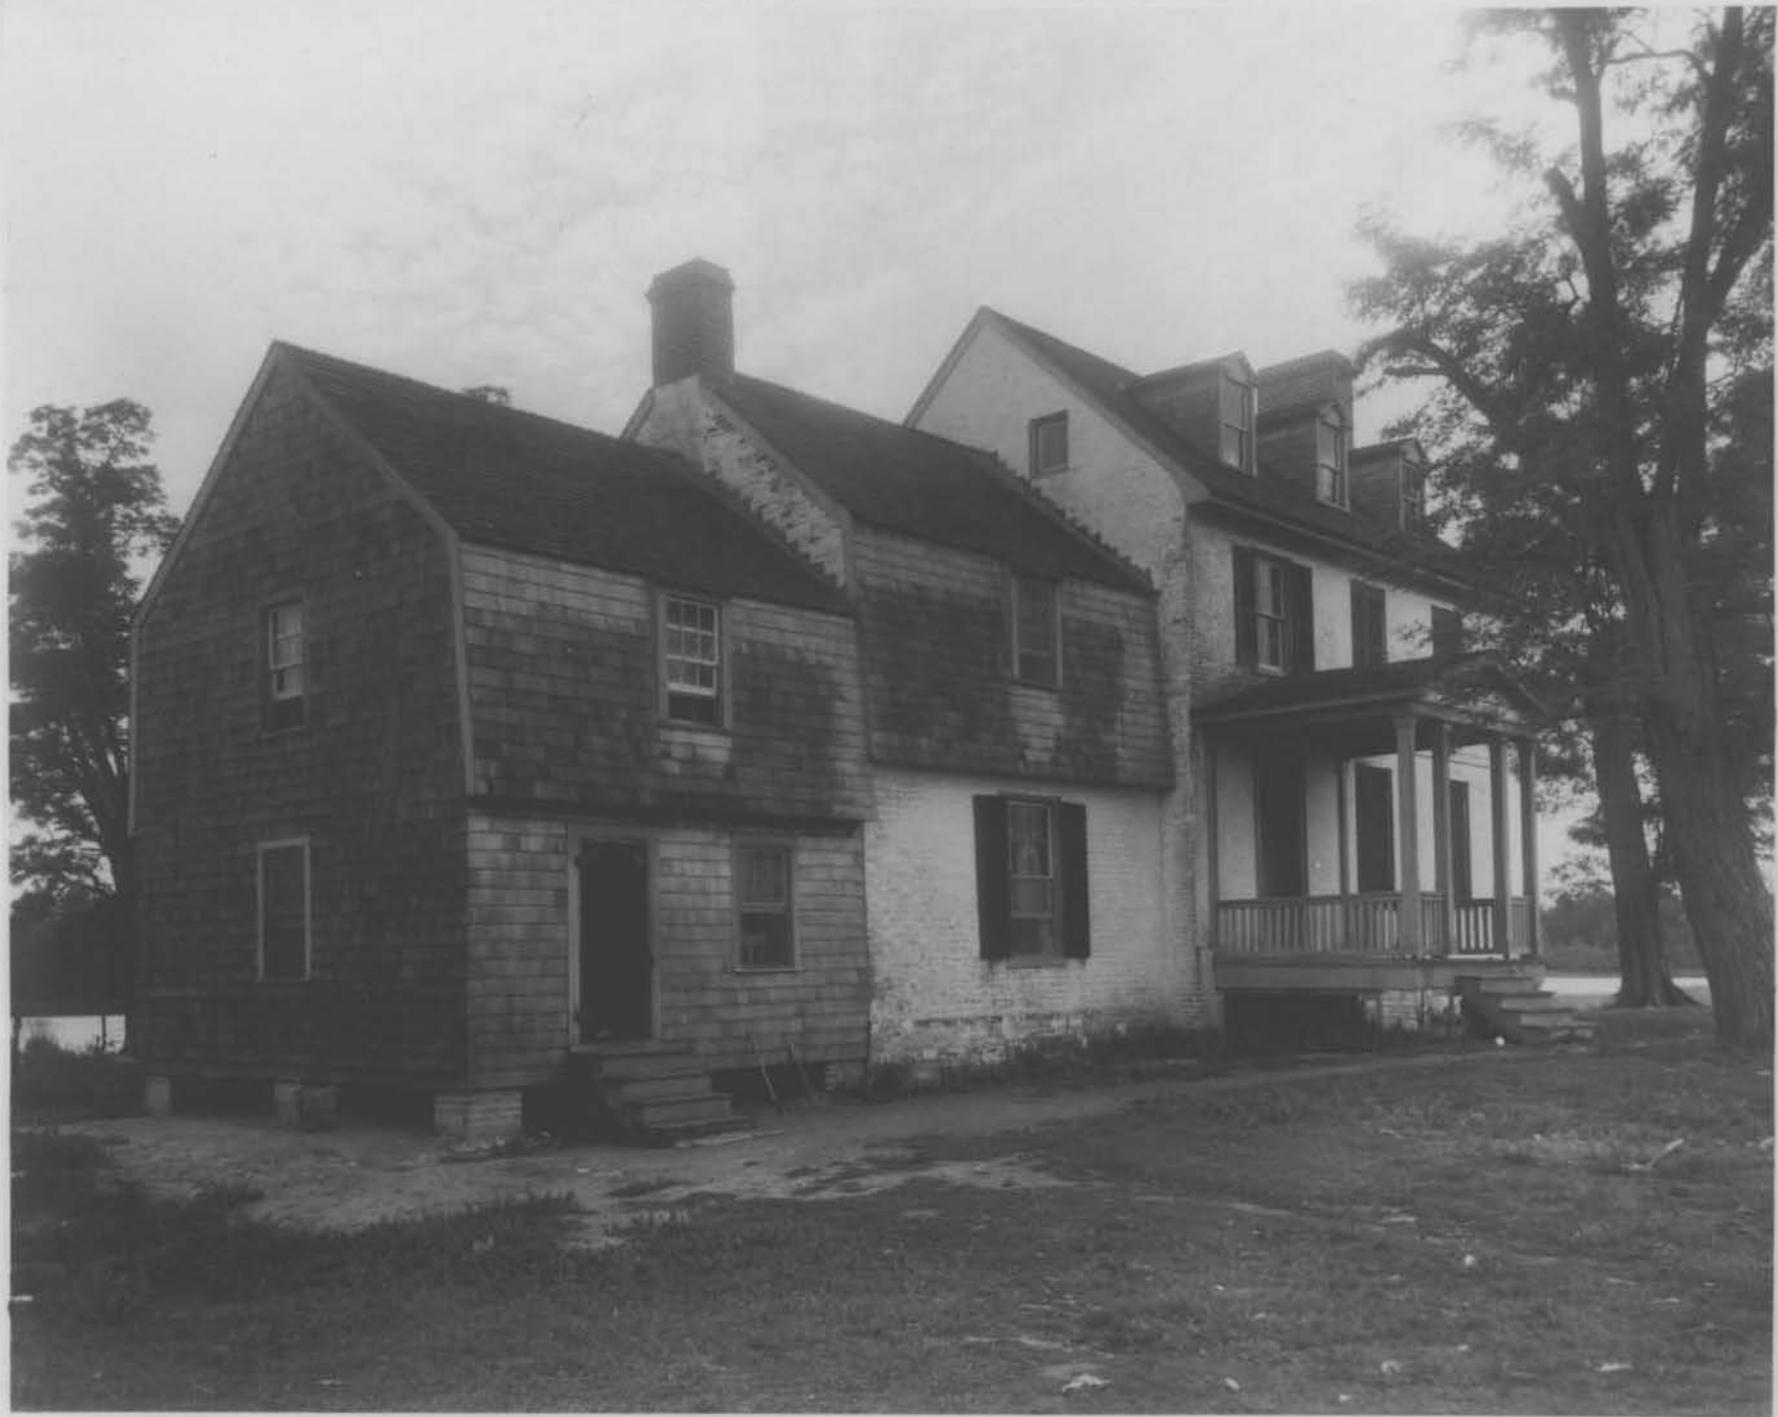
The interior of the main house consists of a side hall, single parlor plan with the stair hall at the east end of the building. The stair rises against the east wall to a landing on the south facade. It is an open-string stair with a molded rail and square ballusters. The square walnut newels are reeded on each face, quite similar to the newels at

Morgan's Enclosure (QA-169). A half-rail and newels are carried up the other side of the stair, against the wall. A single large fielded pine panel fills the area below the carriage, which is decorated with solid scrolled stair brackets of walnut, which contrasts with the pine carriage piece. A six-panel door under the landing opens onto the cellar stairs. A door in the east wall of the hall at the foot of the main stairway leads down four steps into the wing. Handsome paneled exterior doors at opposing ends of the hall are hung on modern H-L hinges. A six-panel door in the west partition wall opens into the parlor. The Federal mantel in this room was brought from New England and installed by a previous owner in the 1930's. Decorative details in the parlor include the paneled soffit and jambs of the door to the hall, splayed but unpaneled window jambs, and architrave trim composed of a wide beaded fascia board with a bold ogee backband.

QA-164 Great Neck
 Stevensville vicinity
 Kent Island
 Orlando Ridout V 1980
 Interior stair
