QA-167

Samuel Aaron Farm
Romanceke vicinity
Private

INVENTORY FORM FOR STATE HISTORIC SITES SURVEY

Samuel Aaron farm, Tolson farm

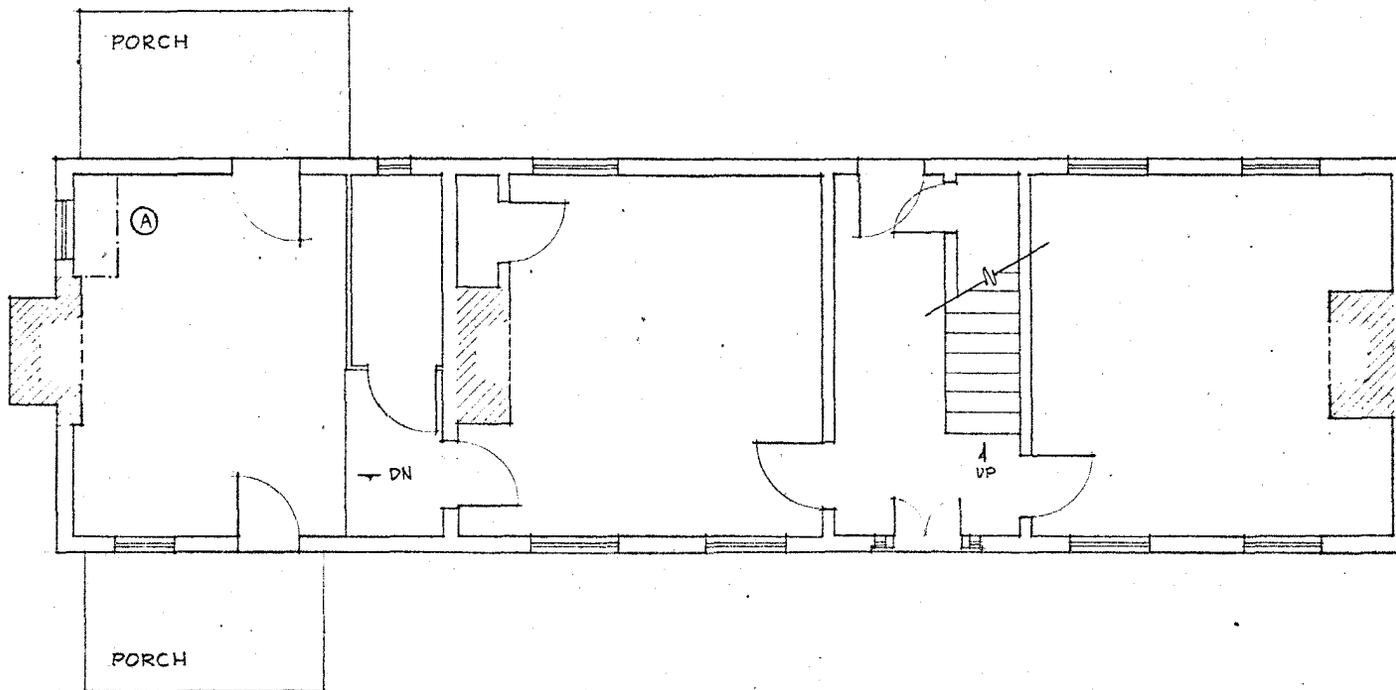
A LOCATION OF ORIGINAL STAIR TO LOFT

belief that this was the traditional method, and there had never been an interior stair. An examination of the loft, however, reveals a stair opening in the southwest corner. Although no evidence of the stair carriages could be found, it seems likely it was a very steep ladder-stair without risers between the treads, similar to the loft stair in the wing of the Goodhand House (QA-10), in nearby Chester. The opening has been covered with short floorboards in the loft, and the hole in the ceiling has been plastered.
