**National Register of Historic Places
Inventory—Nomination Form**

historic Bishopton

Bishopton is a c. 1730 brick dwelling, 1½ stories high, three bays wide, and one room deep with a hall-parlor plan, located near Church Hill in Queen Anne's County, Maryland. The house is sited on open high ground and faces east. The facades are laid in glazed header Flemish bond above a plain water table and English bond foundation; the upper gables feature glazed chevron patterns. The principal (east) facade has a central entrance, flanked by 6/6 windows in segmental-arched openings; three Federal-period 6/6 gable roof dormers are ranged across the second story. The south end of this facade has been extensively repaired. The west facade remains undisturbed, and has similar fenestration. The roof is covered with modern split shingles; the two 6/6 shed roof dormers on the west slope, and the cornice on both sides, are entirely rebuilt. A c. 1974 frame addition extends to the south, replacing a 19th century frame wing of similar proportions and size. The interior evidently remained unfinished throughout the 18th century and was not completed until the Federal period. A brick interior partition se

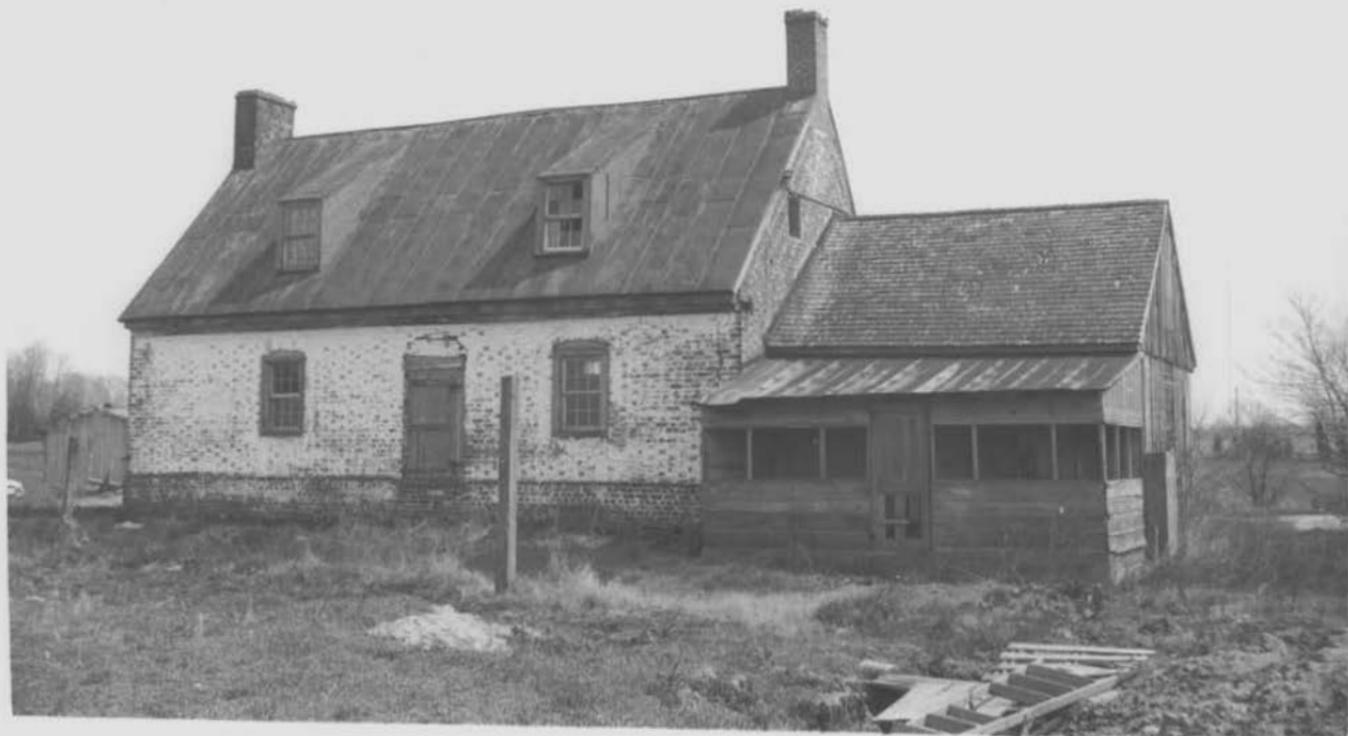
QA # 18
Birstington
West facade

The west facade remains largely undisturbed. The door is offset slightly to south of center, flanked by single 6/6 windows on each side. Two 6/6 shed roof dormers are ranged across the steeply pitched roof. The brickwork is laid in glazed header Flemish bond above a plain water table and an English bond foundation. The window openings have segmentally arched lintels one brick high. Glazed headers alternate with plain stretchers in the arches. The lintel above the door has been reworked. The window frames are not original and are tricked out with early 19th century trim. The roof is covered with modern split shingles and the dormers and cornice are entirely rebuilt.

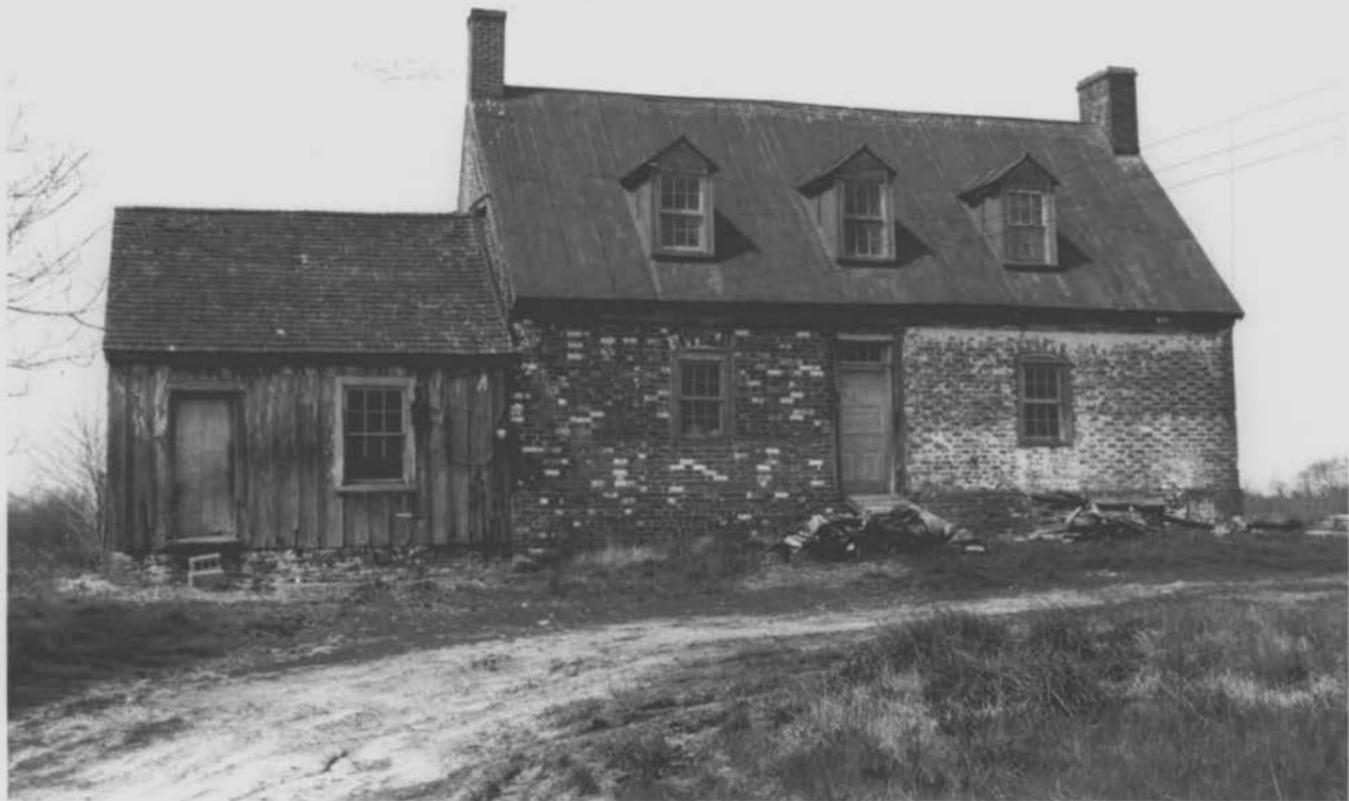
Bishopton
Church Hill vicinity
James W. Valliant, 1973
East facade

The east facade is similar to the west facade except the south end of the wall has been extensively repaired. The center door is flanked by single 6/6 windows; three 6/6 gable roof dormer windows are ranged across the second story. These dormers are pilastered with cornice returns and blocks, typical of the Federal period. The roof is covered with modern split shingles; the cornice is rebuilt.

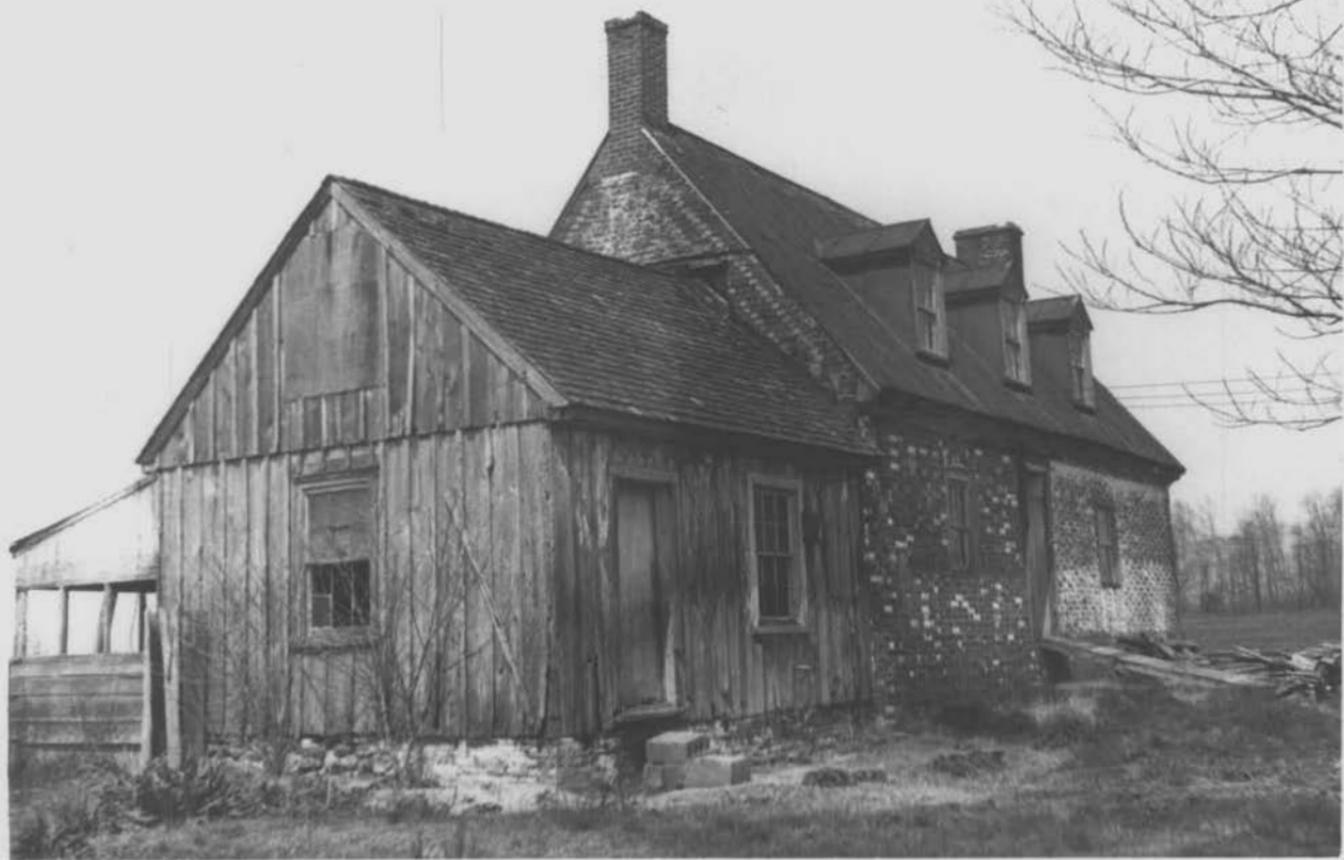
Bishopton
Church Hill vicinity
James W. Valliant, 1973
View from Southeast

The south gable wall has been completely rebuilt. The original bonding pattern was reproduced including the glazed headers and glazed chevron. The only opening is a small window to the right of the chimney in the upper gable.

The frame addition on the south gable wall was constructed circa 1974-1975 and replaced an earlier 19th century frame wing of similar proportions and size.
