QA-190
Sylvester Farm
Queen Anne vicinity
Private

INVENTORY FORM FOR STATE HISTORIC SITES SURVEY

Sylvester Farm

QA-190

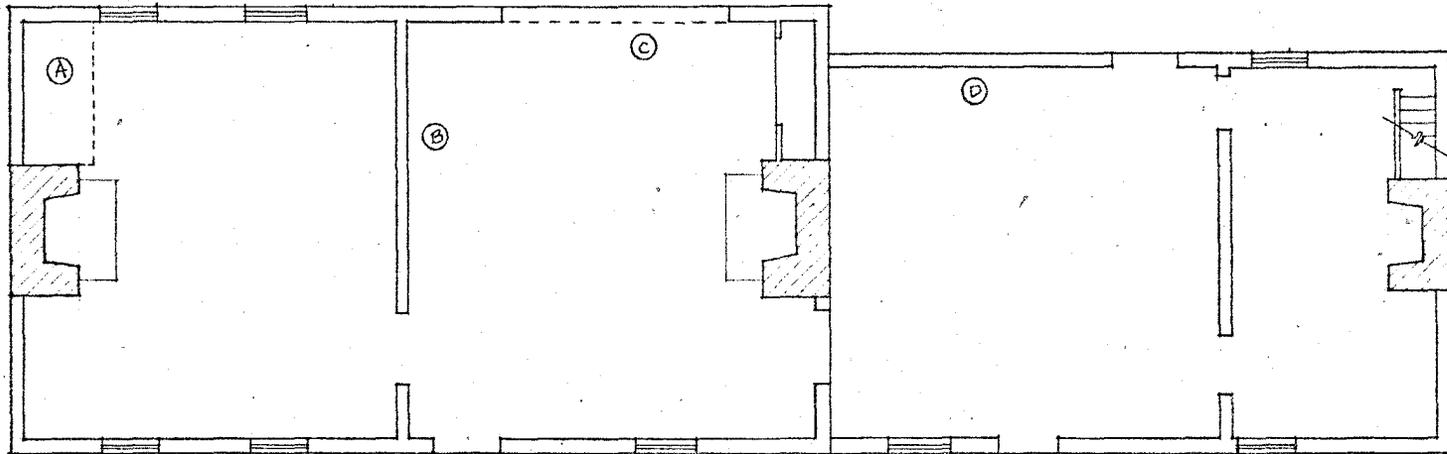
- A PROBABLE LOCATION OF ORIGINAL STAIR
- B LOCATION OF MODERN STAIR
- C REAR WALL OPENED UP INTO MODERN ADDITION
- D MODERN KITCHEN WINDOW

The present stair is modern, and runs in a straight flight along the south wall of the north room, rising from the rear of the house. The west wall in this room has been removed, opening it up into the modern rear addition. Based on seams found in the flooring on the second floor, the original stair was apparently a tight, enclosed winder located in the southwest corner of the south room.

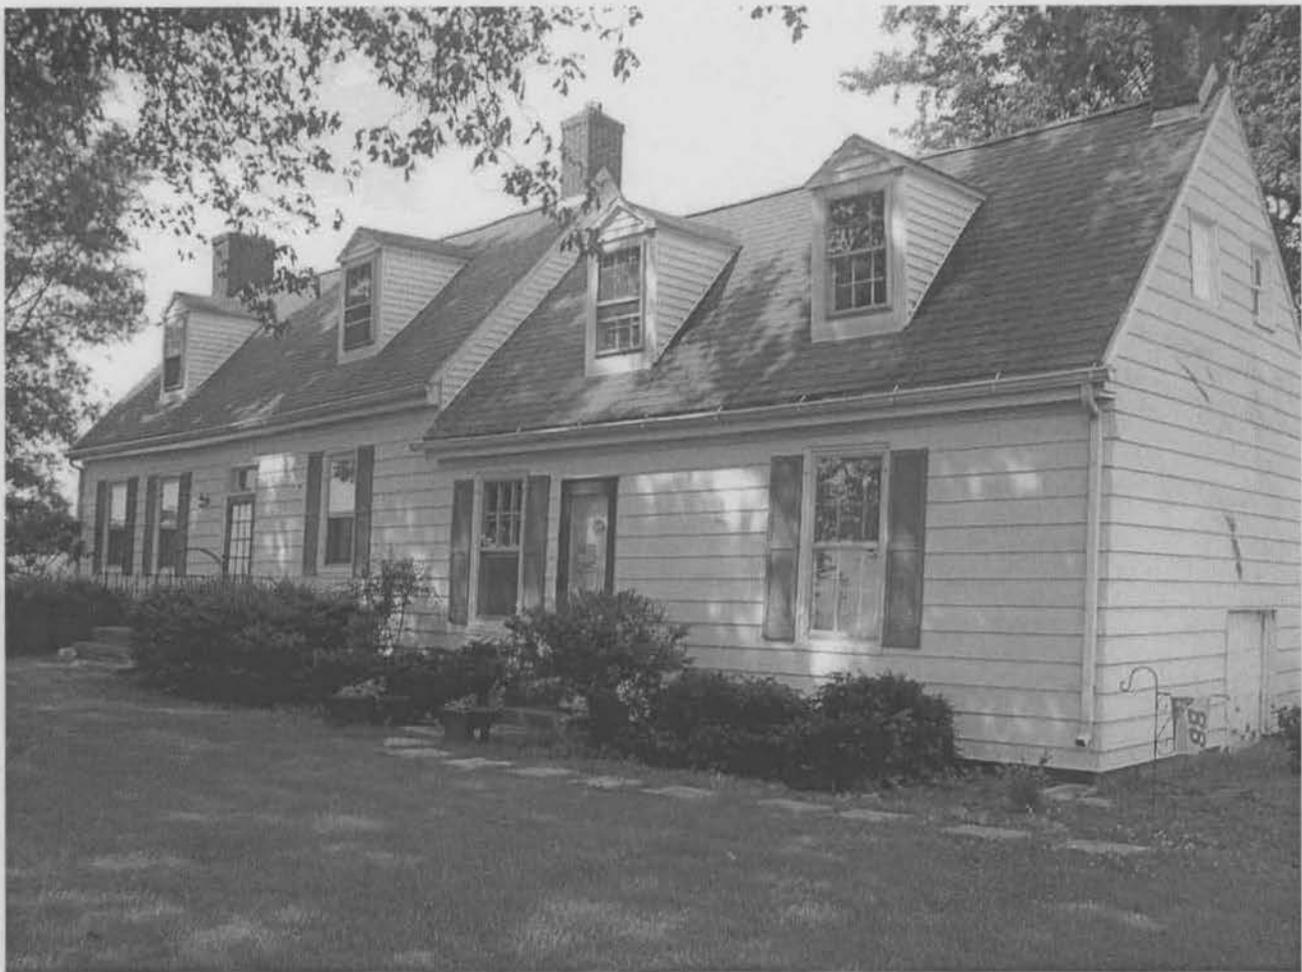
QA-190
Sylvester Farm

Mary McCarthy
Spring/Summer 2003
Digital color photo on file at MHT
