QA-191A  
Poplar Grove Quarter  
Burrisville vicinity  
Private

INVENTORY FORM FOR STATE HISTORIC SITES SURVEY

Poplar Grove Quarter, Brampton

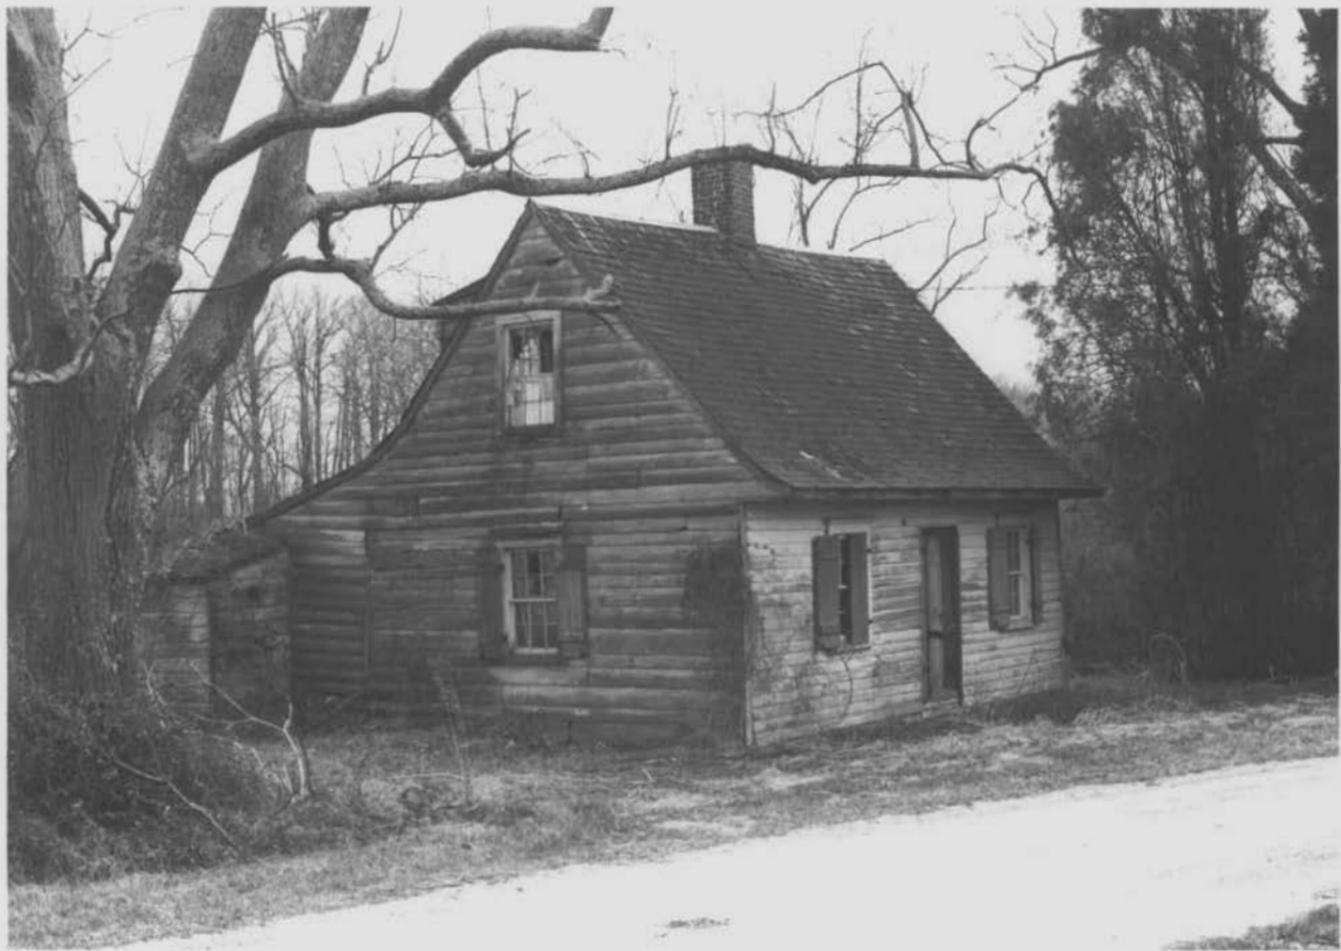
QA-191A Poplar Grove Quarter  
Centreville vicinity  
Orlando Ridout V 1981  
View from Northeast

The building known as the Quarter is of frame construction, one-and-one-half stories high, three bays wide, and one room deep, with a small brick chimney centered on the ridge of the pitched gable roof. The building has been extensively altered over the years, and all that survives of the original structure is the timber frame.

The front facade faces north to the driveway, with a center door flanked by 6/6 windows on the first floor and no openings on the roof. The horizontal weatherboards are 20th century, and the picturesque bell-curve eave to the roof is a 20th

The east gable wall is pierced by single 6/6 windows centered on the first and second floor, and is covered with plain horizontal weatherboards secured with machine nails.
