QA-194

INVENTORY FORM FOR STATE HISTORIC SITES SURVEY

Connolly House

(North side of Water Street) 118 W. Water Street

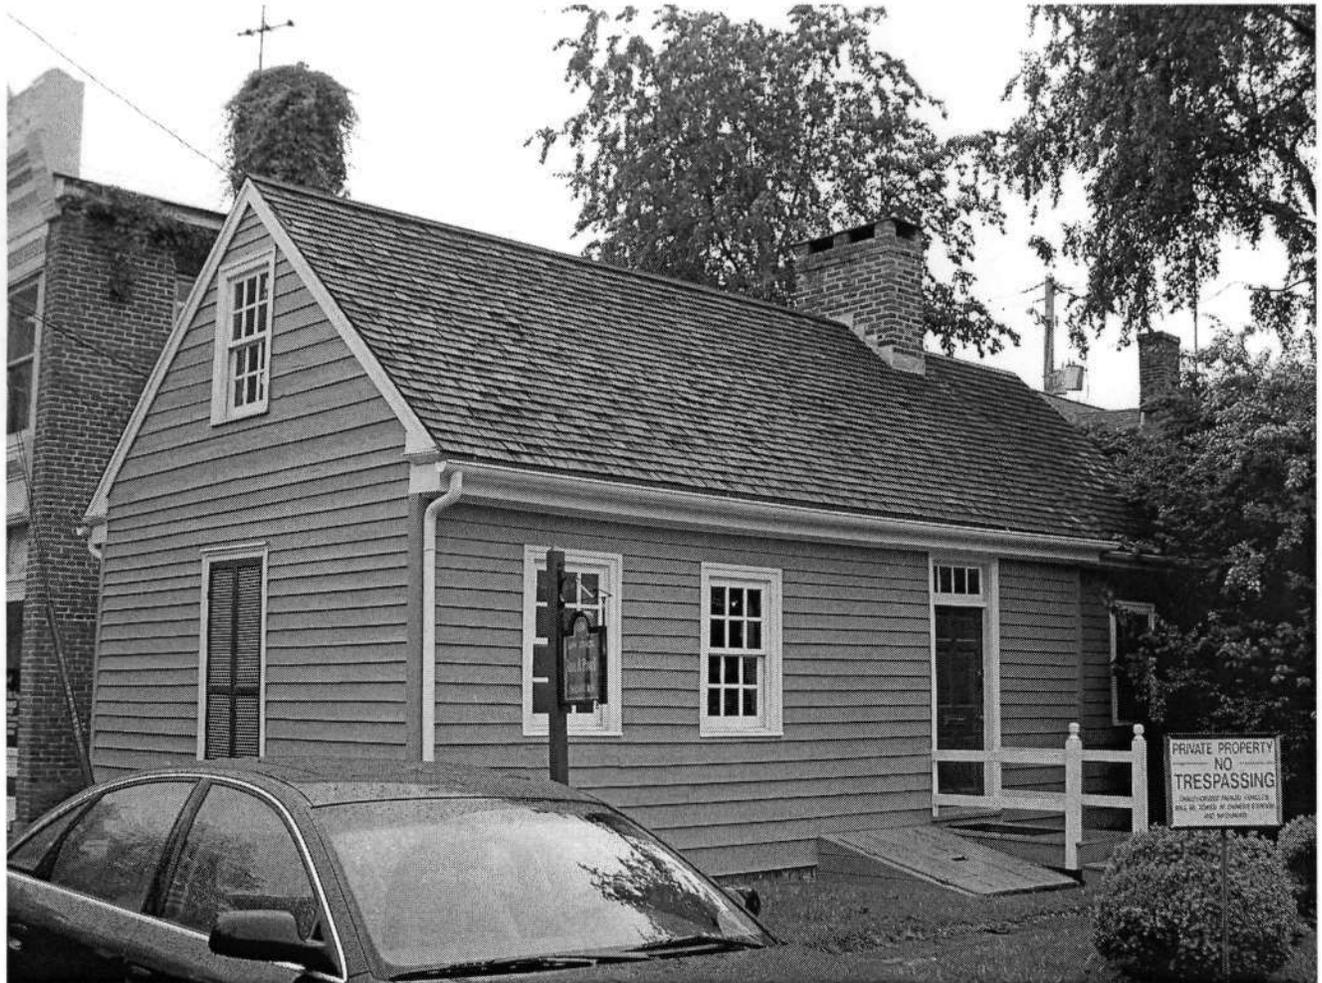
QA-194
Connolly House

Mary McCarthy
Spring/Summer 2003
Digital color photo on file at MHT
