INVENTORY FORM FOR STATE HISTORIC SITES SURVEY

**1 NAME**  
 HISTORIC  
**Dixie**  
 AND/OR COMMON

QA-202

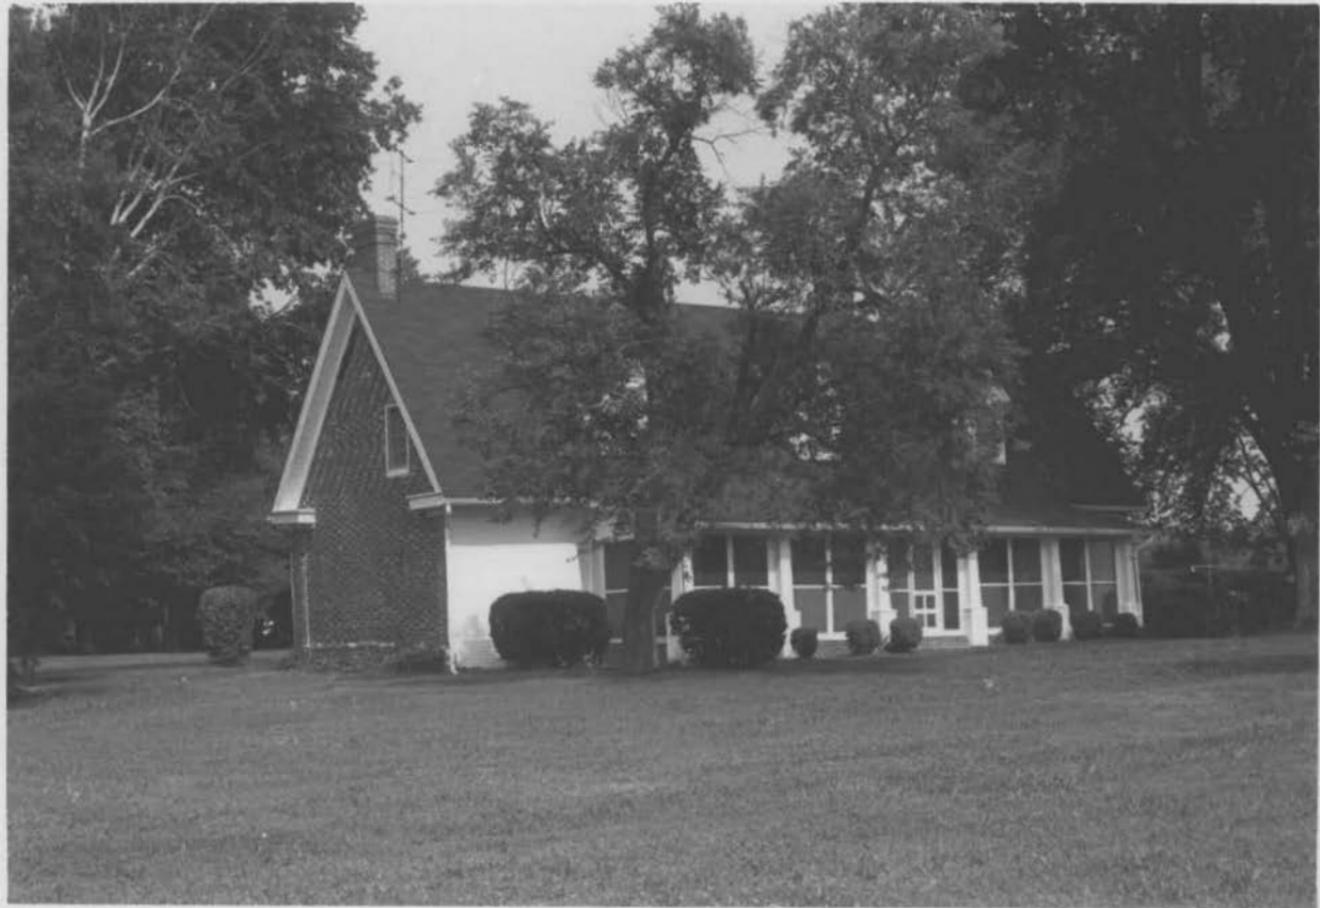
QA-202    Dixie  
          Mattapeake vicinity  
          Orlando Ridout V 1981  
          West facade from northwest

The rear facade faces west to the Chesapeake Bay. The door is located in the center bay, flanked by a single 9/6 window to the north and double doors to the south. There are two 6/6 pitched roof dormers on the roof. The brickwork on this facade is laid in five-course bond above a plain water table and a common bond foundation. Major repairs appear to have been undertaken to the south of the door, and the door opening has been reduced approximately nine inches in width. The eaves and dormers have been rebuilt and covered with aluminum siding; the roof is asphalt shingle.

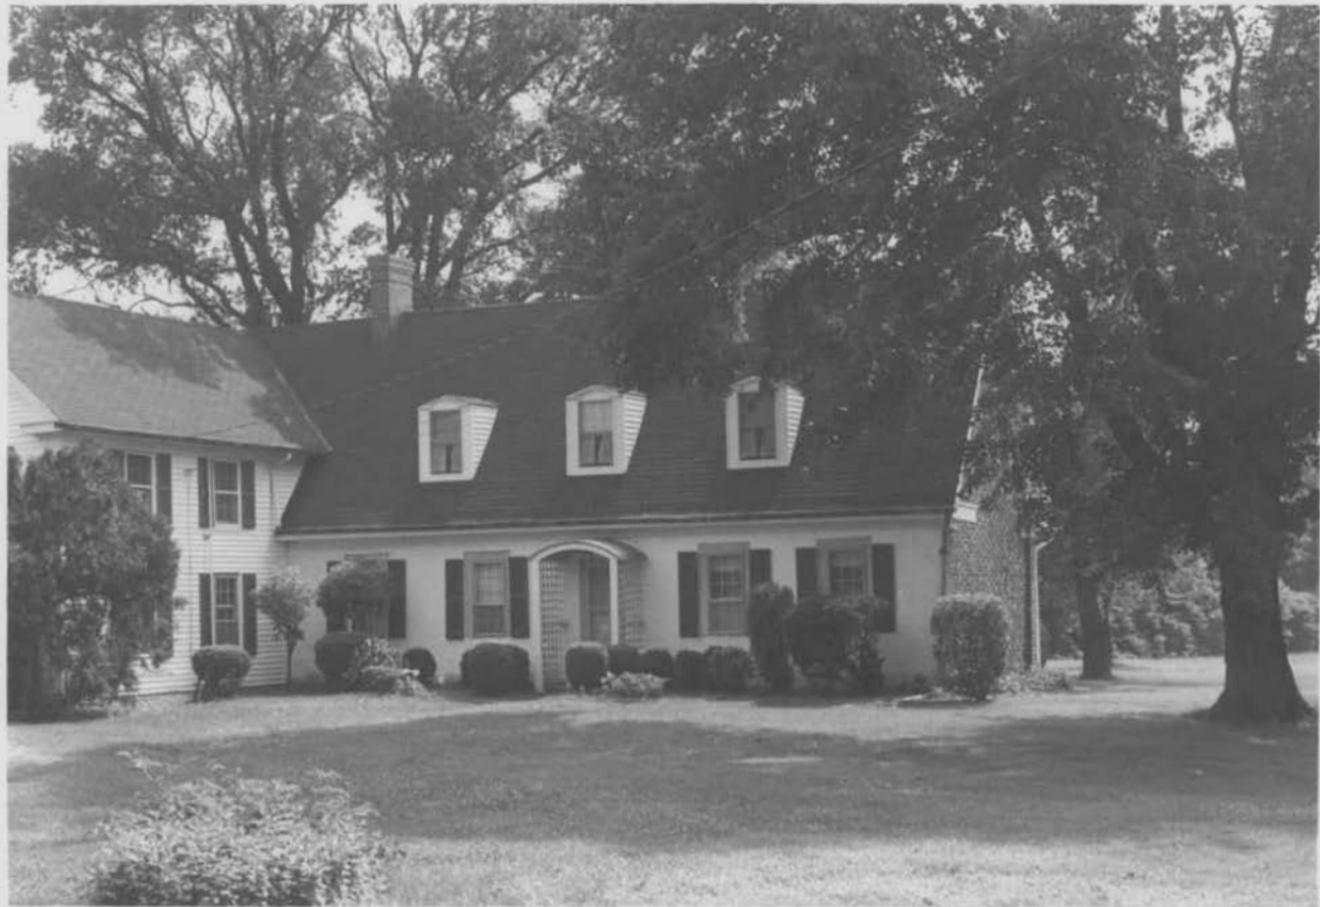
Dixie  
Mattapeake vicinity  
Orlando Ridout V 1981  
East facade

The principal facade faces due east toward Route 8. The door is in the center bay flanked by two 9/6 windows on each side. There are three pitched roof 6/6 dormer windows on the second floor. The brickwork on this facade is heavily whitewashed and difficult to analyze. Large portions of the wall appear to be rebuilt or repaired. One relatively undisturbed section of Flemish bond is visible between the two north windows. The foundation appears to be laid in common bond with a plain water table. The brick facade extends out approximately four inches beyond the north gable wall, and from here it is clear that the facade is

not keyed in to the gable wall, suggesting an early house with frame facades and brick gable ends that later had a brick veneer added on both facade walls. The eaves have been enclosed with aluminum siding; the roof is asphalt shingle. The dormer windows have been completely rebuilt but may be 19th century in date. A seam to the left of the front door indicates that the opening has been reduced by nine inches in width.

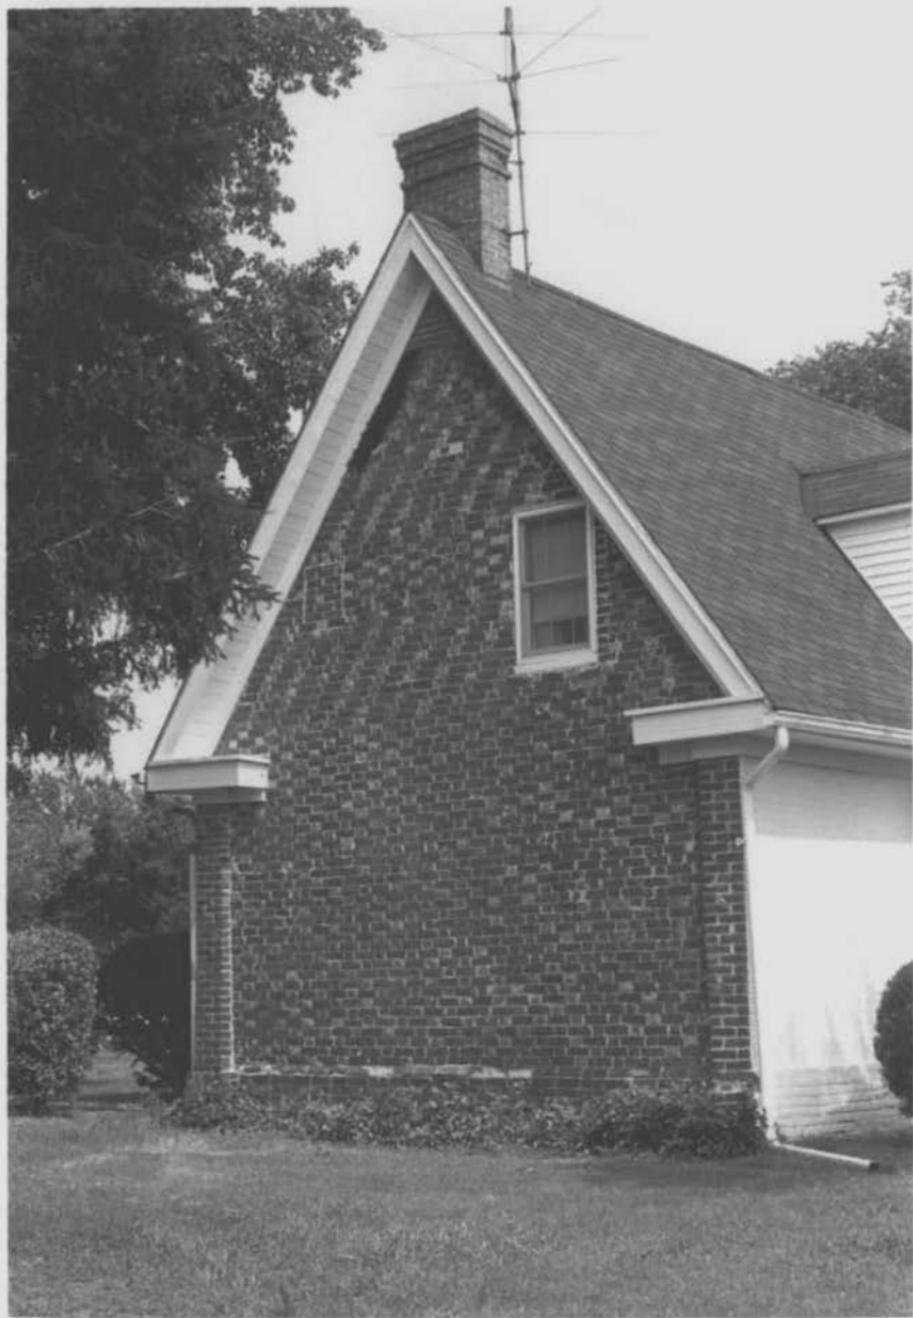
North gable wall

The north gable wall is the most significant exterior feature of the building. The original brickwork remains exposed and unpainted. It is laid in glazed header Flemish bond above a beveled water table and an English bond foundation. Glazed header bricks in the upper gable form a series of chevrons similar to the west gable wall at Stinton (QA-273), a similar house nearby dated 1722 in the east gable. The overall form and detailing also bear comparison with Friendship (QA-163), another similar house nearby. A small window opening in the east bay of the upper gable has been bricked up; a large 6/6 window has been cut into the west bay of the upper gable. The chimney shaft has been rebuilt; the eaves are boxed in with aluminum siding. The most curious feature of this gable wall is the pair of corner

"buttresses" described previously. These are believed to be evidence of a later brick veneer added to both facades.
