QA-22

Shepherd's Fortune
Kings Town vicinity
private

INVENTORY FORM FOR STATE HISTORIC SITES SURVEY

Shepherd's Fortune
AND/OR COMMON

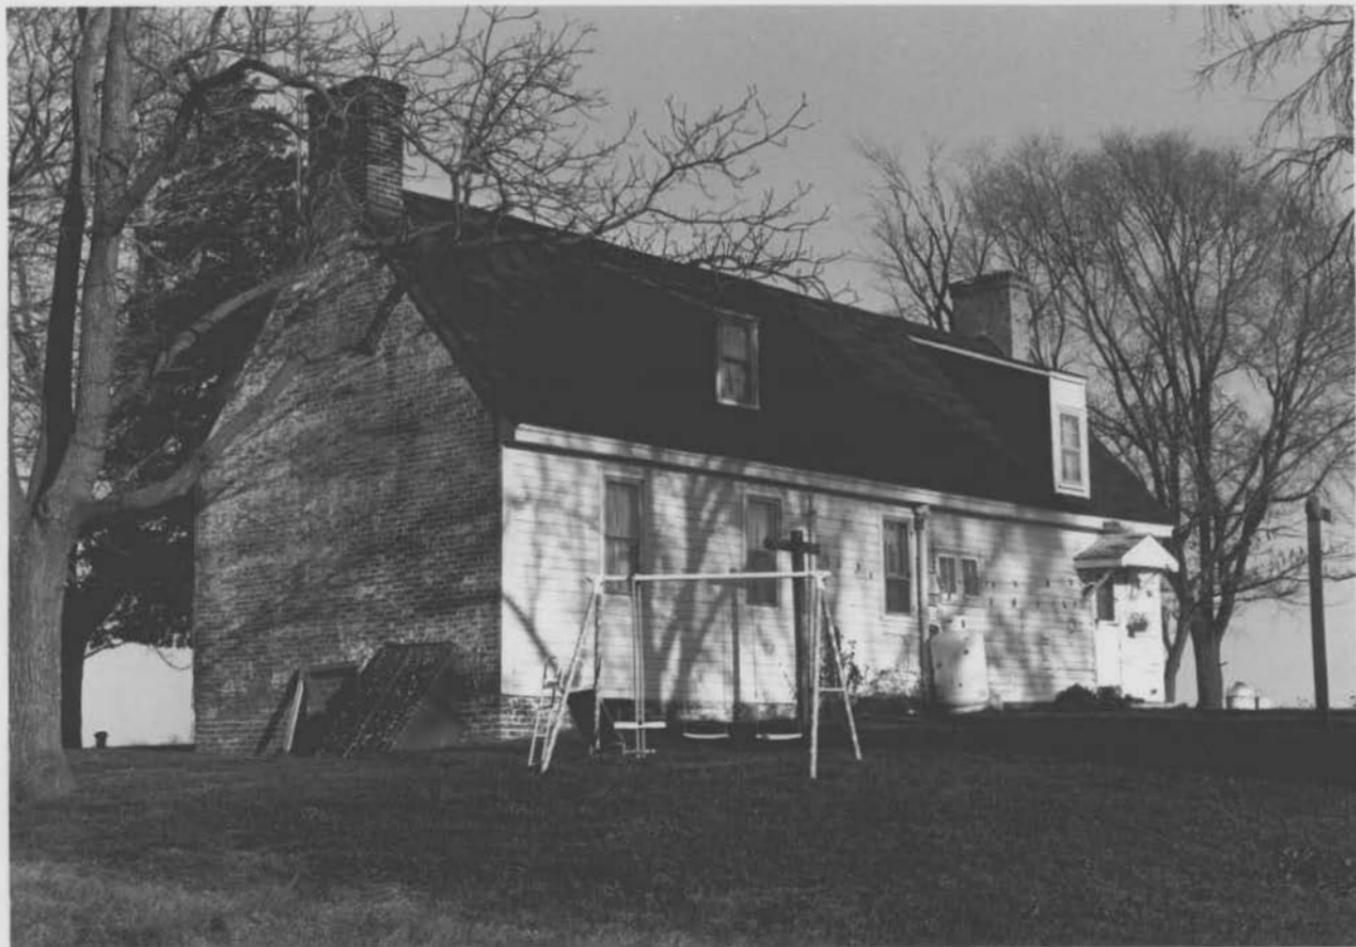
QA-22

Shepherd's Fortune
Kings Town vicinity
Orlando Ridout V 1979
Rear facade from west

The southwest or rear facade has asymmetrical fenestration, partially due to disturbances caused by the removal of the rear wing. There is a single 6/6 window near the center of the facade, two 2/2 windows to the left, and a door at the extreme south end. A

modern kitchen window has been inserted to the right of the 6/6 window. There are two 6/6 shed roof dormers on the second floor; the south dormer was not installed until the wing was removed. The siding, cornice, and roof match the front facade.

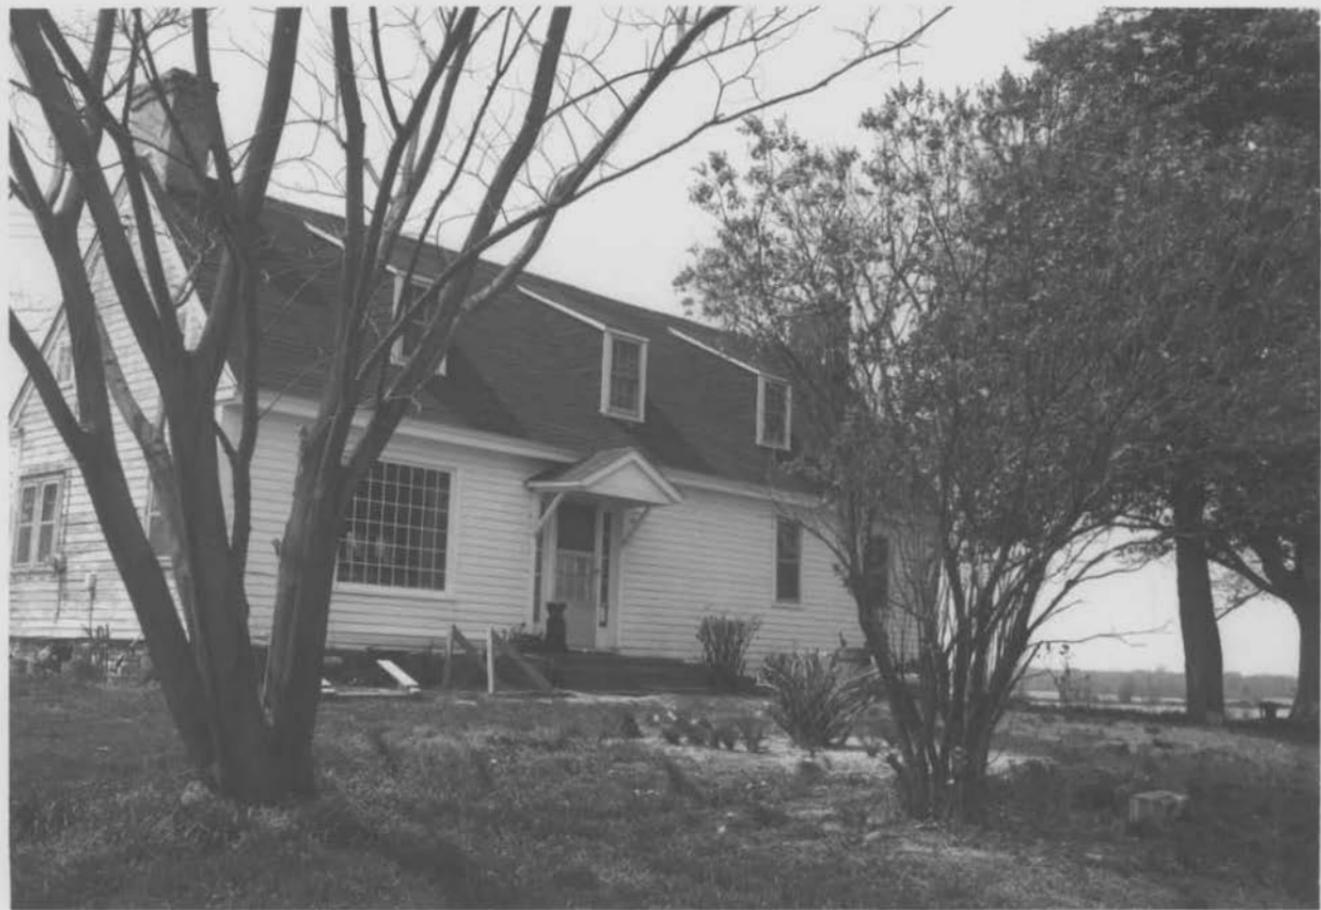
QA-22 Shepherd's Fortune
Kingstown vicinity
Front facade from east

The front facade faces northeast toward Route 213. The left or southeast part of the house is the earliest, resting on a continuous brick foundation. A door with sidelights is located in the right bay of this portion, with a large multi-pane modern

window to the left. A seam in the foundation to the right of the door marks the northeast end of the original house. The later addition is also frame on a brick foundation, with a brick gable end on the northwest wall. There are two 2/2 windows on the front facade of the addition and three 6/6 shed roof dormers ranged across the full length of the roof. German siding extends the full length of the facade with no seam between the two sections. The roof is asphalt shingle above a box cornice with modern crown mold.

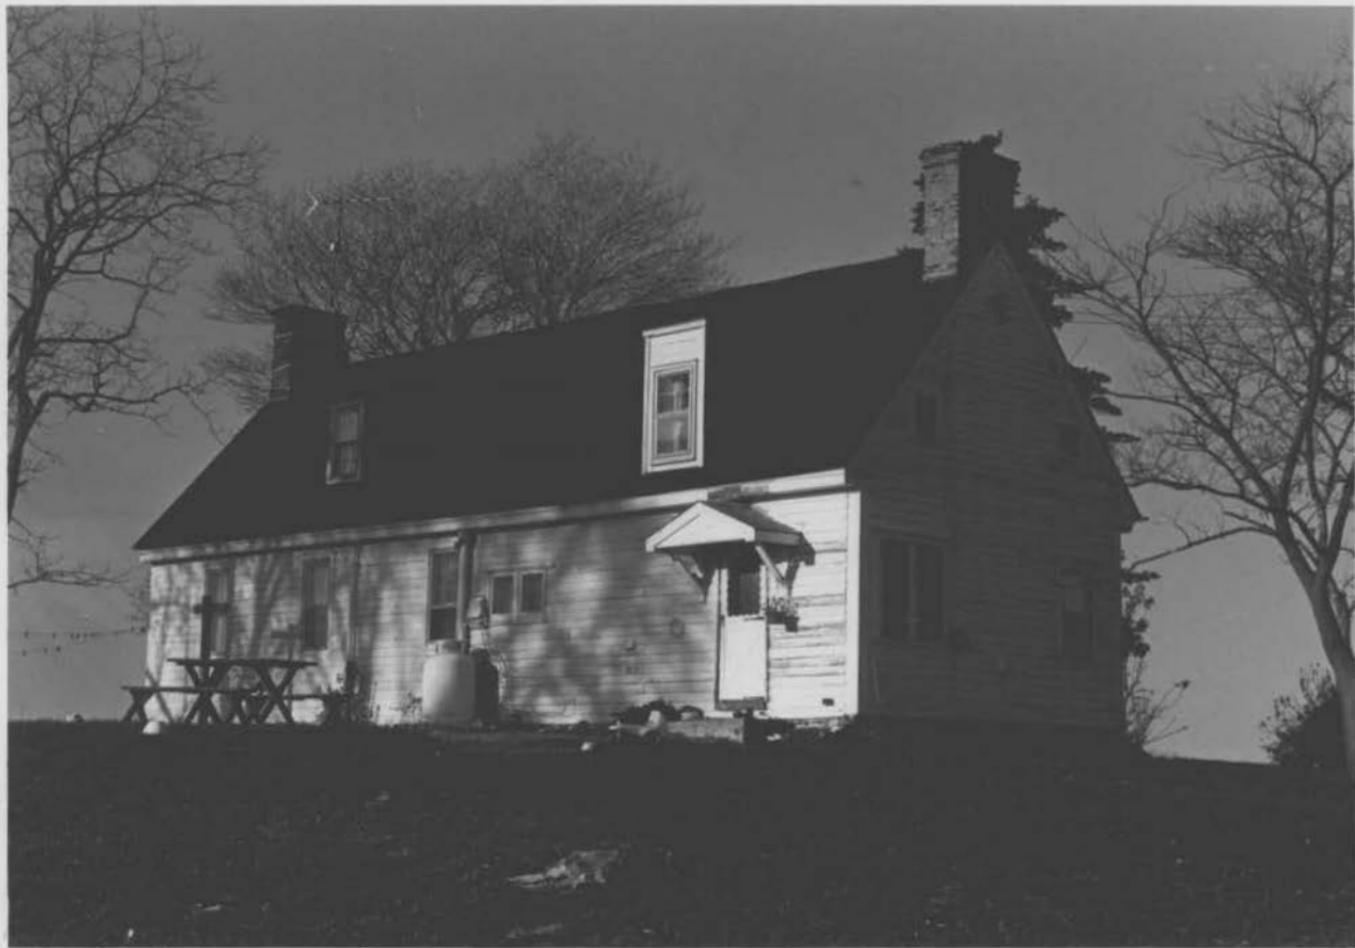
QA-22

Shepherd's Fortune
Kings Town vicinity
Orlando Ridout V 1979
Rear facade from South
