QA-223

Burrisville Methodist Church
Burrisville

INVENTORY FORM FOR STATE HISTORIC SITES SURVEY

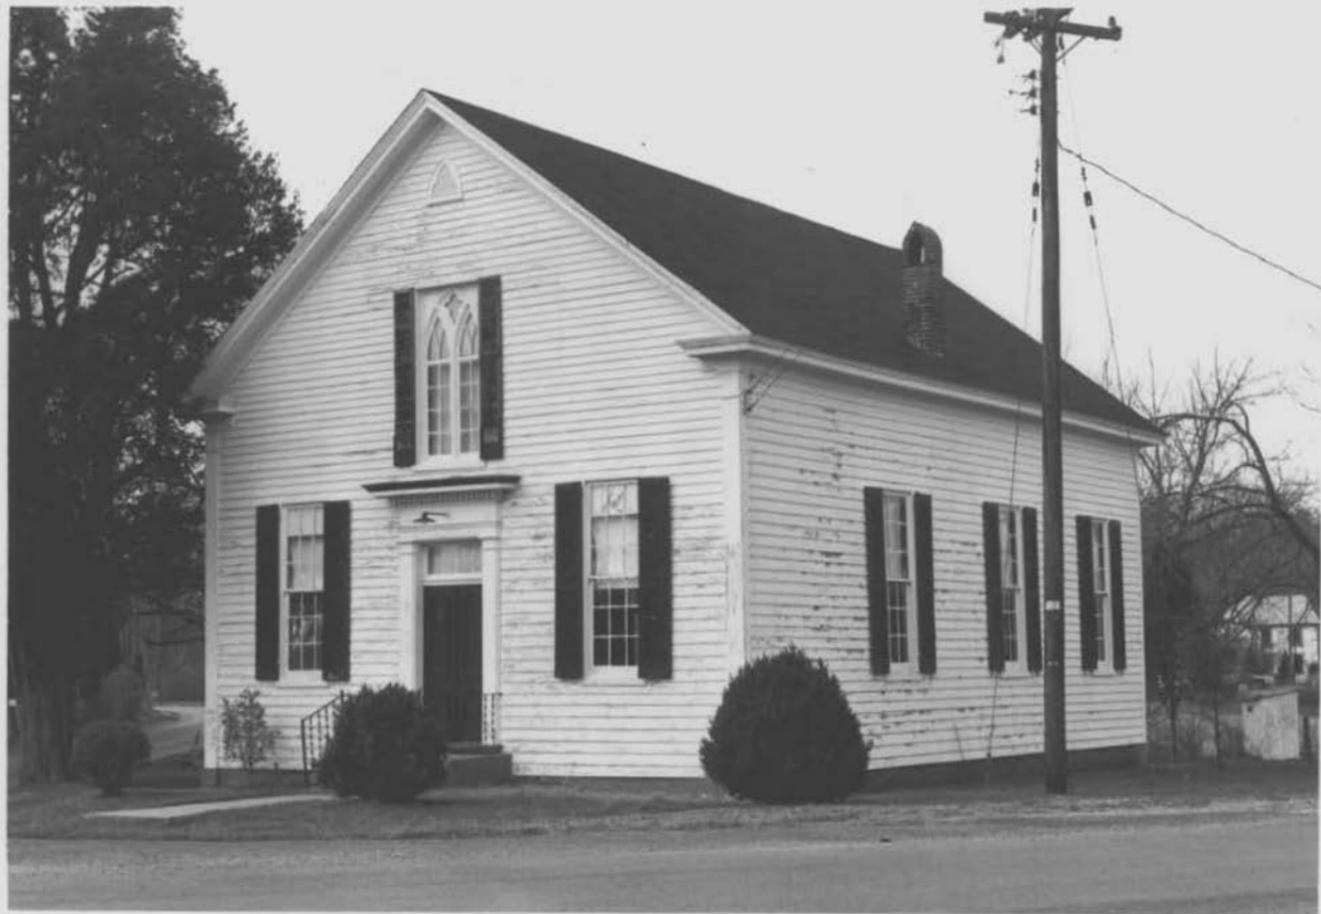
QA-223 Burrisville Methodist Church
Burrisville, Maryland
Orlando Ridout V 1981
Front facade from East

The principal entrance is centered on the southeast gable, and consists of a pair of paneled doors with a four-light transom, set off by a pilastered door surround and an ornamental hood with a dentil block cornice. A single nine-over-nine window flanks the door on each side, and a large window with a Gothic arched opening is located directly above the door. This window is composed of two 8-light, arched sash below a Gothic quatrefoil. The upper lights of the arched sash have translucent glass, while the lower lights are clear. A small trefoil ventilator is centered in the upper gable.

that have molded caps and banding, and the foundation breaks forward to suggest a base. This gives increased visual strength to the corners, as well as adding refinement to the principal gable facade. A cornerstone inscribed with the date "1858" is set into the base of the pilaster on the easternmost corner of this facade.

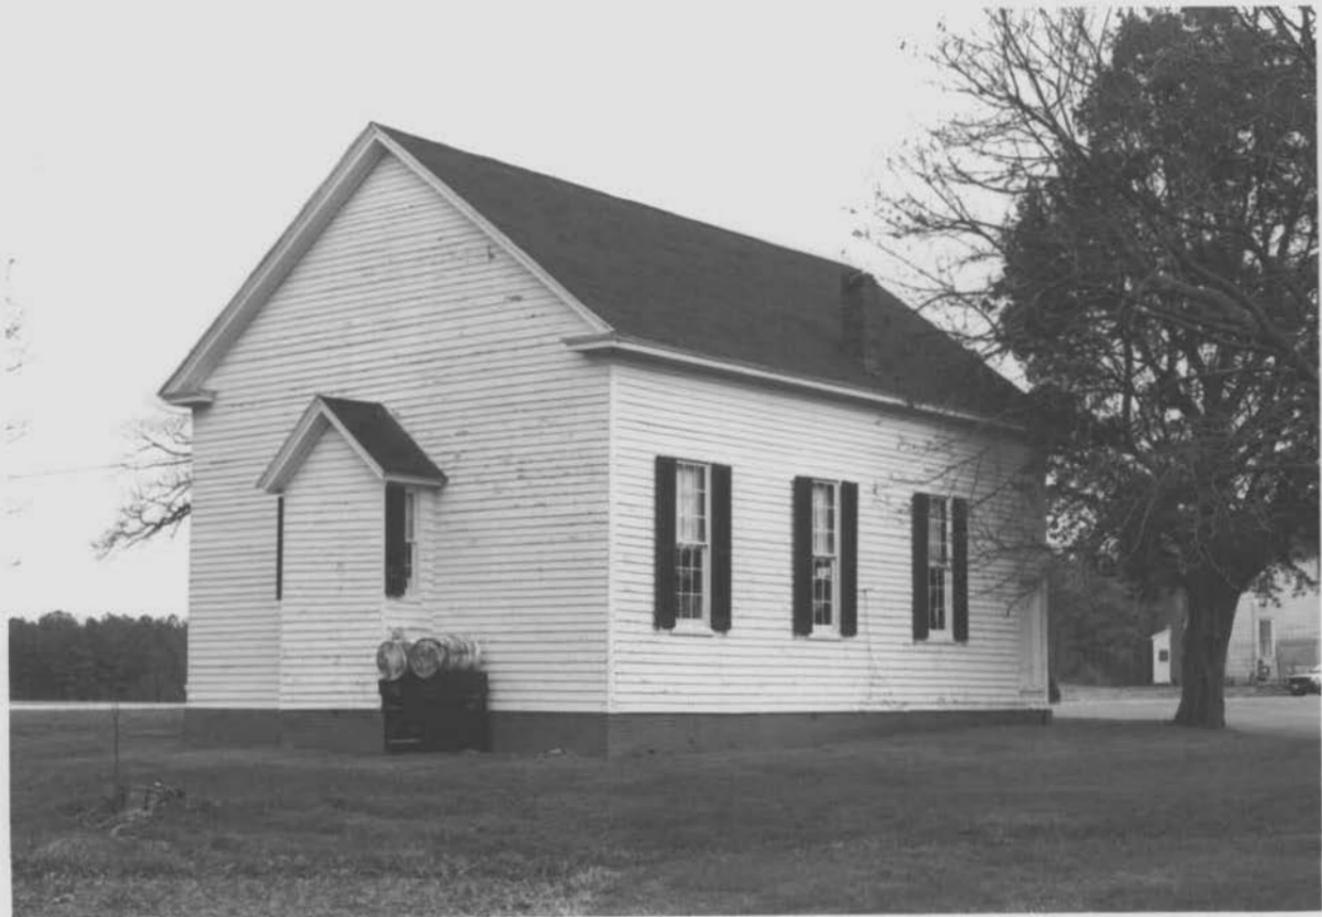
QA-223 Burrisville Methodist Church
Burrisville, Maryland
Orlando Ridout V 1981
Rear facade from West

There are no windows in the northwest gable, but a small chancel with a pitched roof projects from the center of the wall. A single tall, narrow two-over-two window is located on each side wall of the chancel.

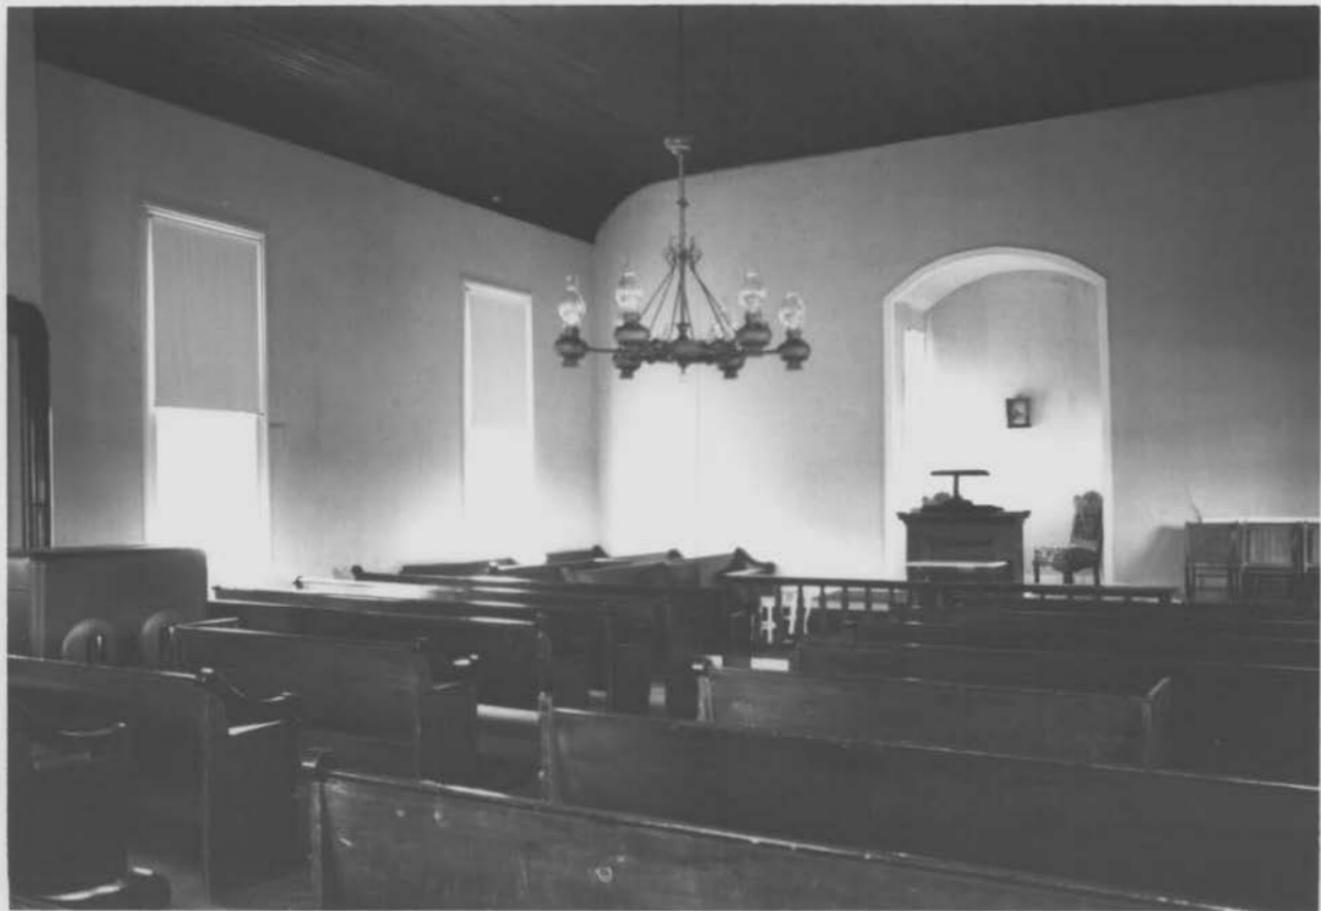
QA-223 Burrisville Methodist Church
Burrisville, Maryland
Orlando Ridout V 1981
Interior View from Door

The interior consists of a single large room, with the pulpit located on a raised platform directly in front of the chancel at the northwest end of the building. A molded railing with square newels and scrolled "splat" ballusters encloses the platform. An original gallery stretches across the southeast end of the sanctuary.

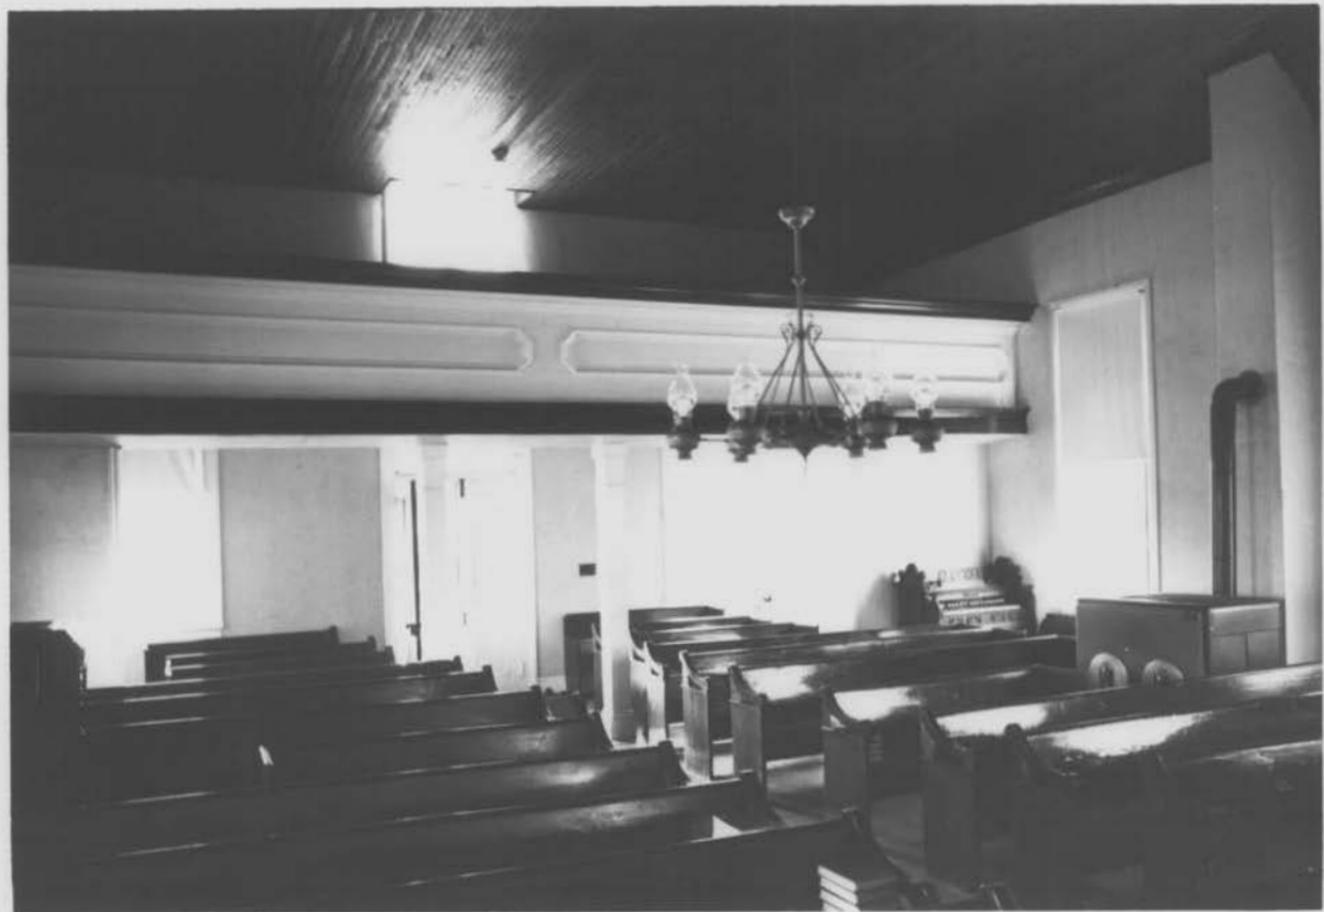
QA-223 Burrisville Methodist Church
Burrisville, Maryland
Orlando Ridout V 1981
Interior View from Altar

It is supported by two square posts flanking the center aisle, and is enclosed by a solid railing decorated with applied moldings that form two elongated panels on the front face of the gallery. There is a small closet below the northeast end of the gallery and a small, enclosed stair hall below the southwest end.

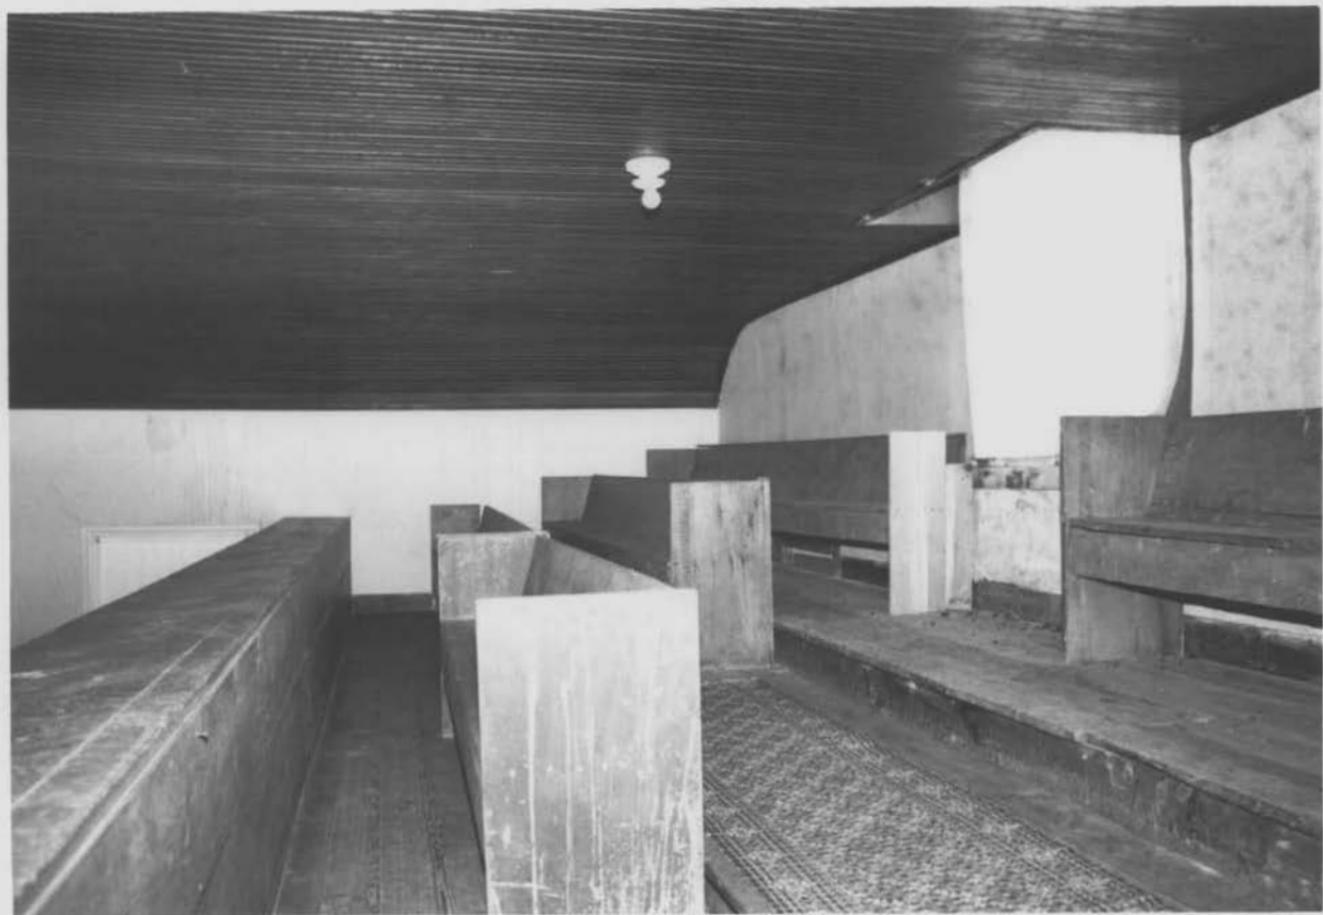
QA-223 Burrisville Methodist Church
Burrisville, Maryland
Orlando Ridout V 1981
Interior View-Gallery

The stairway to the gallery is in the small vestibule or stairhall in the south corner of the building. This vestibule also serves the exterior door located on the southwest facade. This arrangement allows parishioners using the gallery to enter directly from the exterior, without passing through either the principal entrance or the nave. Certainly this lends credence to the tradition that both the gallery and the side door were intended for slaves and/or free blacks. The plain, unfinished state of the gallery, as well as the simple pine benches only serve to reinforce this tradition.
