QA-25

Wilson's Delight

Crumpton

INVENTORY FORM FOR STATE HISTORIC SITES SURVEY

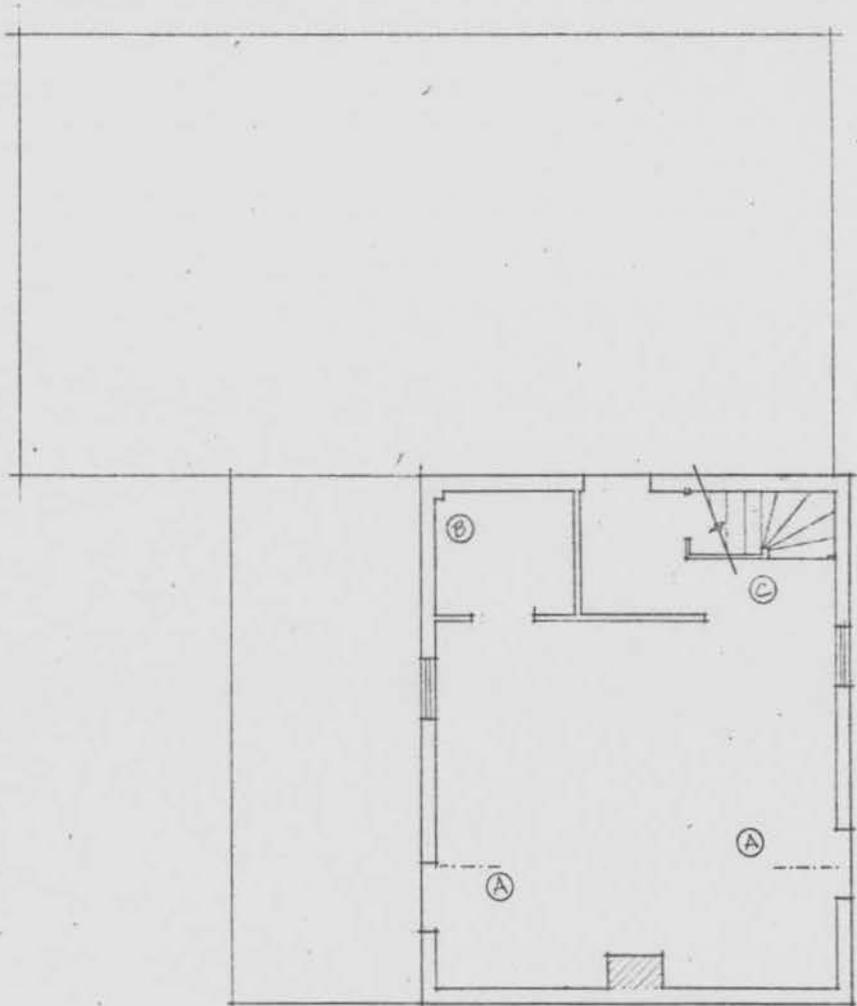
WILSON'S DELIGHT
 CRUMPTON, MARYLAND

NOTE: EARLY STRUCTURE AND
 KEAR PORCH NOW FORM REAR WING
 OF LATE 19th CENTURY CENTER-
 HALL PLAN FARMHOUSE.

- A SEAM IN EXPOSED TOP PLATES
- B EXPOSED CORNER POST
- C VERTICAL FEATHER-EDGE PANEL-
 ING IN STAIR PARTITION
