QA-252  
Ryland Farm  
Ruthsburg vicinity  
Private

circa 1820-35  
late 19th century

## INVENTORY FORM FOR STATE HISTORIC SITES SURVEY

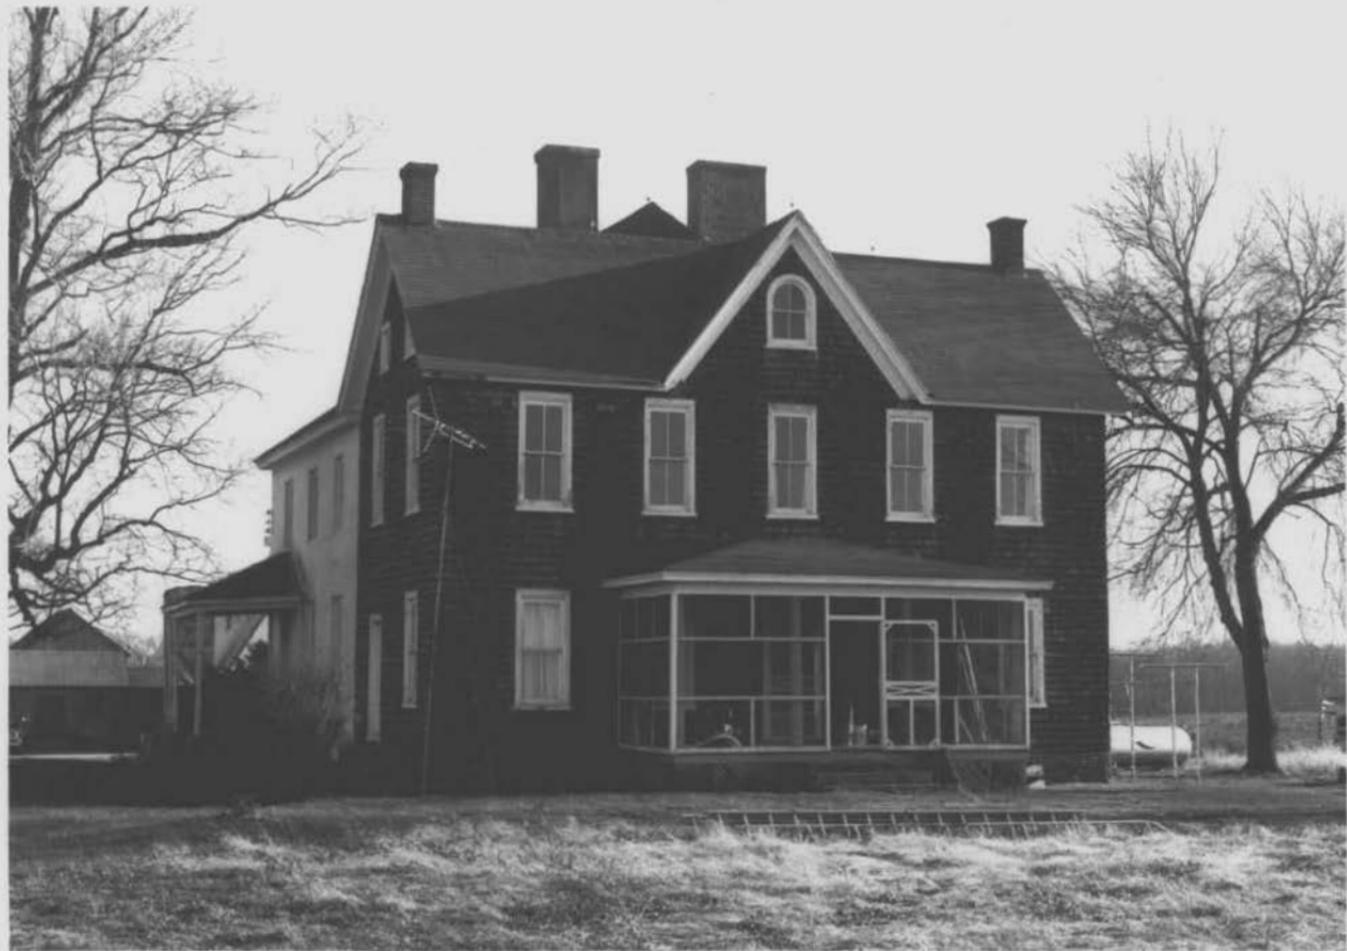
QA-252 Ryland Farm  
Ruthsburg vicinity  
Orlando Ridout V Dec. 1980  
View from Northwest

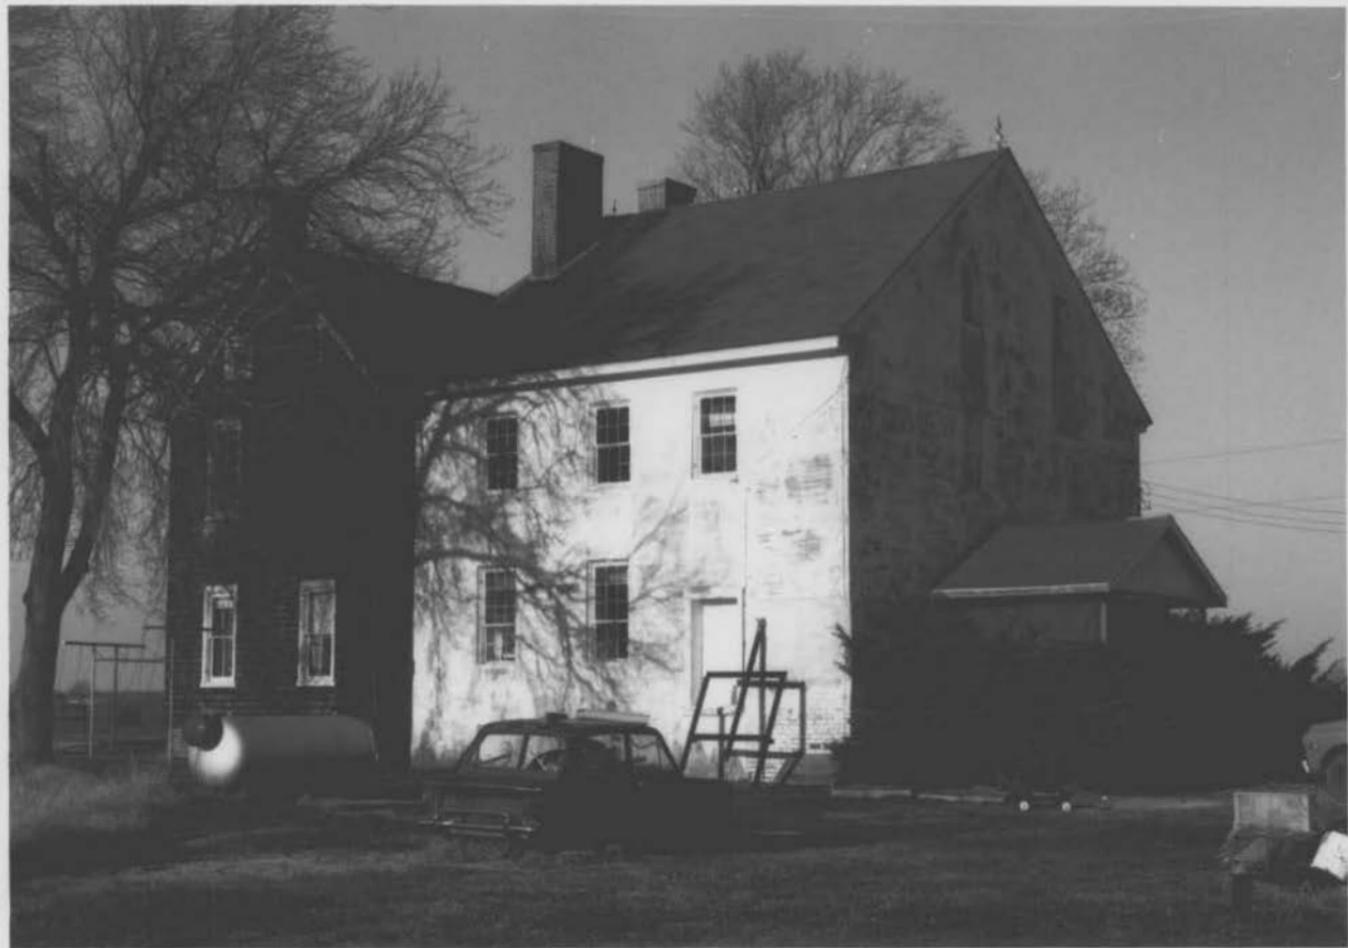
The rear facade is similar to the north facade, but the door lacks a transom. The stucco is rusticated on this facade, but has fallen in places to reveal five-course bond.

QA-252 Ryland Farm  
Ruthsburg vicinity  
Orlando Ridout V Dec. 1980  
View from South
