QA-260

James Baxter House
Stevensville
Private

INVENTORY FORM FOR STATE HISTORIC SITES SURVEY

James Baxter House

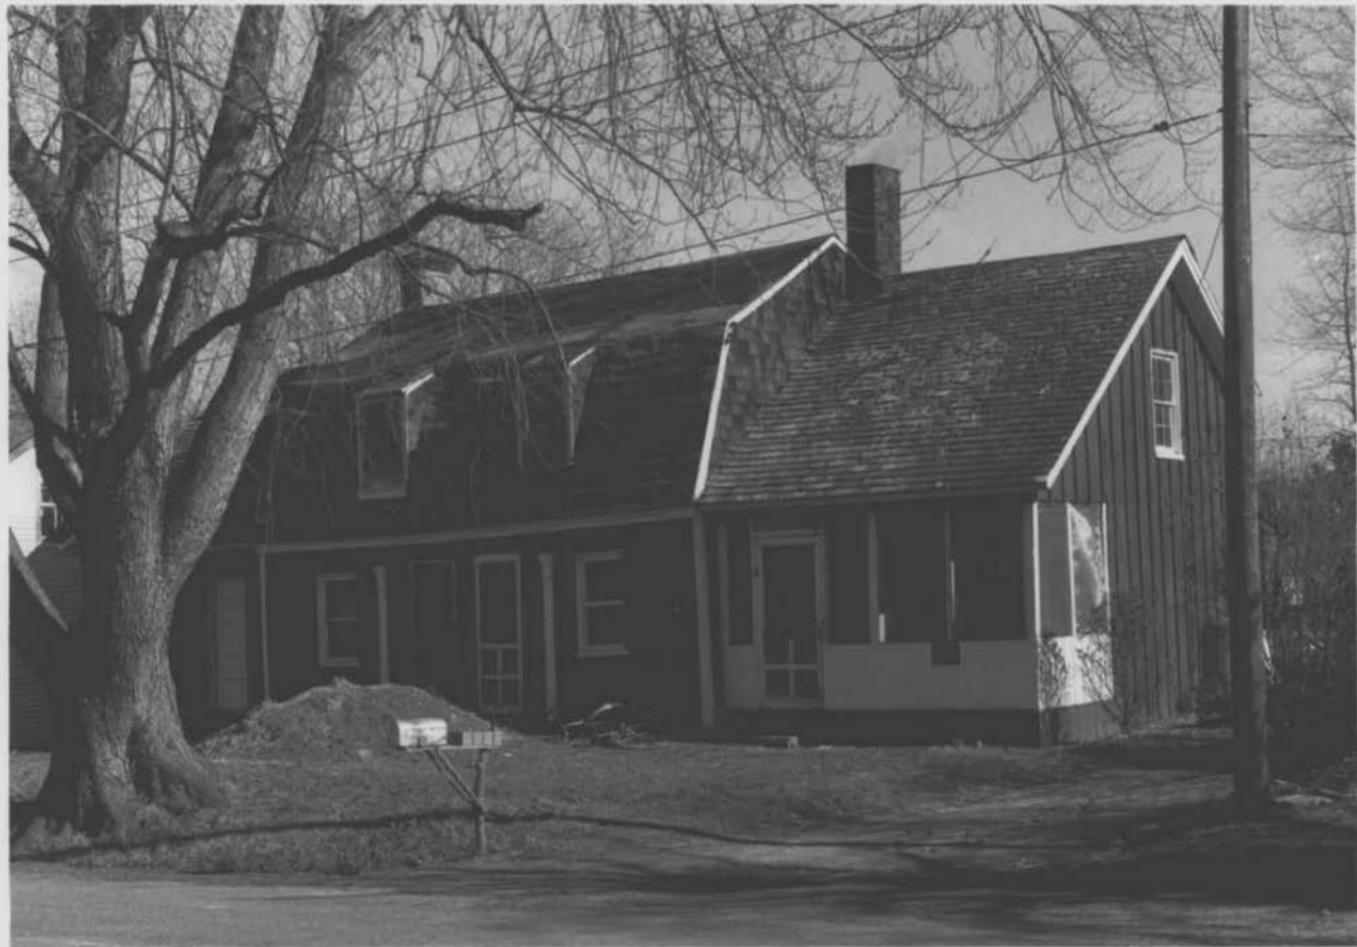
QA-260

The west facade of the house, facing Cockey's Lane, remains relatively unchanged, with two doors in the center flanked by a single 6/6 window on each side. Before the second story was destroyed, there were two 6/6 shed roof dormers on the roof. Flat pilasters with molded caps flank the two doors, all that remains of a small pitched roof entrance porch. The first story is covered with wood shingles; the roof is covered with roofing paper over wood shingles. The gable walls are almost entirely covered by the later wings. Plain weatherboard siding survives underneath the modern wood shingle siding. The rear facade has been altered considerably, but evidently had two 6/6 windows on the first story and shed roof dormers on the second story.

The frame wings are unusual in that the front (west) walls are one story high, while the rear walls are a true story-and-a-half. The steeply pitched gable roofs extend out over open one story porches on the front facade. These wings are two bays wide and are covered with vertical board and batten siding and wood shingle roofs.

James Baxter House
Stevensville, Md.
Orlando Ridout V 1978
View from Southwest
