QA-380

INVENTORY FORM FOR STATE HISTORIC SITES SURVEY

Turner Farm

Crouse Farm

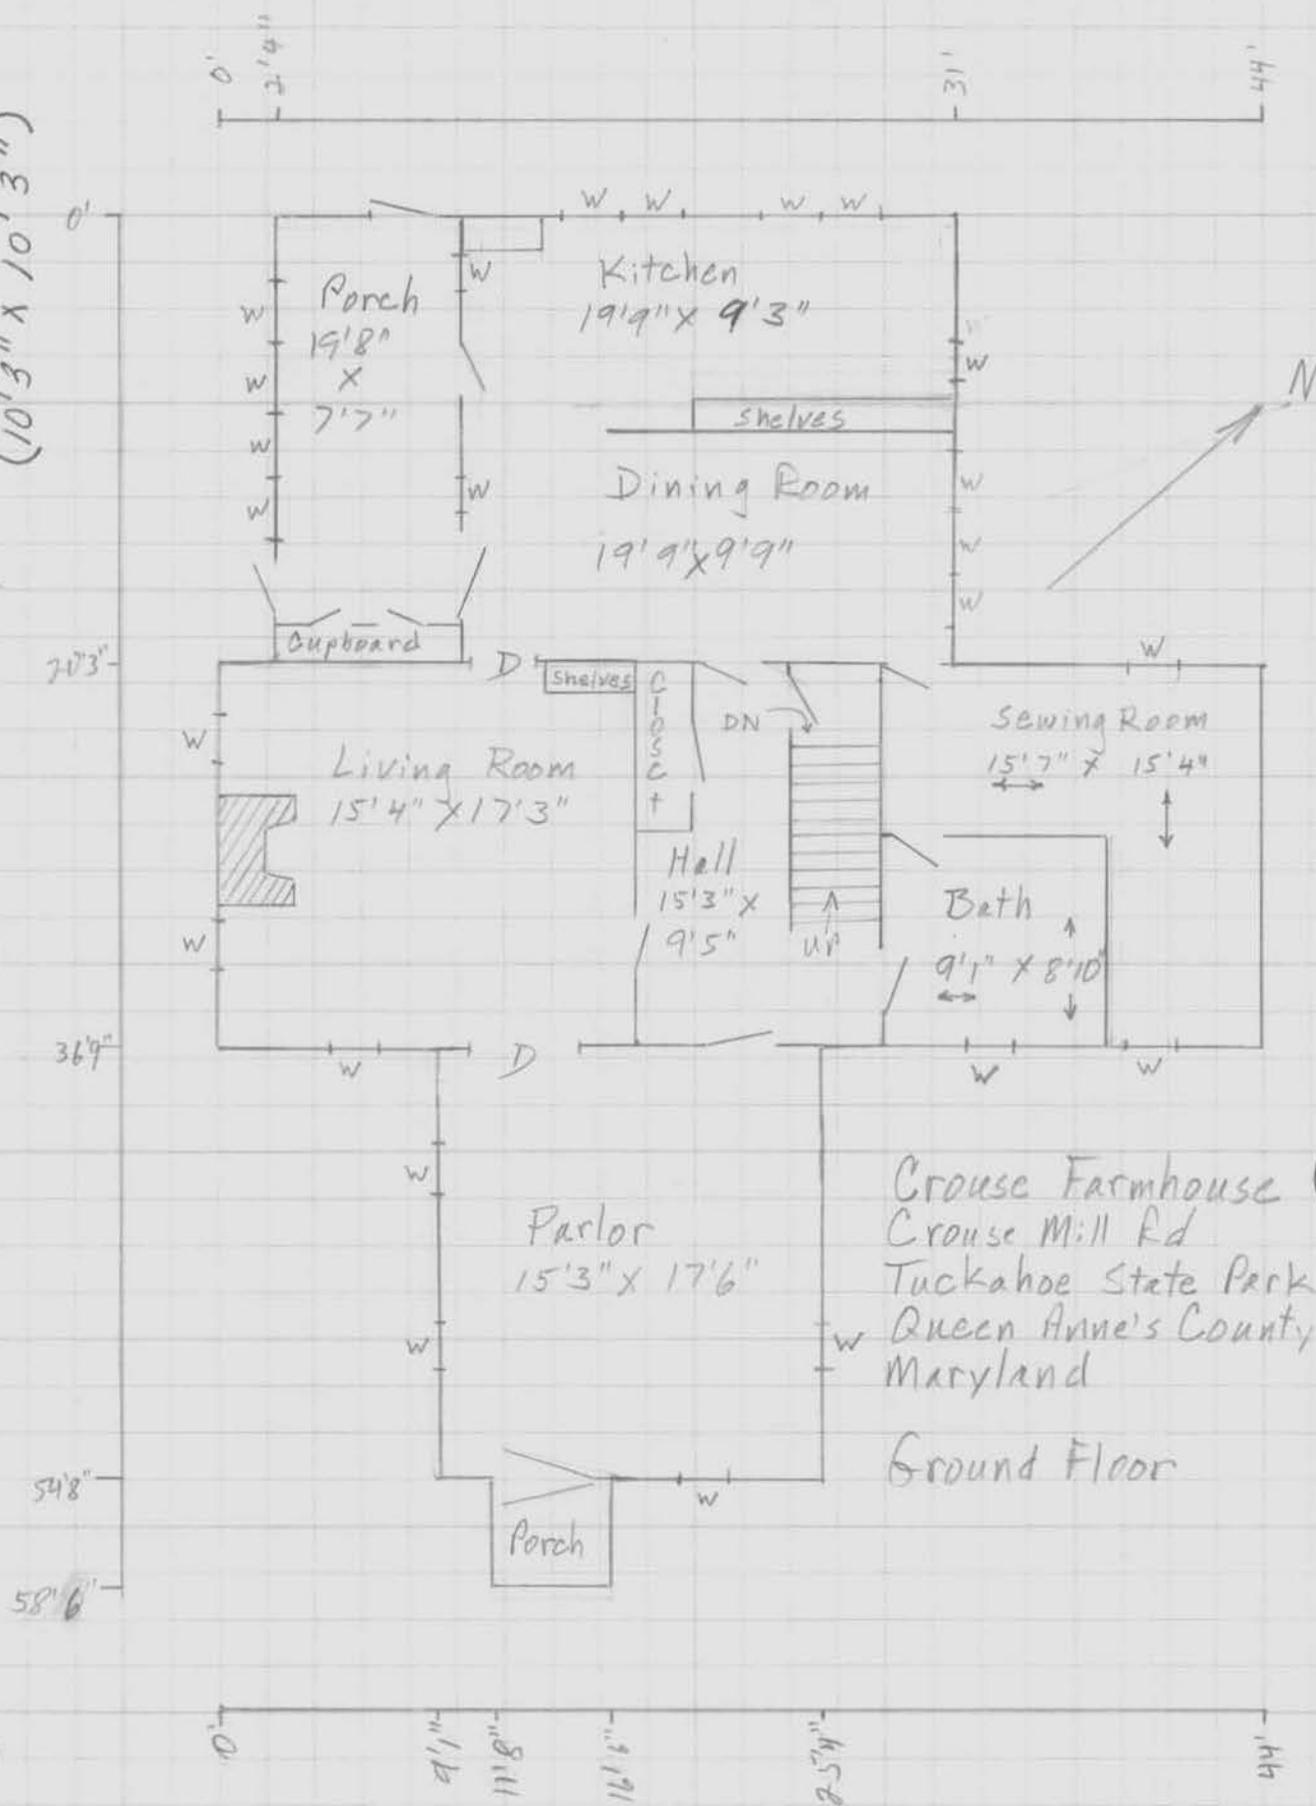
Crouse Farmhouse (QA-380)
Crouse Mill Rd
Tuckahoe State Park
Queen Anne's County
Maryland
Ground Floor

Dairy is 10'3" x 10'3"
(10'3" x 10'3")

Wash House is 20'1" x 12'2"

Exterior Scale: 1/8" = 1'

Although the exterior of the main section has been somewhat modified by the addition of the front and rear wings, the original center hall and double parlor plan is readily discernable on the interior.

The original, paneled exterior door with architraved surround now leads into a closet. The open well two run stairway which ascends along the south wall consists of an open string stair with ornamental brackets. The north parlor has been divided into a modern bathroom and a smaller room. The south parlor remains relatively unchanged except for the fireplace which is located in a projecting chimney breast. It has been redone in recent years. The two rooms on the second floor are bedrooms. The attic is accessible by an enclosed single flight of stairs located in the north wall of the second floor hall.

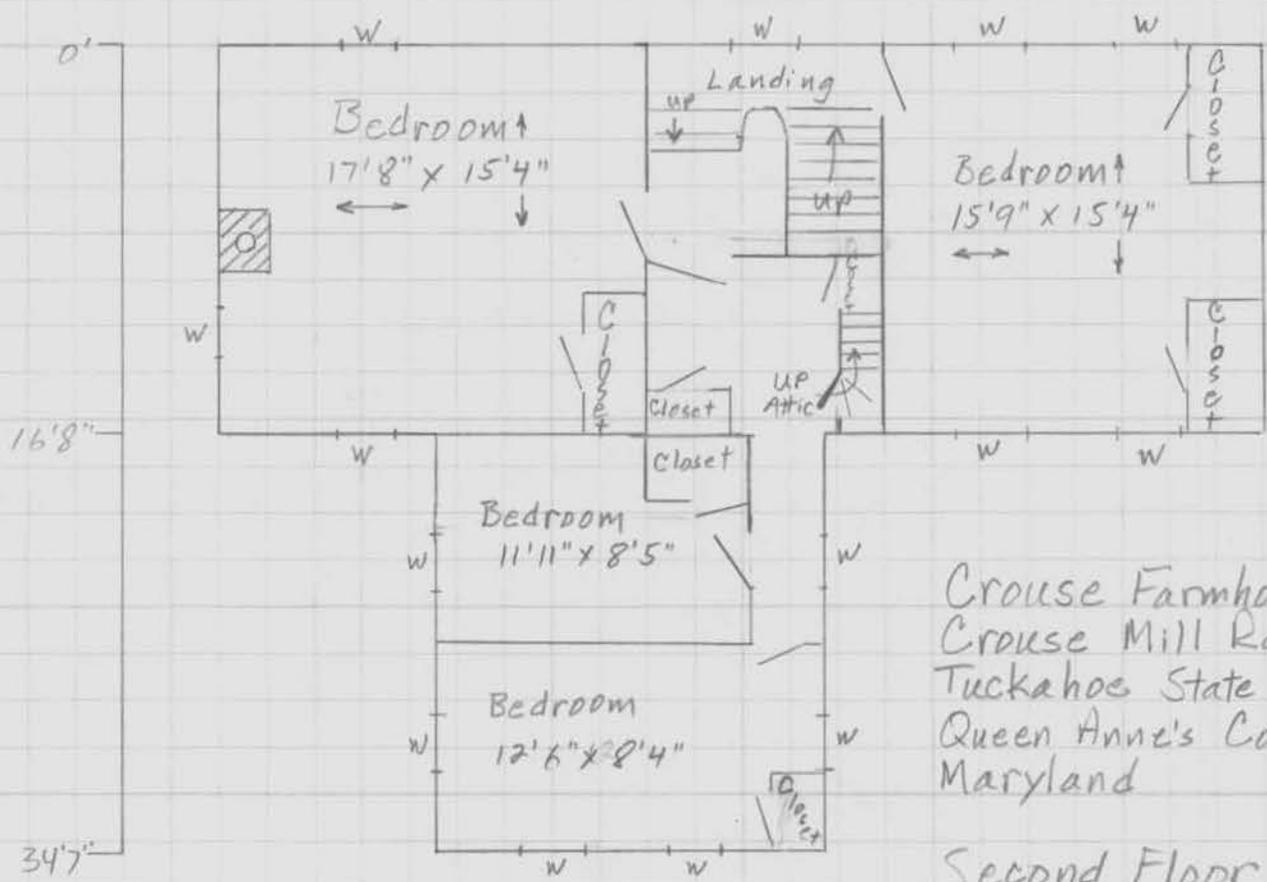
Crouse Farmhouse
Crouse Mill Rd.
Tuckahoe State Park
Queen Anne's County
Maryland

Second Floor

Exterior Scale : 1/8" = 1'

The 20th century wing is a one room front parlor on the first storey. A bedroom occupies the second floor space. Doorway surrounds in this addition consist of architrave trim with corner blocks

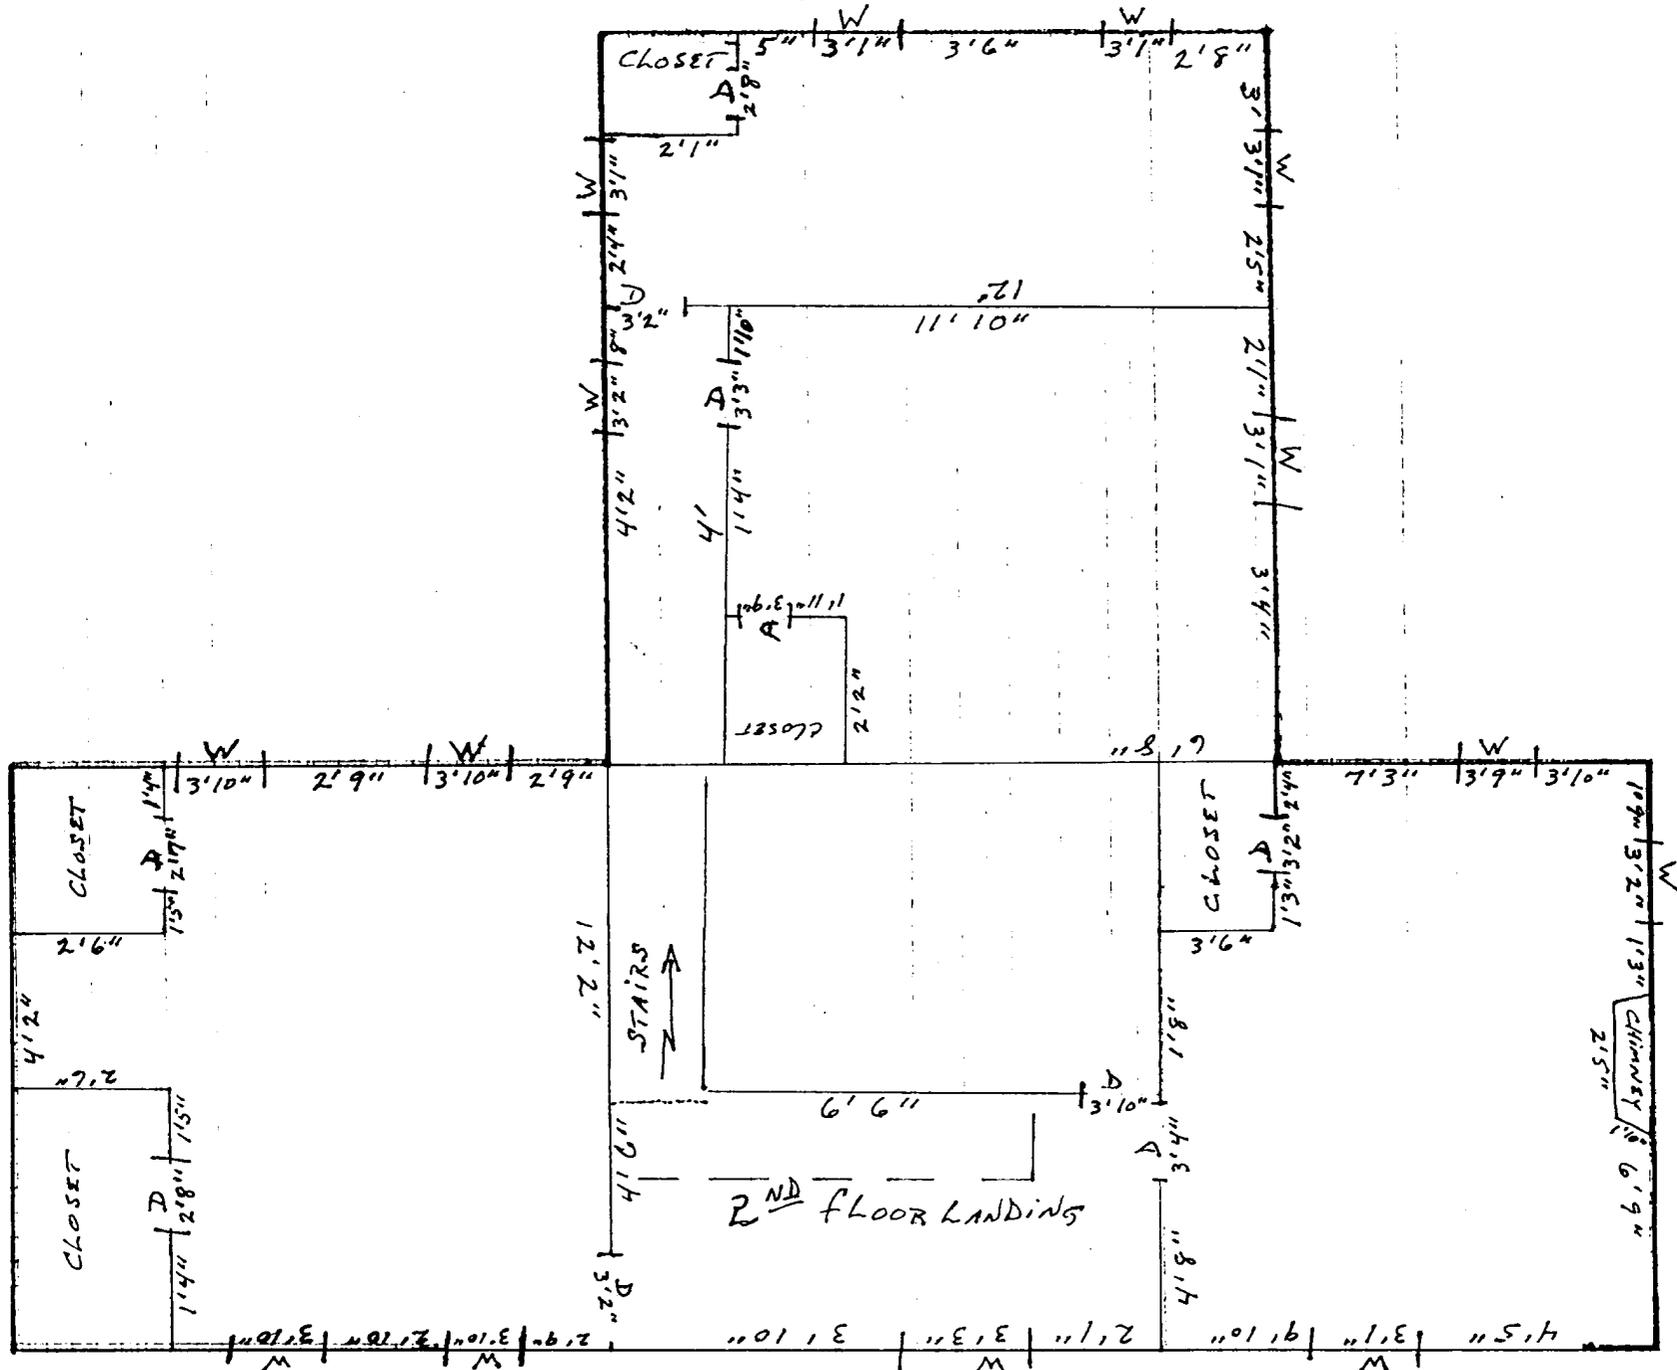
SECOND FLOOR INTERIOR

CROUSE FARM HOUSE, TUCKAHOE STATE PARK, QUEEN ANNE'S COUNTY
