QA-40  
Catherine Rash Farm  
Sudlersville vicinity  
Private

circa 1825-50

INVENTORY FORM FOR STATE HISTORIC SITES SURVEY

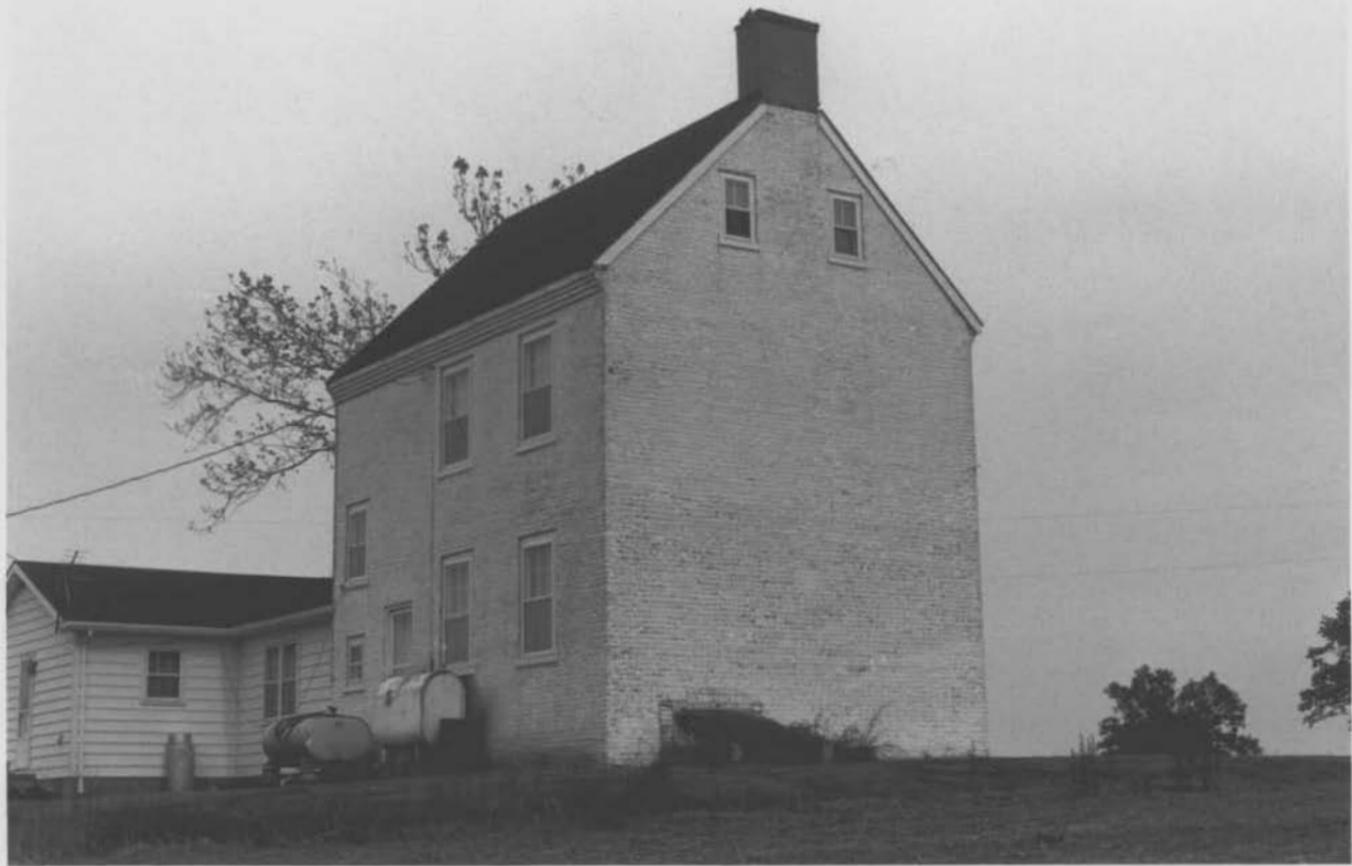
QA-40

The fenestration pattern is somewhat unusual on the north or rear facade. There are 6/6 windows in the center and west bays on both the first and second floors. To the east, there is a door on the first floor with a small four-light window to the left, and a larger 6/6 window downset on the second floor, directly above the four-light window. Both of these openings appear to be original. A single cellar window is centered in

the foundation; there are no dormer windows on the roof. The brickwork is laid in seven-course bond with a corbeled brick cornice identical to the front facade. The roof is covered with asphalt shingles.

Catherine Rash Farm  
Sudlersville vicinity  
Orlando Ridout V 1981  
Rear facade from Northwest

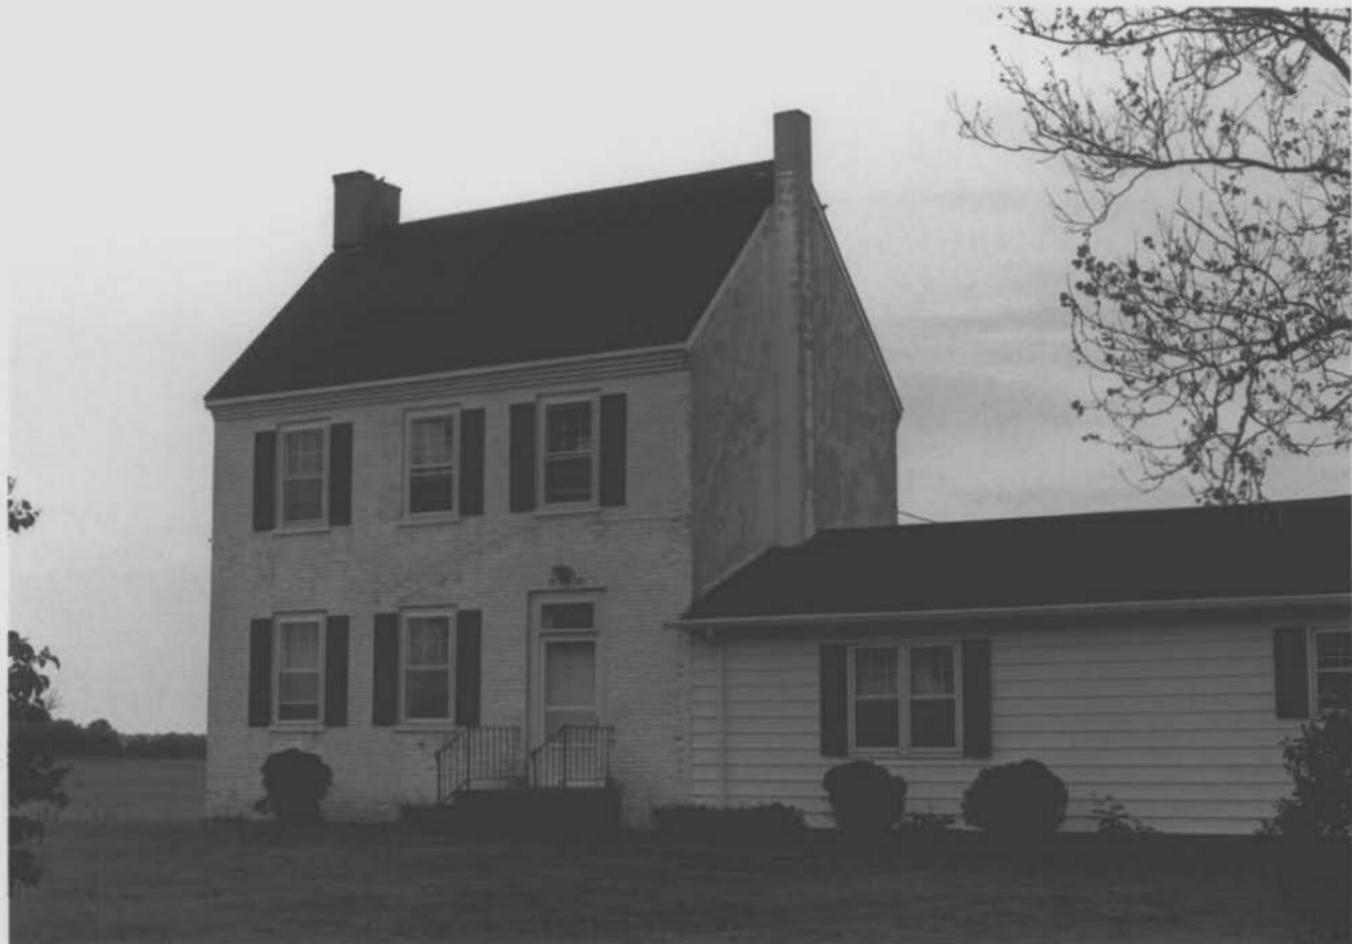
QA-40

The front facade faces south toward Route 300. It is three bays wide with a door in the east bay of the first floor, two 6/6 windows to the west of the door, and three 6/6 windows on the second floor. Small cellar windows are centered directly below the two first floor windows; there are no dormers. The window sash is original but the frames have been covered with aluminum flashing.

The six-panel door is a modern replacement, with an original three-light transom above. The brickwork is laid in Flemish bond above a common bond foundation with no water table or belt course. The cornice is corbeled out four courses with a fifth course set flush with the fourth or top course. The cellar window openings have splayed brick jack arches, all other openings are left plain. A ghost in the whitewashed brickwork indicates a one-story porch sheltered the two east bays on this facade at one time.

Catherine Rash Farm  
Sudlersville vicinity  
Orlando Ridout V 1981  
Front facade from Southeast
