QA-42

Charles Vonville Farm  
Sudlersville vicinity  
Private

circa 1830-50

INVENTORY FORM FOR STATE HISTORIC SITES SURVEY

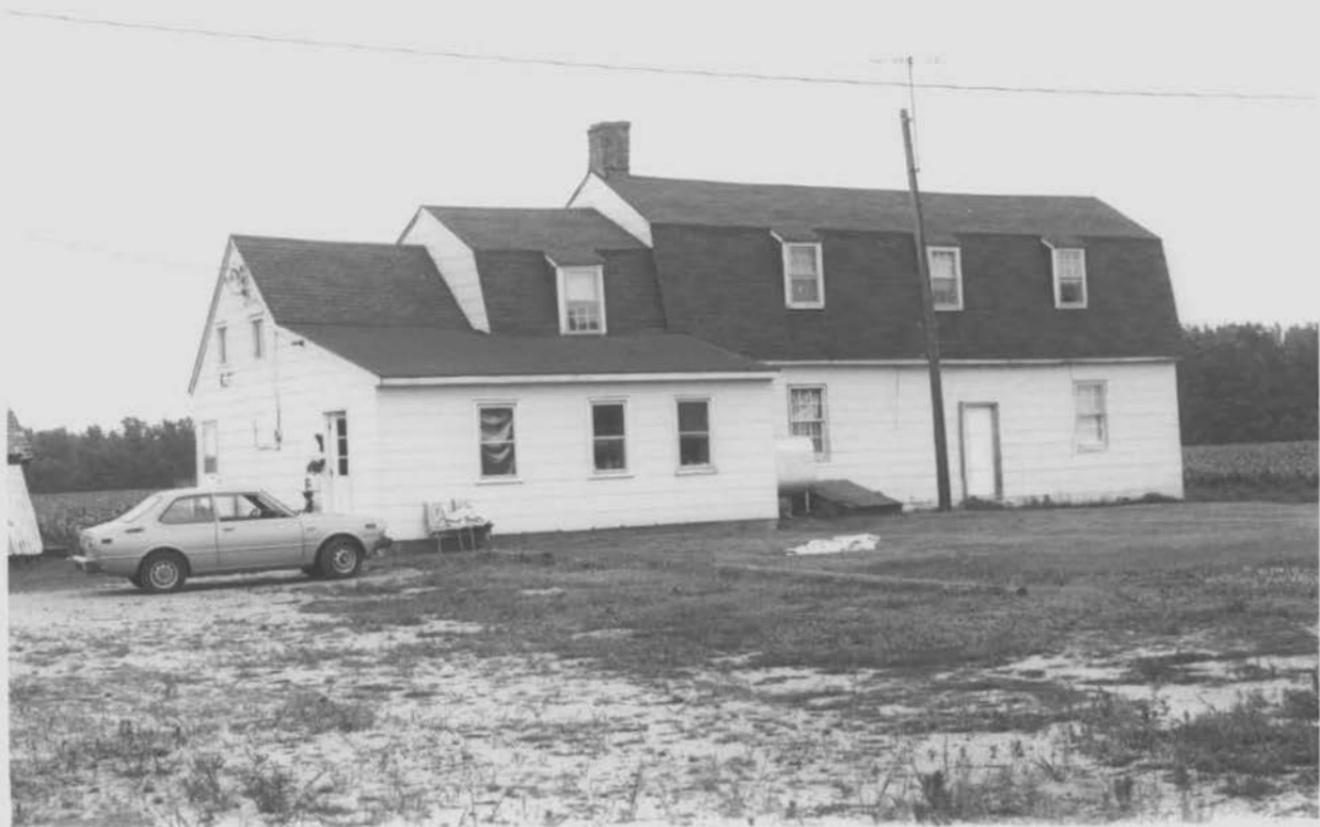
QA-42

On the rear or north facade, there is a single door without transom offset to right of center, and one 6/6 window to east and west on the first floor. Three 6/6 shed roof dormers are ranged across the second story. A bulkhead cellar entrance is located under the east window. The foundation, siding, cornice and roof all match the front facade. The door on this facade is an unusual three-panel example with flattened Greek ogee panel molds.

Charles Vonville Farm  
Sudlersville vicinity  
Orlando Ridout V 1981  
Rear facade from north

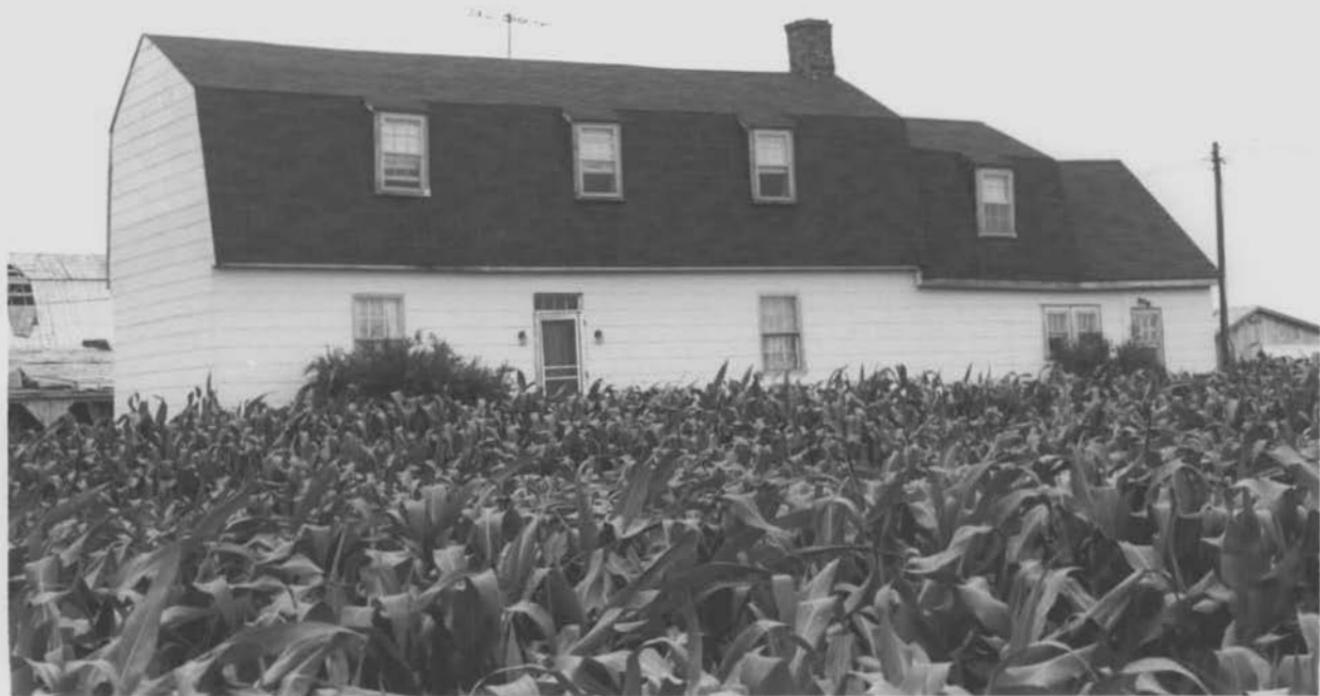
QA-42

The principal facade of the main house faces south to the road. The door is offset to left of center with a four-light transom above, one 6/6 to the west and another 6/6 to the east. There are three 6/6 shed roof dormers on the second floor. These are symmetrically placed on the roof, in contrast to the asymmetry of the first floor openings.

The building rests on a continuous foundation of concrete block and is covered with asbestos siding, a plain box cornice and asphalt shingle roofing.

Charles Vonville Farm  
Sudlersville vicinity  
Orlando Ridout V 1981  
Front facade from south
