QA-432

Clark Nicholson Farm
Centreville vicinity
Private

INVENTORY FORM FOR STATE HISTORIC SITES SURVEY

Clark Nicholson Farm

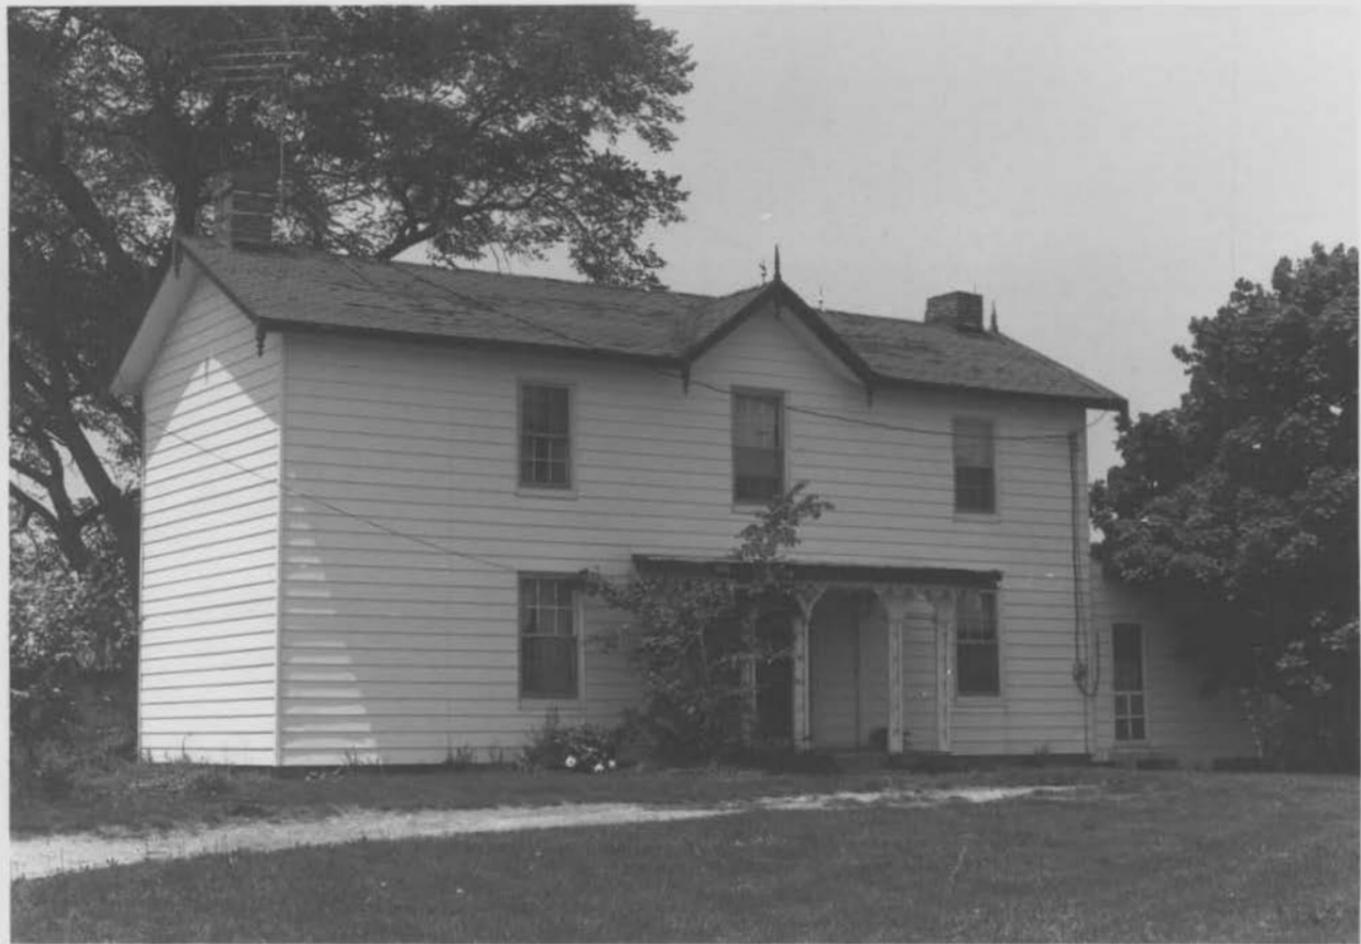
QA-432 Clark Nicholson Farm
Centreville vicinity
Orlando Ridout V 1980
Front facade

The front facade of the enlarged house faces east, toward Tanyard Road. The entrance is in the center bay, flanked by a 6/6 window on each side. There are three 6/6 windows on the second floor; a cross gable is centered on this facade. A small shamrock shaped ventilation window in the center of the cross gable has been blocked from outside but remains visible from the attic. The front door is set off by sidelights and a transom, and is protected by a small entrance porch with ornately scrolled support posts and arched Gothic spandrels. The building rests on a stuccoed foundation and is covered with vinyl siding and an asphalt shingle roof. The eaves oversail and are boxed in, with turned drops at each corner of the building and at the base of the cross gable.

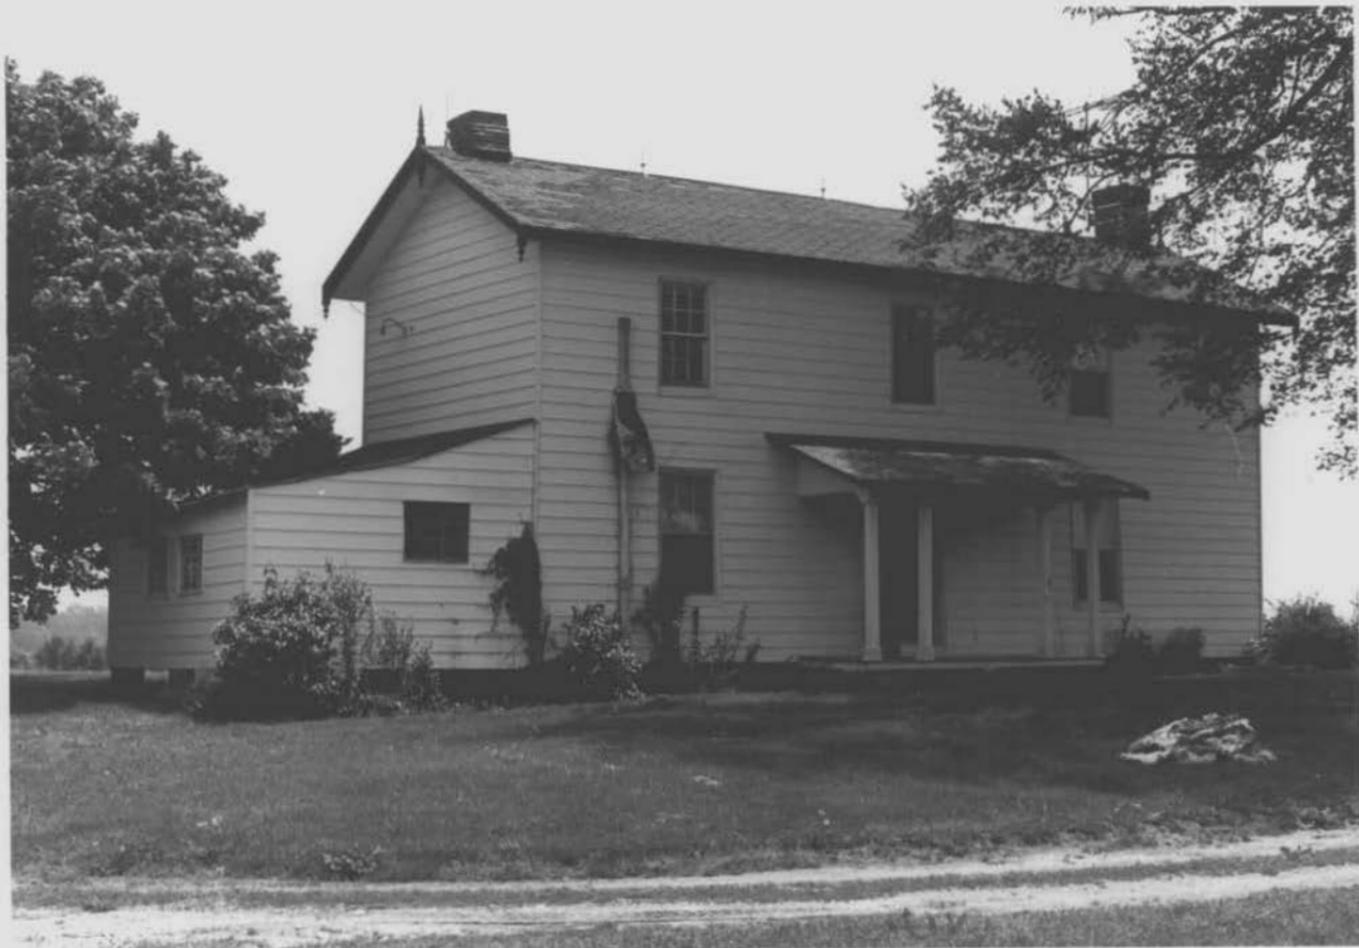
QA-432

Clark Nicholson Farm
Centreville vicinity
Orlando Ridout V 1980
Rear facade

The rear facade is similar to the front facade, with a center door flanked by 6/6 windows on the first floor and three 6/6 windows on the second story. The door has a four-light transom but no sidelights. The small porch over the door on this facade is relatively plain, without decorative posts or spandrels.

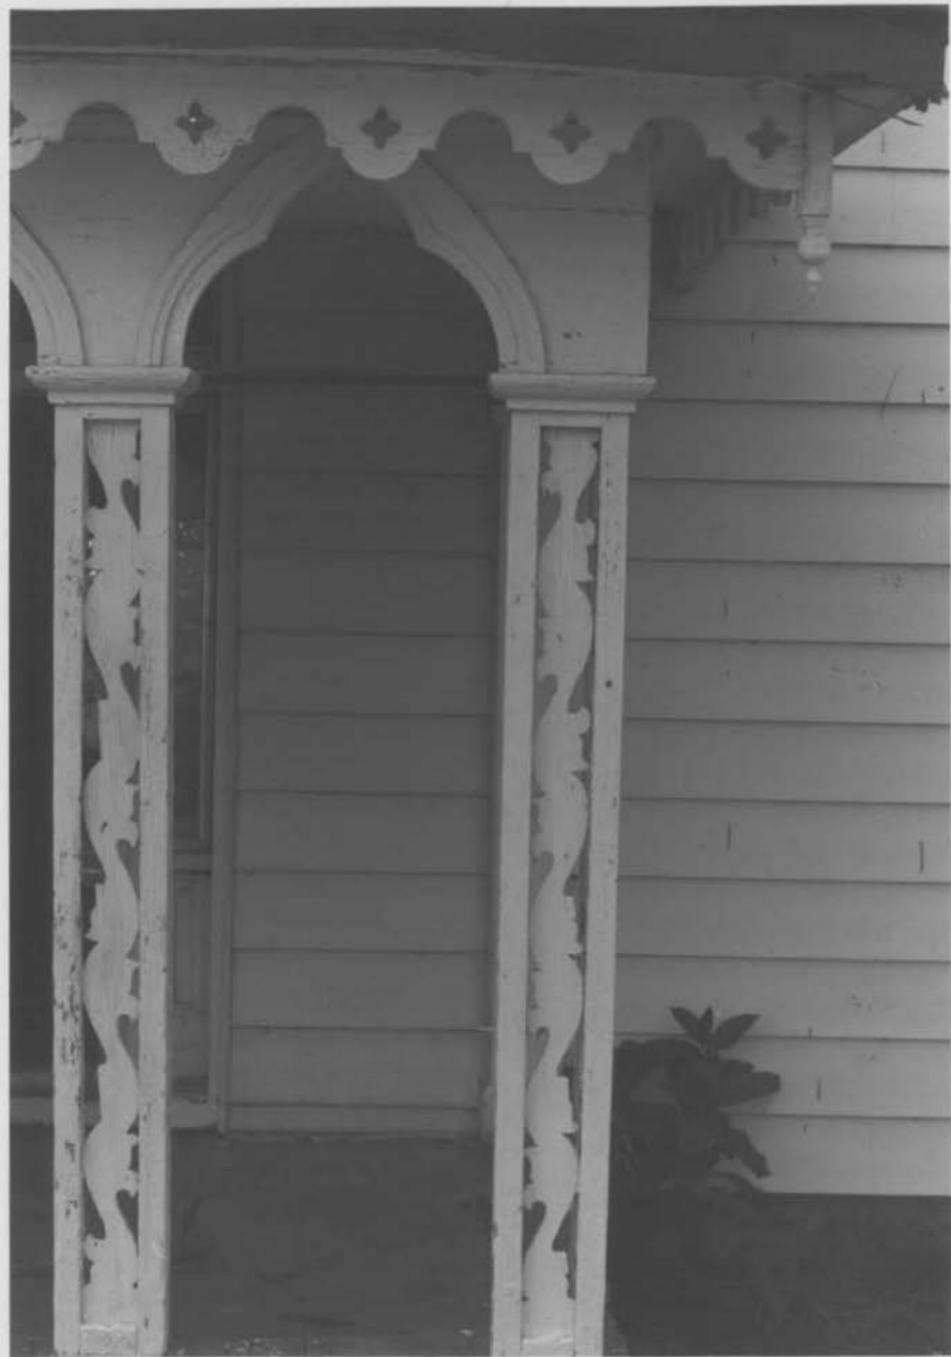
QA-432 Clark Nicholson Farm
Centreville vicinity
Orlando Ridout V 1980
Detail of Porch
