QA-44  
Hadden Hall  
Sudlersville  
Private

## INVENTORY FORM FOR STATE HISTORIC SITES SURVEY

Hadden Hall

HADDEN HALL  
SUDLERSVILLE, MARYLAND

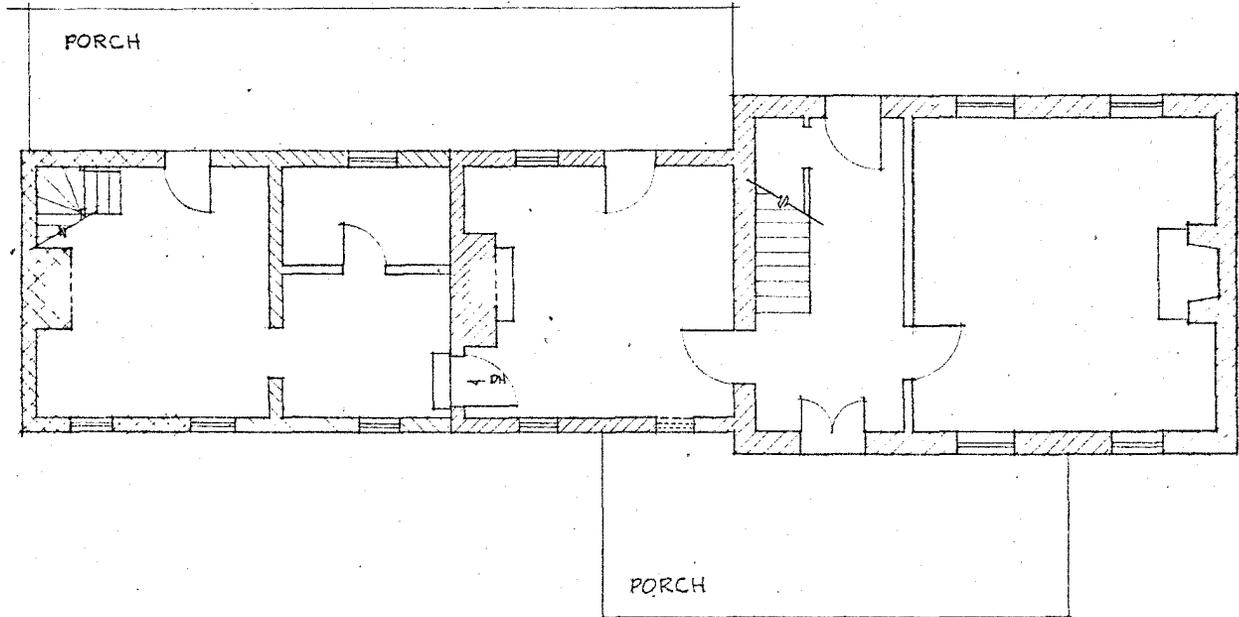
QA-44

The interior remains relatively intact to each building period. The original house, with its side-hall, single-parlour plan, was transformed into a center-hall plan with flanking parlours. This plan is repeated on the upper floors, except that the north end of the stair hall is partitioned, creating a small, unheated chamber on the second and third floor. The expanded kitchen wing now consists of two rooms on each floor, with an enclosed winder stair in the southeast corner of the east room providing access to the second floor.

- ▨ PERIOD I C. 1820
- ▩ PERIOD II 1829
- ▤ PERIOD III LATE 19th C.
