QA-47

Jesse Merchant Farm
Crumpton vicinity
Private

INVENTORY FORM FOR STATE HISTORIC SITES SURVEY

Jesse Merchant Farm

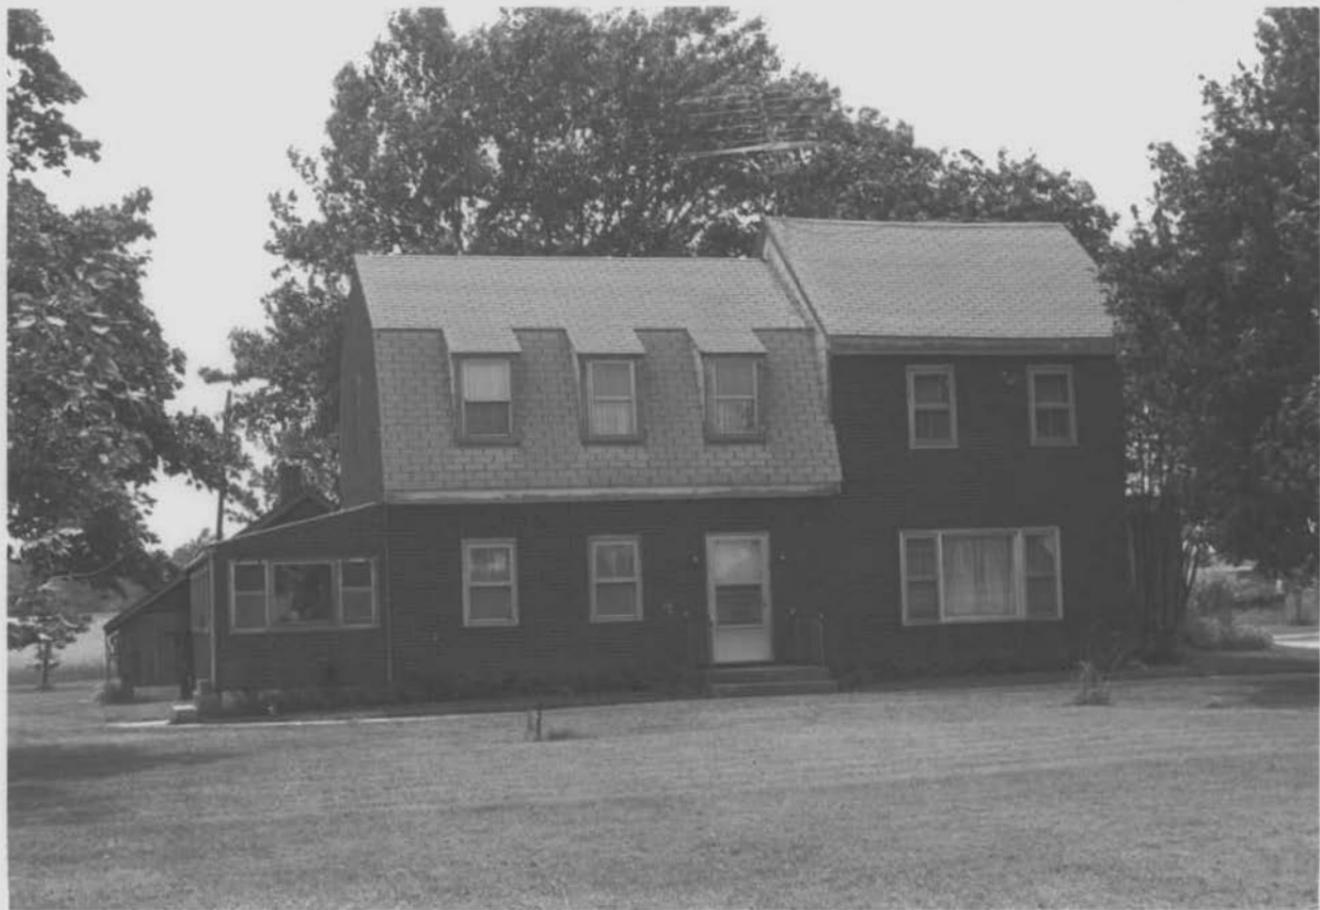
QA-47

Jessie Merchant Farm
Crompton vicinity
Orlando Ridout V 1981
Front facade from northeast

The front facade of the gambrel section faces east toward Route 290. The door is located in

the north bay with two 6/6 windows to the south on the first floor and three 6/6 shed dormers on the second story. The original siding has been covered with brick-pattern, asphalt roll tarpaper. The north gable wall is completely concealed by the later two story addition. On the south gable wall, the flush brick chimney has been removed and a single 6/6 window installed in the upper gable. The first story of the rear facade has been covered by a 20th century addition, leaving three 6/6 shed roof dormers on the second story. The original rear door survives, now opening into the rear addition.

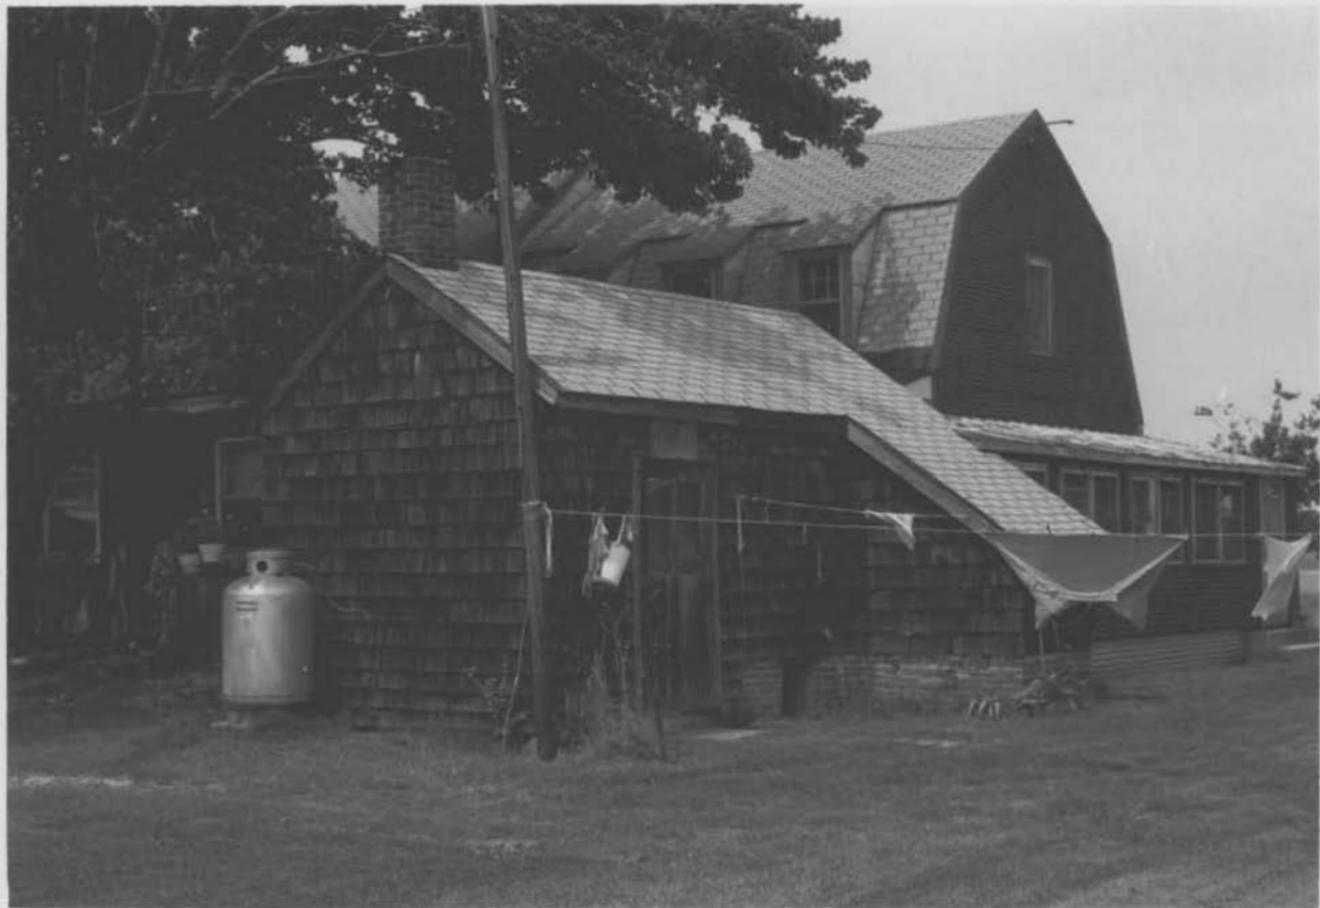
QA-47

Jessie Merchant Farm
Crompton vicinity
Orlando Ridout V 1981
Rear view with potato house

Located to the southwest of the original house, this small frame building has been incorporated into the rear addition. Constructed as a storehouse for sweet potatoes, the building evidently dates to the late 19th century.

The storehouse has an L-plan below a pitched gable oriented on a northeast-southwest axis. The southeast slope of the roof is carried down over the small L, which serves as a covered entrance to a small cellar. A brick chimney is centered on the southwest gable wall. The only openings are a door in the southeast facade opening into the first story and a door on the northeast wall opening onto the cellar stairs. The building

is of frame construction on a continuous brick foundation and is covered with wood shingle siding. The cellar does not extend the full length of the building and the floor level is raised up above the cellar to allow additional head room. It is not clear why the building is laid out in this manner and little evidence survives to explain how the building was used.
