**MARYLAND HISTORICAL TRUST
NR-ELIGIBILITY REVIEW FORM**

QA-529

PROPERTY NAME: Pemberton Farm
ADDRESS: 113 Pemberton Farm Lane, Queen Anne, MD 21657
OWNER: William B. Messix, III
TAX PARCEL NUMBER: 30
PROJECT: MD 404 from US Route 50 to Denton Bypass
SITE VISIT BY: Archaeological and Historical Consultants, Inc.
NAME: Wendy Zug-Gilbert

Inventory No. **QA-529**

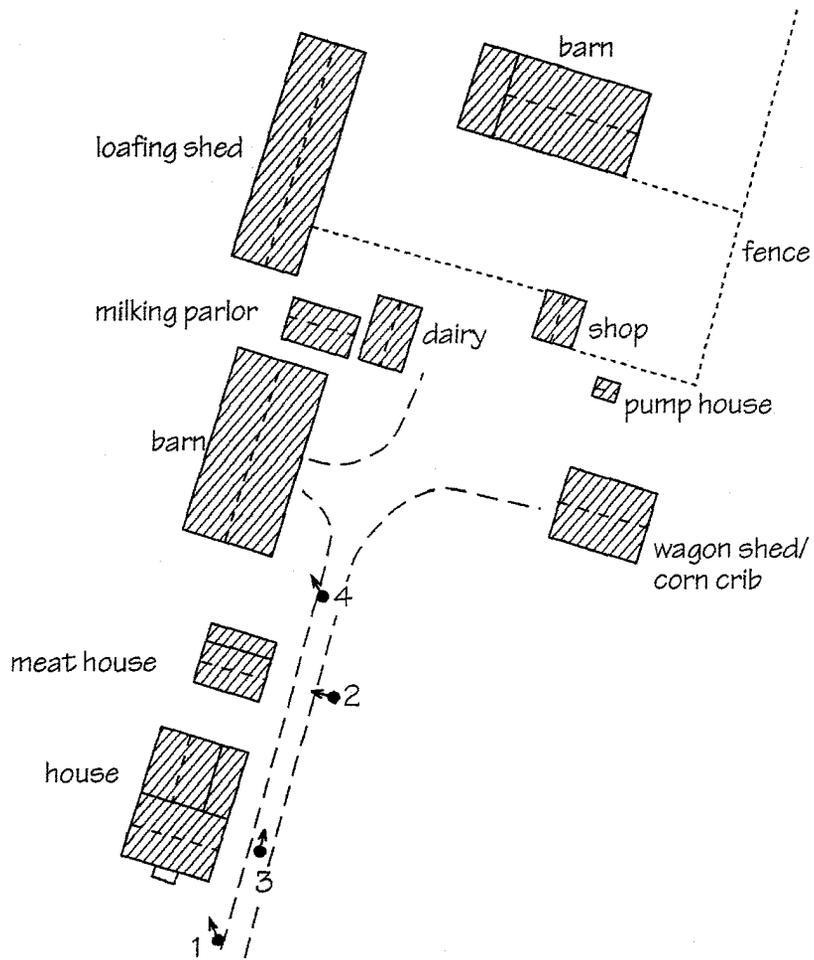
Willoughby Vicinity
Queen Annes County, Maryland
Resource Sketch Map

● = Photo Viewpoint
▨ = Historic Structure
not to scale

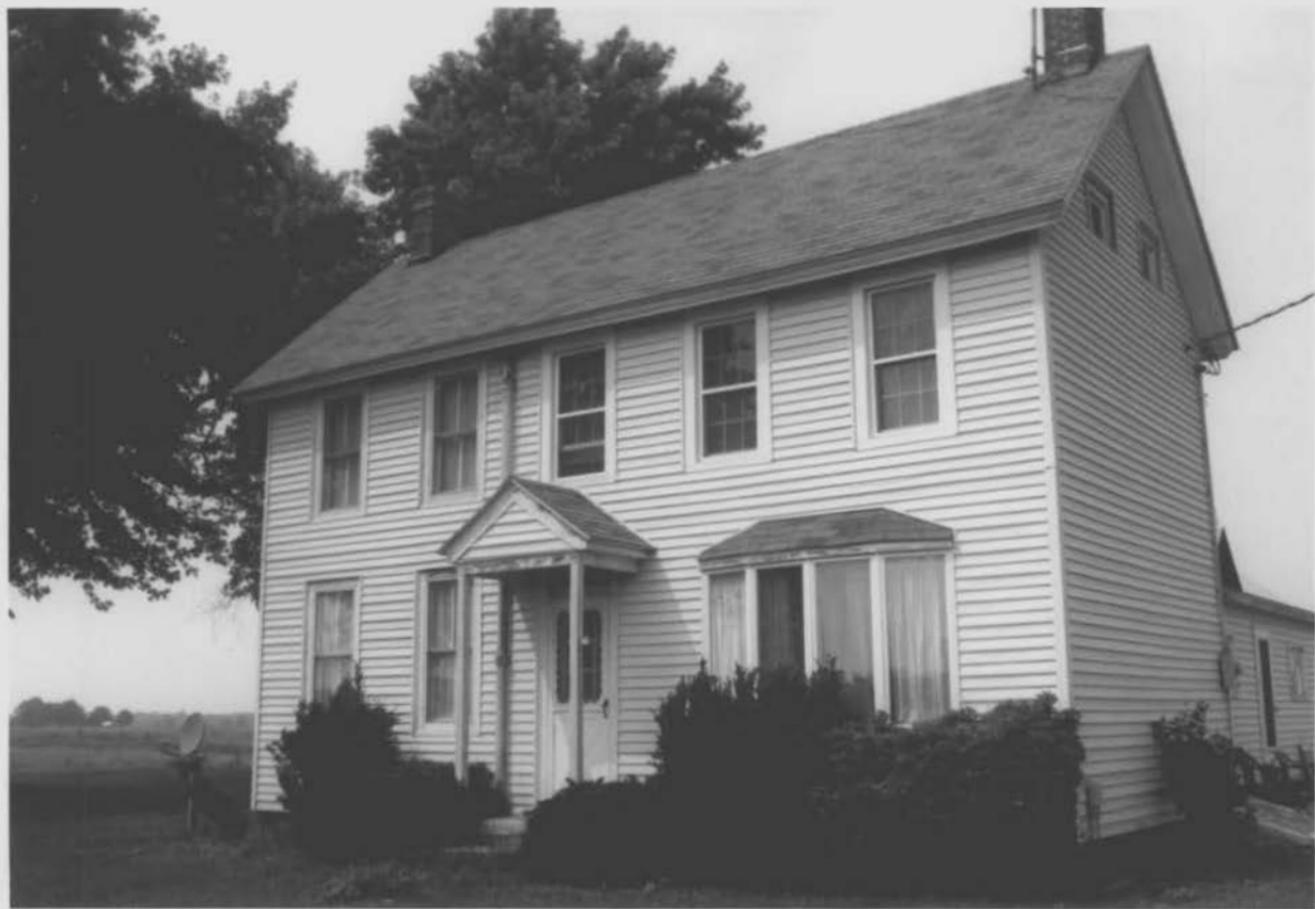
1 of 4

Farmhouse, facade (south elevation), facing north

The farmhouse is a two-and-a-half-story, L-shaped dwelling consisting of a five-bay main block with a rear kitchen wing of the same height. A one-story addition is located in the rear ell. At first glance, this residence appears to be a symmetrical late nineteenth-century farmhouse; however, upon closer inspection, it may have actually been constructed in two phases. The eastern three-bay portion of the structure has six-over-six sash windows consistently throughout. The western two-bay portion has two-over-two sash windows throughout. If this house were constructed in two phases, then the eastern section would be the older of the two and its plan would have originally been side-hall. The western two bays and the rear ell may have been added later, giving the appearance of a symmetrical façade. The interior brick end chimneys are also dissimilar, further suggesting multiple construction phases. The structure is covered with vinyl siding, has an asphalt-shingle roof, and sits on a brick foundation. A small gabled porch roof at the front entry is supported by squared posts. A bay window has replaced the two first-story windows on the eastern section of the façade.

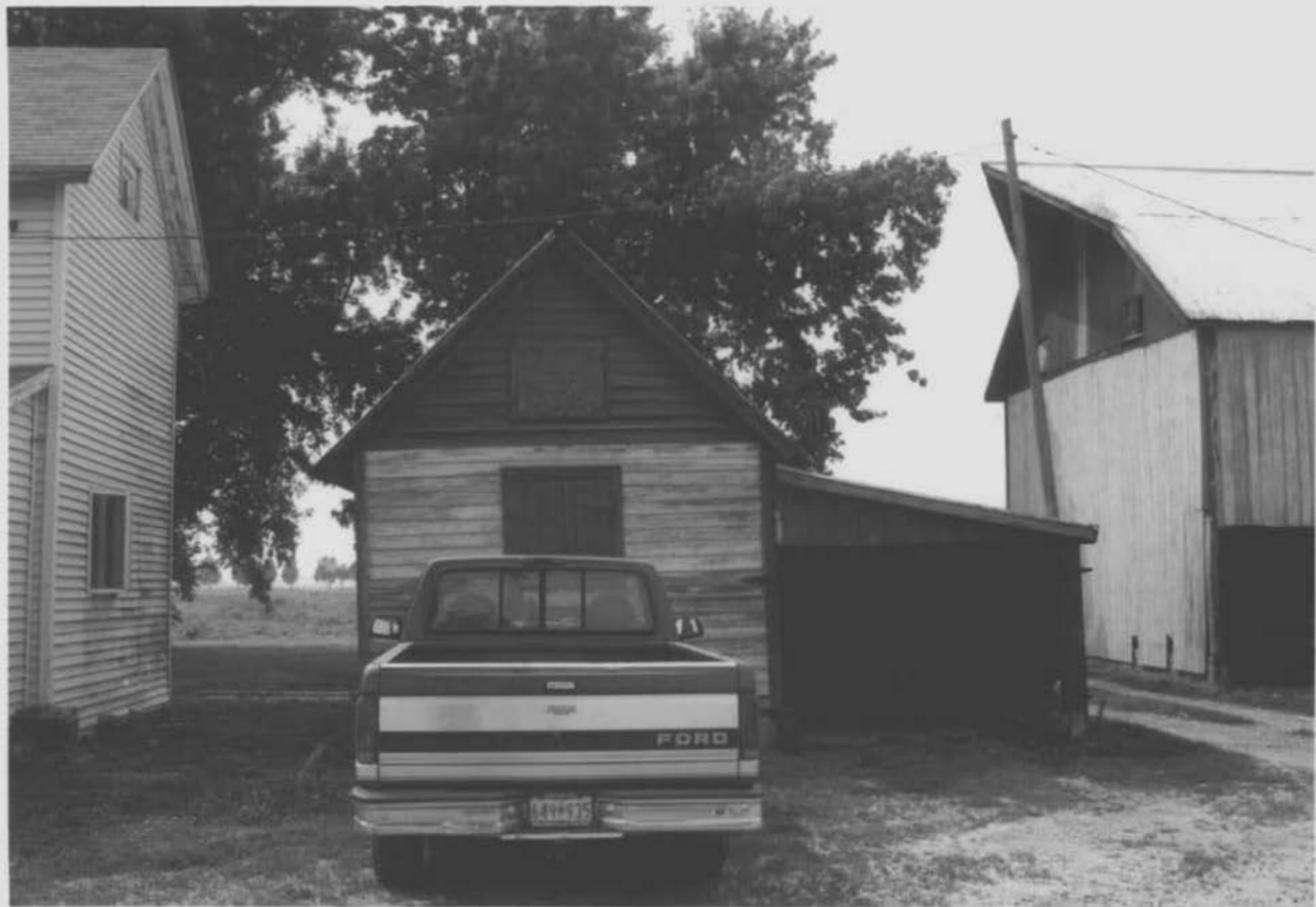
2 of 7

Meat house with addition east elevation, facing west

The property's outbuildings date to the late nineteenth/early twentieth-century. Directly behind the farmhouse is a frame gable-roof meat house with a shed-roof addition on its northern side wall. The agricultural buildings are located north of the farmhouse and are organized such that the larger buildings form the perimeter of the farmyard in which the smaller buildings are situated. The west side of the farmyard is framed by a large barn and a loafing shed, both of which were built in the 1930s. Both are frame with metal roofs. The gambrel-roofed barn is covered with vertical planks, has a hay hood on its south end, and has a large addition on its north end that substantially increases the size of the structure. The north end of the farmyard is formed by a smaller, more recent barn. Referred to as the 'colt barn,' the frame structure sits on a concrete-block foundation and has plank siding and a metal-covered gabled roof. Smaller outbuildings within the middle of the farmyard include the milking parlor, dairy (milkhouse), and shop, all of which were constructed during the first half of the twentieth century. The milking parlor is a concrete-block structure with a gabled metal roof. The dairy and shop are frame structures on concrete-block foundations and are covered with wood siding and have metal gable roofs. The dairy has a tall brick chimney with an arched hood on its eastern side wall. The east side of the farmyard is framed by a pumphouse and a corncrib/wagonshed. The pumphouse is a low concrete-block structure with a metal roof. The corncrib/wagonshed is a frame building with a gable-front metal roof.

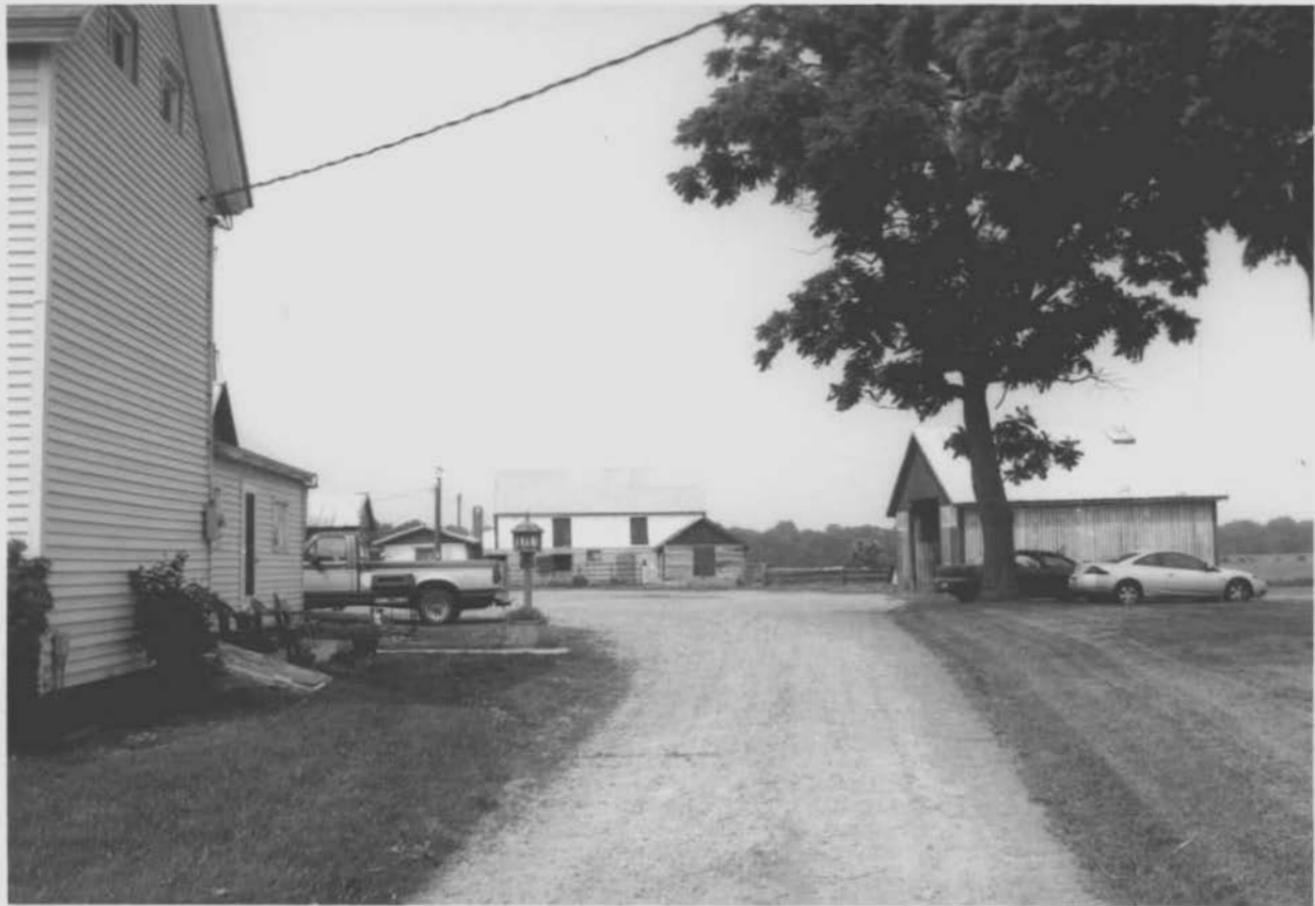
3 of 4

View of farmyard showing corner crib/wagon shed, shop, barn, and dairy,
facing north.

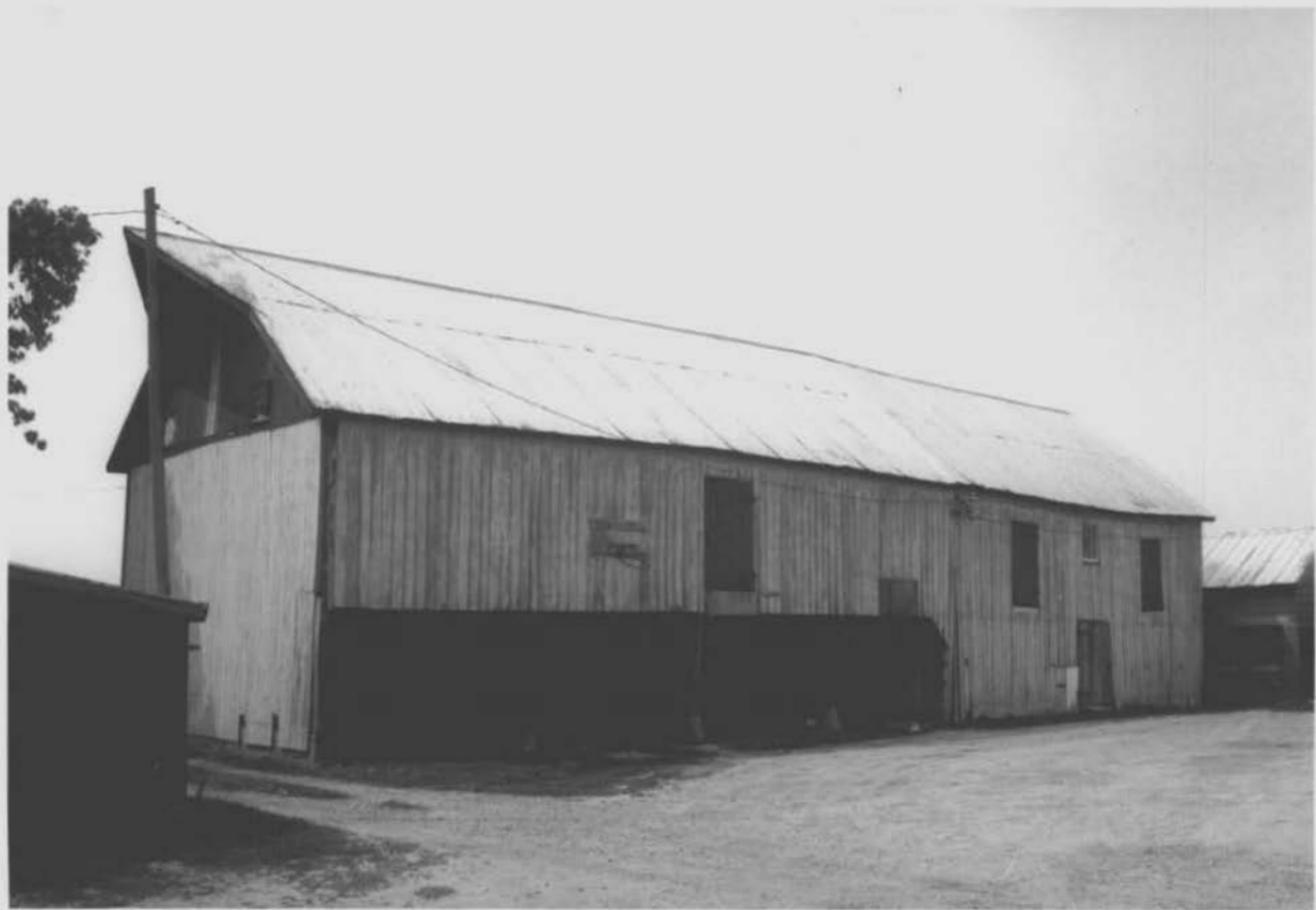
4 of 4

Barn with addition, east elevation, facing northwest.

NOTE: milking parlor at far right
