QA-57
Cohey Farm
Church Hill
Private

INVENTORY FORM FOR STATE HISTORIC SITES SURVEY

Allen and Charles Cohey farm

COHEY FARM,
CHURCH HILL, MARYLAND

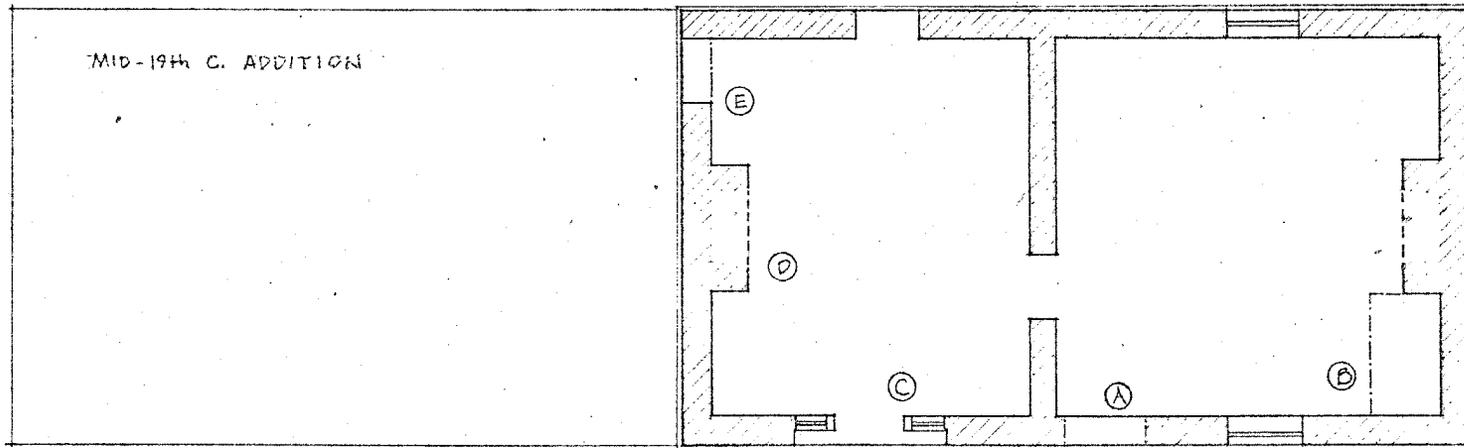
- A LOCATION OF ORIGINAL EXTERIOR DOOR.
- B LOCATION OF ORIGINAL STAIR.
- C MID-19th C. EXTERIOR DOOR.
- D ORIGINAL FIREPLACE CONCEALED BY
MID-19th C. STAIR (NOT SHOWN).
- E CONNECTING DOOR CUT IN FOR ADDITION.
