QA-61

John R. Smith Farm

INVENTORY FORM FOR STATE HISTORIC SITES SURVEY

John R. Smith Farm, Samuel Everett Farm

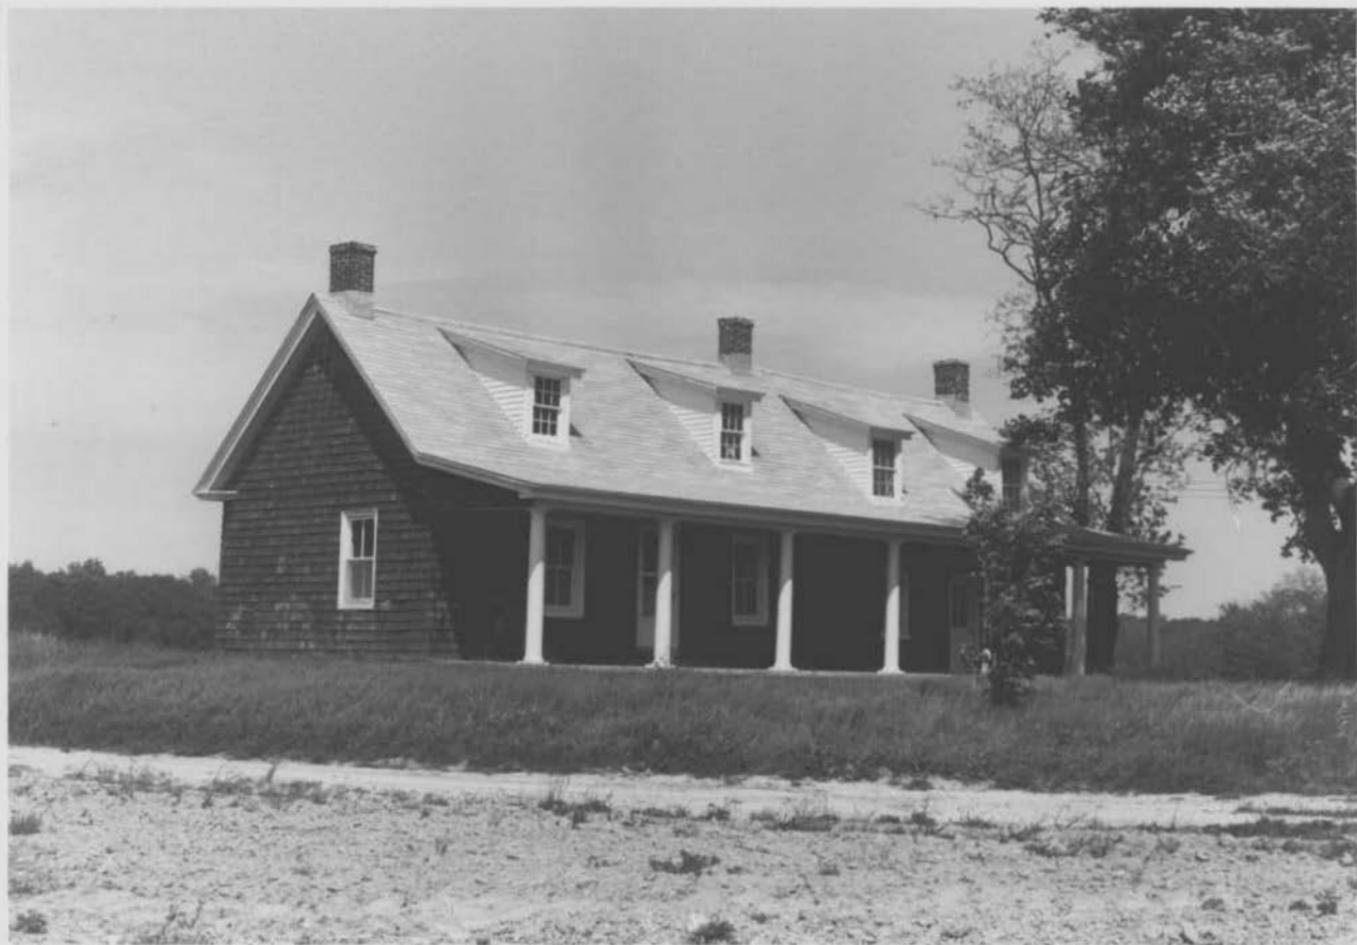
QA-61

The front facade of the original house faces south toward Rabbit Hill Road. The door is located in the center bay, flanked by a single 2/2 window on each side. There are two 6/6 shed roof dormers on the second floor. The first floor window sash and door are all late 19th century replacements. The dormer windows appear to have been reworked when the house was enlarged.

Front facade from Southwest

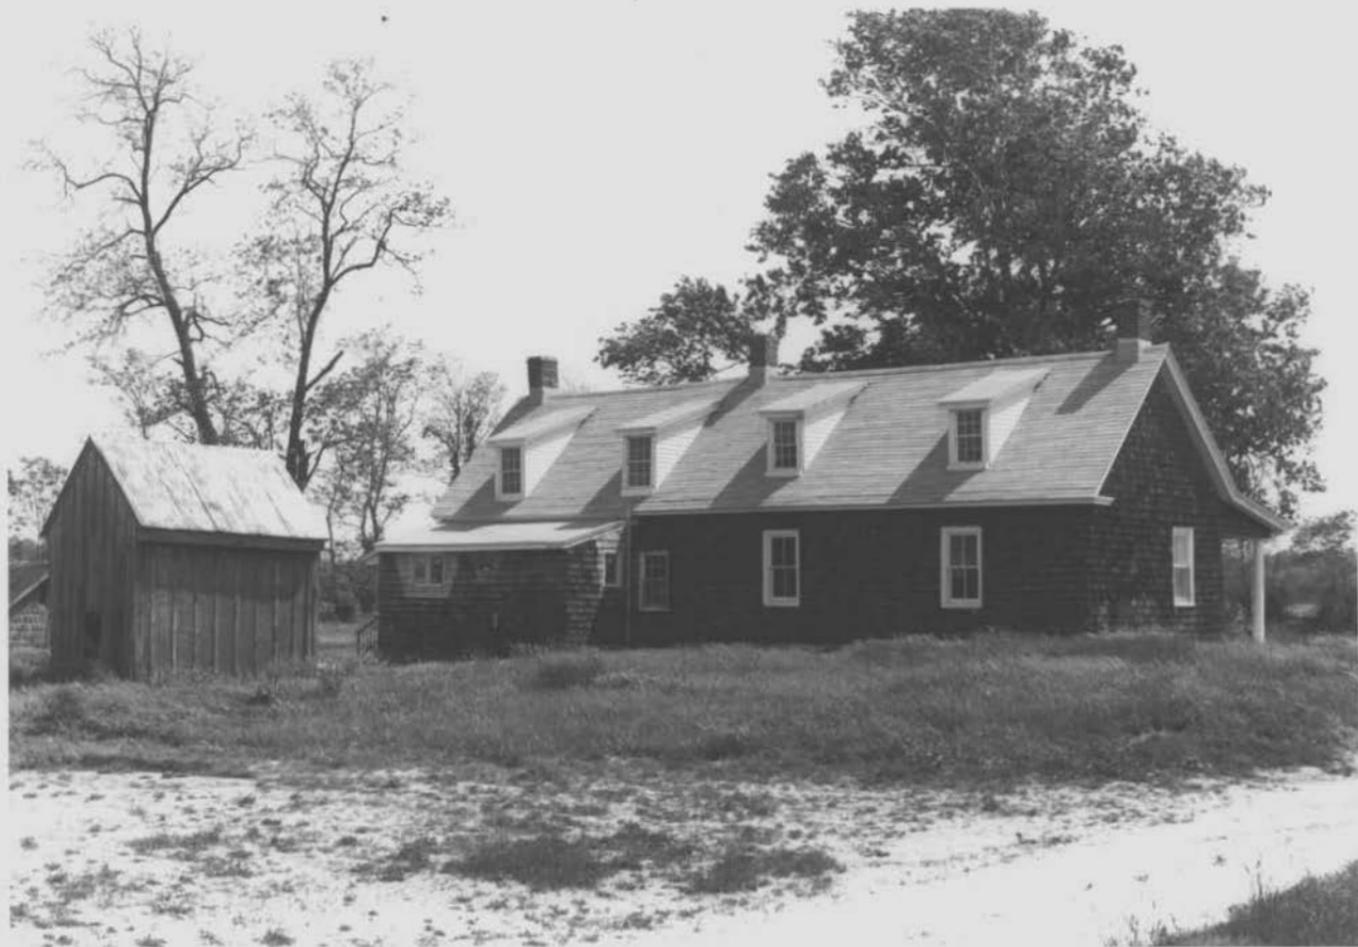
QA-61

On the rear facade of the original section, there are two 2/2 windows on the first floor and two 6/6 shed dormers on the second floor.

Rear facade from north
