MARYLAND HISTORICAL TRUST
NR-ELIBILITY REVIEW FORM

QA-66

other Thomas Farm, C. P. Merrick Farm (modern)

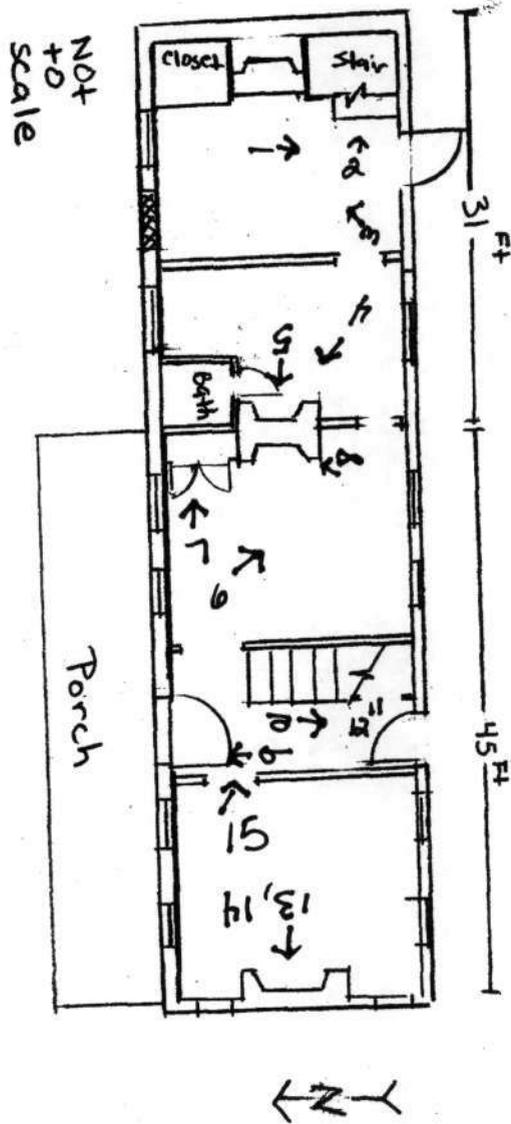
Sketch floor plan of C. P. Merrick Farmhouse/ Thomas Farmhouse. Numbers correspond with photograph locations.

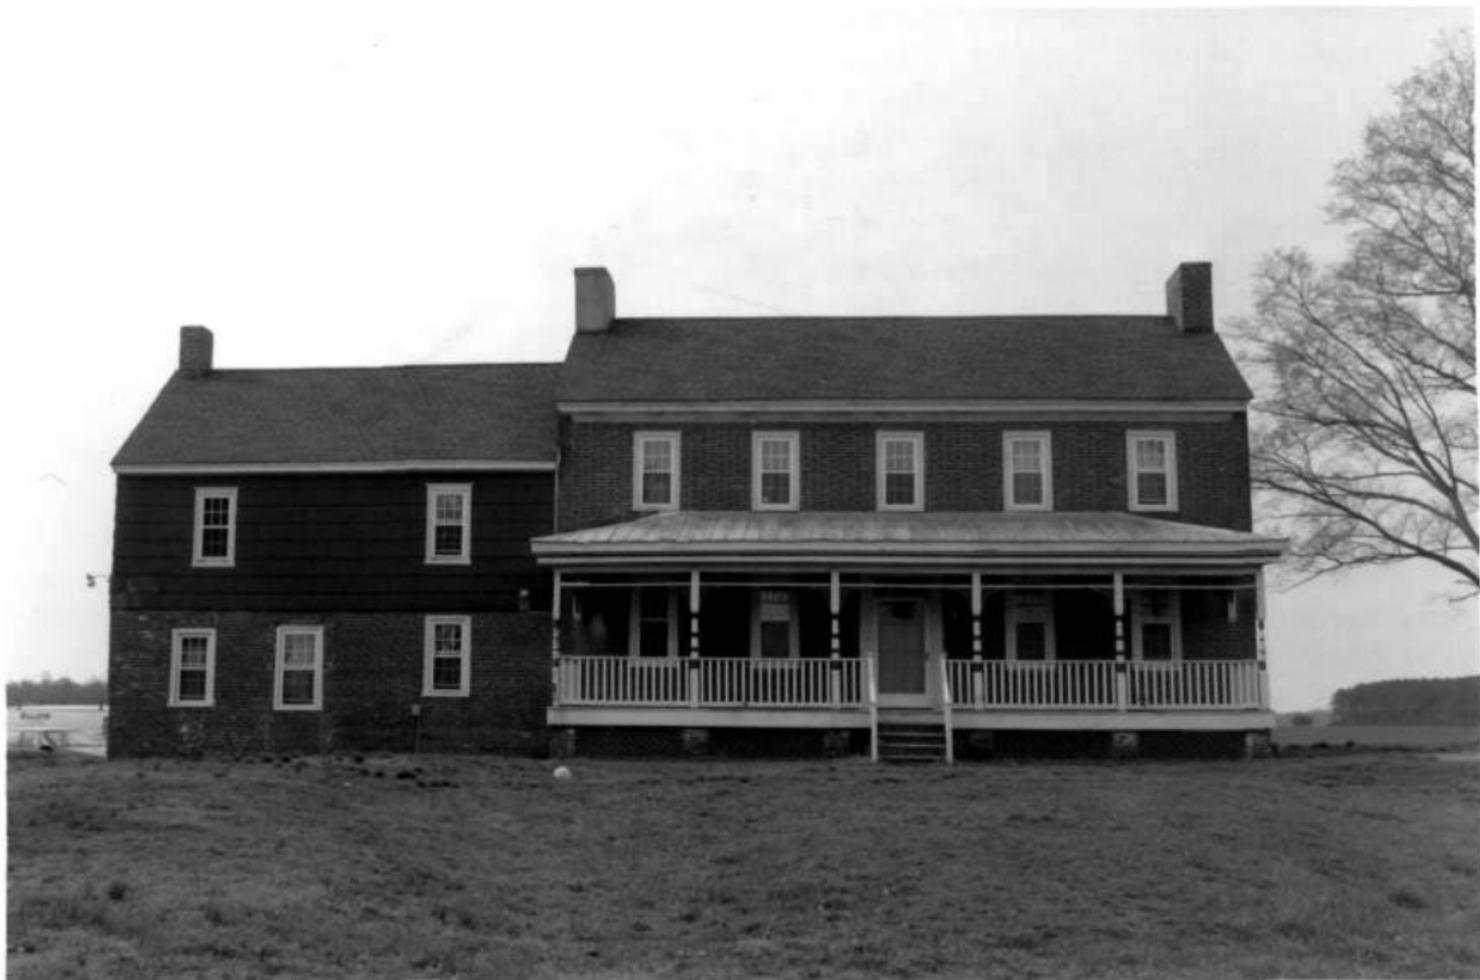
Photo 2 of 13

Façade fenestration consists of two 6/6 windows on either side of a center entrance, while five, 6/6 windows illuminate the second story. The sash windows are modern replacements, but the original complex paneled architraves remain in place. Five cellar windows are obscured by the presence of a full-width, Victorian-era porch. Ghosting evidence of an earlier 1-story, 1-bay entry porch remains visible on either side of the doorway. The entrance retains its six-panel door, paneled pilaster surround, and a diamond-patterned transom with paneled soffit and jambs.

Front (north) facade

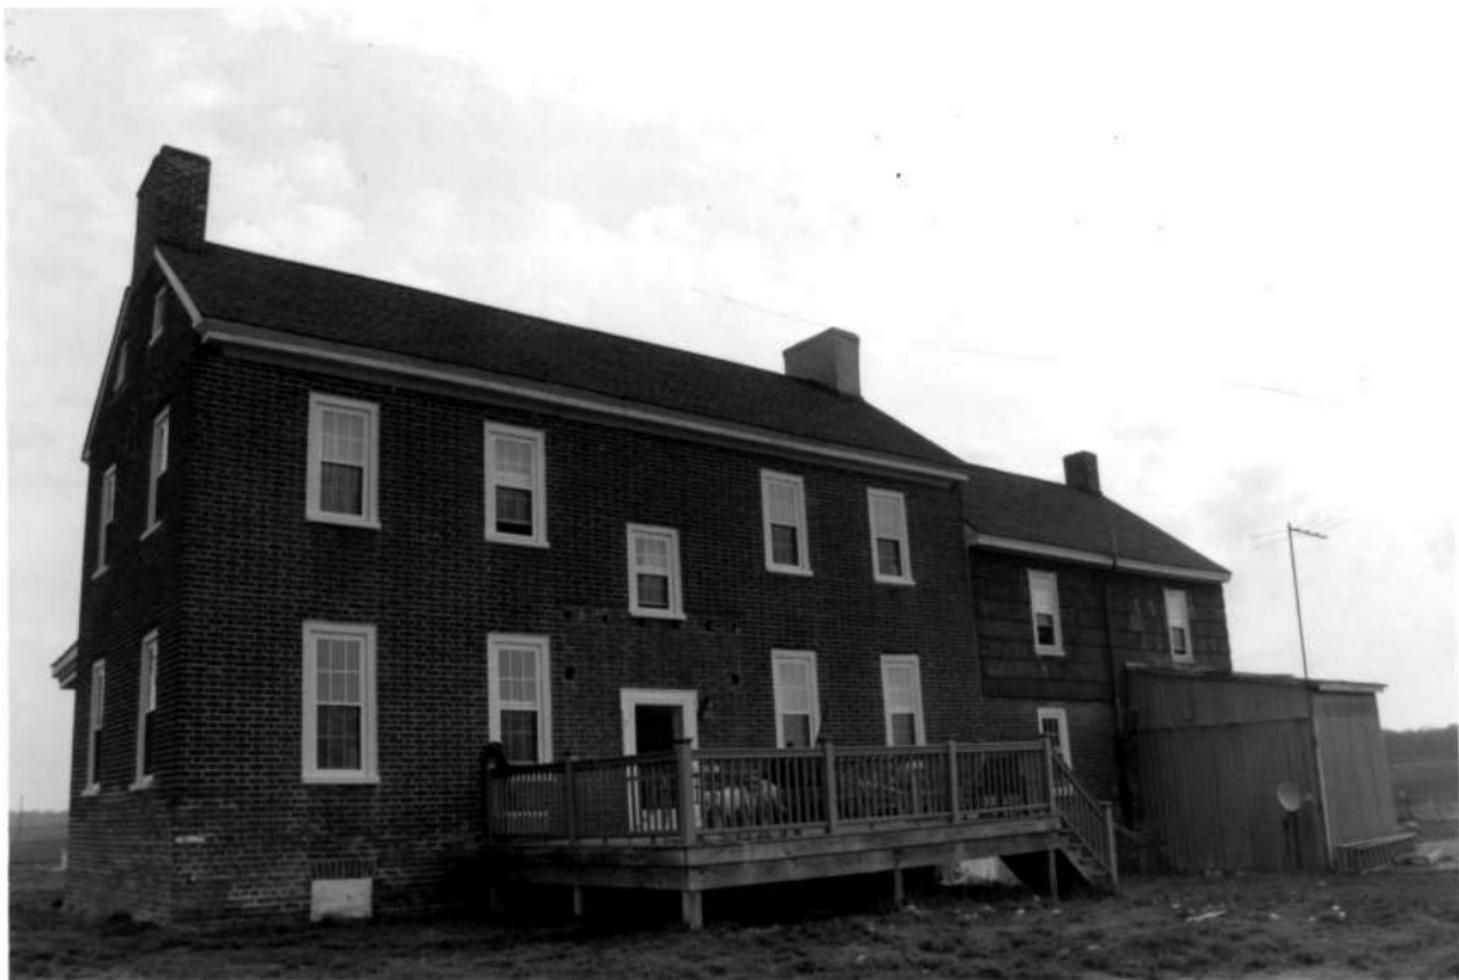
photo 3 of 13

The rear façade also displays five bays and a center entrance. As with the primary façade, the 6/6 windows are modern replacements. The entrance displays paneled soffits and jambs, as well as a crosstetted surround. A modern storm door protects the six-panel door. The door's lower height and the placement of a second story window reflect the presence of the interior staircase. A brick to the right of the rear door is inscribed "1805". The small shed porch seen in Ridout's photographs was removed to accommodate a large wooden deck.

Rear (south) elevation

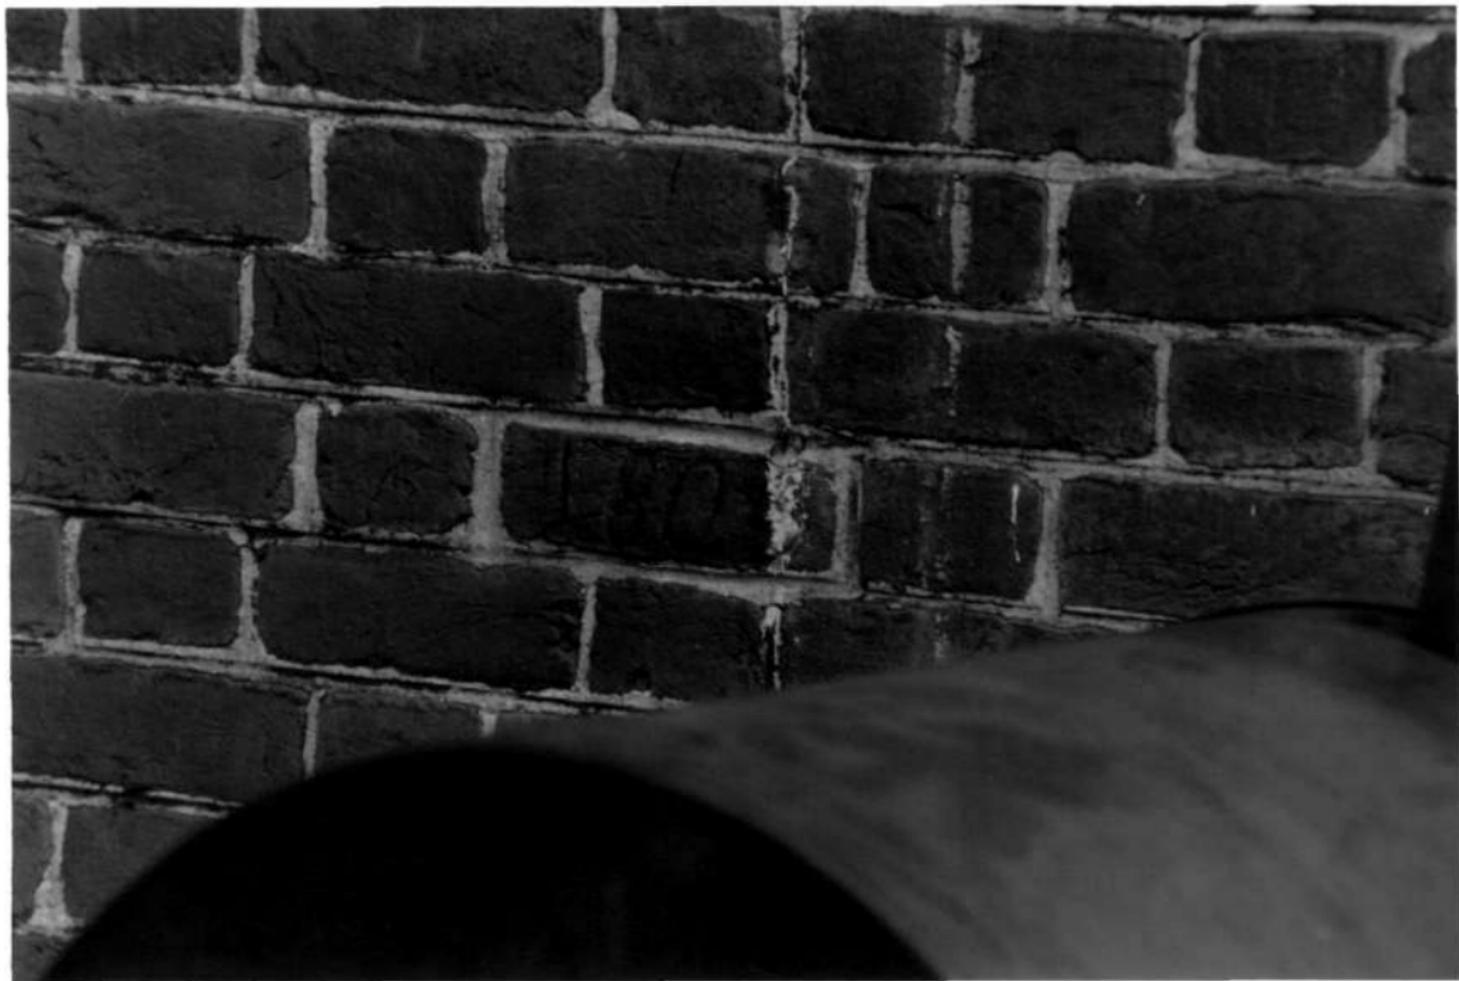
photo 4 of 13

The main house on the C. P. Merrick Farm/ Thomas Farm is a large brick dwelling with an original brick wing, constructed in 1805. The 1805 construction date is derived from a date brick located adjacent the rear (south) entry and supported by other architectural evidence. The house is 2 ½ stories high, five bays wide and features a center-passage, single-pile plan. Bricks are laid in Flemish bond above a 1:3 common bond foundation. There is neither watertable nor beltcourse. The soft, hand-made bricks show evidence of a developing moisture problem. The steeply pitched roof terminates at either end with a rebuilt or heavily repaired flush chimney. The box cornice features a complex crown and bed mold, with a Wall-of-Troy style dentil course adding additional elegance.

"1805" Date Brick on rear wall

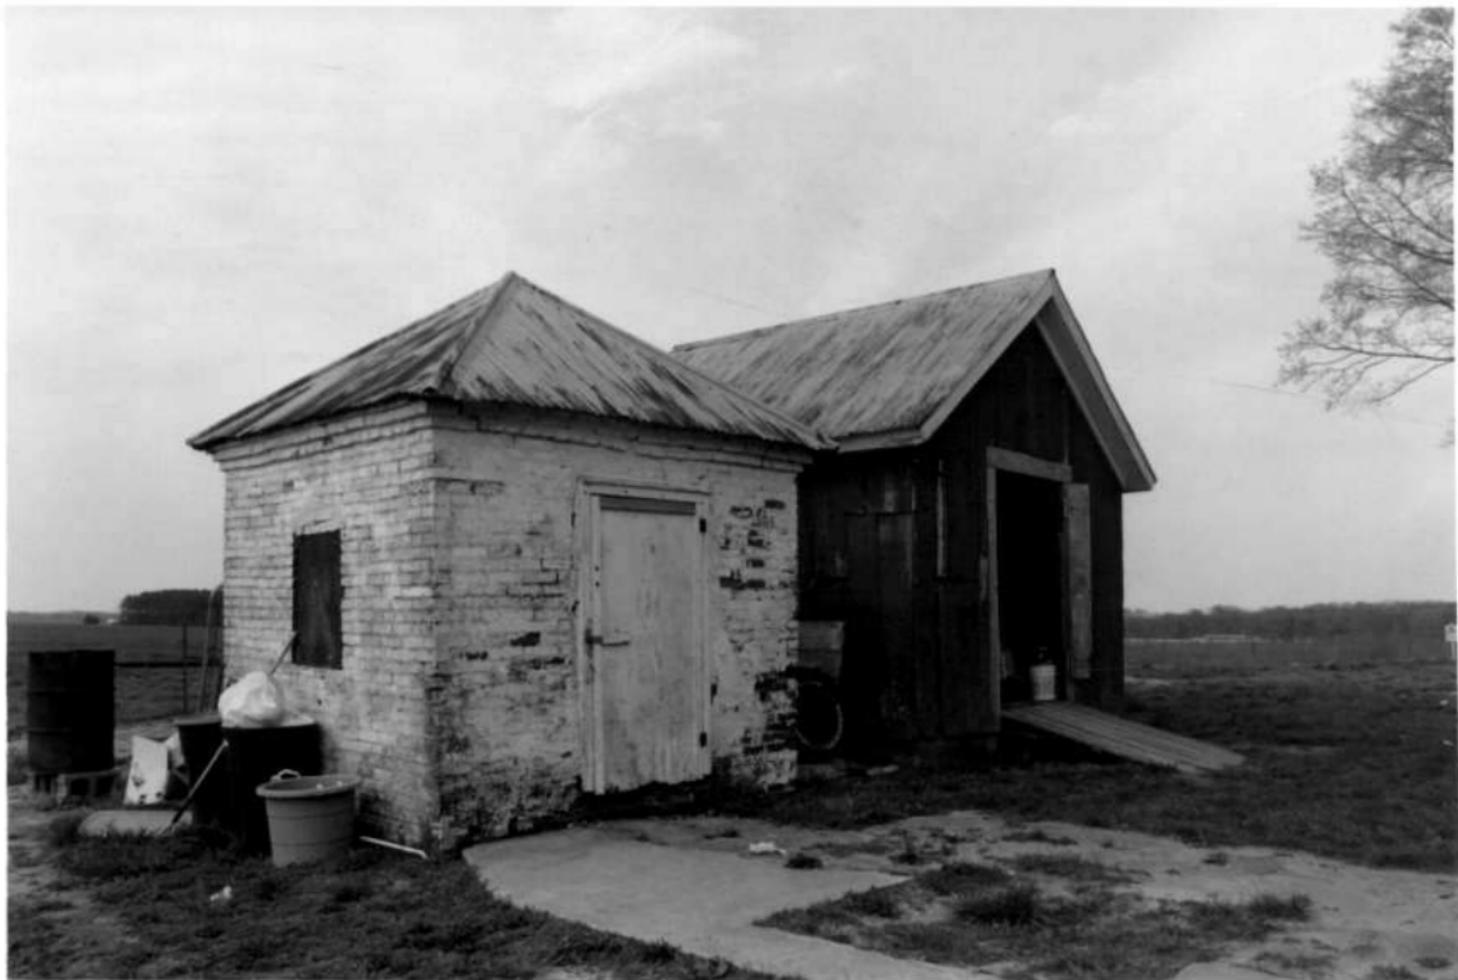
Photo 5 of 13

A small brick dairy is situated a few yards south of the kitchen wing. This building measures 9' x 9'. The soft, deteriorating bricks are laid up in 7:1 common bond. Walls terminate at the roofline with a corbelled cornice. The pyramidal roof is covered with metal. A plywood board serves as a door and windows are boarded over.

A mid-20th century, frame, gable-roofed storage shed stands immediately west of the dairy. Walls are sheathed with vertical planks and rest on a poured concrete foundation.

19th Century Dairy + 20th
Century Shed

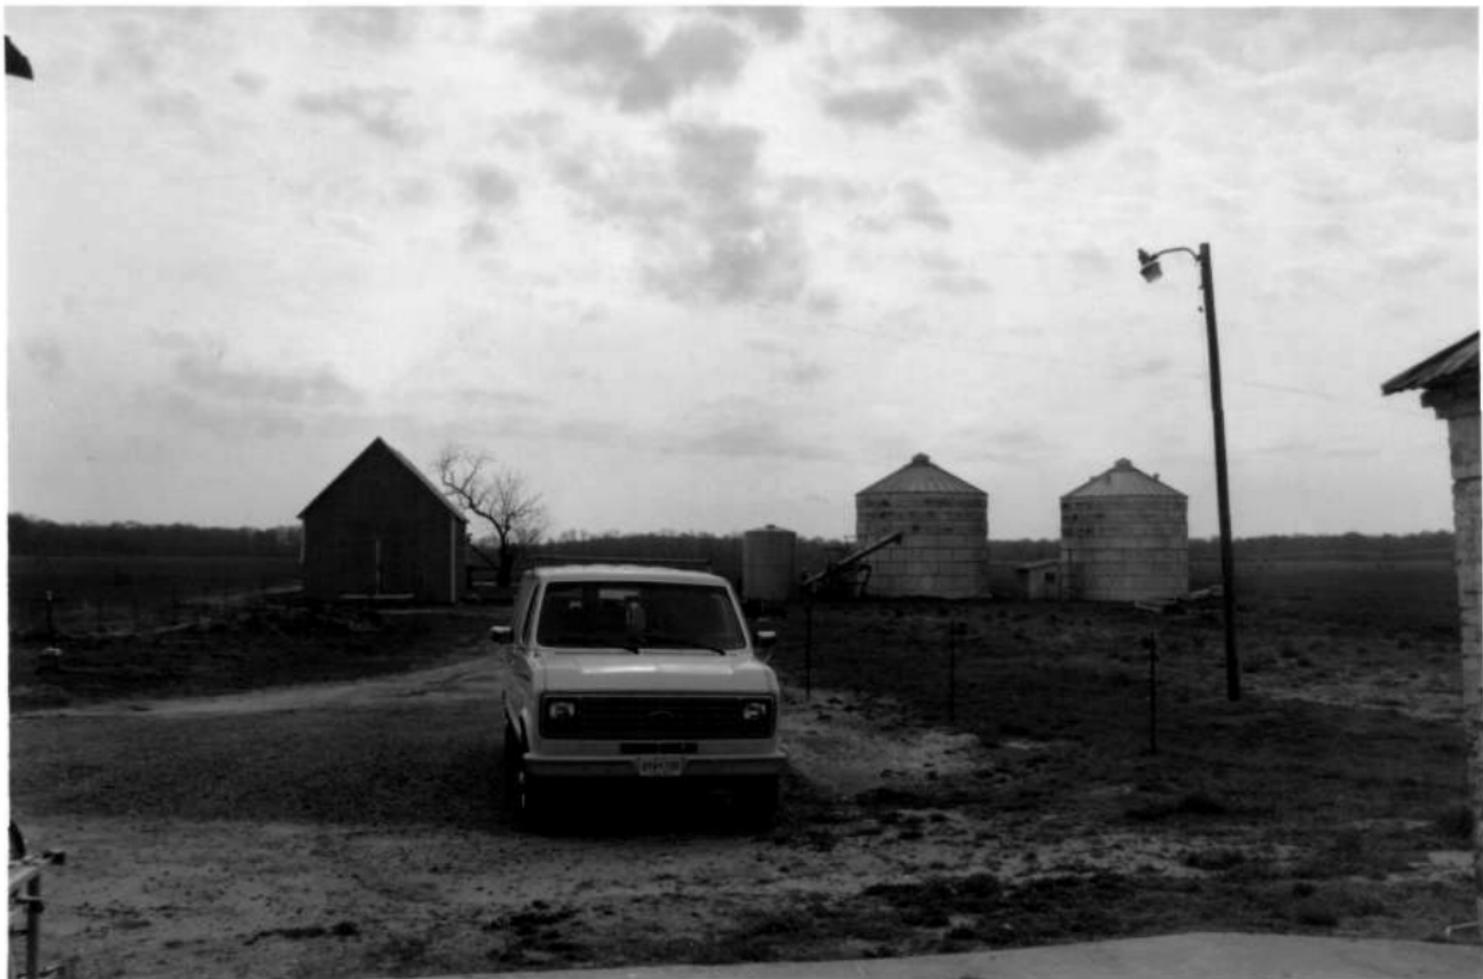
photo 6 of 13

Three modern metal grain silos and a small shed are located immediately east of the house. These structures are not historic and are not legally associated with the house lot.

Silos + Shed, Camera facing east

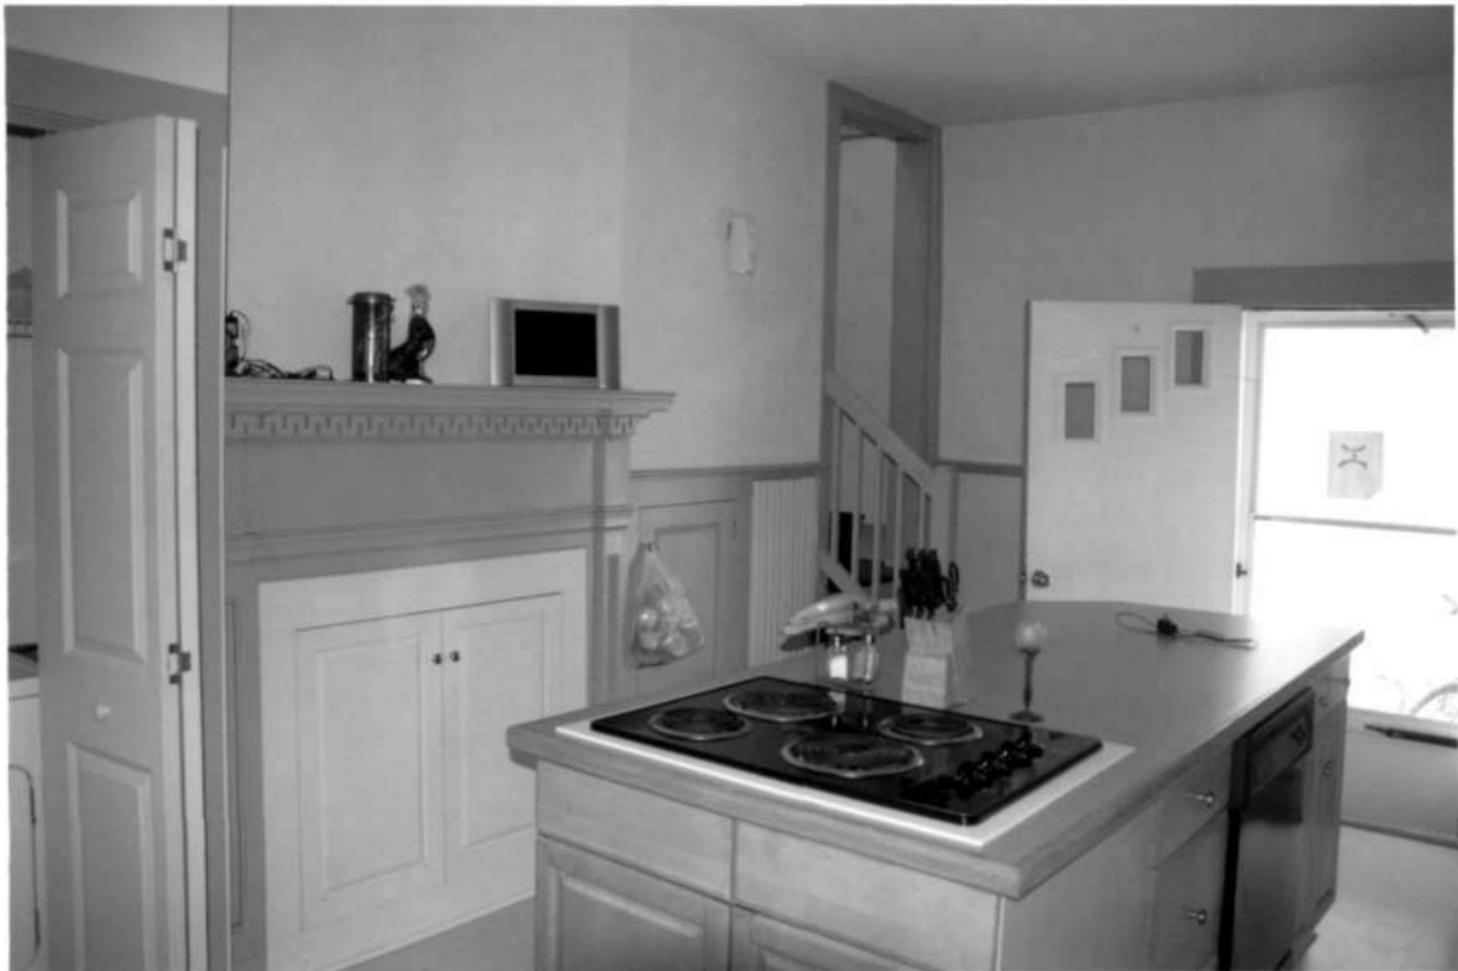
photo 7 of 13

Interior conditions remain essentially the same as described by Orlando Ridout in 1981. The primary exception is the newly modernized kitchen. In 1981 that space was already described as "altered", with

the large fireplace enclosed and the mantle removed. The fireplace now features a mantle featuring a boldly carved Greek Key design and paneled pilasters. It is unclear if this piece is historically associated with the house or relocated from another building. Its excellent condition and character different from the dwelling's other mantles, suggest it is not historic. The firebox has been converted to storage space and fitted with modern doors. Please refer to the attached keyed floor plan and photographs for an illustration of current interior conditions.

Kitchen (wing)

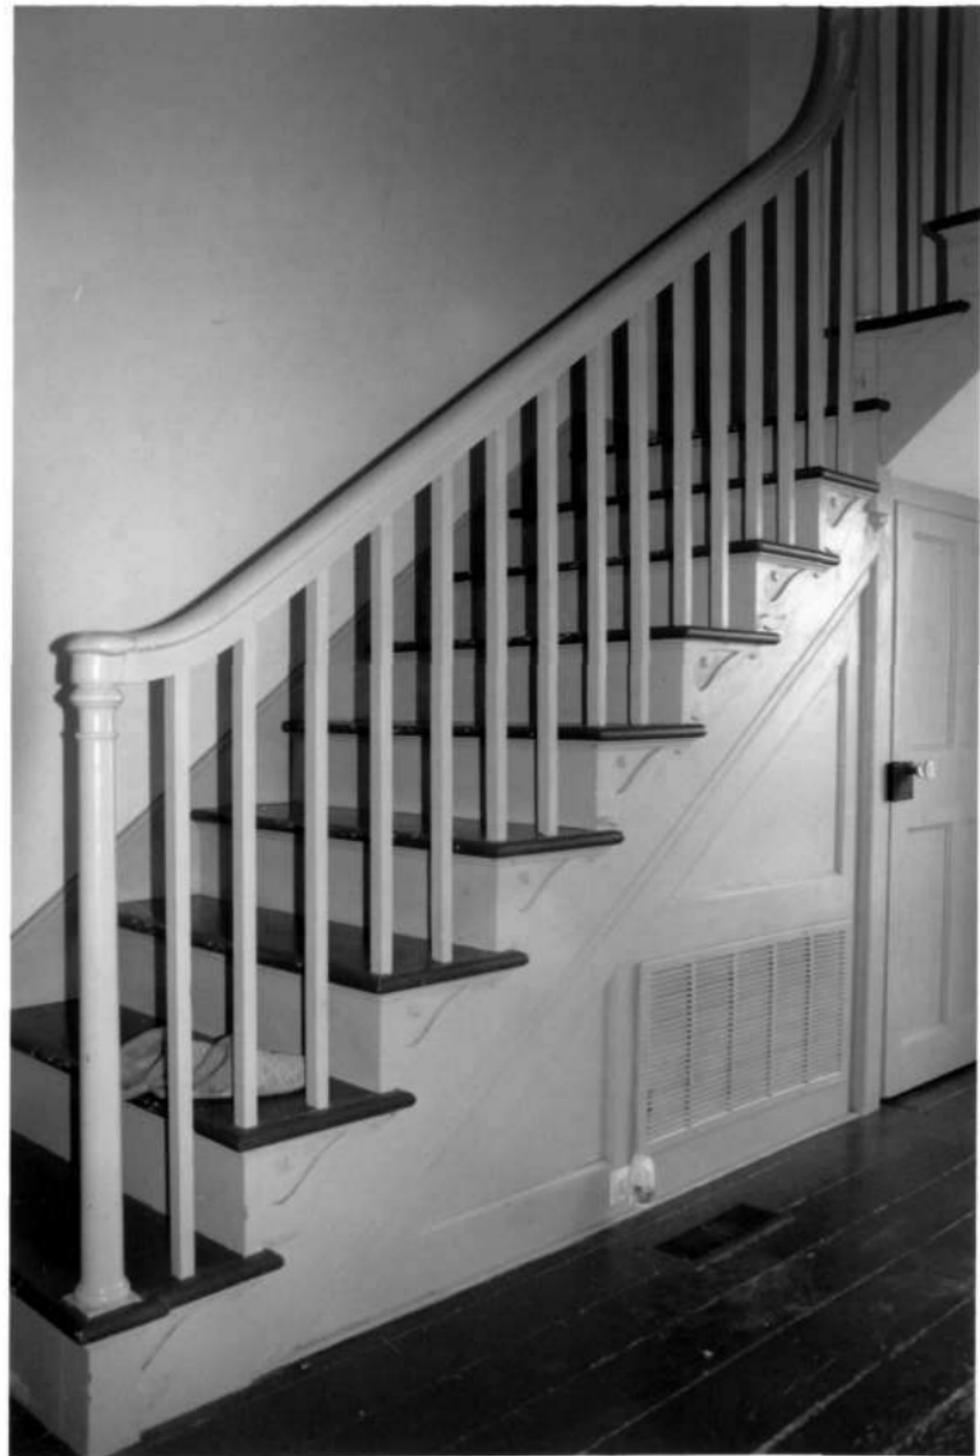
photo 8 of 13

Dining room with view towards
Wing

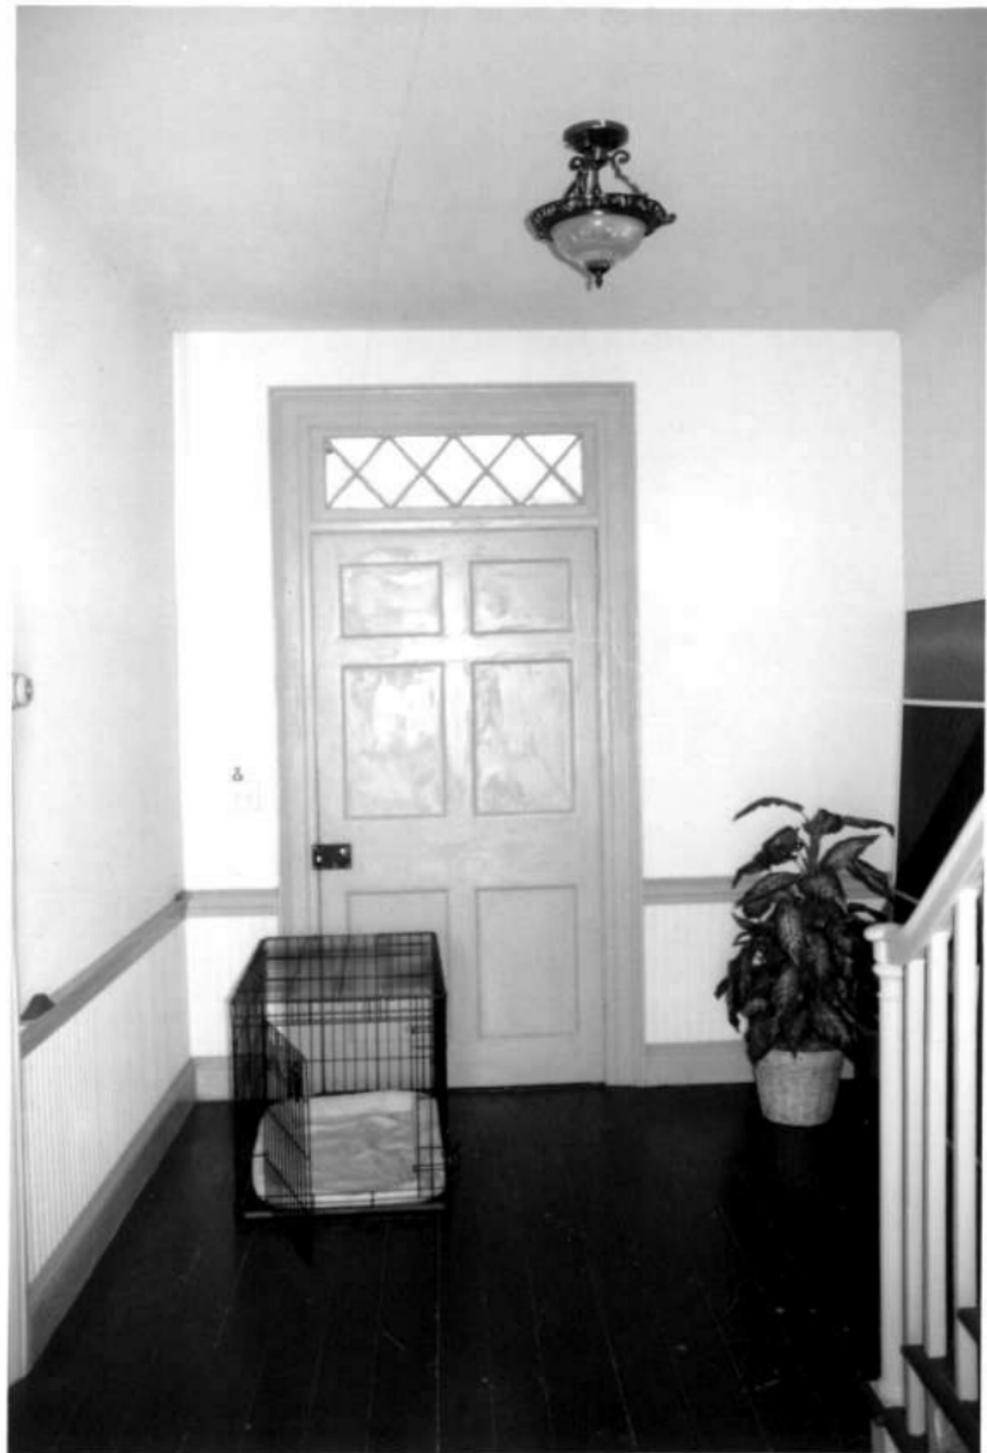
Stair
neg. at MD SHPO
photo 9 of 13

second floor. It is an open-string stair on the first floor, with turned newels, square balusters and a simple molded and ramped rail. The molded carriage piece is embellished with scrolled stair brackets. A four-panel door under the landing opened onto an interior cellar stair that only partially remains. The original broken-field Federal architrave trim survives intact, but the trim and the stair are painted and grained, presumably a Victorian alteration.

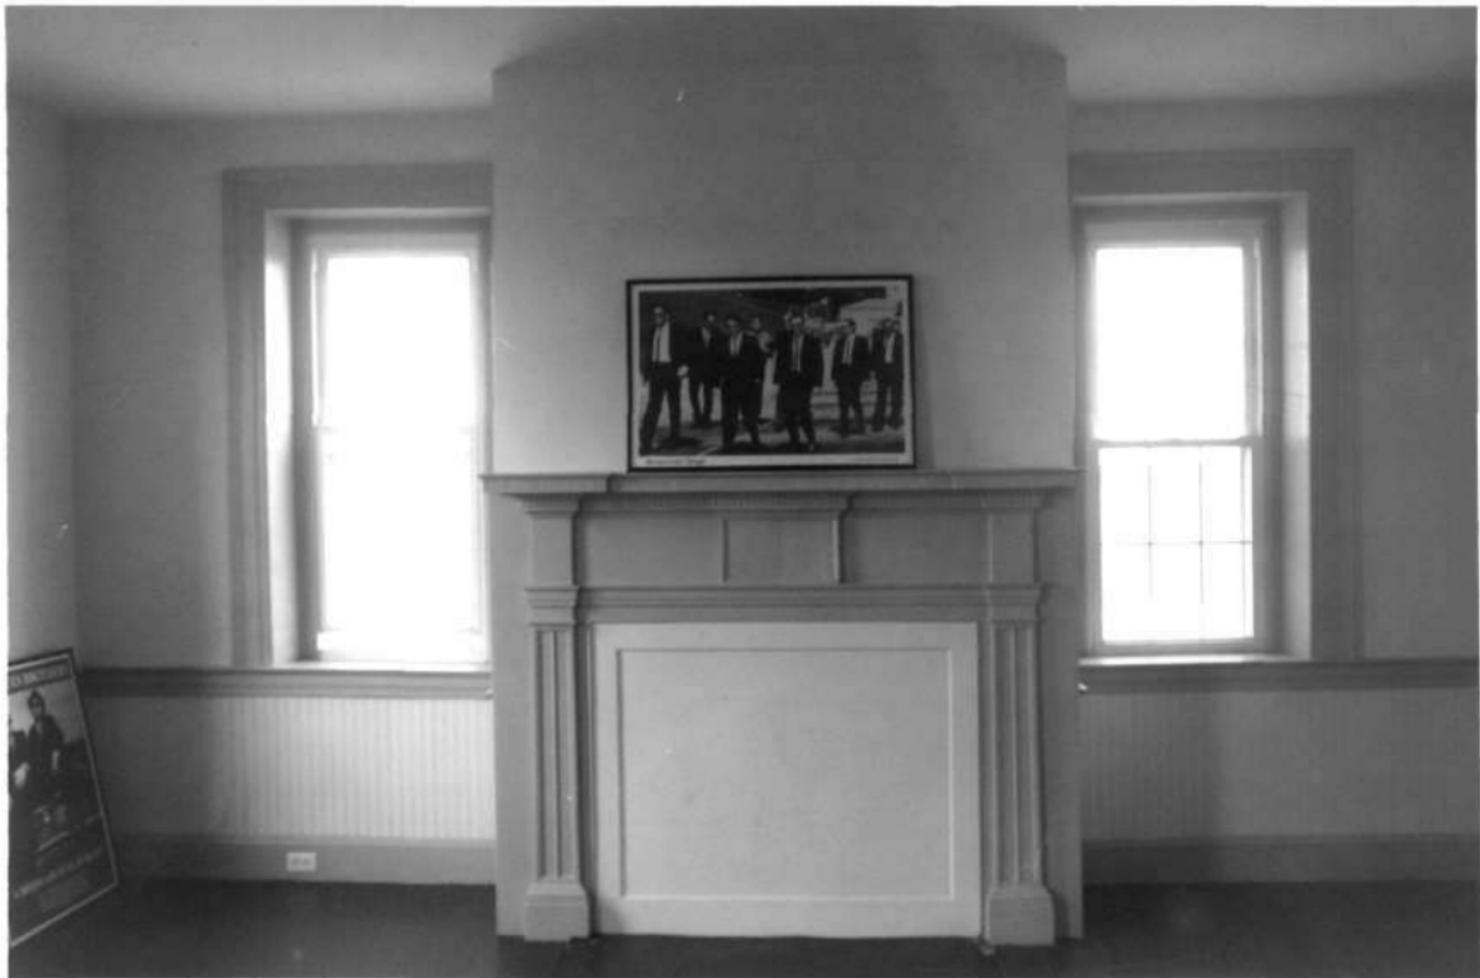
photo 13 of 13

Parlor mantle

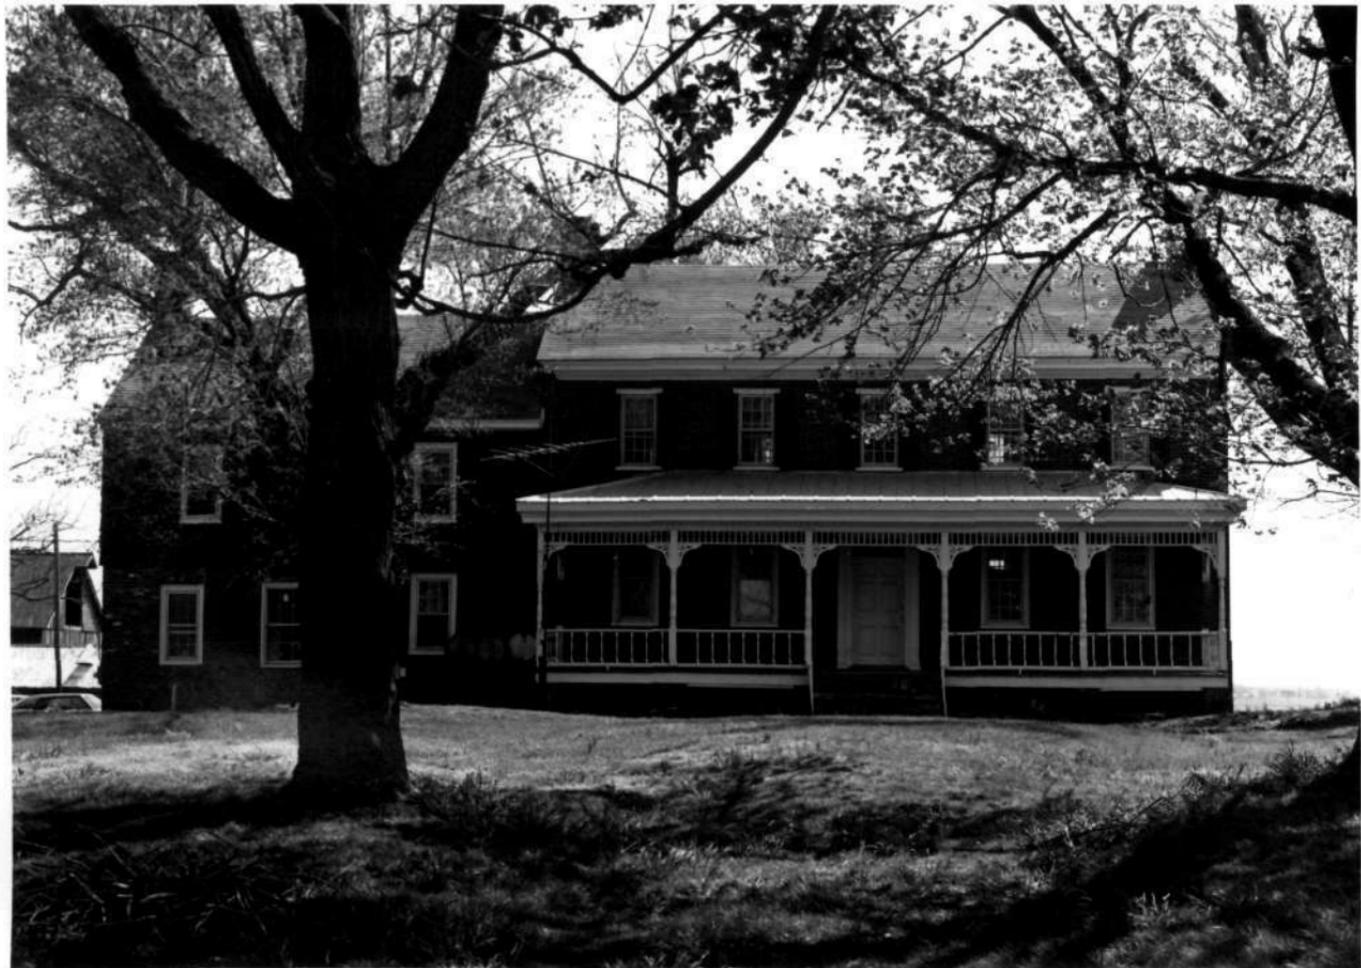
QA-66

C.P. Merrick Farm
Merrick Corner
Ingleside vicinity
Orlando Ridout V 1980
Front facade

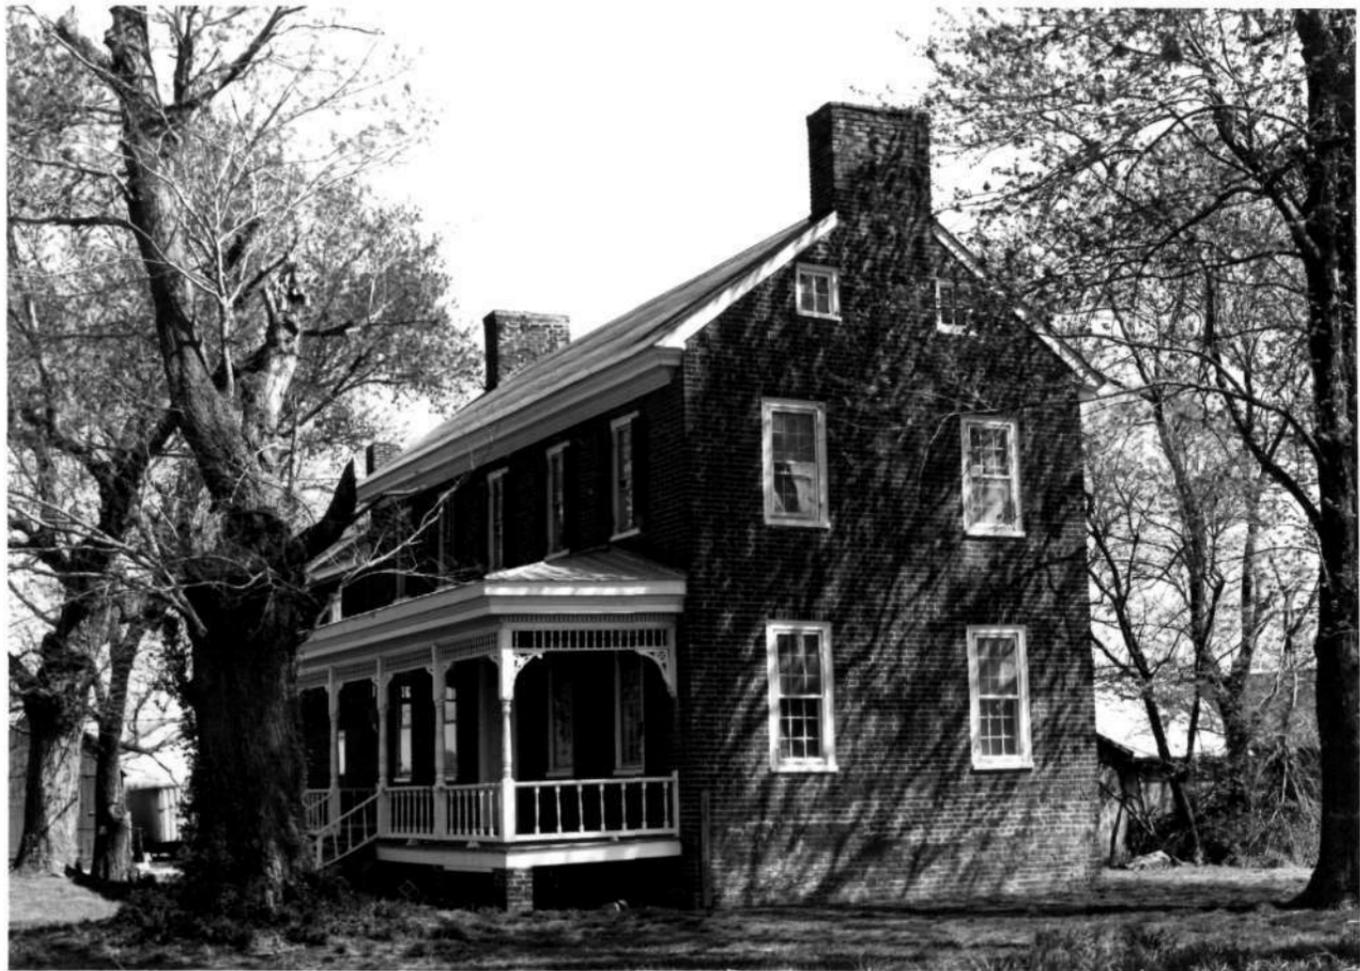
The brickwork is laid in Flemish Bond above a three-course bond foundation, with no water table or belt course. At one time the façade was painted red, and may have had stenciled joints, as at Ripley (QA-55, also built in 1805). The majority of the window openings are finished with king closers, although two jambs feature queen closers on the edge of the opening rather than being set back one-half brick. The flat lintels consist of a single rowlock course; the sills are wood. The eaves are trimmed with a box cornice with a large complex crown mold and handsome complex bed mold with a Wall-of-Troy dentil course. The roof is now covered with asphalt shingles.

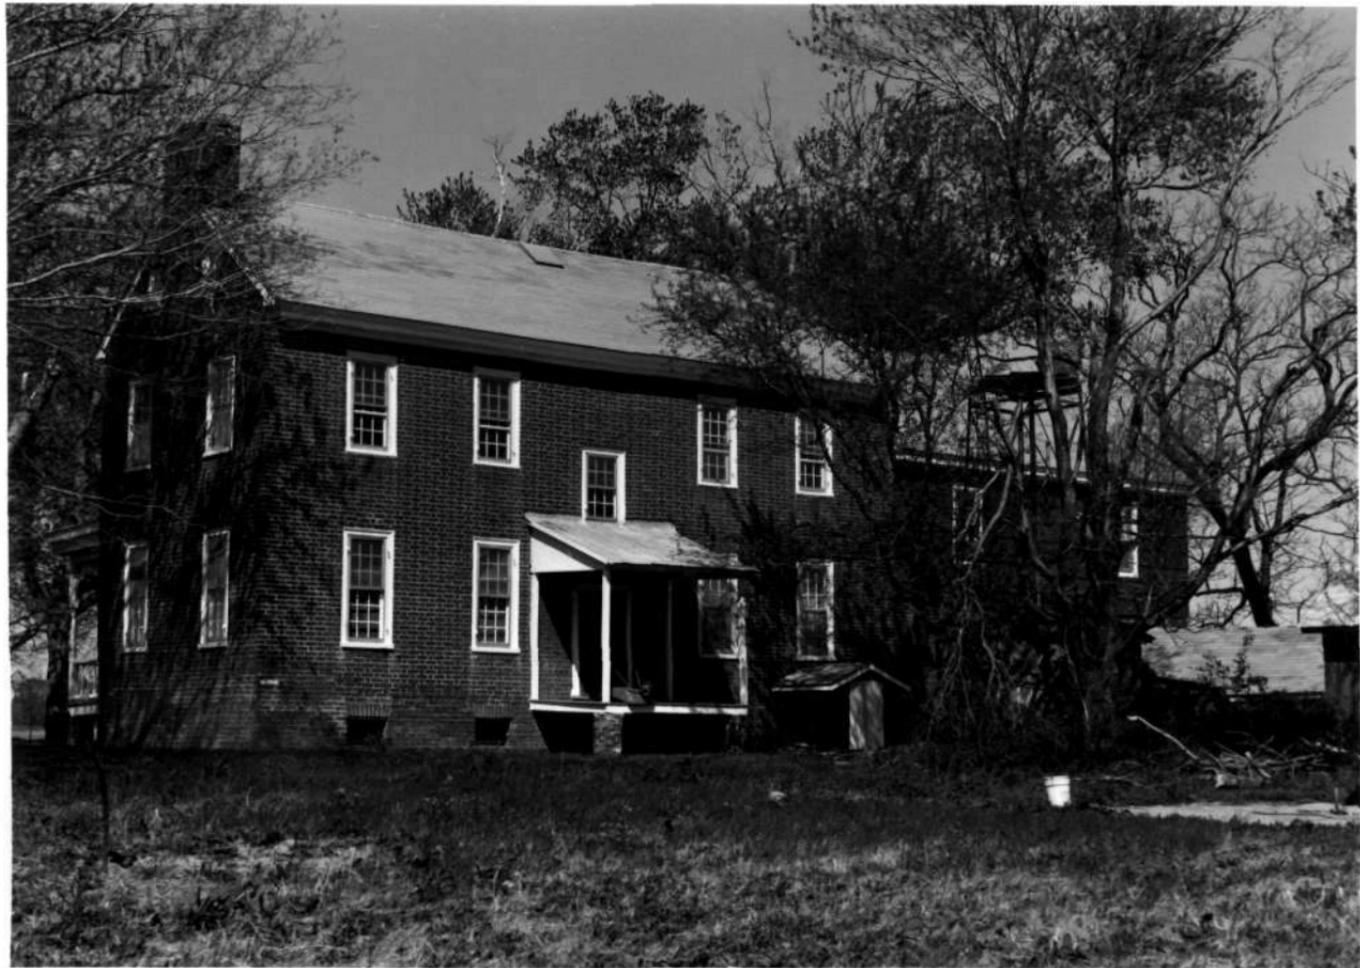
QA-66

C.P.Merrick Farm
Merrick Corner
Ingleside vicinity
Orlando Ridout V 1980
Rear facade

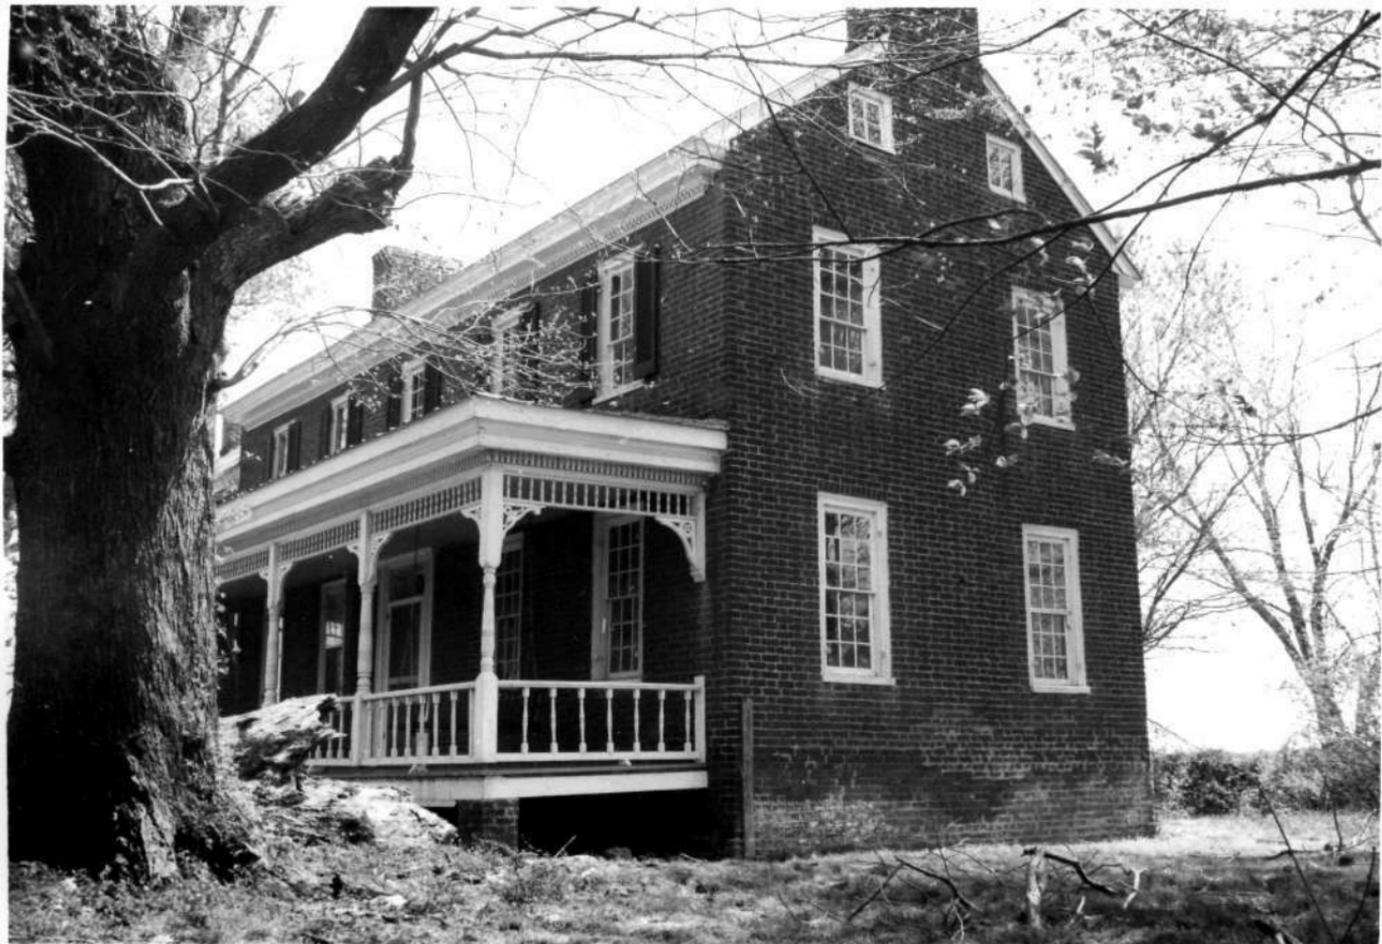
The rear façade is similar to the front façade, with a central door flanked by two 9/9 windows on each side of the first floor. On the second floor, a 6/6 window is down-set in the center bay, flanked by two 9/6 windows on each side. There are five cellar windows with horizontal iron bars. The brickwork is Flemish Bond above a three-course bond foundation. Filled put-log holes are clearly visible on this façade, as well as the west and north walls. The eaves are boxed in with a large complex crown mold and bed mold. The center door is relatively low in height due to the interior stair landing. The six-panel door is set off by paneled soffit and jambs and a cross-topped architrave. Filled holes in the brick walls to left and right of the door are evidence of an original entrance porch, now replaced by a simple one-story lean-to that protects the center bay. A brick to the right of the door is inscribed "1805."
