# National Register of Historic Places Registration Form

historic name Stratton  
other names QA-90; Hortense Fleckenstein Farm; Solomon Scott Farm

QA-90  
Stratton

Queen Anne's County, Maryland

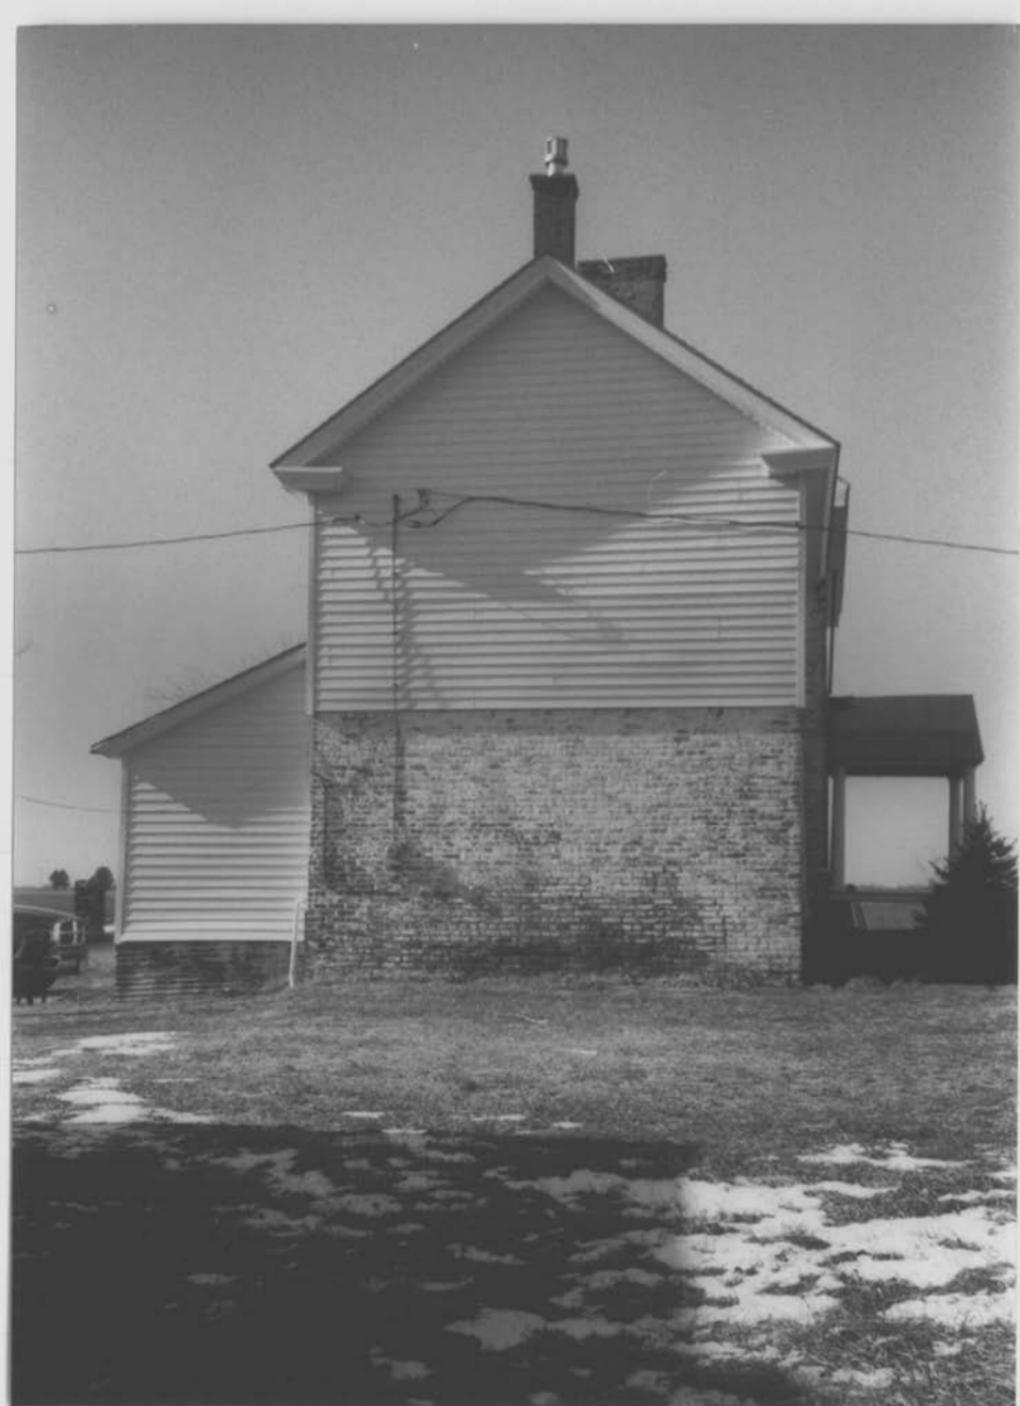
4 of 9

East facade

The majority of the east gable wall is concealed by the enlarged two-story wing. The paired 2/2 windows survive in the upper gable and several put-log holes remain visible. An early

The majority of the east gable wall is concealed by the enlarged two story wing. The paired 2/2 windows survive in the upper gable and several put-log holes remain visible. An early beaded but untapered rakeboard survives on the south pitch of this gable; the north rakeboard has been replaced.

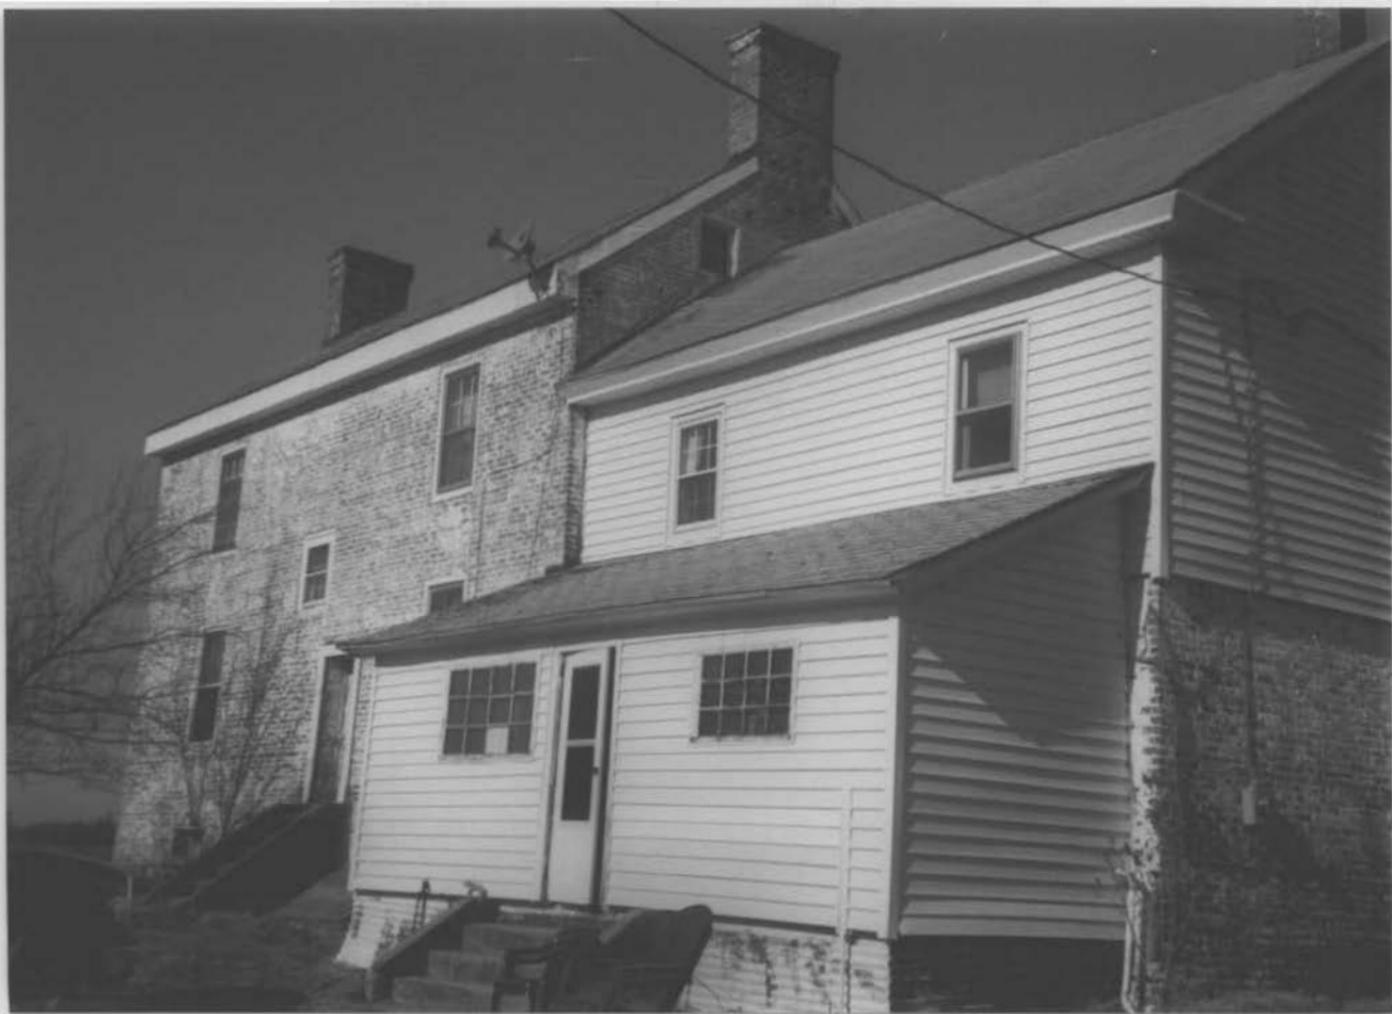
5 of 9

rear facade

The rear façade, facing south, is not symmetrical with the front façade. The rear door is offset to right of center with one large 6/6 window on each side. There are two 6/6 windows on the second floor, one directly above each first floor window, and one 3/6 window downset in the center bay. A three-light cellar window pierces the foundation in the west bay, balanced by a bulkhead cellar entrance in the east bay. The first floor sash probably replaces 9/6 sash, and it would appear that the overall height of each opening has been reduced by one brick course at the top. The small 3/6 window in the center bay appears to be set in an original, heavy pegged and beaded frame with an ovolo backband. All other frames appear replaced. The rear door and architrave have also been replaced, but the paneled jambs survive. It is interesting to note that the lintels on all but the 3/6 window are expressed on this façade by a single rowlock course. The box cornice is a replacement; the roof is asphalt shingle.

The rear facade, facing south, is not symmetrical with the front facade. The rear door is offset to right of center with one large 6/6 window on each side. There are two 6/6 windows on the second floor, one directly above each first floor window, and one 3/6 window downset in the center bay. A three-light cellar window pierces the foundation in the west bay, balanced by a bulkhead cellar entrance in the east bay. The first floor sash probably replaces 9/6 sash, and it would appear that the overall height of each opening has been reduced by one brick course at the top. The small 3/6 window in the center bay appears to be set in an original, heavy pegged and beaded frame

with an ovolo backband. All other frames appear replaced. The rear door and architrave have also been replaced, but the paneled jambs survive. It is interesting to note that the lintels on all but the 3/6 window are expressed on this facade by a single rowlock course. The box cornice is a replacement; the roof is asphalt shingle.

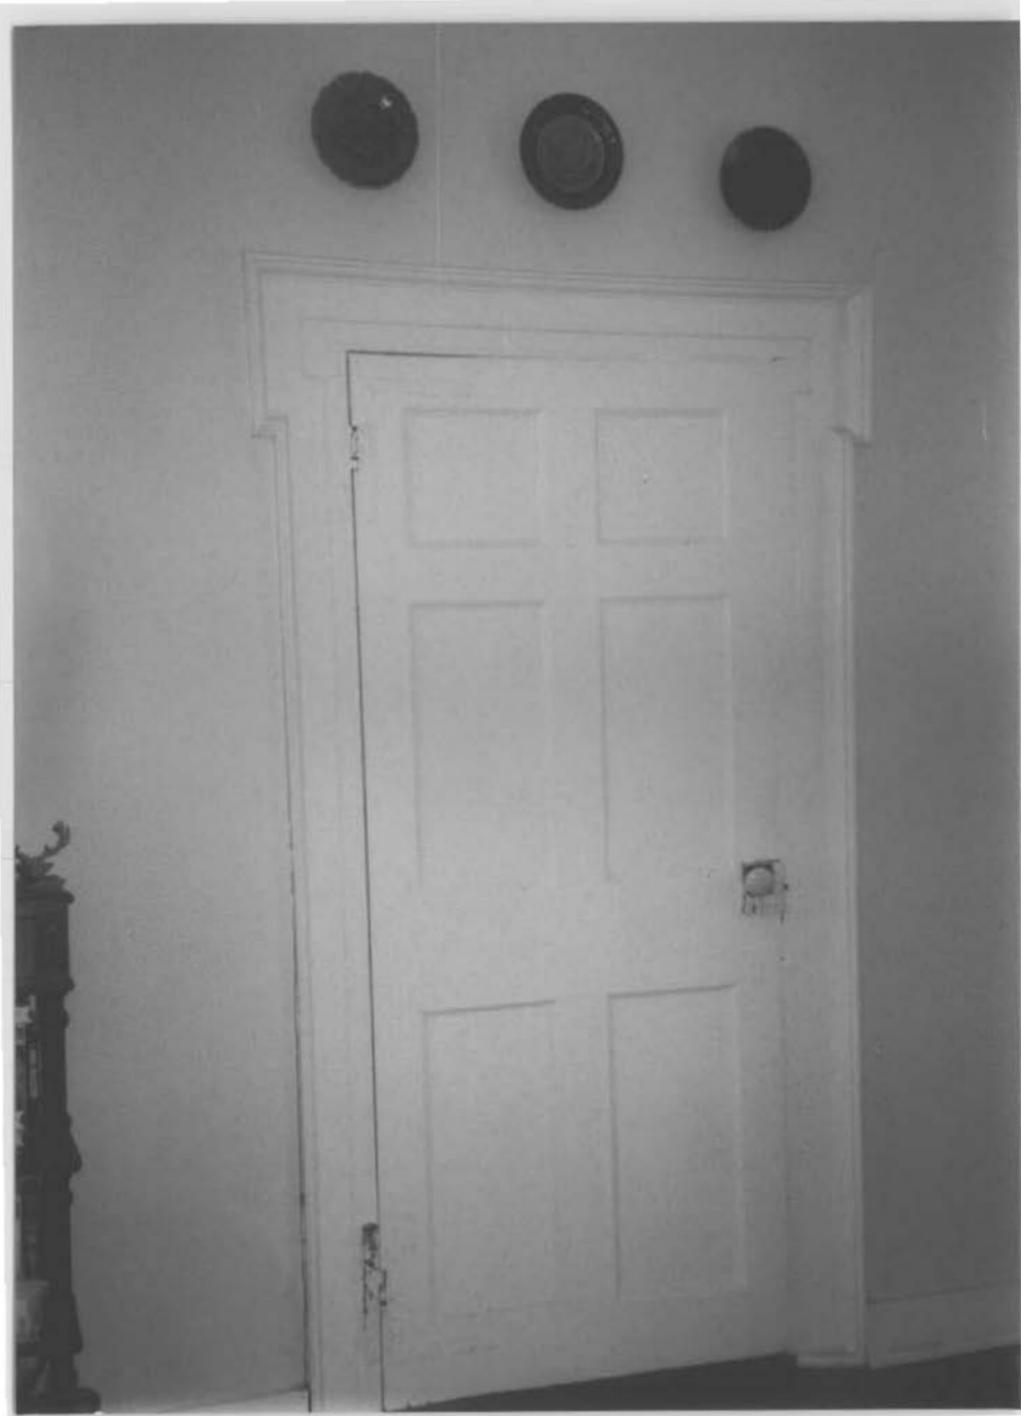
8 of 9

west parlor door

In the west parlor, there are two windows in the front wall and a single window centered in the rear wall. The fact that the windows are fitted with 6/6 sash with large panes (10" x 16") and very thin muntins suggests that these replace earlier 9/6 (or even 9/9) sash. The windows retain original double architraves with beaded center moldings and ovolo backbands; they are not crosssetted.

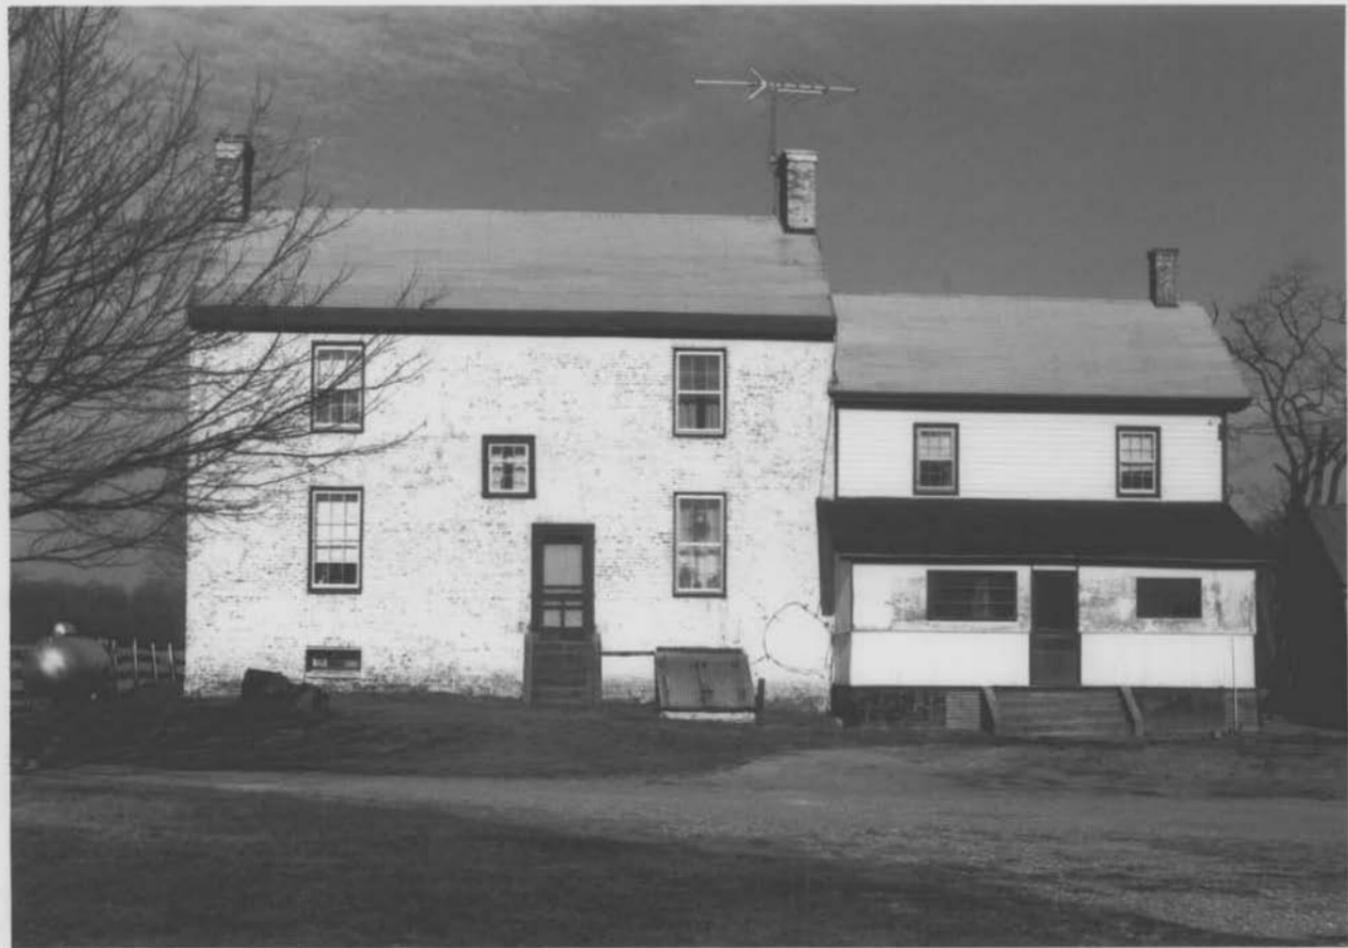
QA-90  
Hortense Fleckinstein Farm  
Ruthsburg vicinity  
Orlando Ridout V Dec. 1980  
View from Northwest

The front facade faces north toward the road. The brickwork is laid in Flemish bond above a three-course bond foundation, with no water table or belt course. The door is offset to left (east) of center with one 6/6 window to the left and two to the right. There are four smaller 6/6 windows on the second floor and two three-light cellar windows. The first floor 6/6 sash probably replaces original 9/6 sash. The original front door has been replaced with a four-panel door, but the

original paneled jambs and broken-field exterior architrave survive intact. The window openings on this facade have wood sills and no visible lintels on the first and second floor. The front door has a large granite sill. The cellar windows have rowlock lintels. The original cornice has been replaced with a simple box cornice; the roof is asphalt shingle.
