QA-94  
Paul Ward Farm  
Ruthsburg vicinity  
Private

circa 1815-1830

## INVENTORY FORM FOR STATE HISTORIC SITES SURVEY

Paul Ward farm

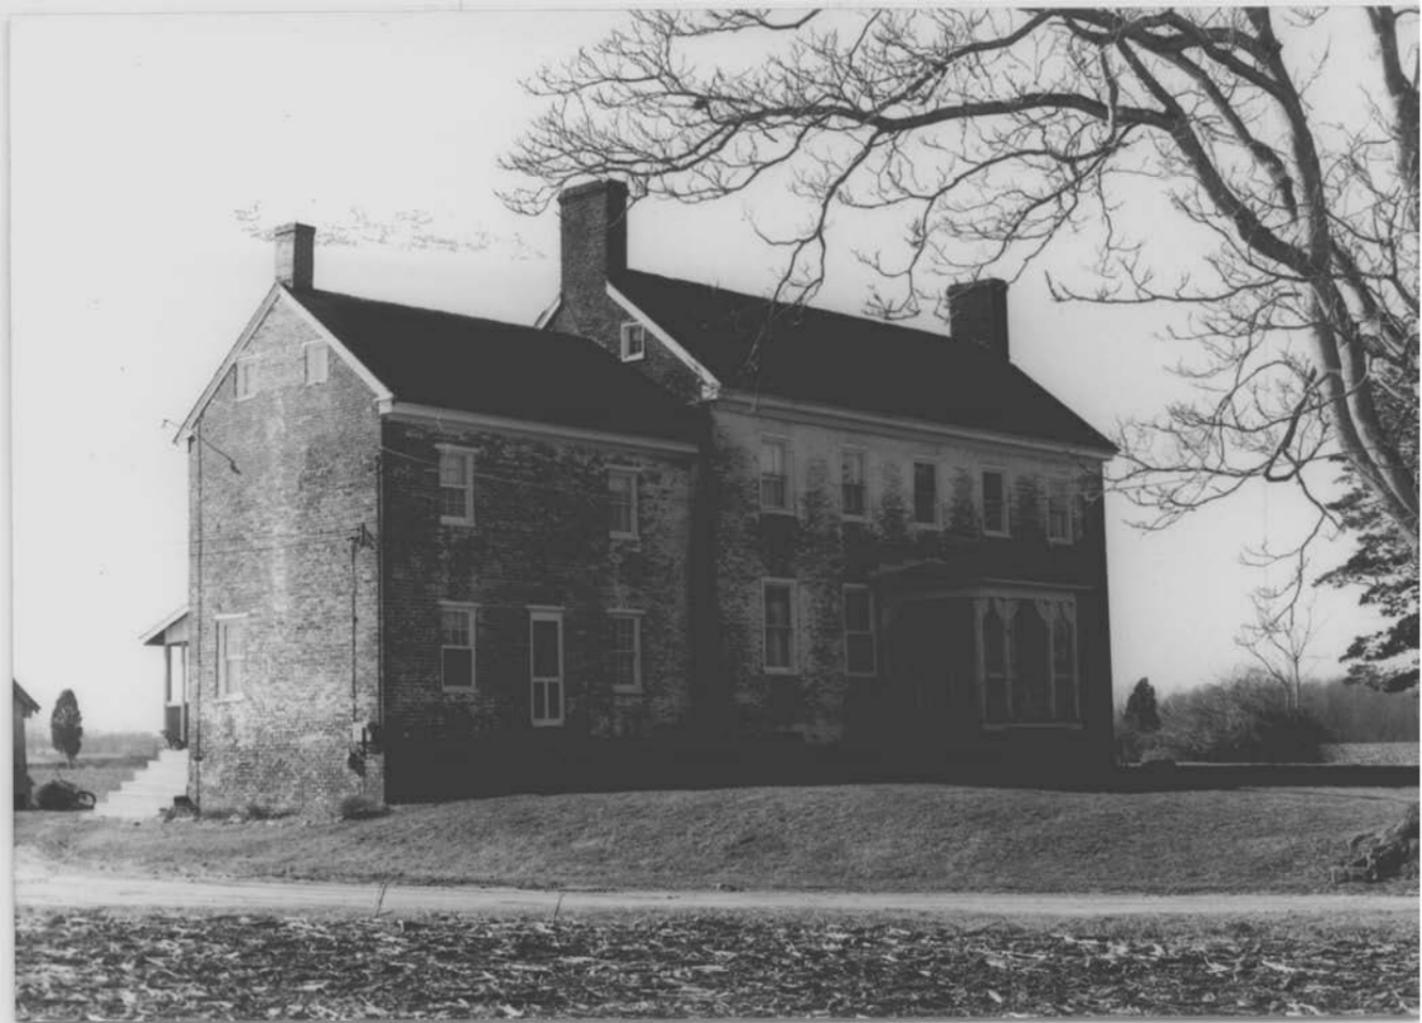
QA-94 Paul Ward Farm  
Ruthsbury vicinity Md.  
Orlando Ridout V, 1978 (MHT)  
Front facade, camera facing SW

The front (north) facade of the main house is laid in Flemish bond above a five-course bond foundation, while the rear facade and both gable ends are five-course bond. The wing is laid in seven-course bond, and may have been a later addition. One interesting feature found on the north facade of the main house is the omission of a series of header bricks between the first and second story windows and near the east and west end of the building. These are apparently scaffolding or "put-log" holes, left from when the building was constructed. Similar holes may be found at Great Hopes (QA-1), near Sudlersville,

The principal entrance is located in the center bay of the north facade, and consists of double paneled doors with paneled soffit and jambs and a four-light transom, flanked by a pair of windows on each side. There are five windows on the second floor, and four cellar windows, one below each first floor window. Only the cellar windows retain early eight-light sash, the remaining windows have been replaced with late 19th century two-over-two sash. A small Victorian entrance porch with chamfered posts, scrolled brackets, and a shallow hip roof covers the front door.

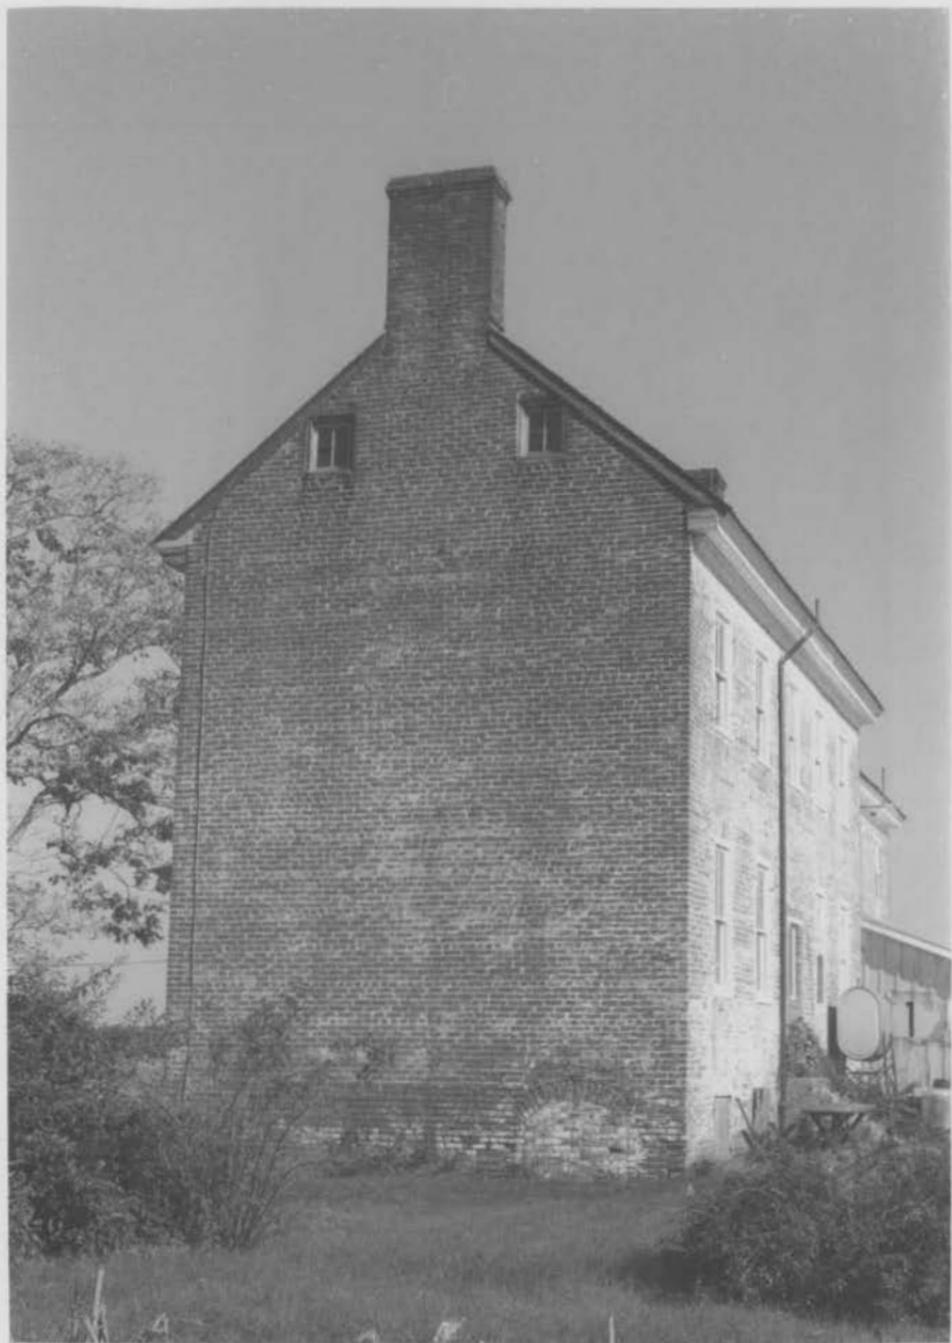
QA-94 Paul Ward Farm  
Ruthsburg vicinity, Md.  
Orlando Ridout V, 1978 (MHT)  
West Gable, camera facing East

On the west gable, a blocked-up bulkhead cellar entrance with a segmental arched lintel is located in the southeast corner, and a pair of four-light windows flank the chimney in the upper gable.
