QA-96
Temple Callahan Farm
Starr vicinity
Private

INVENTORY FORM FOR STATE HISTORIC SITES SURVEY

AND/OR COMMON
 Temple Callahan Farm

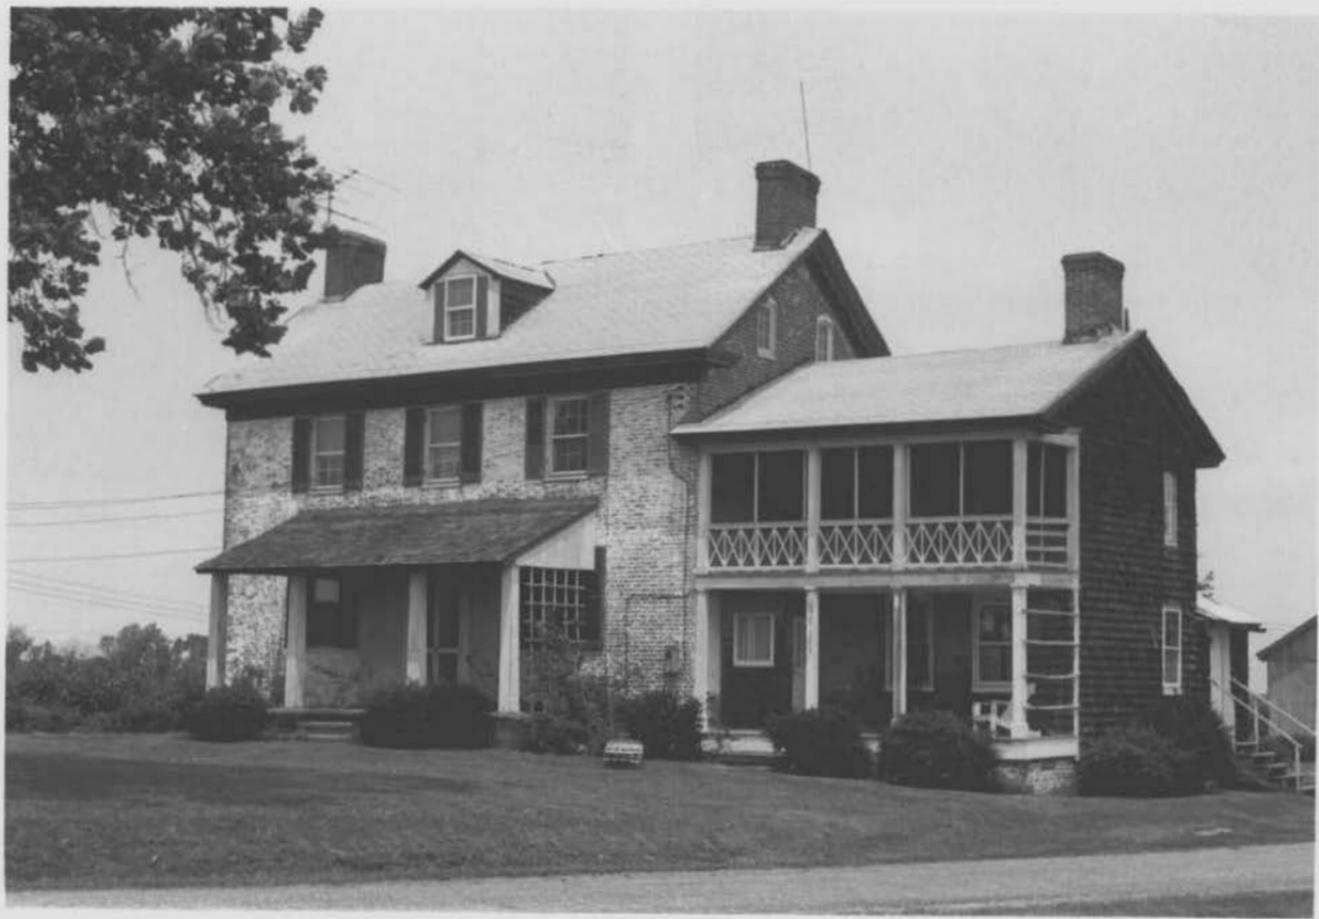
QA-96

The principal facade of the main house faces southwest toward the road. The entrance door is located in the center bay, flanked by single 6/6 windows on either side. These first floor windows

are relatively large and may originally have had 9/6 sash. There are three 6/6 windows on the second floor and a large, 20th century pitched roof dormer with 6/6 sash in the center bay of the third story. Splayed jack arches for two cellar windows are evident protruding above the floor of the porch. These windows are located directly below the first floor windows and have been blocked by a one story shed roof porch that protects all three bays on the first story but does not extend the full length of the facade. The front door has a handsome decorative transom and is framed with paneled sidelights and jambs with flattened Greek ogee panel molds. The first floor window openings also have splayed jack arch lintels; the lintels of the second story openings are hidden by the cornice. The brickwork on this facade is Flemish bond above a seven-course bond foundation; there is no water table or belt course. The eaves are boxed in with a bold crown mold that dominates the fascia and a smaller bed mold applied to a wide frieze with banded molding below a deep soffit. In general appearance this cornice could be Greek Revival, but it is carried around each corner to return on the gable, a feature generally associated with the post-Civil War period. The roof

Temple Callahan Farm
Starr Road
Centreville vicinity
Orlando Ridout V 1981
Front facade from south

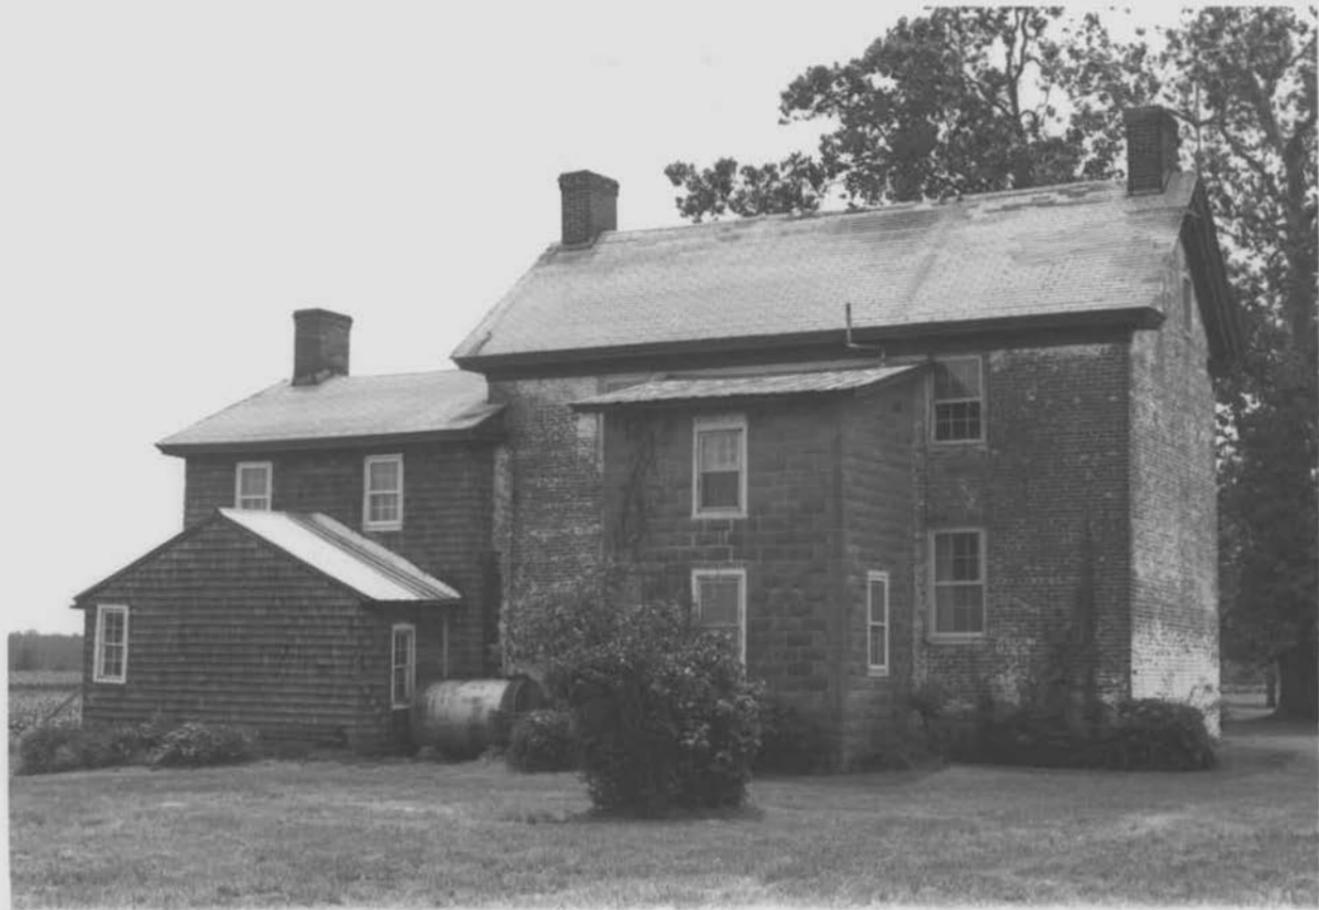
QA-96

The center bay of the rear facade is now concealed by a modern, two story shed roof addition. There are single, large 6/6 windows to east and west on the first story and smaller 6/6 windows on the second story. The west cellar window has been bricked up; the east cellar window has been adapted for a modern cellar entrance. The brickwork is laid in five- to six-course

Temple Callahan Farm
Starr Road
Centreville vicinity
Orlando Ridout V 1981
Rear facade from north
