S-112
Old Barnes Farmhouse
Princess Anne vicinity
private

Maryland Historical Trust State Historic Sites Inventory Form

historic Old Barnes Farmhouse

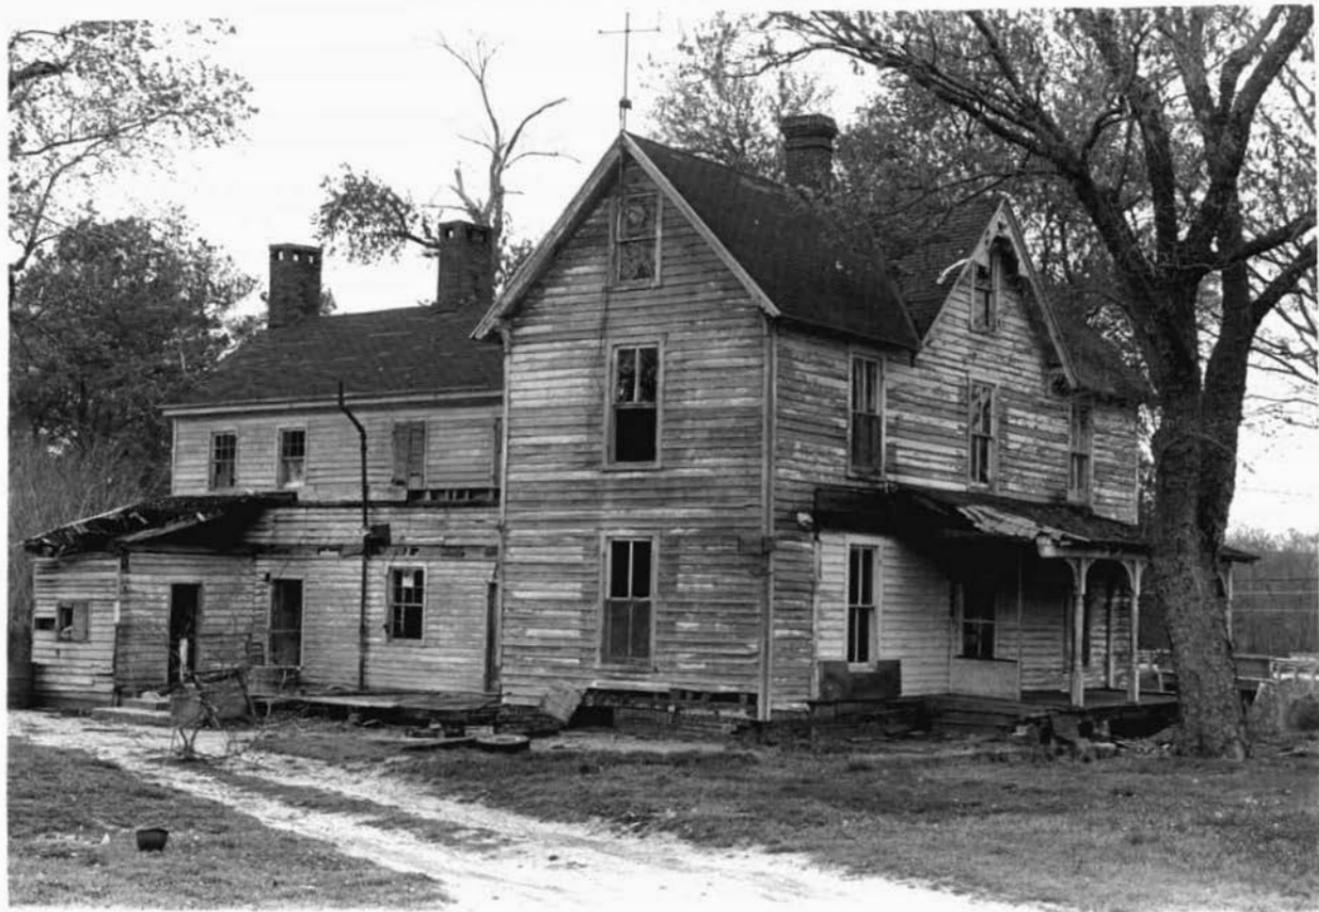
The northeast (main) facade is a symmetrical three-bay elevation with a center double door and flanking two over two sash to each side. The double doors are glazed above the lock rail and paneled below. A three-bay porch stretches across the first floor and is supported by turned porch posts with sawn eave brackets. The second floor is marked by three two over two sash windows, while the center cross-gable is pierced by a multi-pane sash window. The upper eave is decorated with sawnwork, and the principal corners of the roof have simple C-shaped brackets.

A pair of brick chimneys rise from the center of the main block and flank the hall. Each chimney is finished with a corbelled cap. Most of the Federal period exterior finish has been removed from the principal facade except for one diamond cross-sectioned foundation grill that is located under the front porch. Some of the siding has been removed which exposes the mortise and tenon framing of the early house.

Old Ben Barnes House S-112
Princess Anne Vicinity, Somerset County
Northeast Elevation
4/85, Paul Touart, Photographer
Neg/ Md. Historical Trust

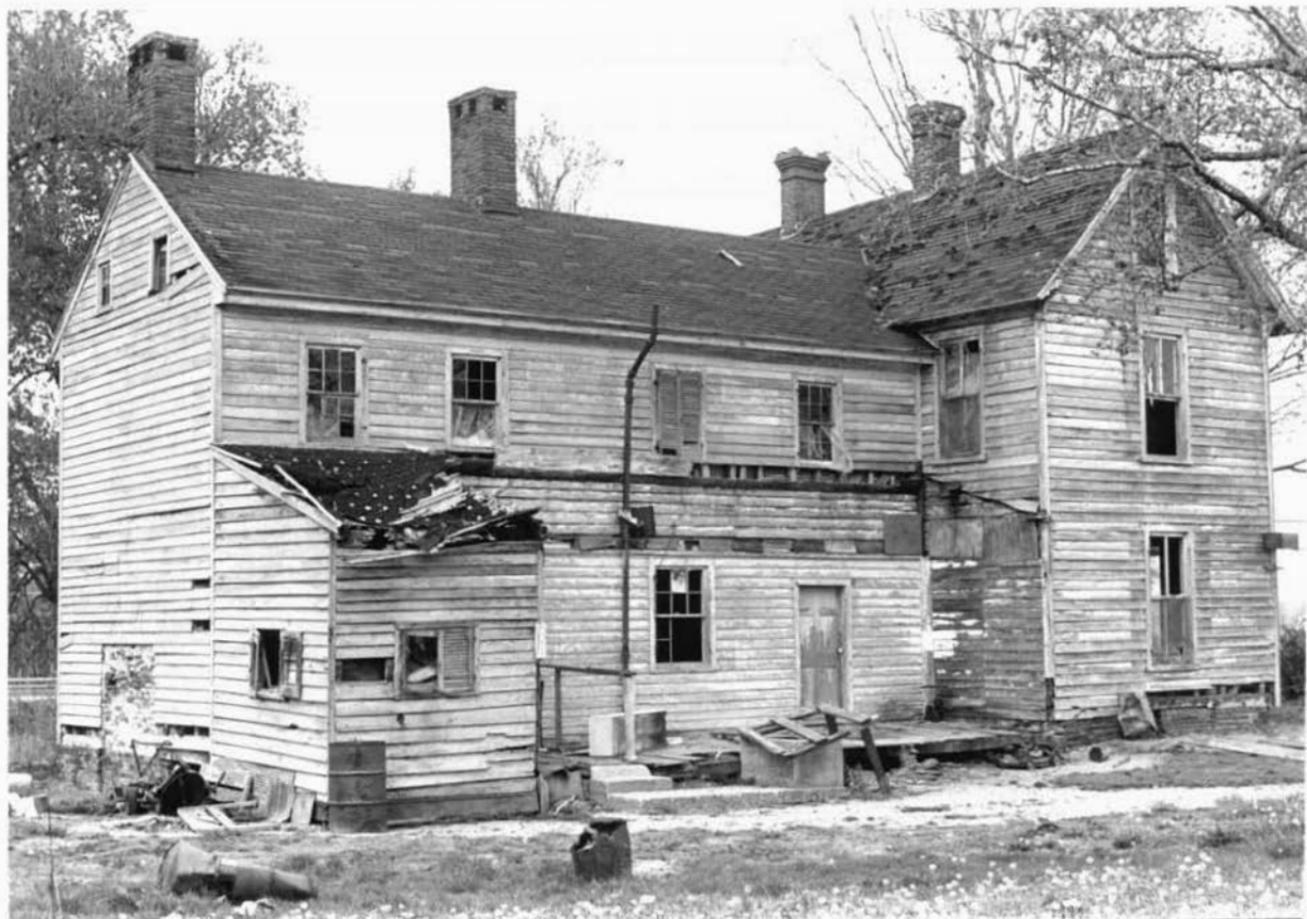
Old Ben Barnes House S-112
Princess Anne Vicinity, Somerset County
East Elevation
4/85, Paul Touart, Photographer
Neg/Md. Historical Trust

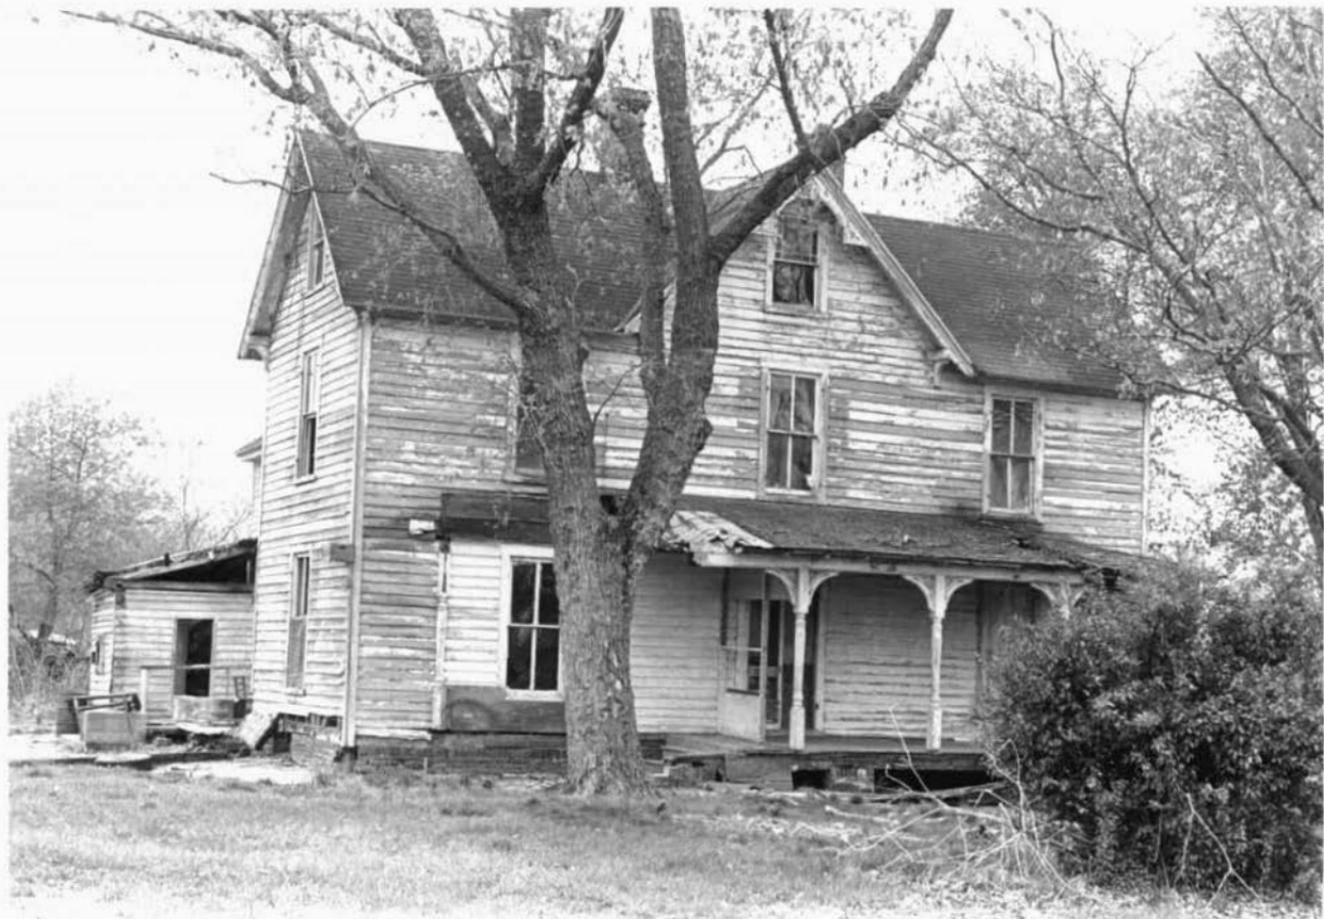
Old Ben Barnes House S-112
Princess Anne Vicinity, Somerset County
North Elevation
4/85, Paul Touart, Photographer
Neg/Md. Historical Trust
