FORD HOUSE
Lower Fairmount
Private

State Historic Sites Inventory Form

historic FORD HOUSE

Survey No. S-145

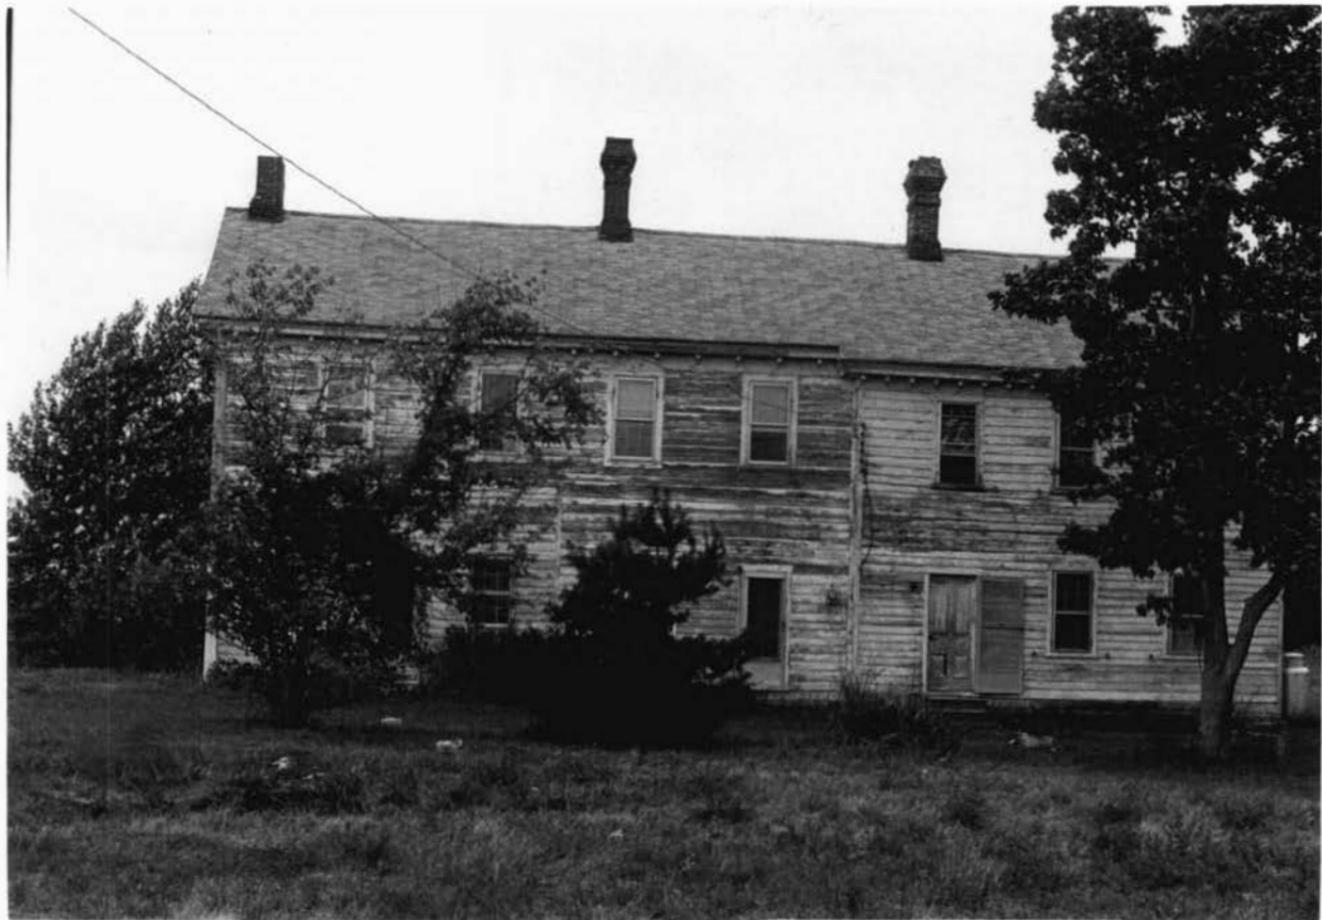
South Elevation

This c. 1860-1870 two-story eight-bay by one room frame house is located in the southern extremity of Lower Fairmount and is one of the most distinctive dwellings with its long elevation and four brick chimneys which pierce the gable roof.

From an exterior analysis, it appears the two-story three-bay portion to the east is the original house since it is off-set from the adjacent five-bay portion. There is another break in the weatherboarding between the third and fourth bay from the left.

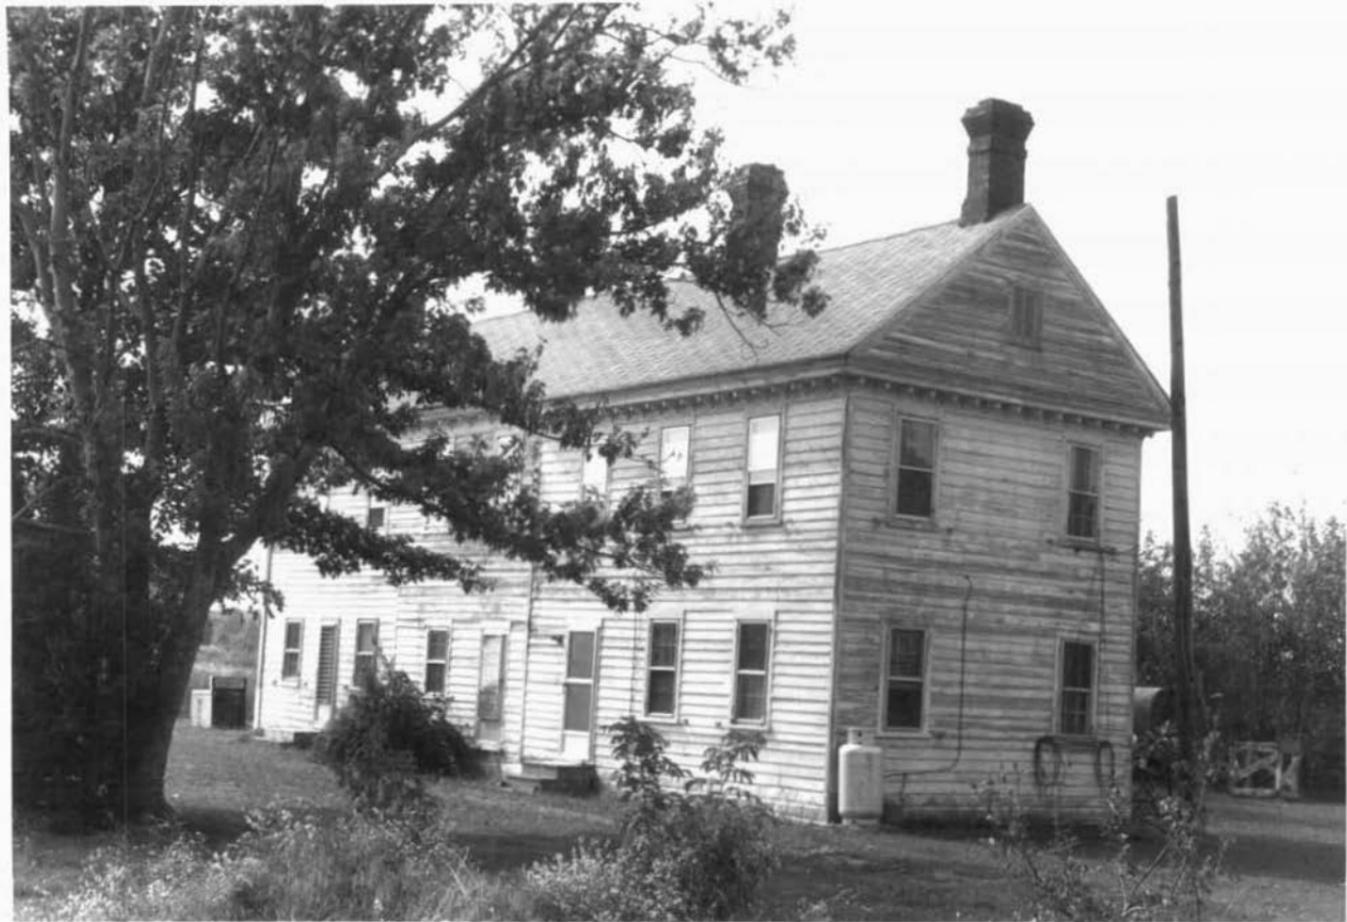
~~East~~ Elevation

The boxed cornice extends around the east side of the house and is embellished with brackets. This house, along with the Sam Green farmhouse (SMST -), was built with an odd projecting gable end above the plate to allow for a row of brackets under the eave. An interior end brick chimney with decorative cap is flanked by six over six sash on each floor, and a four-pane window lights the attic. Four-panel doors are located at each entrance. Three other brick chimneys pierce the roofline, and the center two survive with their decorative caps.

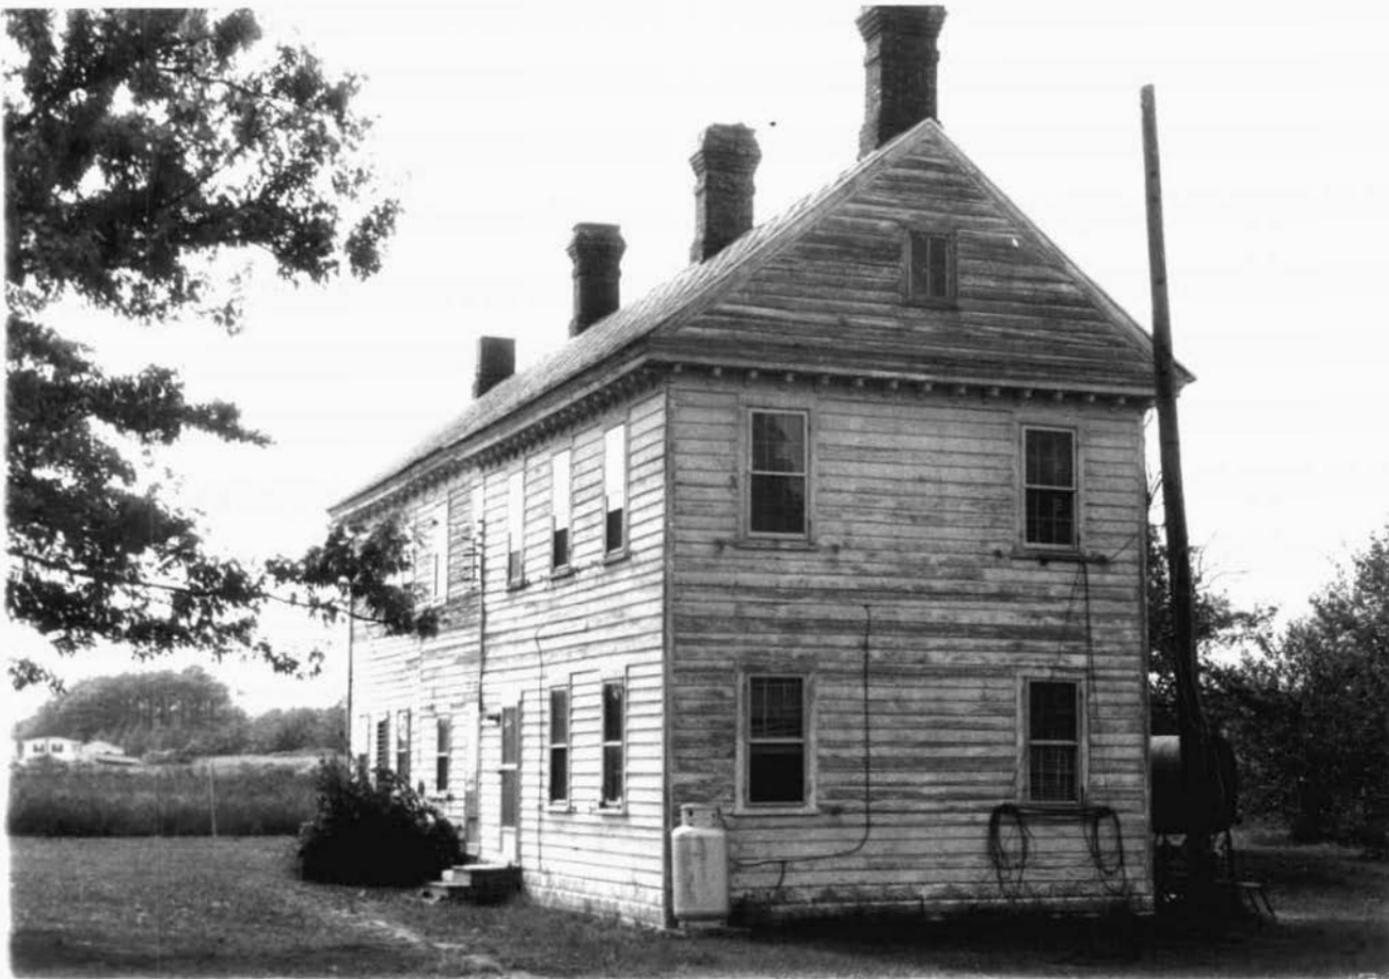
Ford House S-145
Lower Fairmount, Somerset Co., MD.
Southeast elevation
10/83, Paul Touart, Photographer
Neg./ MD. Hist. Trust

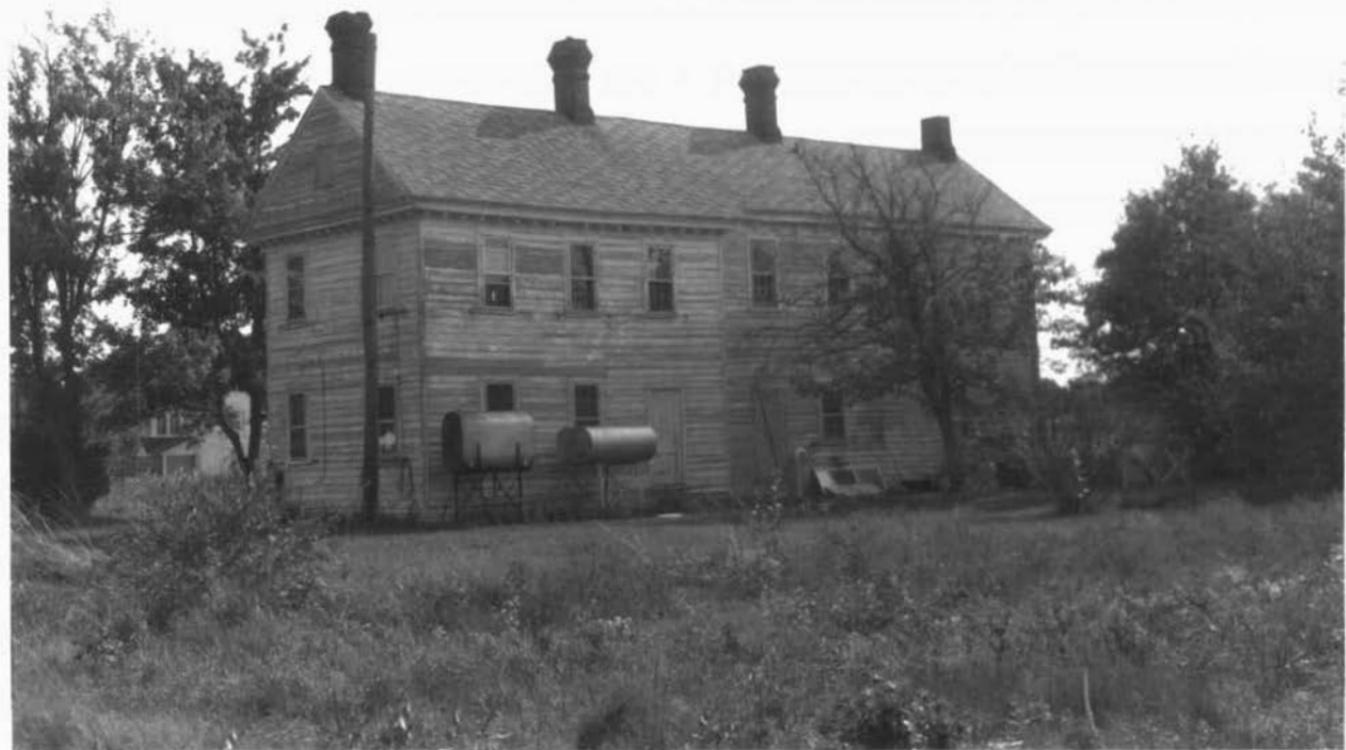
FORD House
Lower Fairmount, Somerset County
North Elevation
10/83 Paul Touart
Neg./Md. Historical Trust

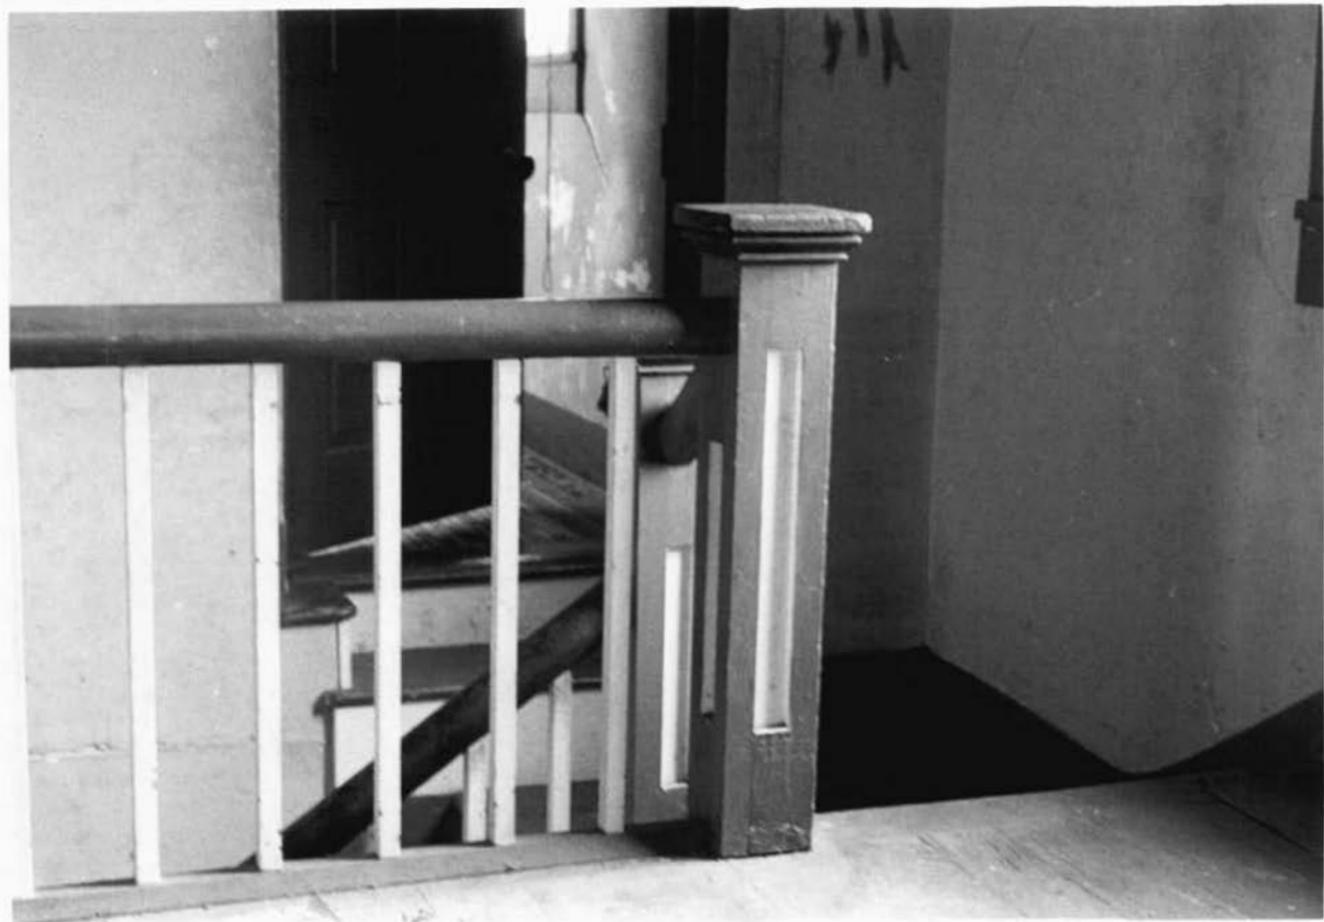
Ford house S-145
Lower Fairmount, Somerset County
Second floor newel post
8/85, Paul Touart, Photographer
Neg./Md. Historical Trust

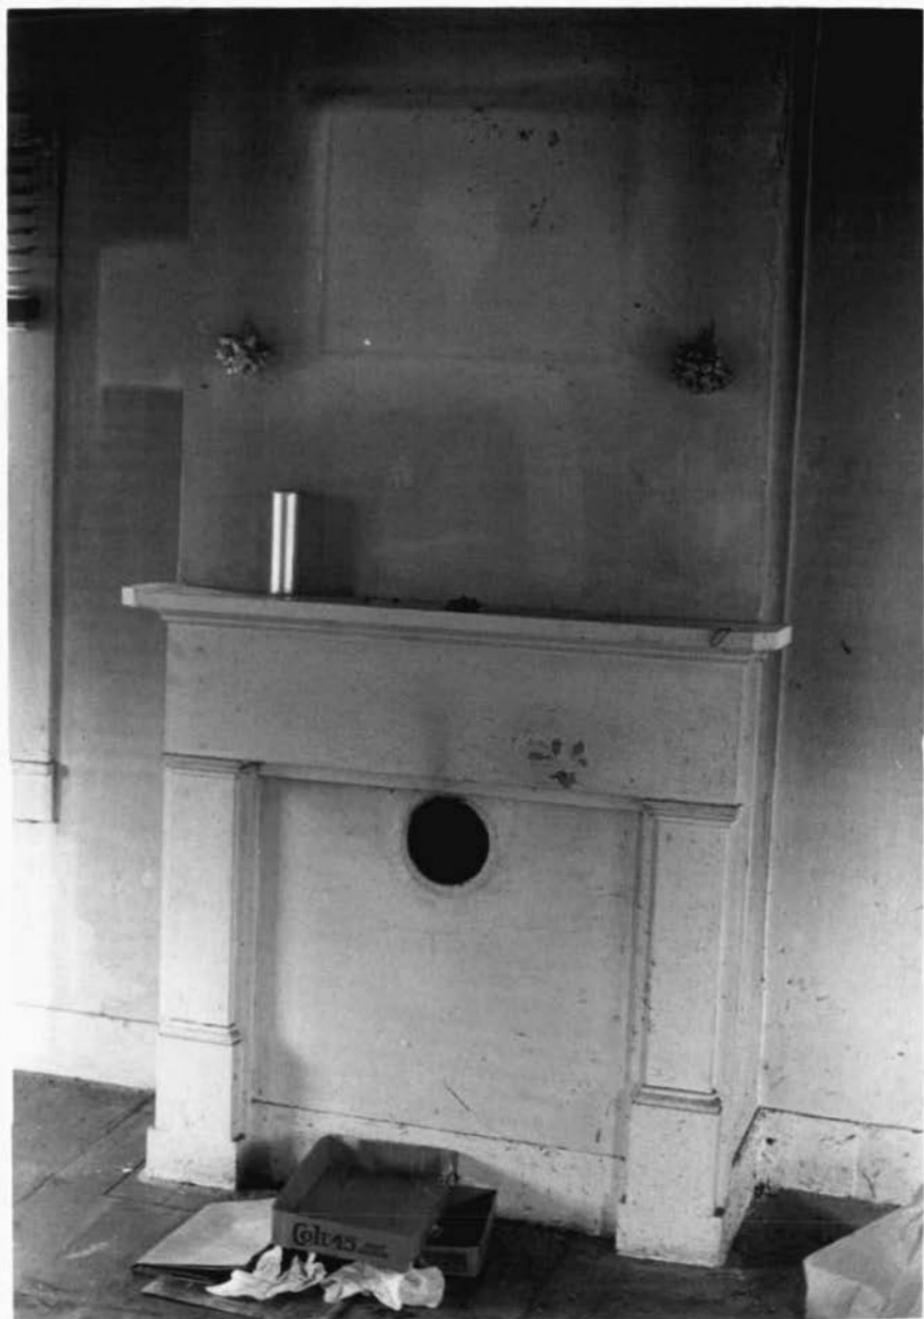
Ford House S-145
Lower Fairmount, Somerset County
Bedroom Mantel
8/85, Paul Touart, Photographer
Neg./Md. Historical Trust
