S-210  
Carrigan Farm  
Near Dublin  
Private

# Maryland Historical Trust State Historic Sites Inventory Form

historic Carrigan Farm

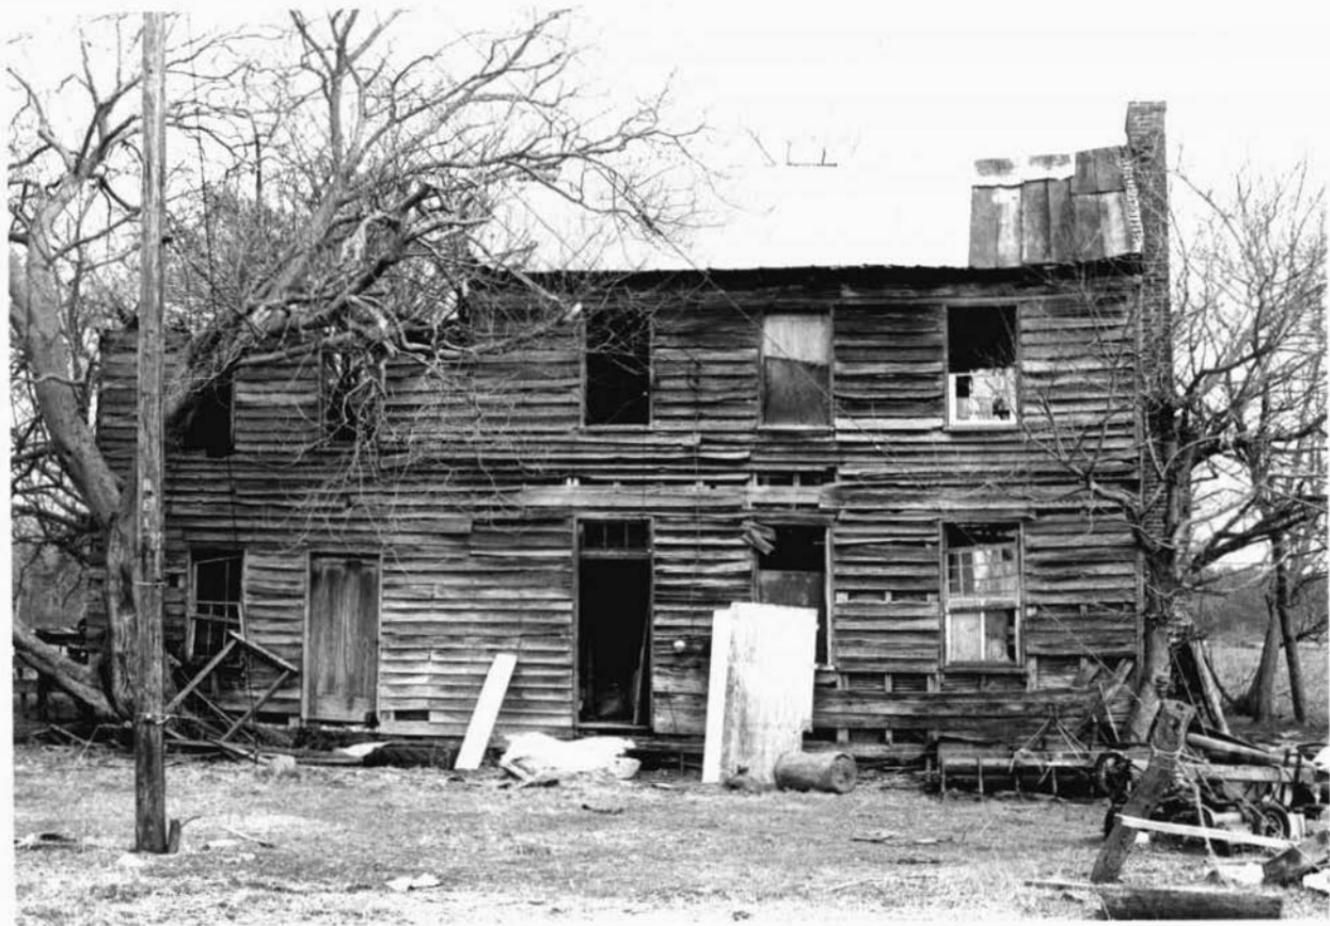
S-210

Carrigan Farm  
Near Wellington, Somerset County  
North Elevation  
5/84 Paul Touart  
Neg./ Maryland Historic Trust

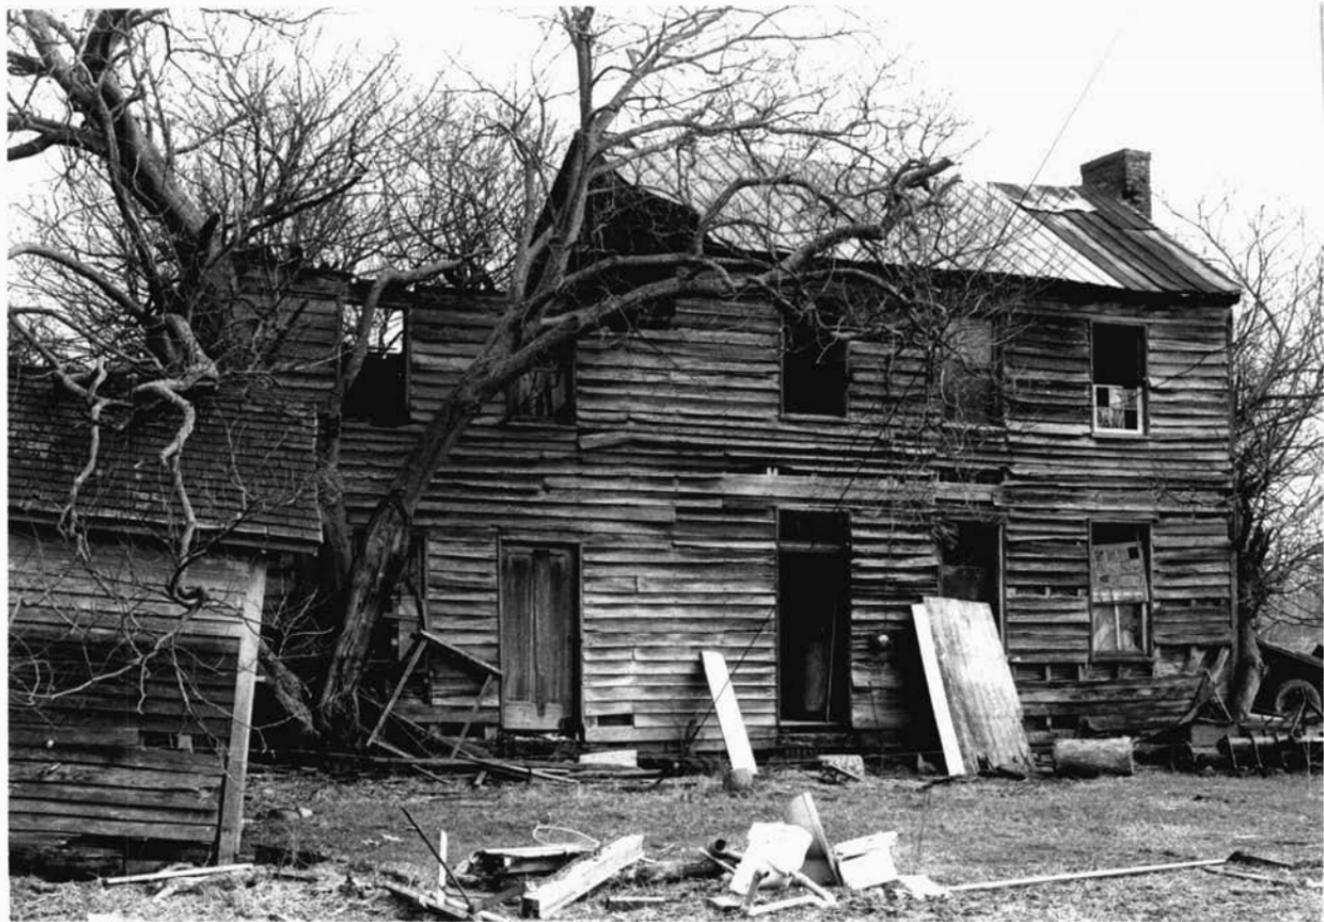
S-210

The west gable end of the main house is largely covered by the slightly shorter two-story, two-bay addition. The north side has a two-panel door opening in the west bay, and 6/6 sash windows occupy the three remaining openings. The roof has fallen in, and the east end is badly deteriorated.

Carrigan Farm  
North Elevation  
Near Wellington, Somerset County  
5/84 Paul Touart  
Neg./ Maryland Historic Trust

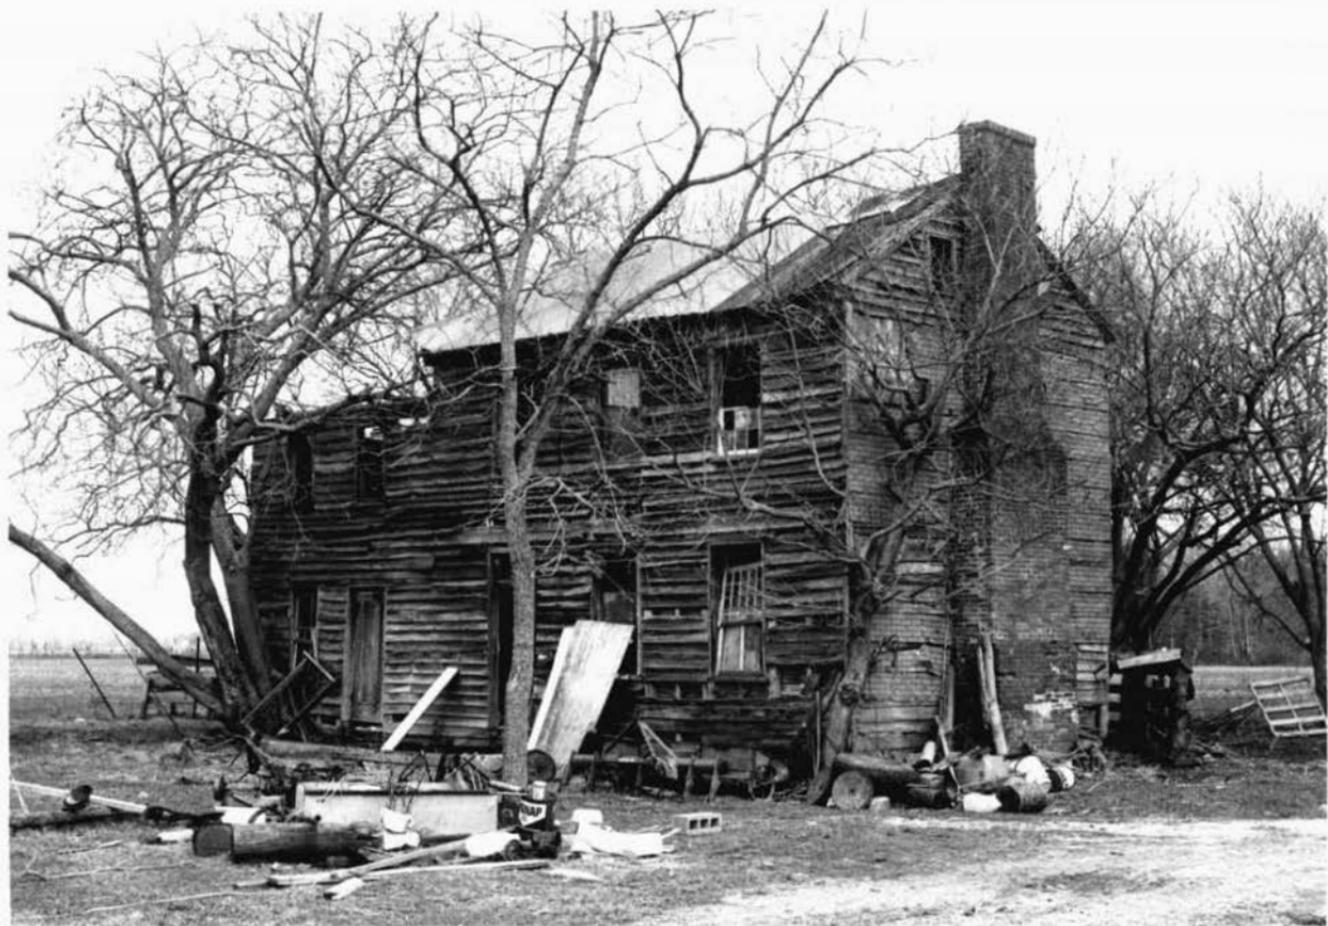
S-210

Carrigan Farm  
Near Wellington, Somerset County  
Northwest Elevation  
5/84 Paul Touart  
Neg./ Maryland Historic Trust

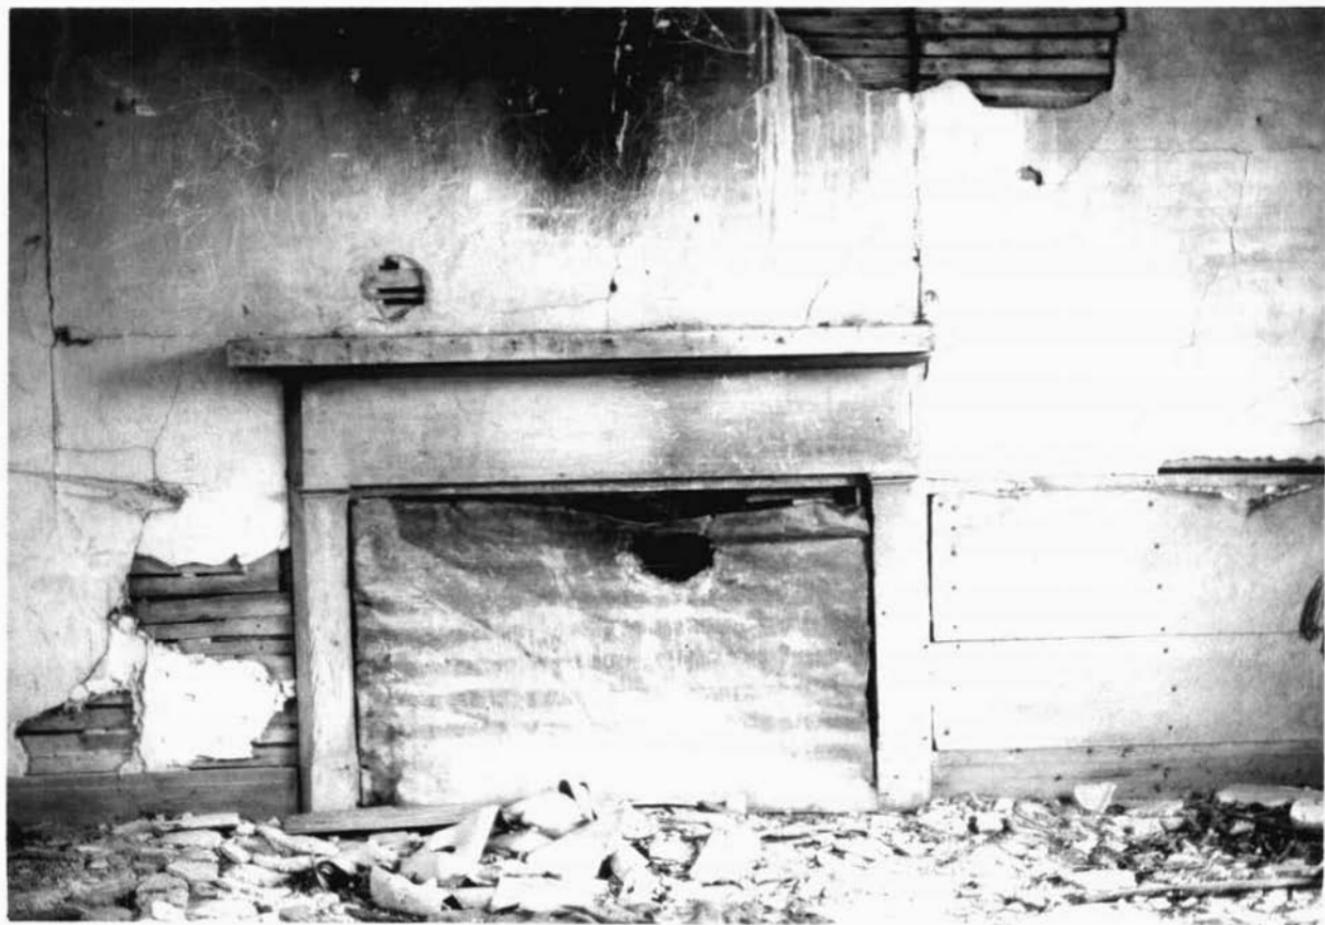
S 210

The second floor is divided into a bedroom and a small room at the head of the stairs. The attic stair is located in this small room. A one-panel door encloses the small stairway. The bedroom is simply finished with lath and plaster. A plain post and lintel mantel survives on the end wall.

Carrigan Farm  
2nd Floor Mantel  
Near Wellington, Somerset County  
5/84 Paul Touart  
Neg./ Maryland Historic Trust

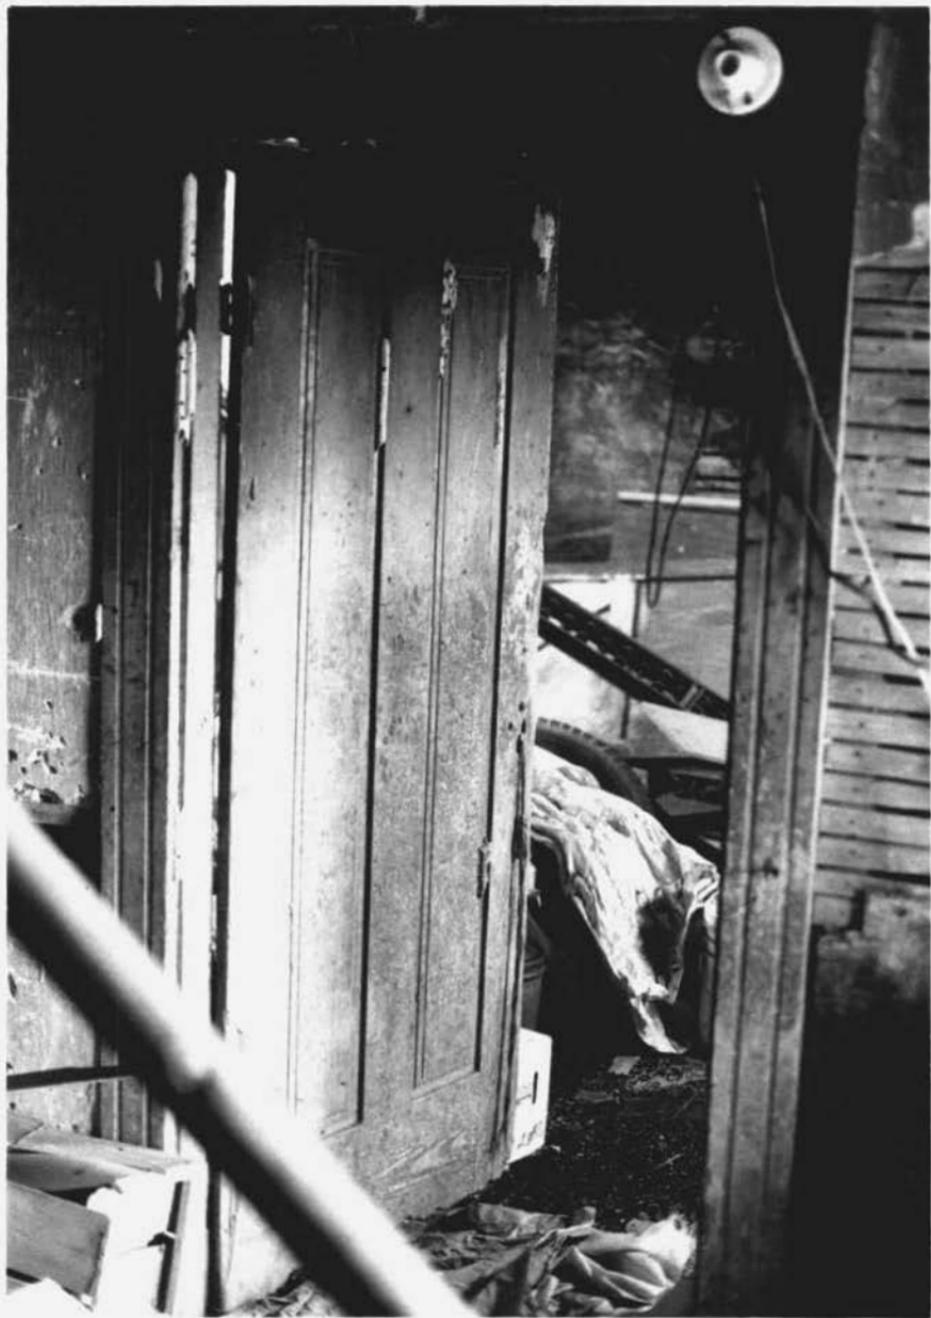
S-210

Inside the main house, the walls are plastered with riven oak lath fastened by cut-nails. A dog-leg stair rises in the southeast corner. A slender square newer post & square balusters support a circular-profile handrail. A two-panel Greek Revival door is framed by a fluted surround with corner blocks. The door opens into a nearly square parlor with end wall hearth. The plain post and lintel mantel has been removed from its original location.

Carrigan Farm  
Parlor Door  
Near Wellington, Somerset County  
5/84 Paul Touart  
Neg./ Maryland Historic Trust

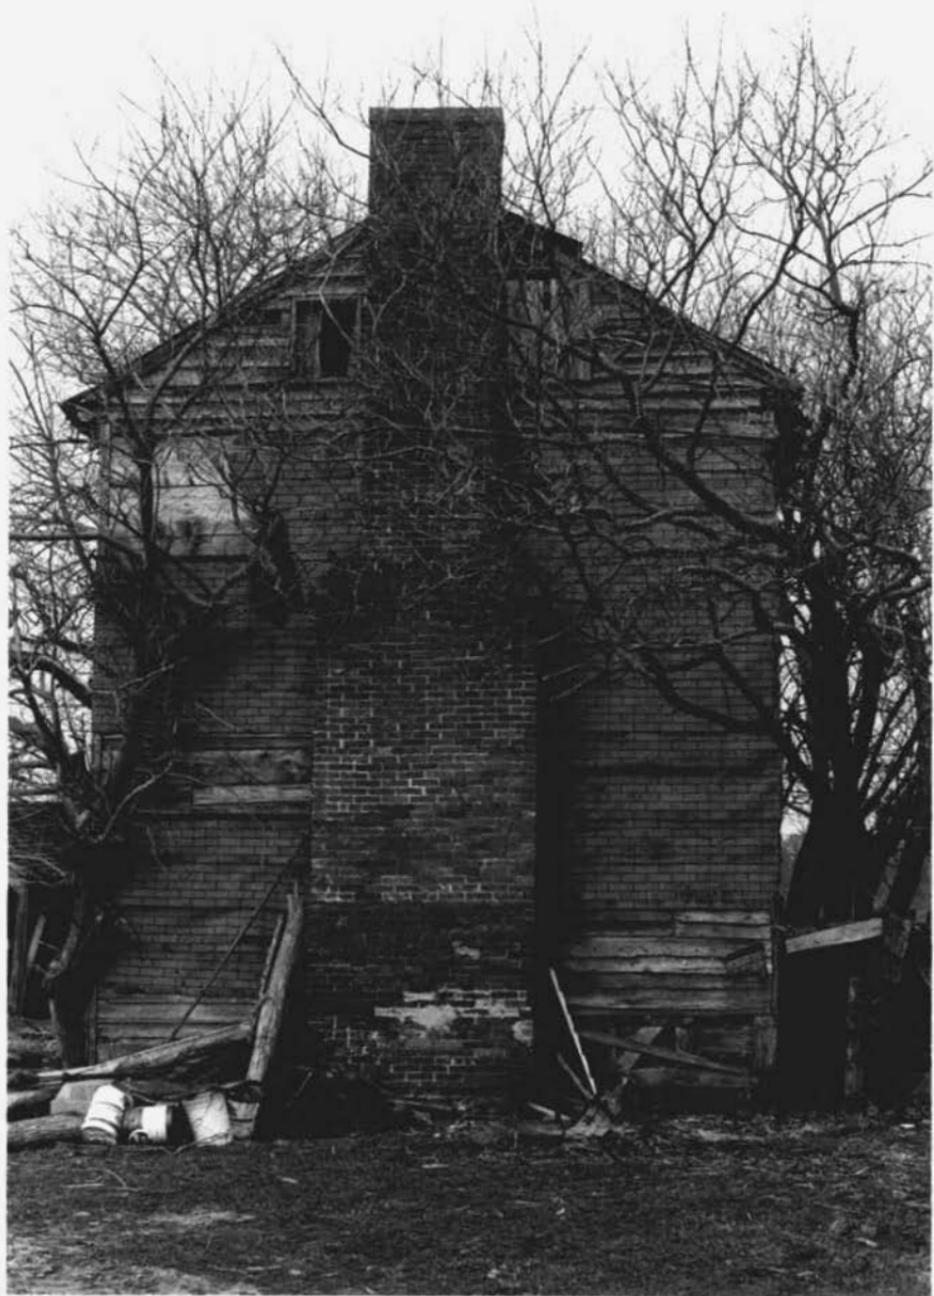
S-210

The west gable end of the main block has an exterior 6:1 common bond brick chimney with corbelled shoulders at the second floor height. A layer of imitation brick asphalt siding partially covers the west gable end. Two small attic window openings flank the stack.

Carrigan Farm  
West Gable End  
Near Wellington, Somerset County  
5/84 Paul Touart  
Neg./ Maryland Historic Trust

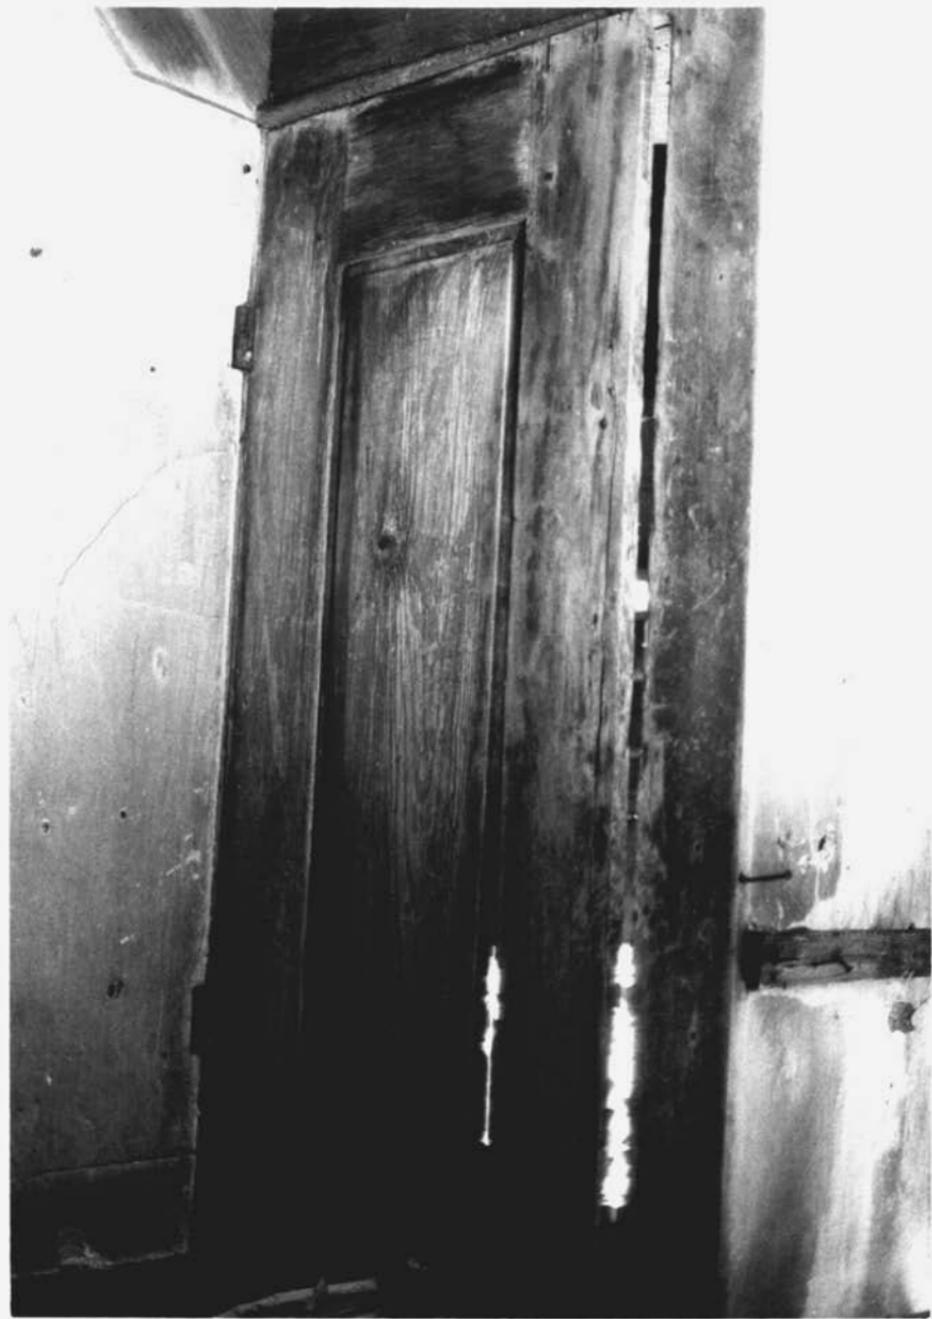
S-210

Carrigan Farm  
Attic Door  
Near Wellington, Somerset County  
5/84 Paul Touart  
Neg./ Maryland Historic Trust
