S-214
 Isaac Harris House or
 Brittingham Farm
 Near Wellington
 Private

c. 1780-1798,
 with c. 1880-1890
 addition

Maryland Historical Trust State Historic Sites Inventory Form

Survey No. S-214

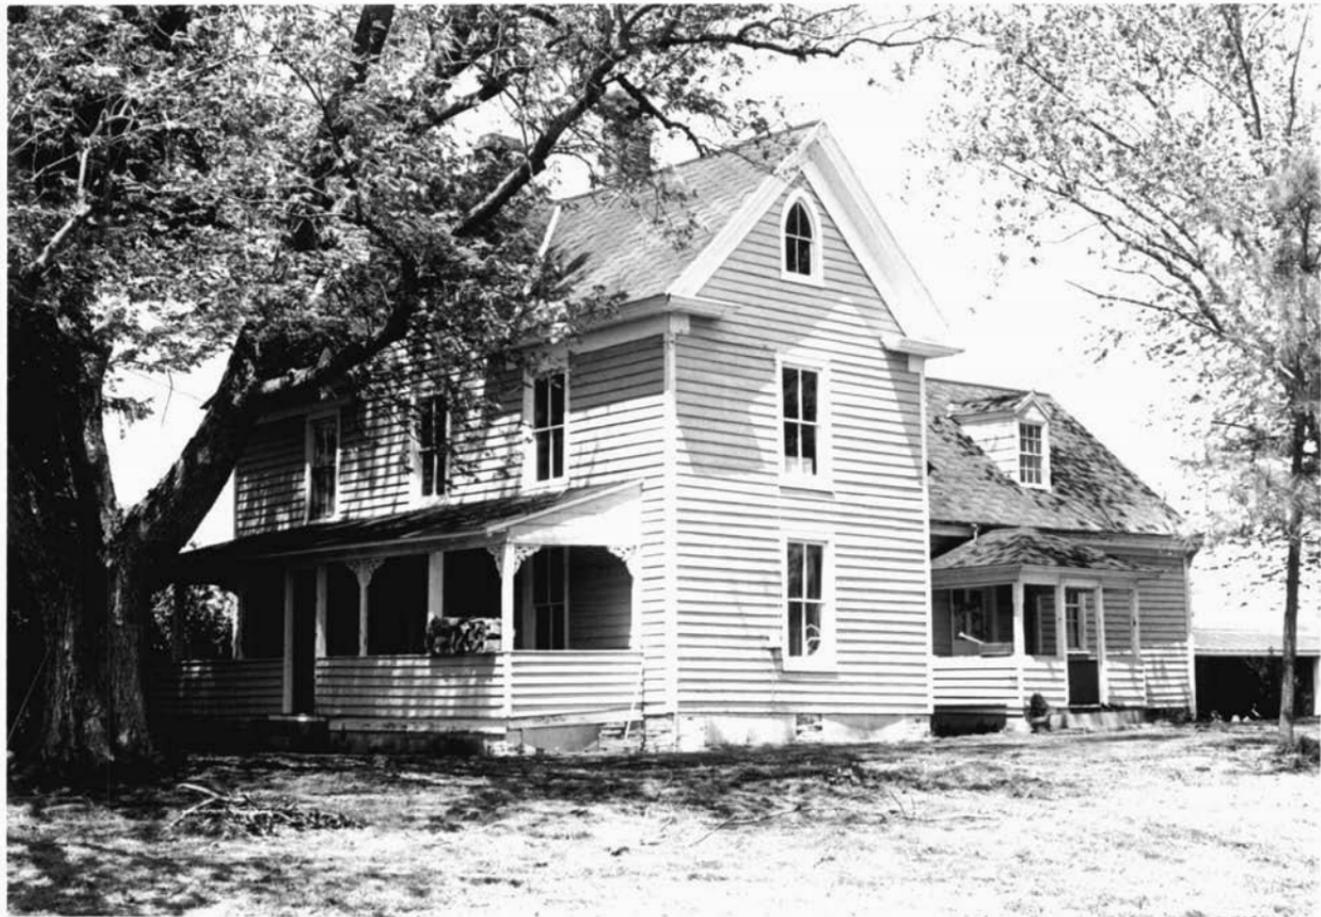
S-214

Brittingham Farm
Near Cokesbury, Somerset County
Southwest Elevation
5/84 Paul Touart
Neg./ Maryland Historic Trust

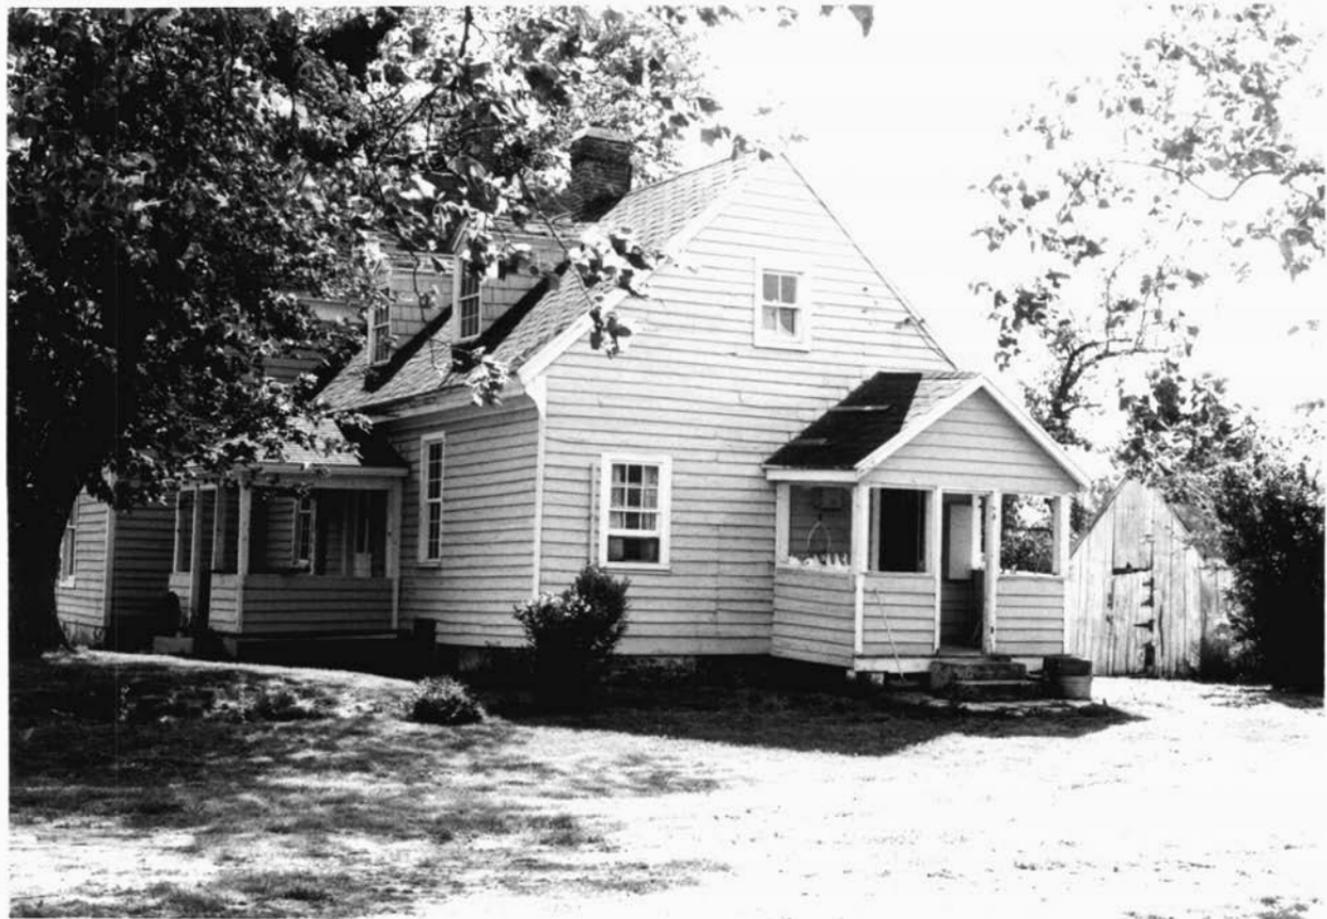
S-214

The northeast gable end is sheathed with narrow weatherboards. The remnants of the brick chimney arch is quite visible in the brick rubble foundation. A gable end entrance with gable-front stoop occupies the northern half of the end wall, while a 2/2 sash window pierces the upper story.

Brittingham Farm
Near Cokesbury, Somerset County
Northeast Elevation
5/84 Paul Touart
Neg./ Maryland Historic Trust

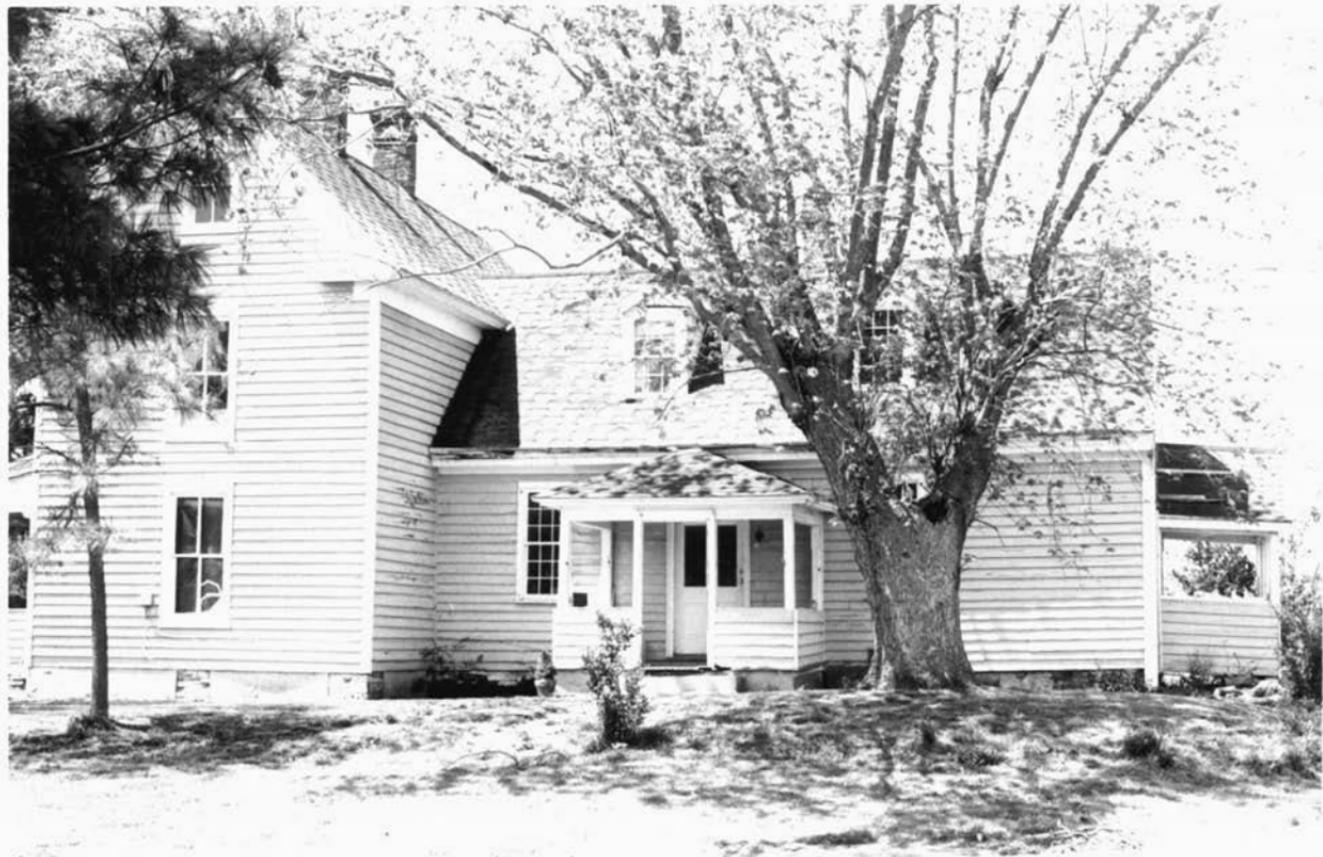
S-214

The southeast elevation is three bays across with a center entrance flanked by 9 sash windows. The door is a late 19th century replacement but the window sash survive intact with cyma curve surrounds. A hip roofed entrance stoop covers the front door. The boxed cornice stretches across at the base of the roof with crown and bed moldings.

Brittingham Farm
Near Cokesbury, Somerset County
Southeast Elevation
5/84 Paul Touart
Neg./ Maryland Historic Trust

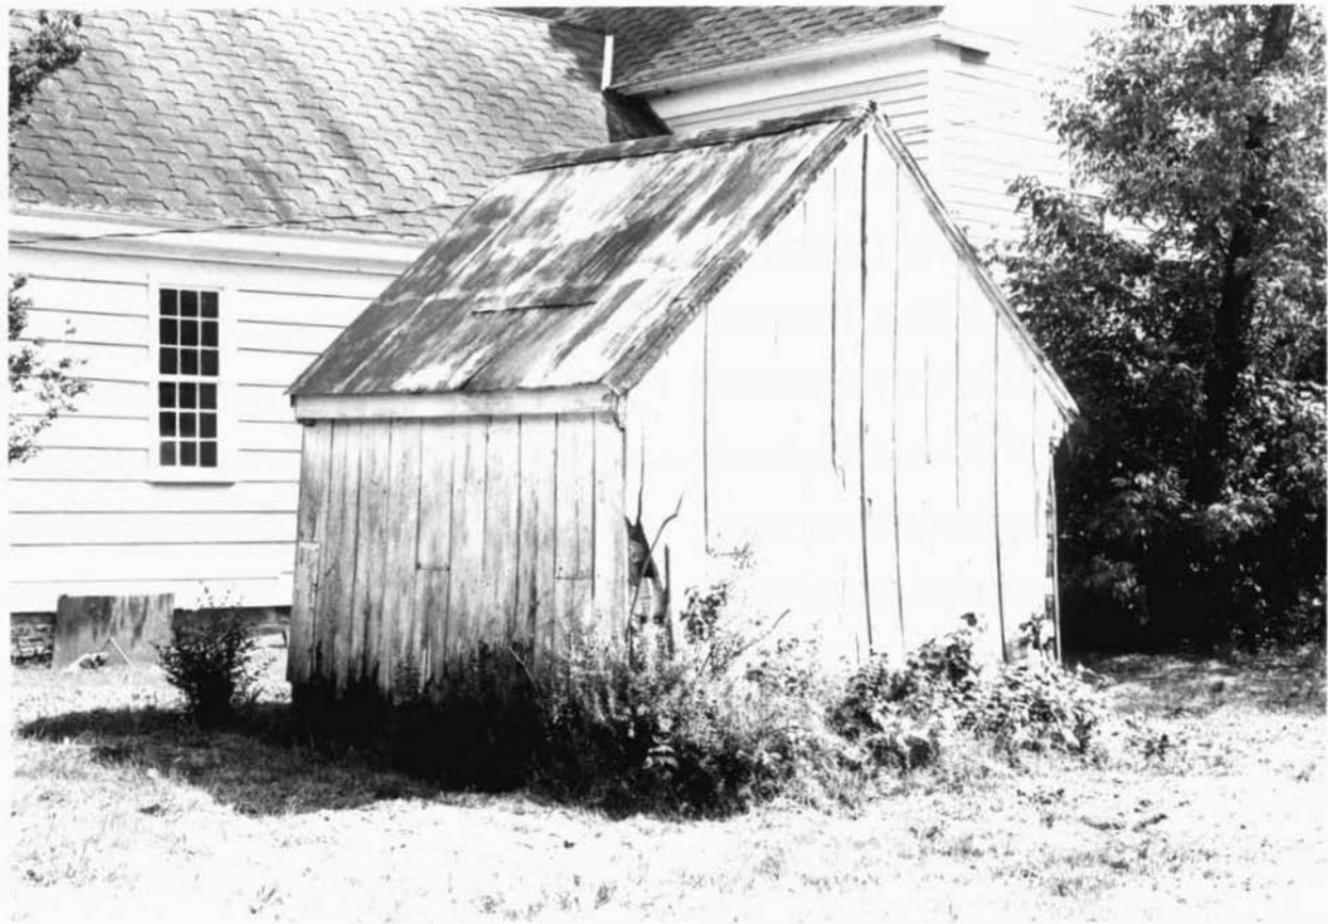
S-214

Britting, Ham Farm
Near Cokesbury, Somerset County
Northeast Elev. of Smoke House
6/84 Paul Touart
Neg. / Maryland Historic Trust

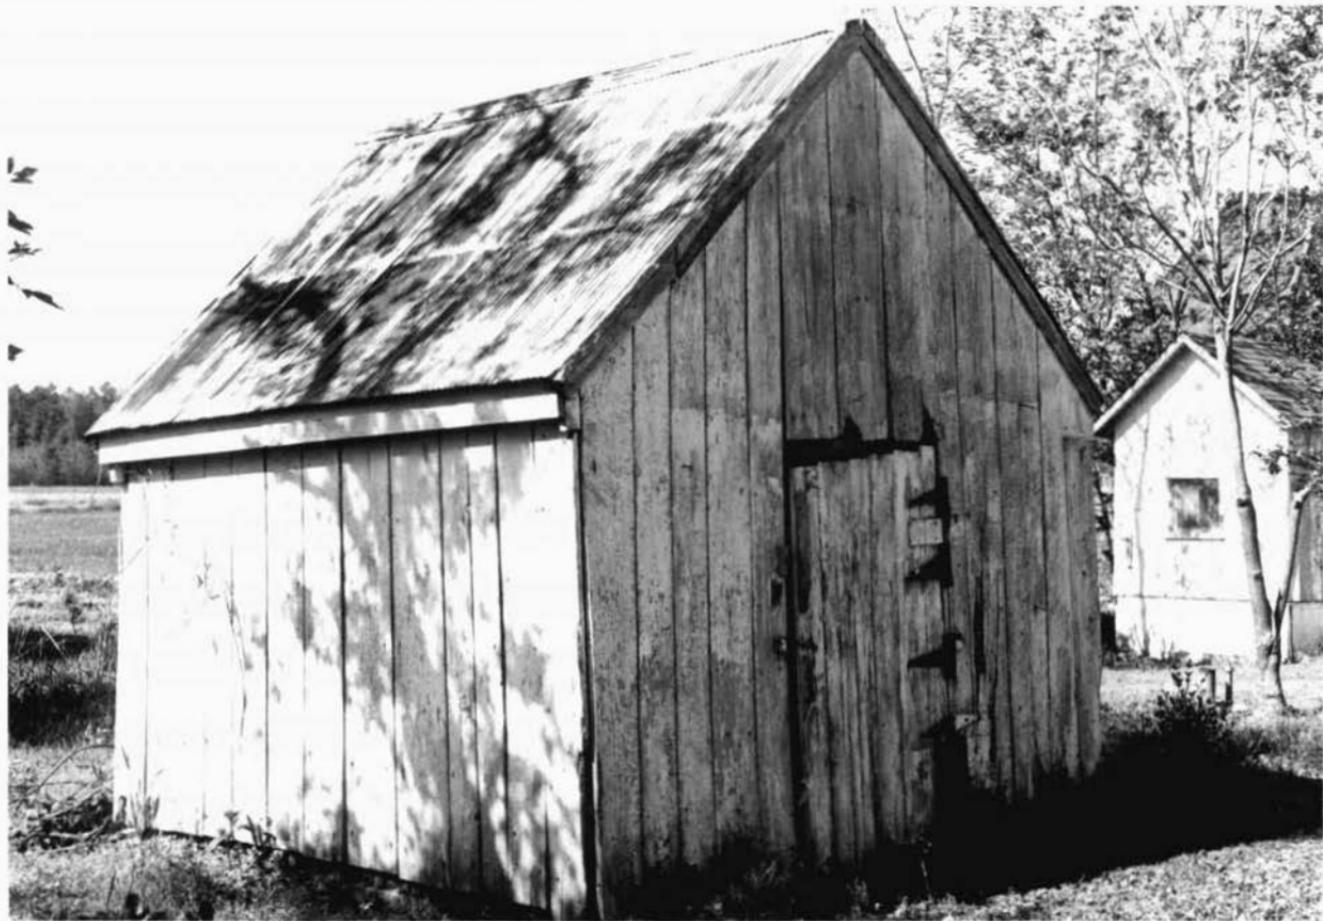
S-214

Brittingham Farm
Near Cokesbury, Somerset County
Southwest Elevation - *Snake House*
5/84 Paul Touart
Neg./ Maryland Historic Trust

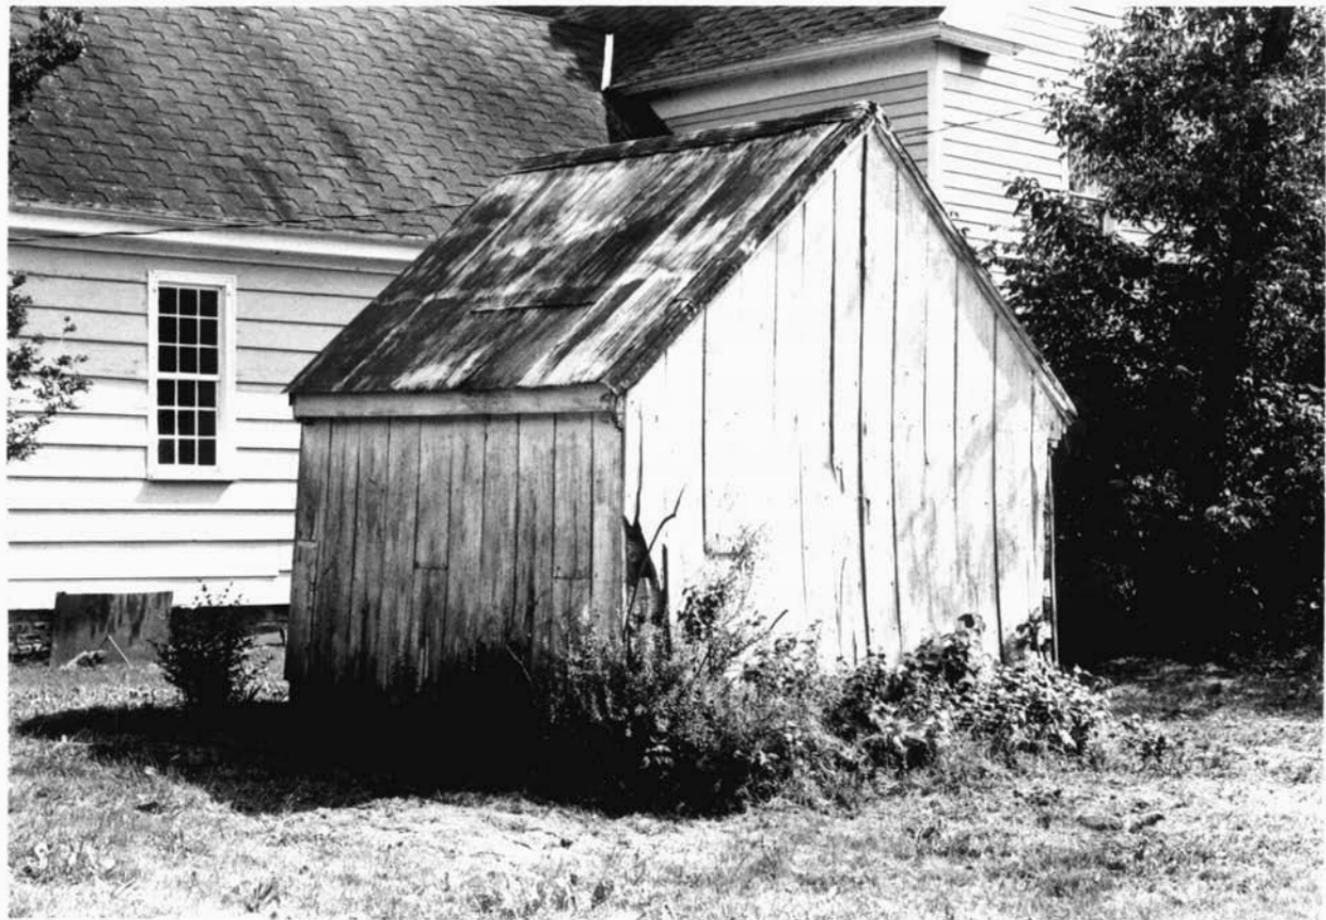
S-214

Brittingham Farm
Near Cokesbury, Somerset County
Northeast Elev.of Smoke House
5/84 Paul Touart
Neg./ Maryland Historic Trust

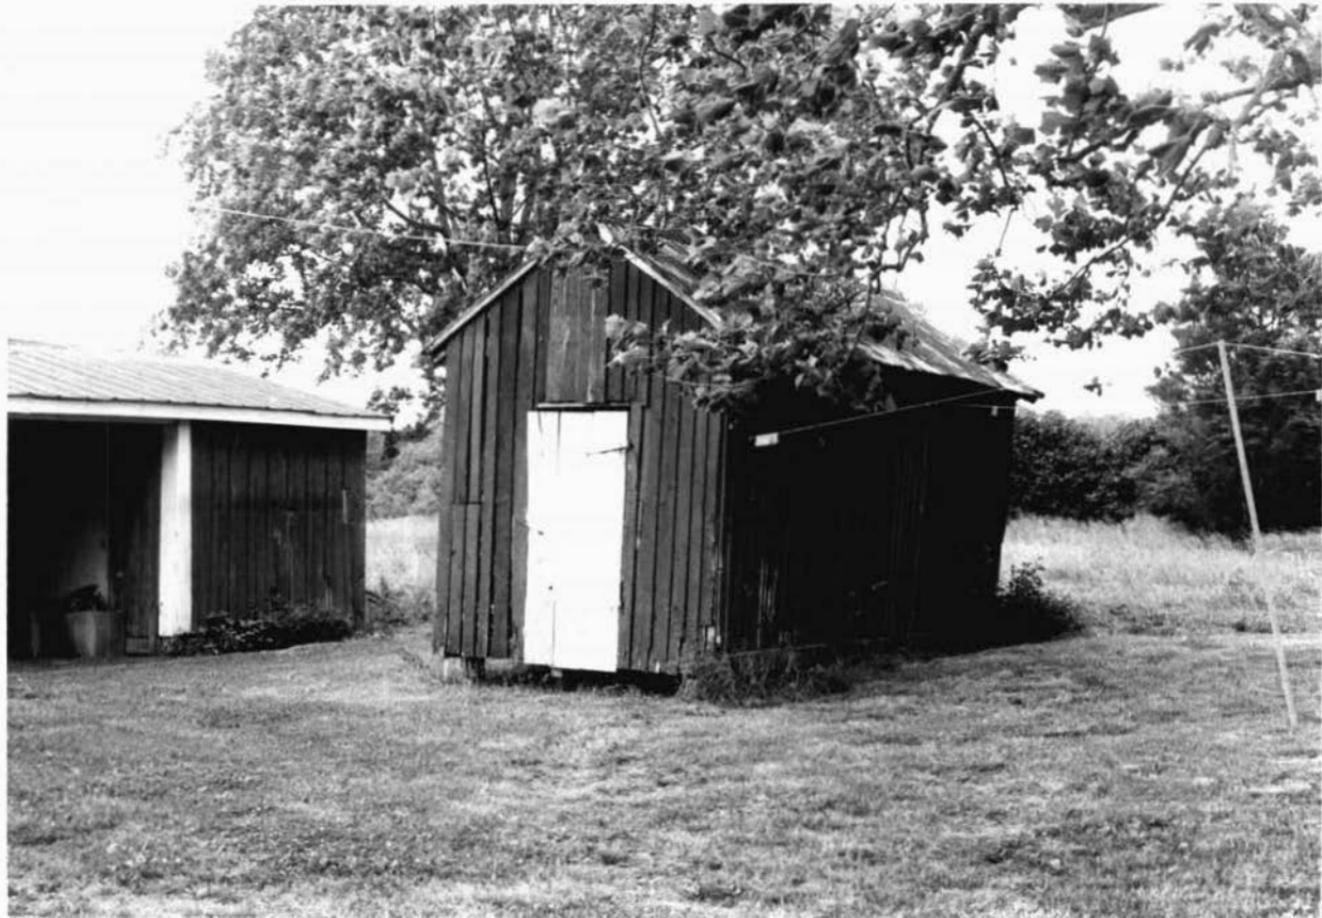
S-214

Brittingham Farm
Near Cokesbury, Somerset County
Wagon Shed and Corn Crib
5/84 Paul Touart
Neg./ Maryland Historic Trust

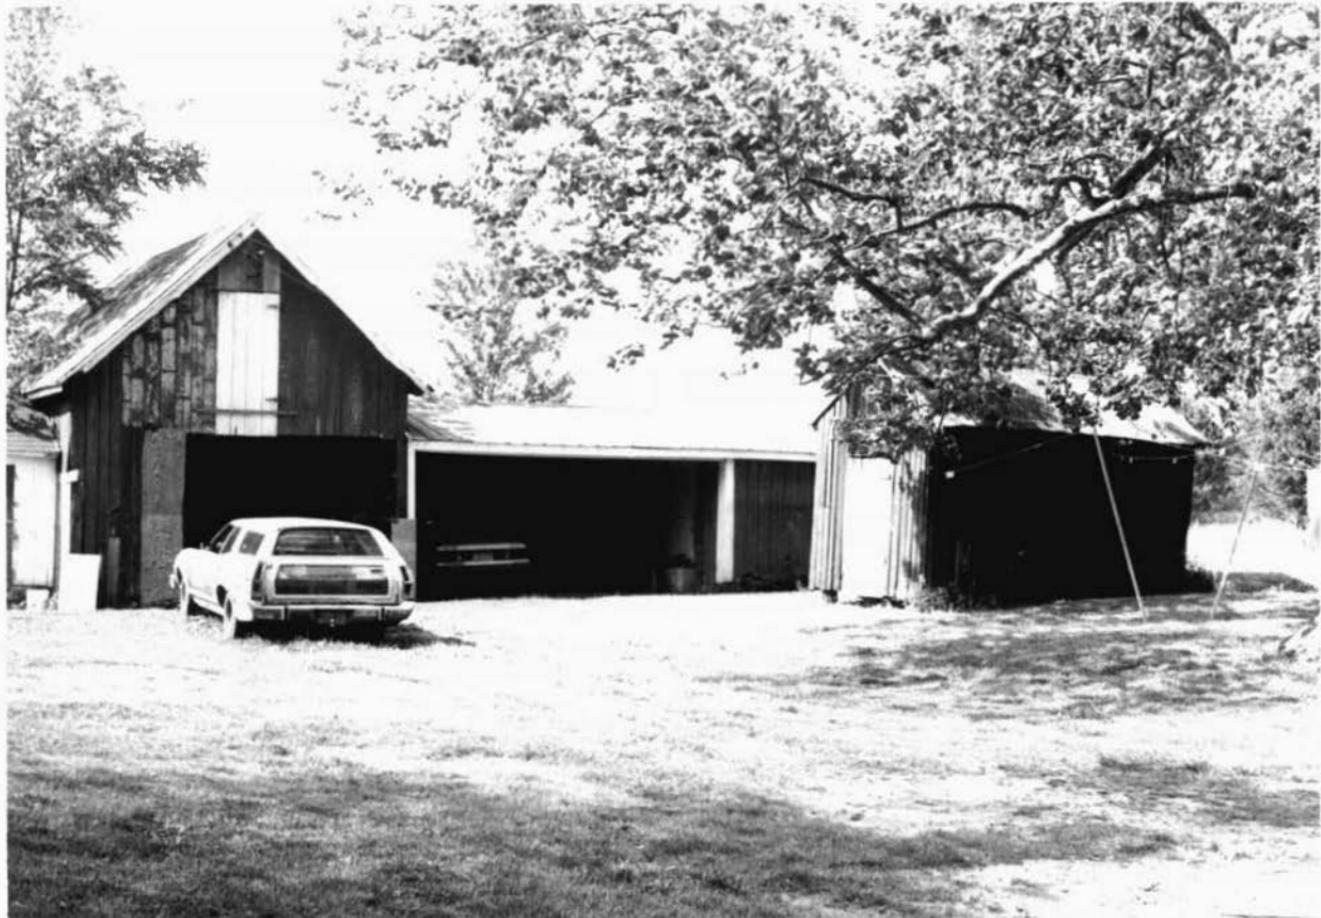
S-214

Brittingham Farm

Corn Orib - Southwest Elevation

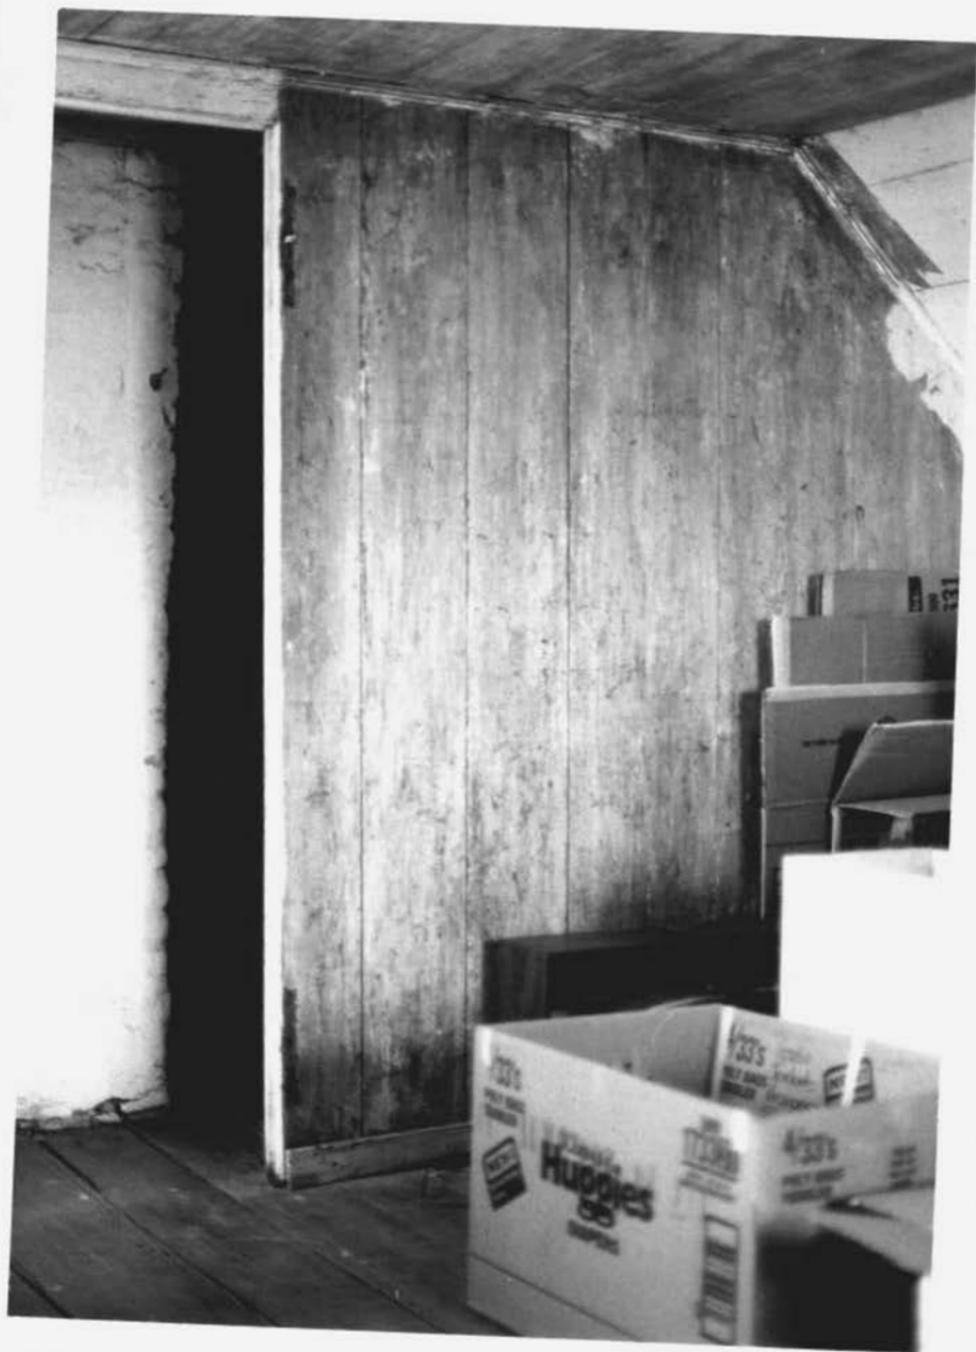
S-214

Brittingham Farm
Near Cokesbury, Somerset County
2nd floor partition
5/84 Paul Touart
Neg./ Maryland Historic Trust

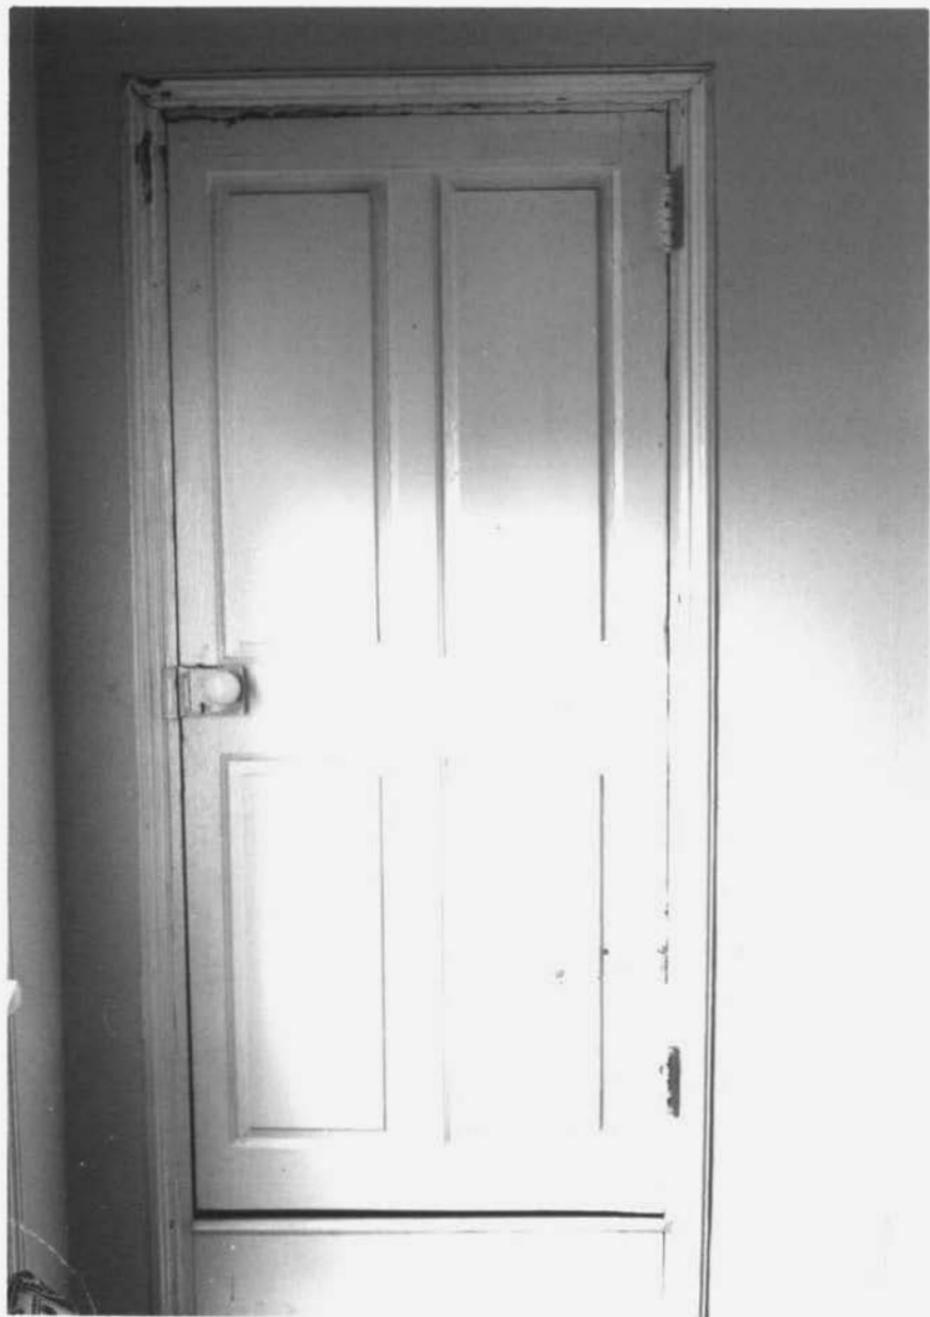
S 214

The rear service wing is divided as it was in the 18th century by a centrally located vertical board wall. An enclosed winder stair has a four-panel door as well as its early molded surround. In fact most door and window openings retain their original surrounds. A simple post and lintel mantel has been applied to the middle partition for a focal point surrounding the stove.

Brittingham Farm
Near Cokesbury, Somerset County
18th-century four-panel door
5/84 Paul Touart
Neg./ Historic Trust

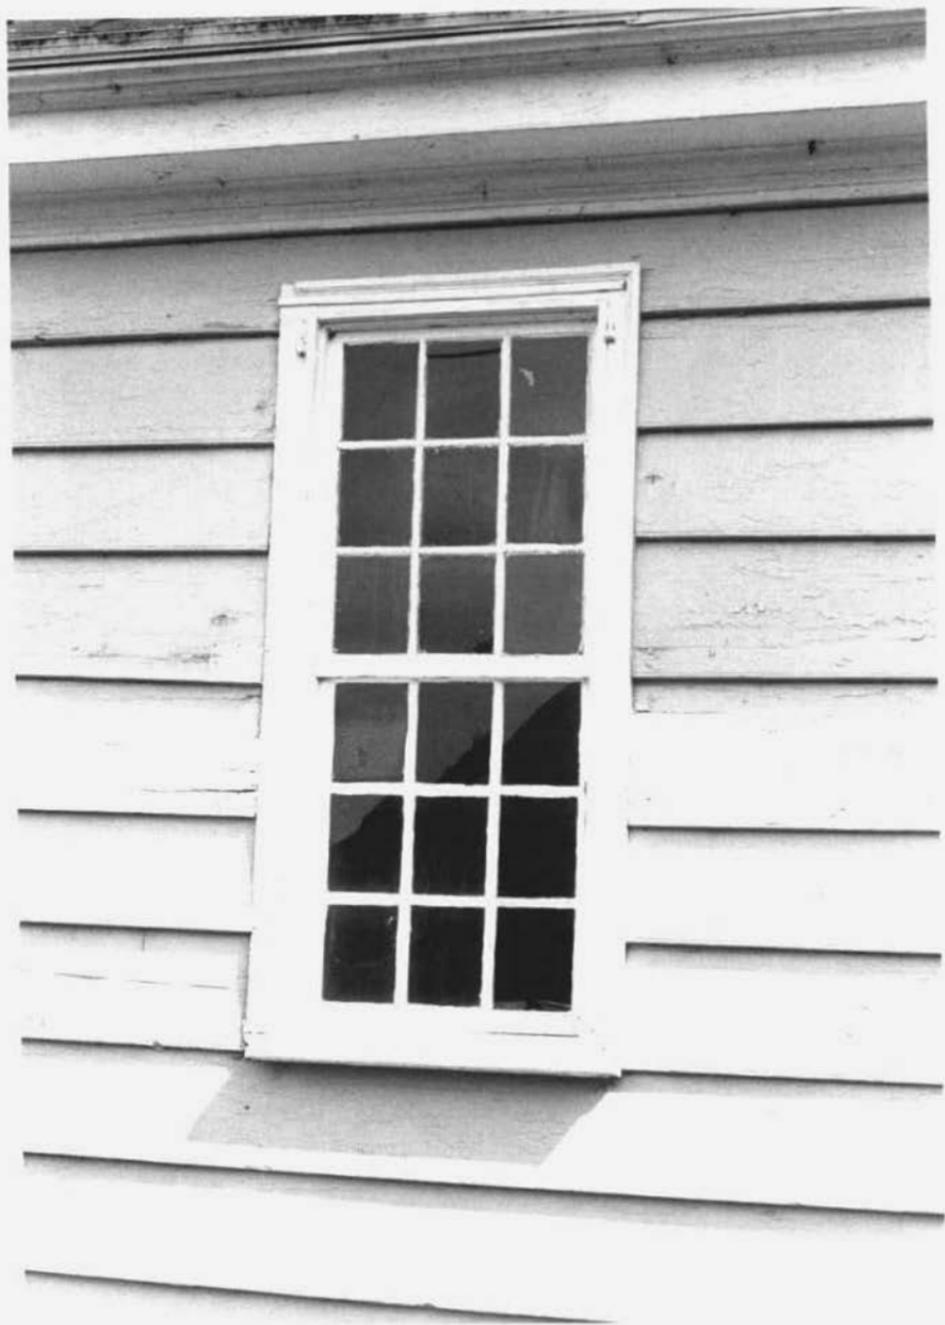
S-214

The northwest side retains a large portion of its wide beaded weatherboards in addition to the crown and bed moldings of the boxed cornice. The center door has been replaced, but is topped by a five-light transom and framed by a cyma curve surround. Located to either side of the door are early 9/9 sash windows. The foundation walls have been partially rebuilt with concrete blocks. Found within the crawl space was the early mortise and tenon frame wooden grill with vertical diamond-cross sectioned bars.

Brittingham Farm
Near Cokesbury, Somerset County
Northwest Elev. 9/9 sash window
5/84 Paul Touart
Neg./ Maryland Historic Trust

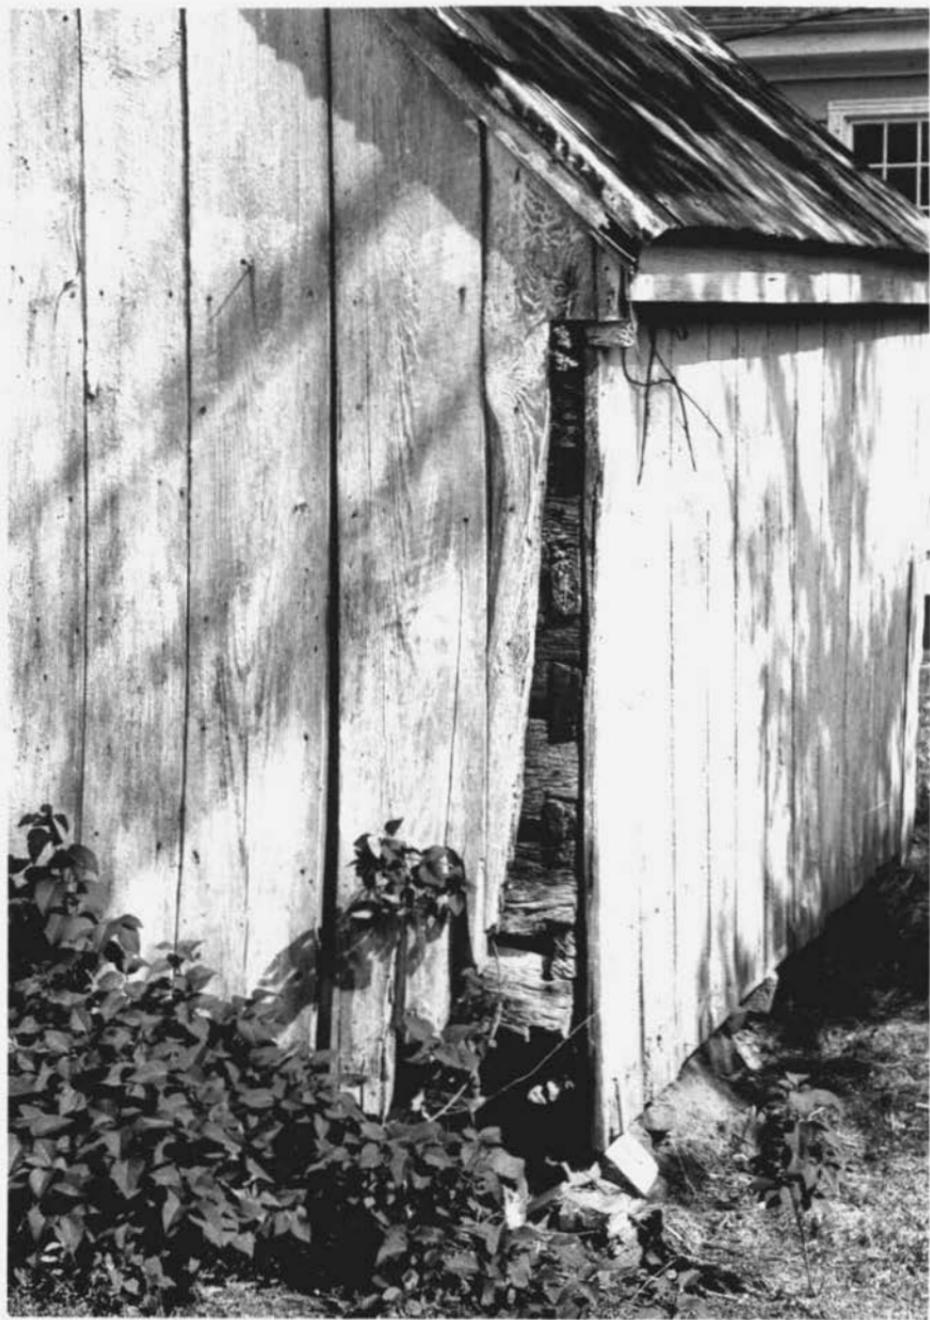
S-214

Brittingham Farm
Near Cokesbury, Somerset County
Corner Dovetailing
5/84 Paul Touart
Neg./ Maryland Historic Trust
