**MARYLAND HISTORICAL TRUST
DETERMINATION OF ELIGIBILITY FORM**

Property Name: Dr. Thomas Costen House Inventory Number: S-253
 Address: 31306 Old Rehobeth Road City: Westover Zip Code: 21871
 County: Somerset USGS Topographic Map: Kingston
 Owner: Brett Smith & Jeff Smith, same address Is the property being evaluated a district? ___yes
 Tax Parcel Number: 0008 Tax Map Number: 0059 Tax Account ID Number: 03-037924
 Project: Great Bay Wind Energy Center Agency: _____
 Site visit by MHT Staff: X no ___yes Name: _____ Date: _____
 Is the property located within a historic district? ___yes X no

Great Bay Wind Energy Center
 Somerset County - Maryland
Historic Resources Assessment
 February 2014

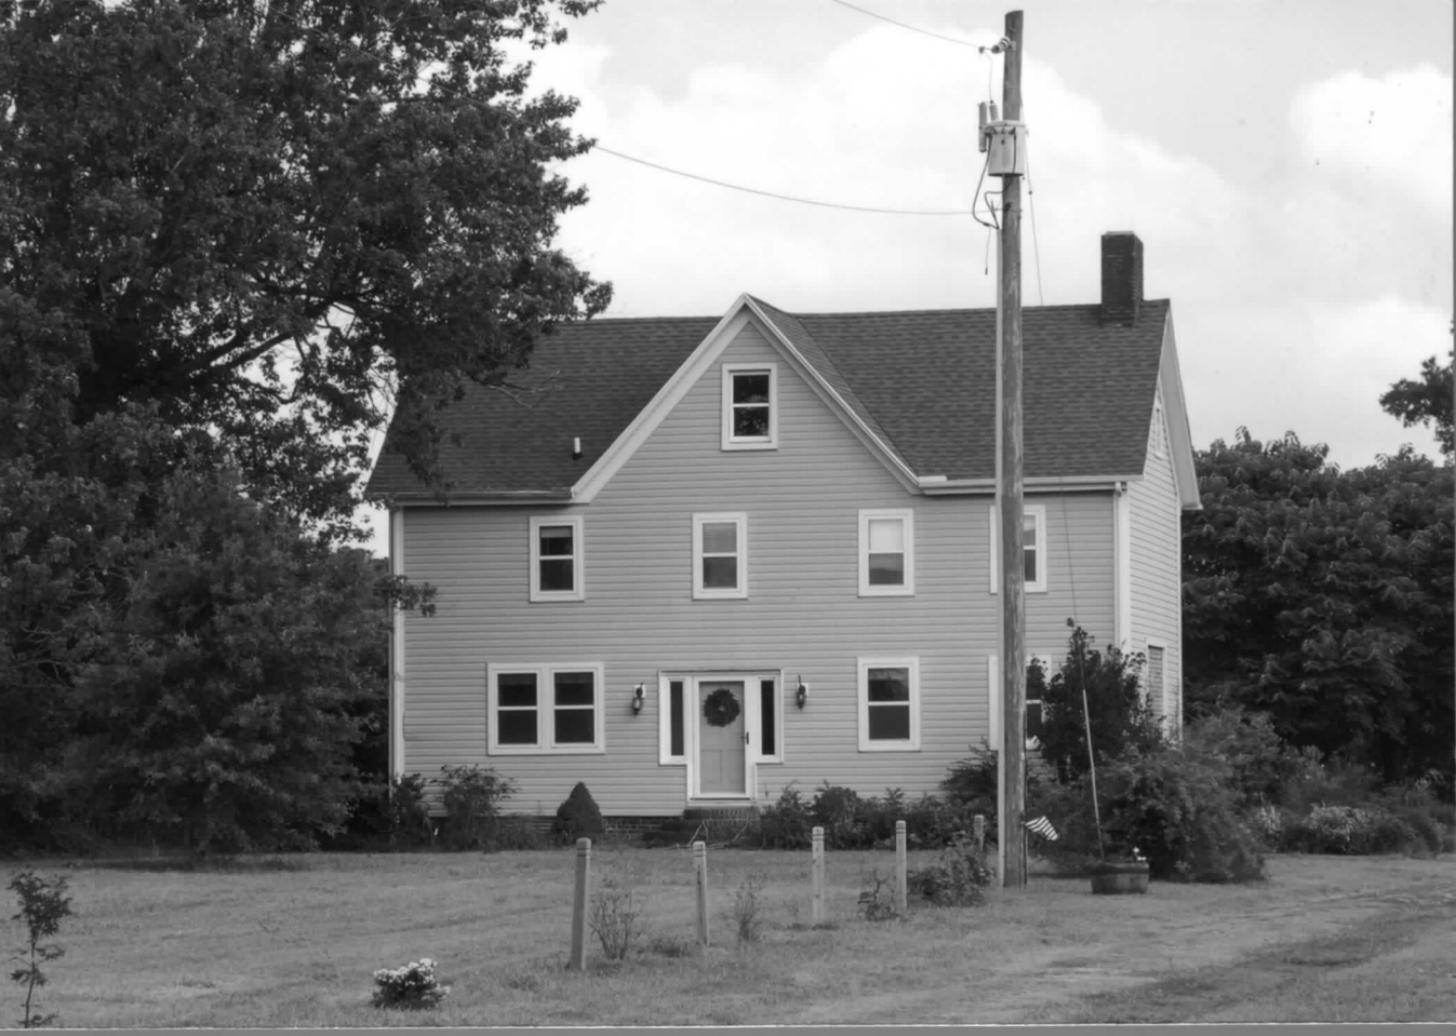
Photo #1/4

VIEW N TOWARD SOUTH & EAST FACADES OF HOUSE

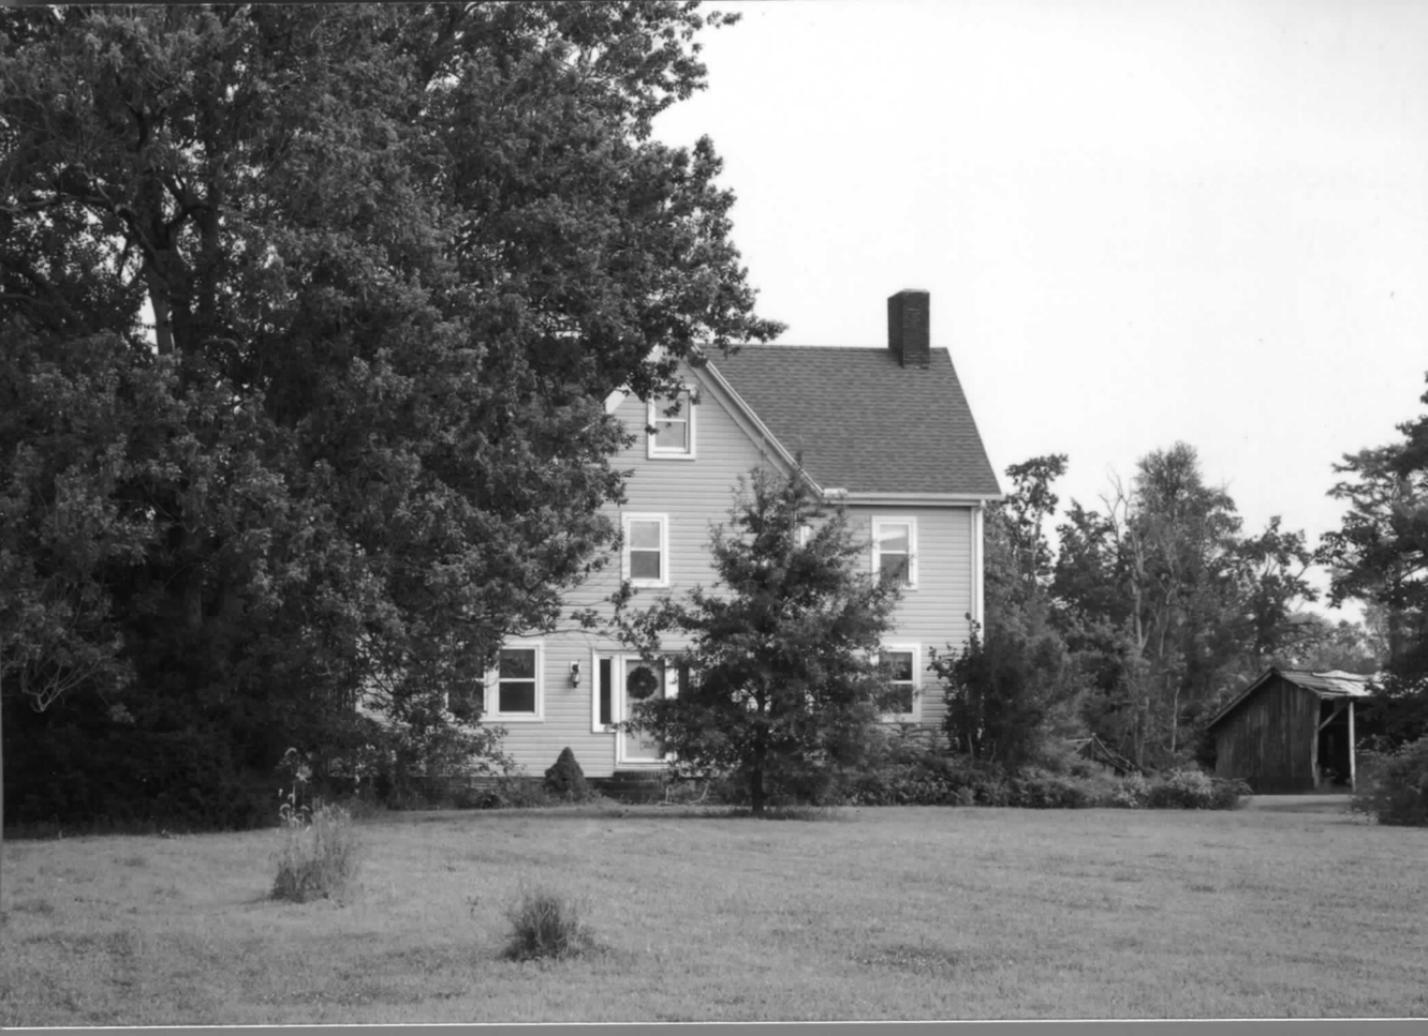
PHOTO #2/4

VIEW NE TOWER HOUSE & OUTBUILDINGS

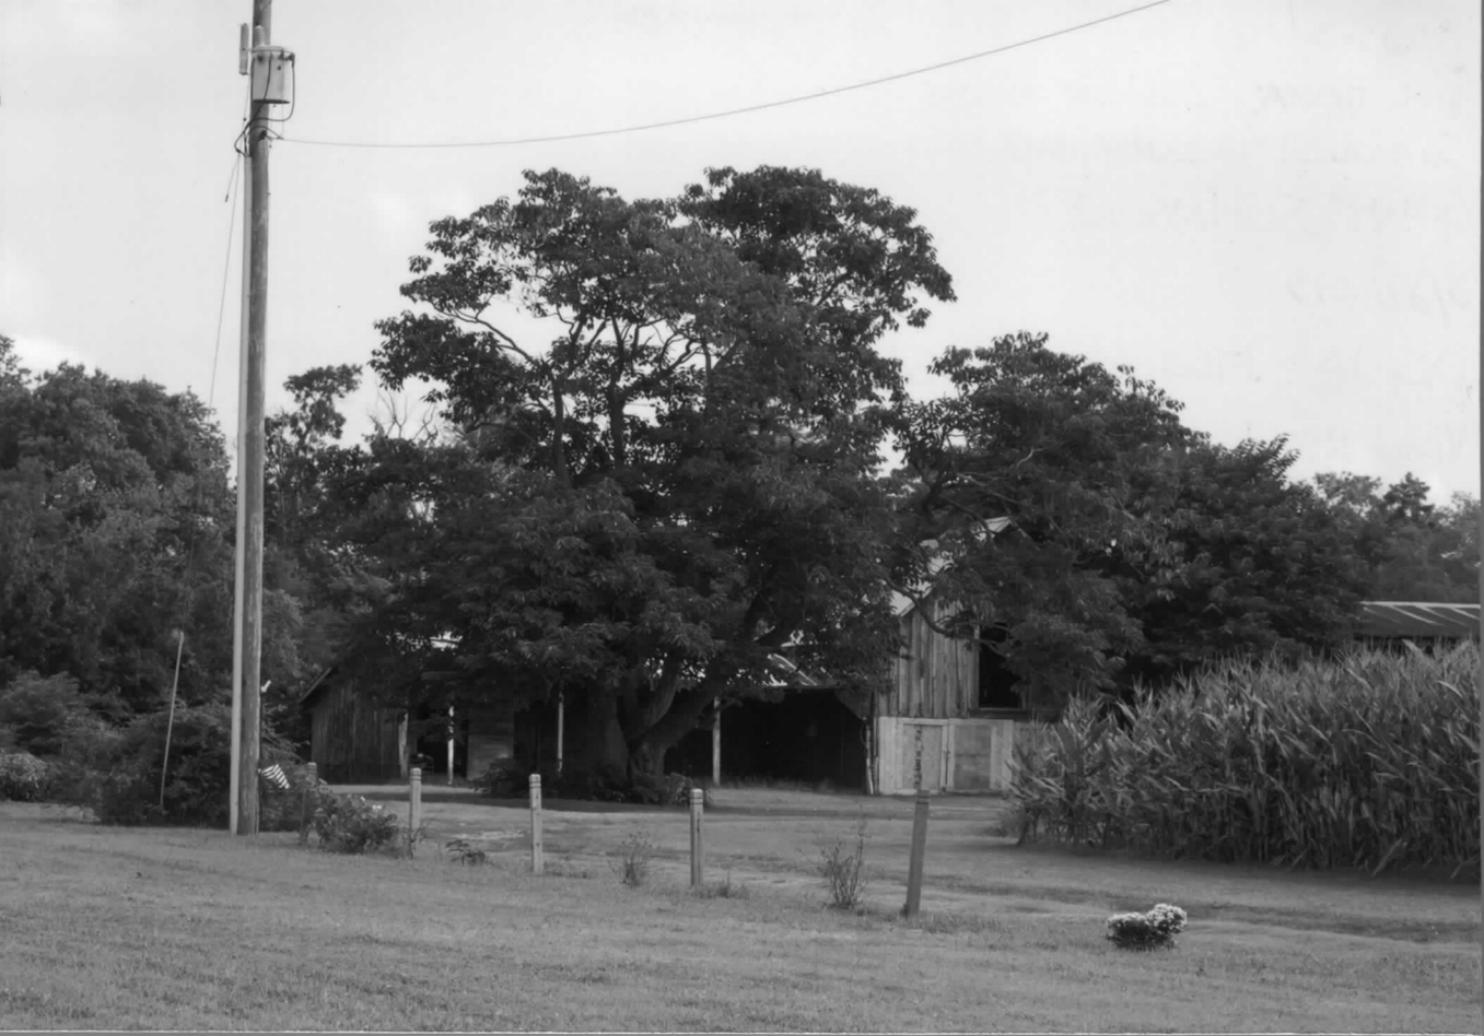
PHOTO # 3/4

VIEWING TOWARD BARN & SHEDS

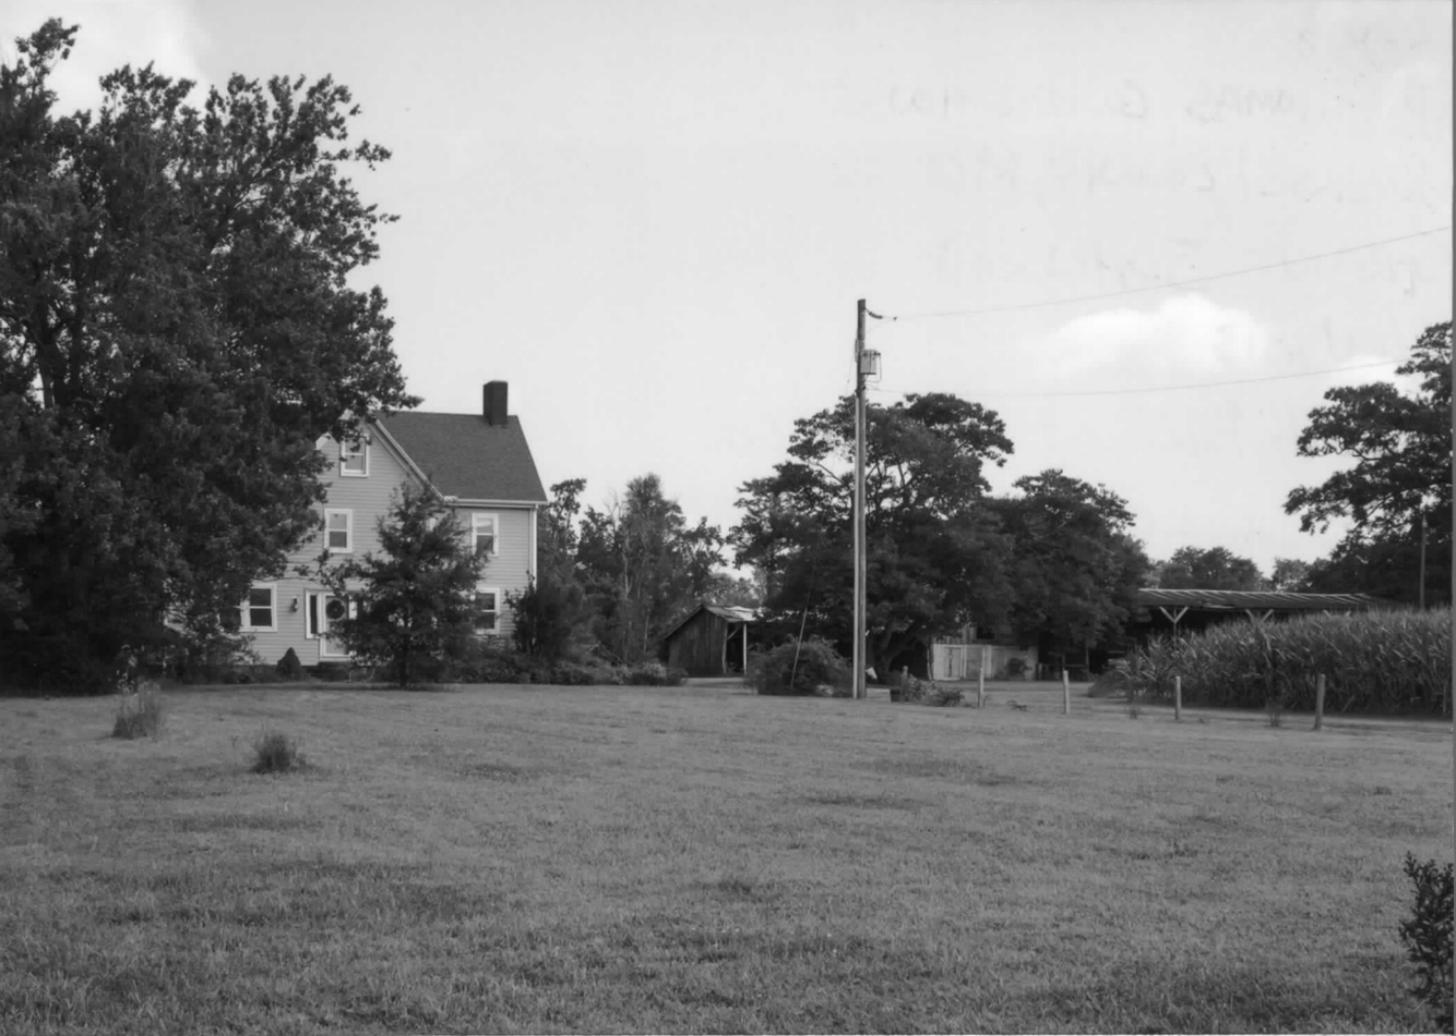
PHOTO #4/4

VIEW NE TOWARD SOUTH FACADE OF HOUSE

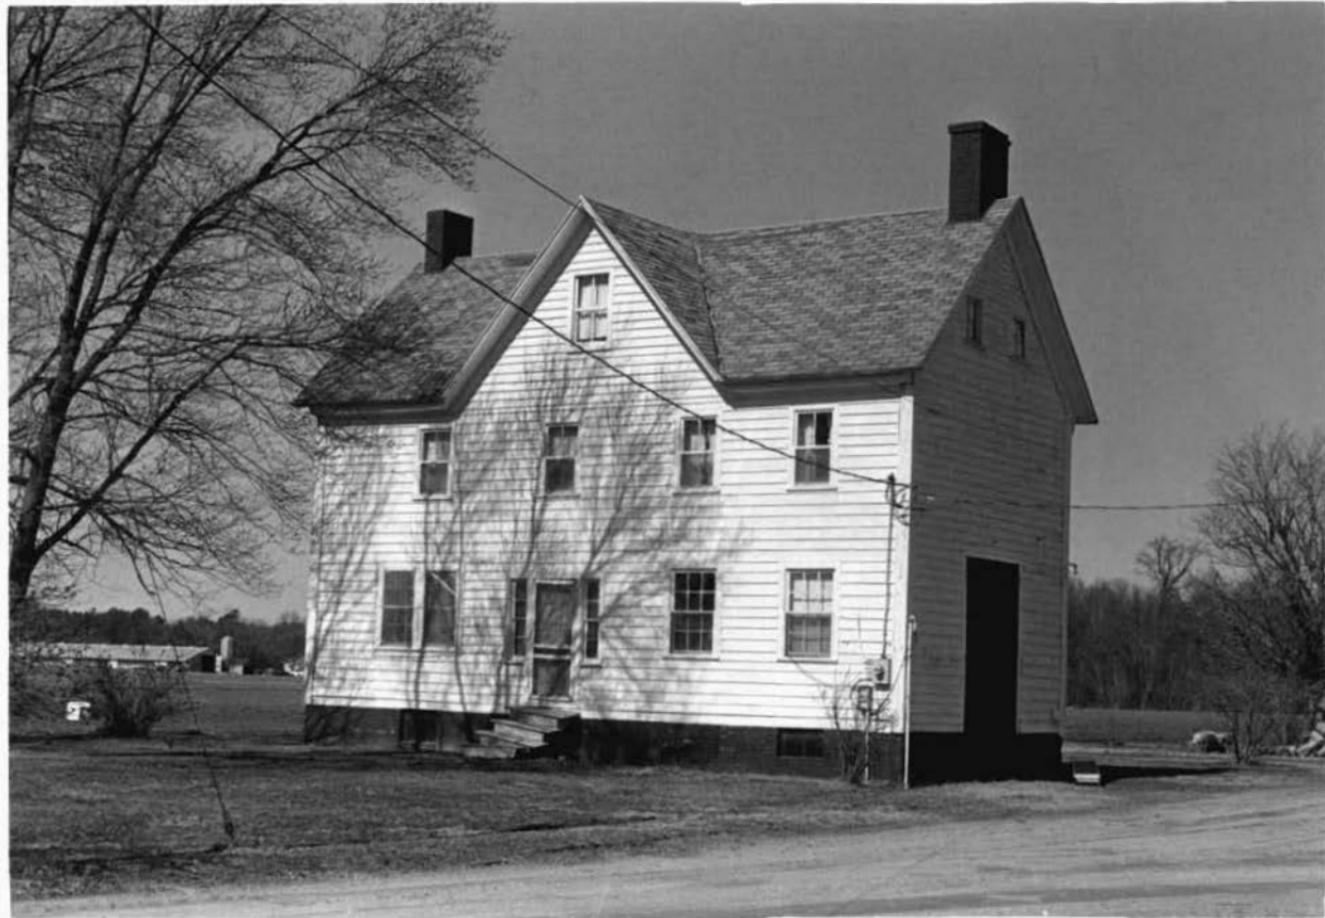
The asymmetrical south facade is divided into four bays with the entrance occupying the second bay from the west. A six-panel door is flanked by 2/2 sash sidelights. The two bays to the east are marked by two 6/6 sash windows, while the single bay to the west is filled with a modern paired 6/6 sash window. The second floor is lighted by four 2/2 sash windows, and the front gable is pierced by the same 2/2 sash light.

Dr. Thomas Costen House S-253
Near Rehobeth, Somerset County
South Elevation
4/85, Photographer, Paul Touart
Neg./MD. Historical Trust

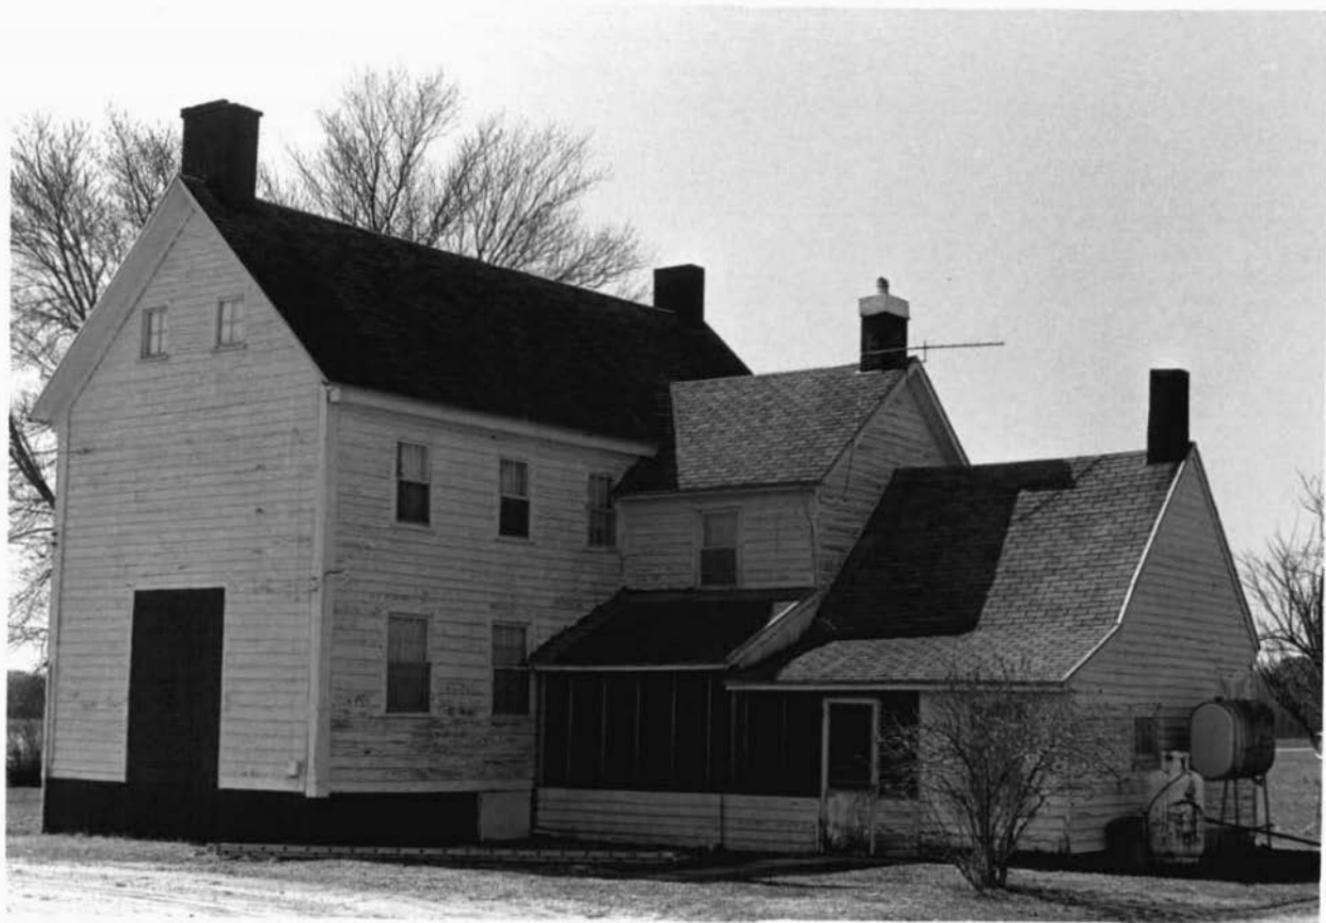
Extending from the back of the house is a shorter two-story one-bay by one-room post-Civil War frame section with a medium pitched roof, exposed rafter feet and an internal end brick chimney. The kitchen, on the other hand, appears contemporary with the main house. The single-story one-room plan frame structure sits close to the ground and is covered by a steeply pitched asphalt shingle roof. The kitchen walls are covered with weatherboards. A screened-in porch is attached to the east side of both the kitchen and the dining room. An altered six-panel door and a 6/6 sash window mark the east kitchen wall.

Dr. Thomas Costen House S-253
Near Rehobeth, Somerset County
Northeast Elevation
4/85, Photographer, Paul Touart
Neg./MD. Historical Trust

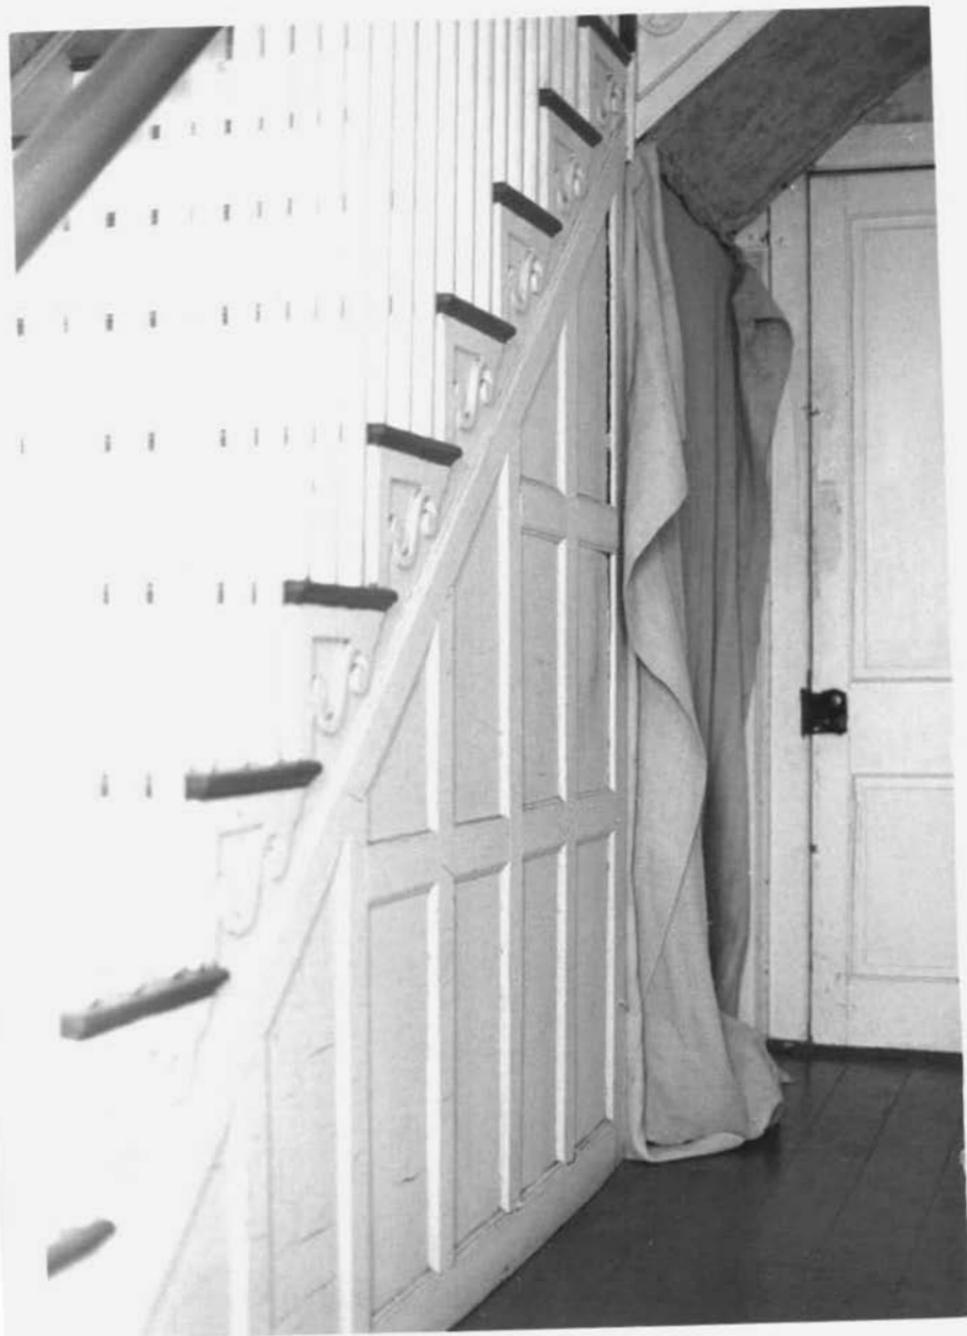
A slender turned newel post with ball finial supports a circular-profile handrail. Three rectangular balusters rise from each step. The stringer is decorated by s-scrolled trim, while the space below the stringer is divided into a flush paneled grid. In addition to the stair, the hall is fitted with early 19th-century chair rail, door surrounds and six-panel doors.

Dr. Thomas Costen House S-253
Near Rehobeth, Somerset County
Stair paneling
4/85, Photographer, Paul Touart
Neg./MD. Historical Trust

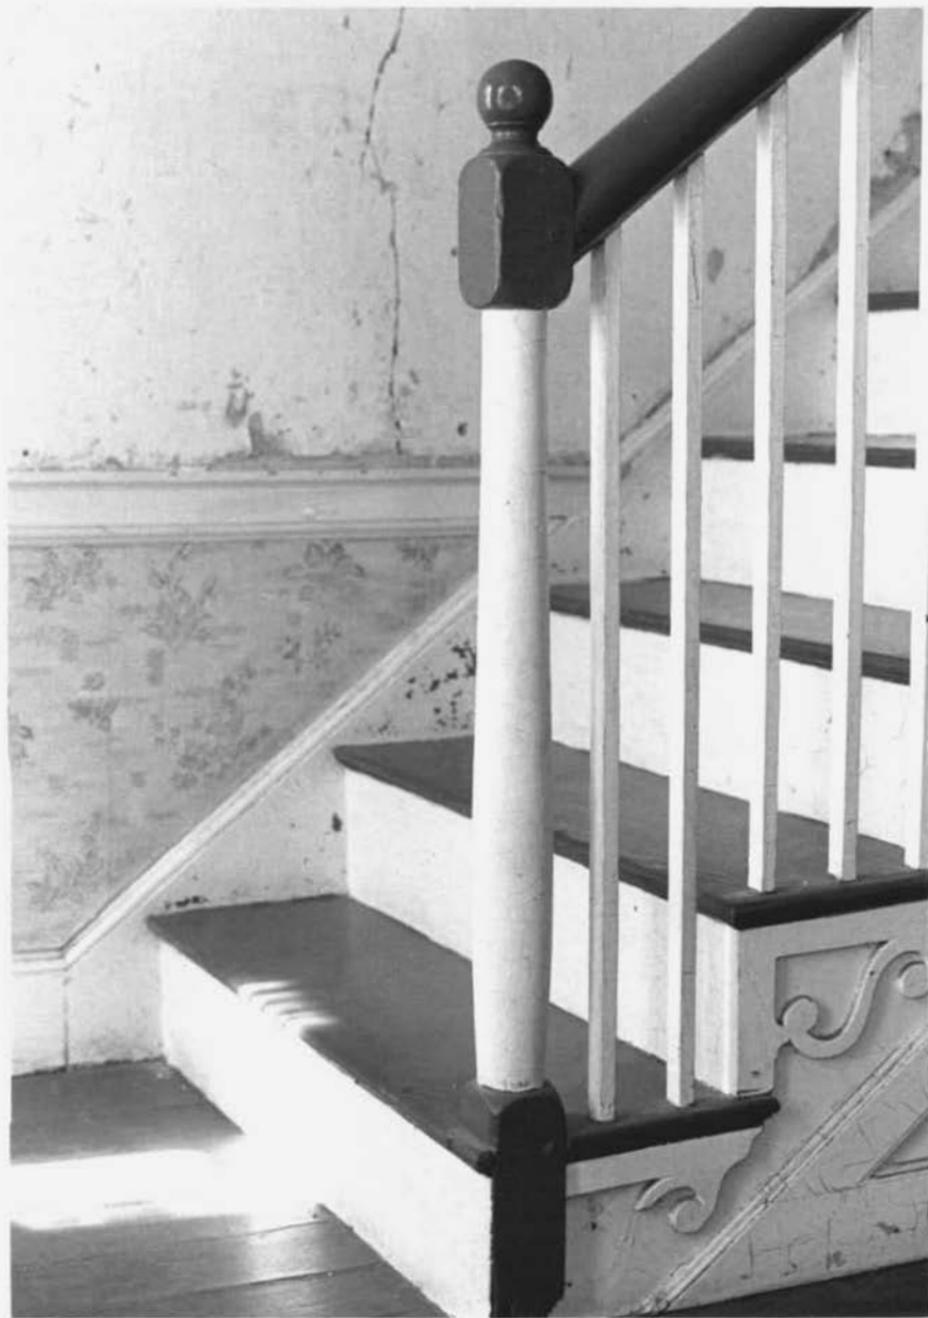
Dr. Thomas Costen House S-253
Near Rehobeth, Somerset County
Stair
4/85, Photographer, Paul Touart
Neg./MD. Historical Trust

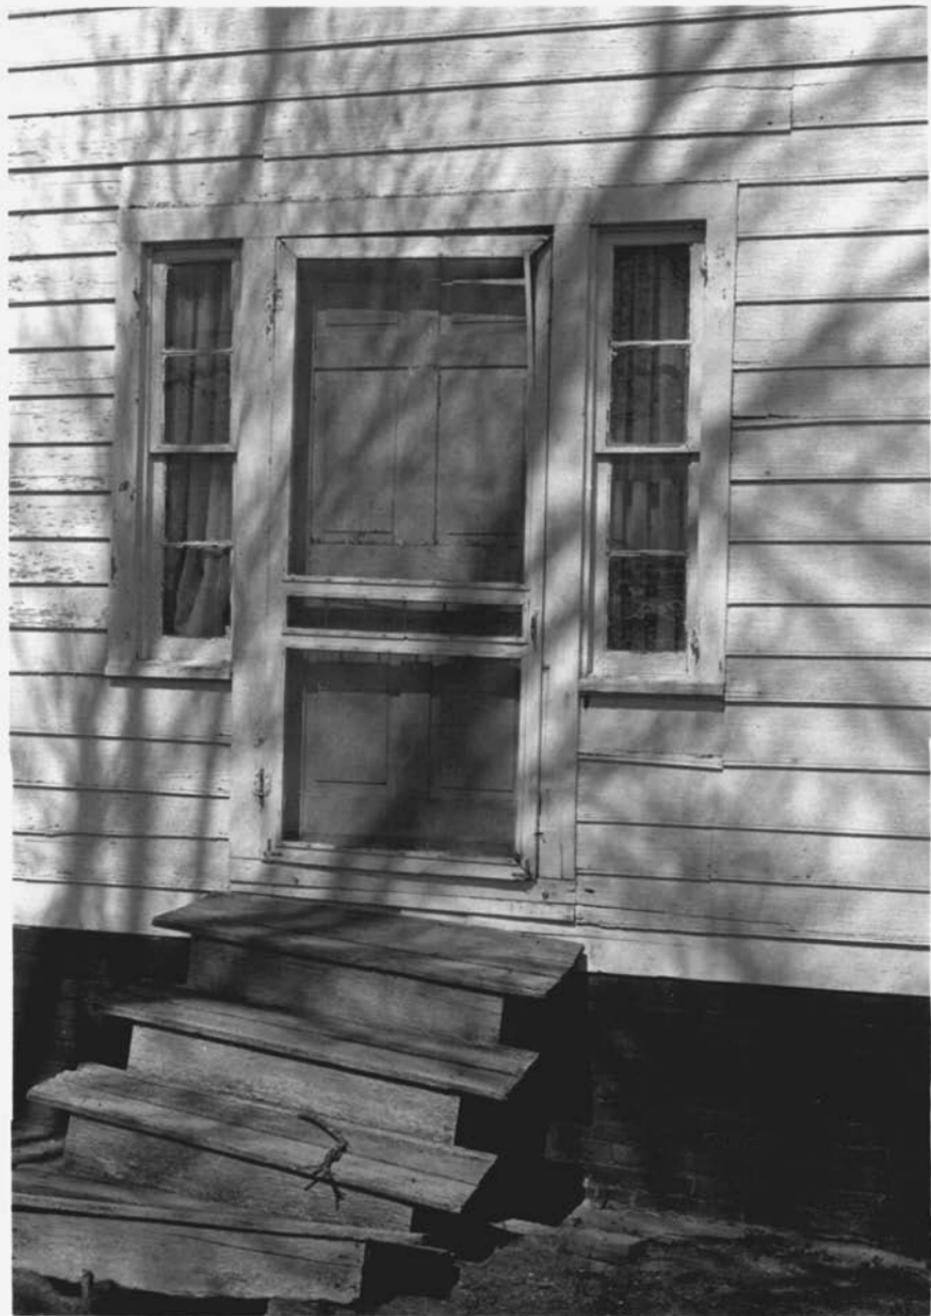
Dr. Thomas Costen House S-253
Near Rehobeth, Somerset County
Front Entrance
4/85, Photographer, Paul Touart
Neg./MD. Historical Trust

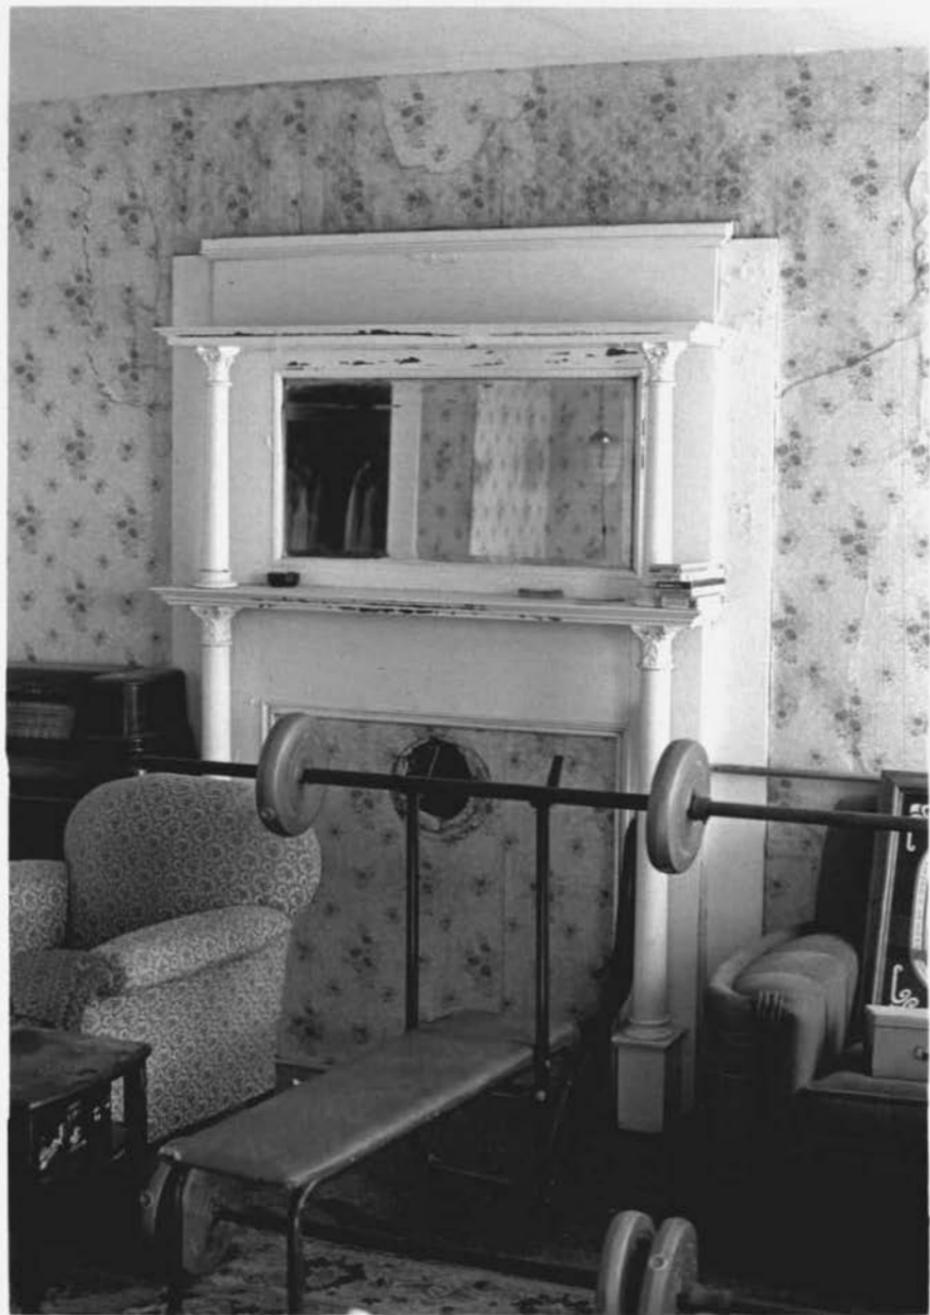
The adjacent east room, or the parlor, retains the same chair rail as well as door and window surrounds. However, the Federal mantel has been replaced with a c.1900 detailed column colonial revival mantel with mirror overmantel.

Dr. Thomas Costen House S-253
Near Rehobeth, Somerset County
Parlor Mantel
4/85, Photographer, Paul Touart
Neg./MD. Historical Trust
