S-259 /
Rumbl~~ey~~ Point Road House
Tulls Corner vicinity
private

Maryland Historical Trust State Historic Sites Inventory Form

and/or common Rumbley Point Road House

Survey No. S-259

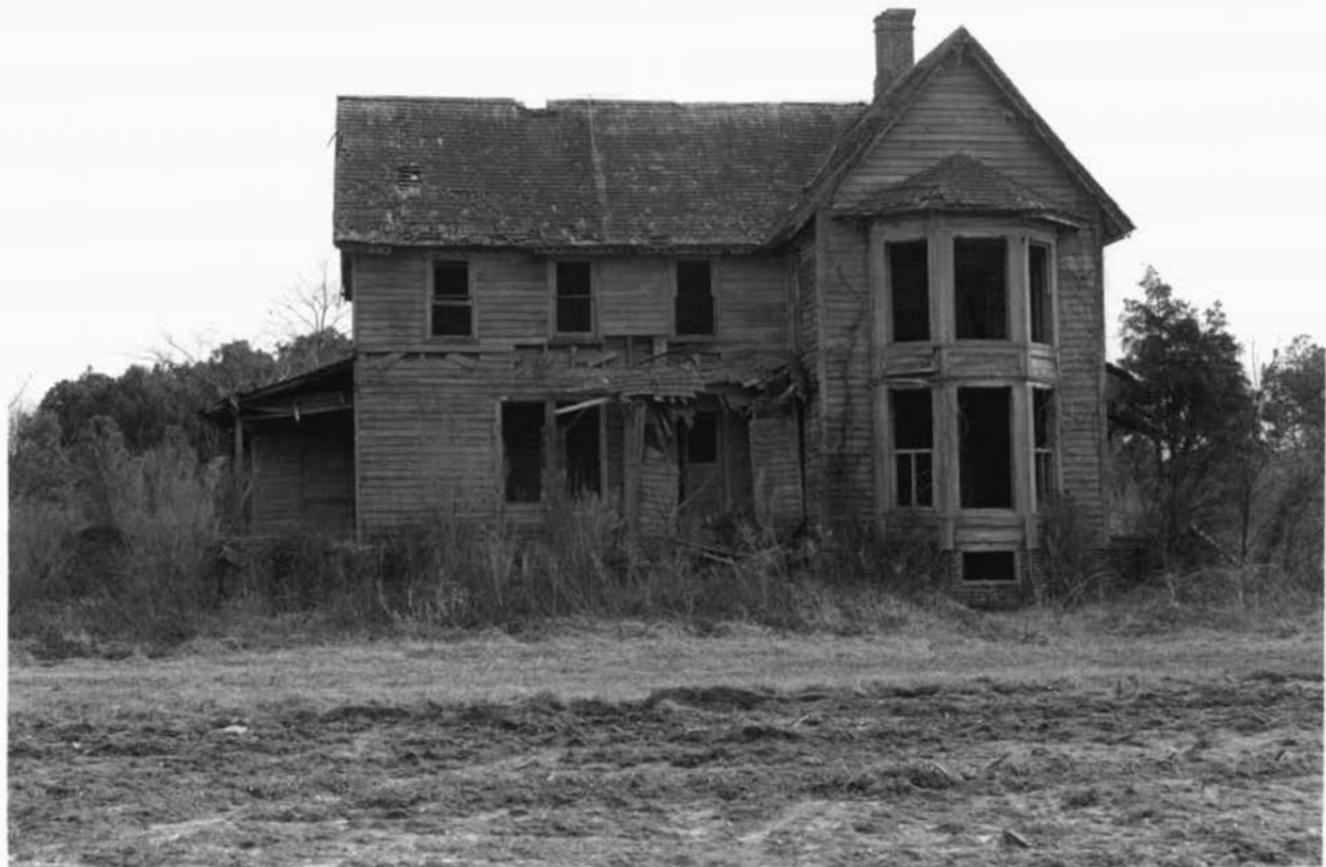
Rumbley Point Road House S-259
Near Marumscro, Somerset County
North Elevation
4/85, Photographer, Paul Touart
Neg./MD. Historical Trust

The north and south gable ends are essentially alike with a two-story semi-octagonal bay window. Three windows light each floor and are divided by flat panels at the second floor level. The eave is also trimmed with Victorian sawnwork.

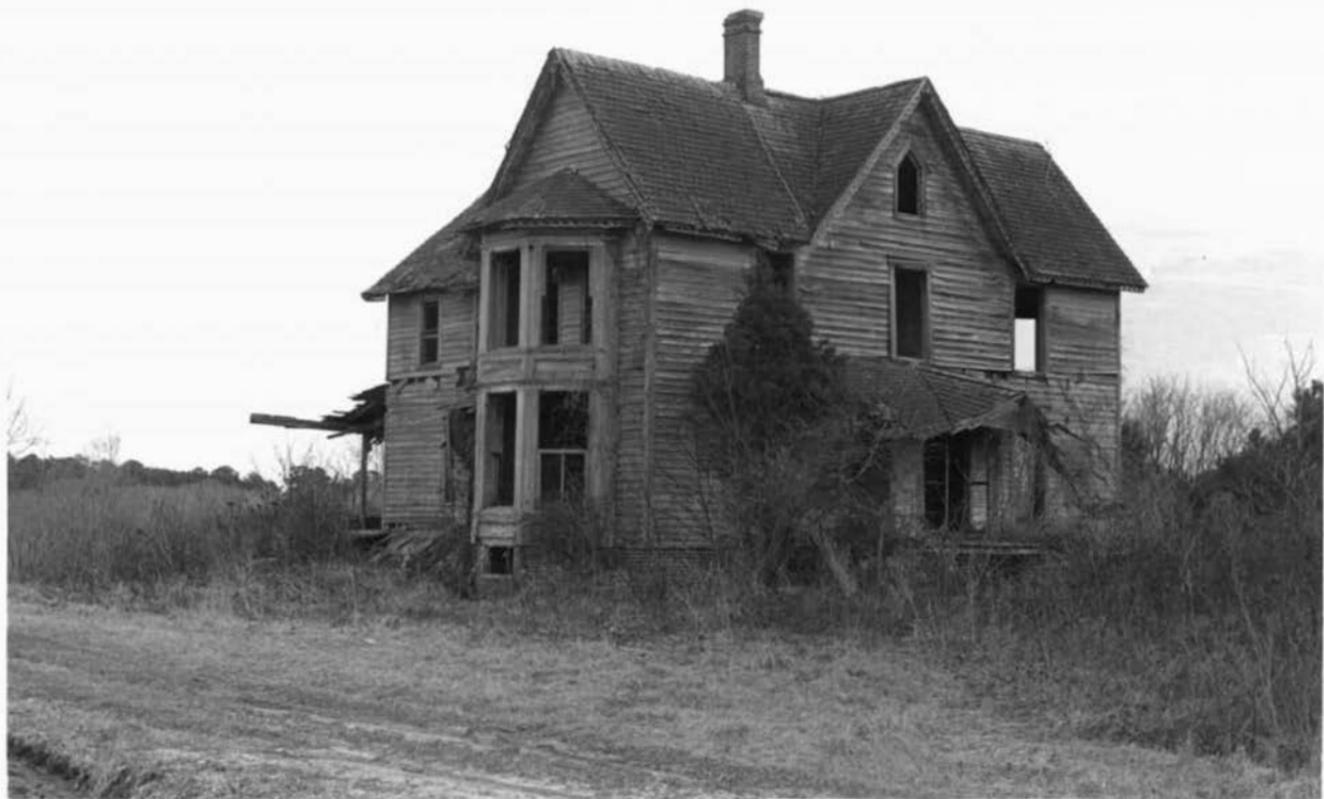
Rumbley Point Road House S-259
Near Marumscot, Somerset County
Northwest Elevation
4/85, Photographer, Paul Touart
Neg./MD. Historical Trust

Built c. 1900, the center hall frame house has reached an advanced state of deterioration. A raised common bond brick foundation supports the weatherboarded frame structure, which is covered by a steeply pitched wood shingle roof. A two-story service wing extends to the rear (east).

The west (main) elevation is symmetrically arranged with a center door and flanking window sash, Now all broken out. A collapsed shed porch formerly covered the first floor, while the second floor is lighted by three evenly spaced windows. The cross-gable is pierced by a pointed arch window. The eaves of the roof extend beyond the wall surface and are trimmed with Victorian sawnwork. Rising from the roof is a single corbelled cap brick chimney. The other stack on the south side has been leveled off.

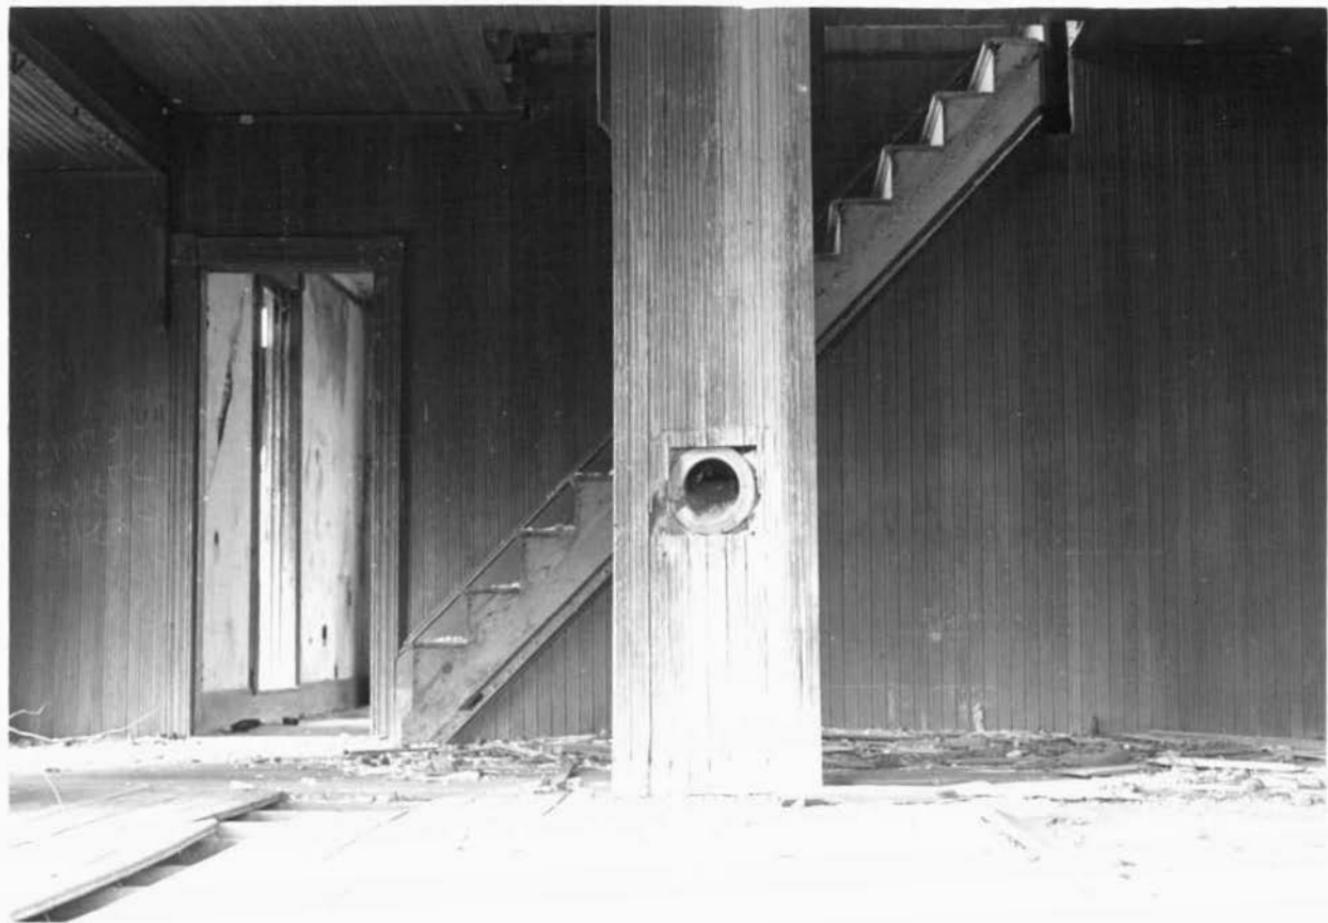
Rumbley Point Road House S-259
Near Marumscro, Somerset County
Parlor And Hall
4/85, Photographer, Paul Touart
Neg./MD. Historical Trust

The interior has been stripped of much of its decorative woodwork including spindled screens between the center hall and south room along with the newel post and balustrade. The south room does retain its narrow vertical board sheathing and a few fluted door surrounds with bulls-eye blocks. The brick stove stack is covered with narrow beaded board as well.

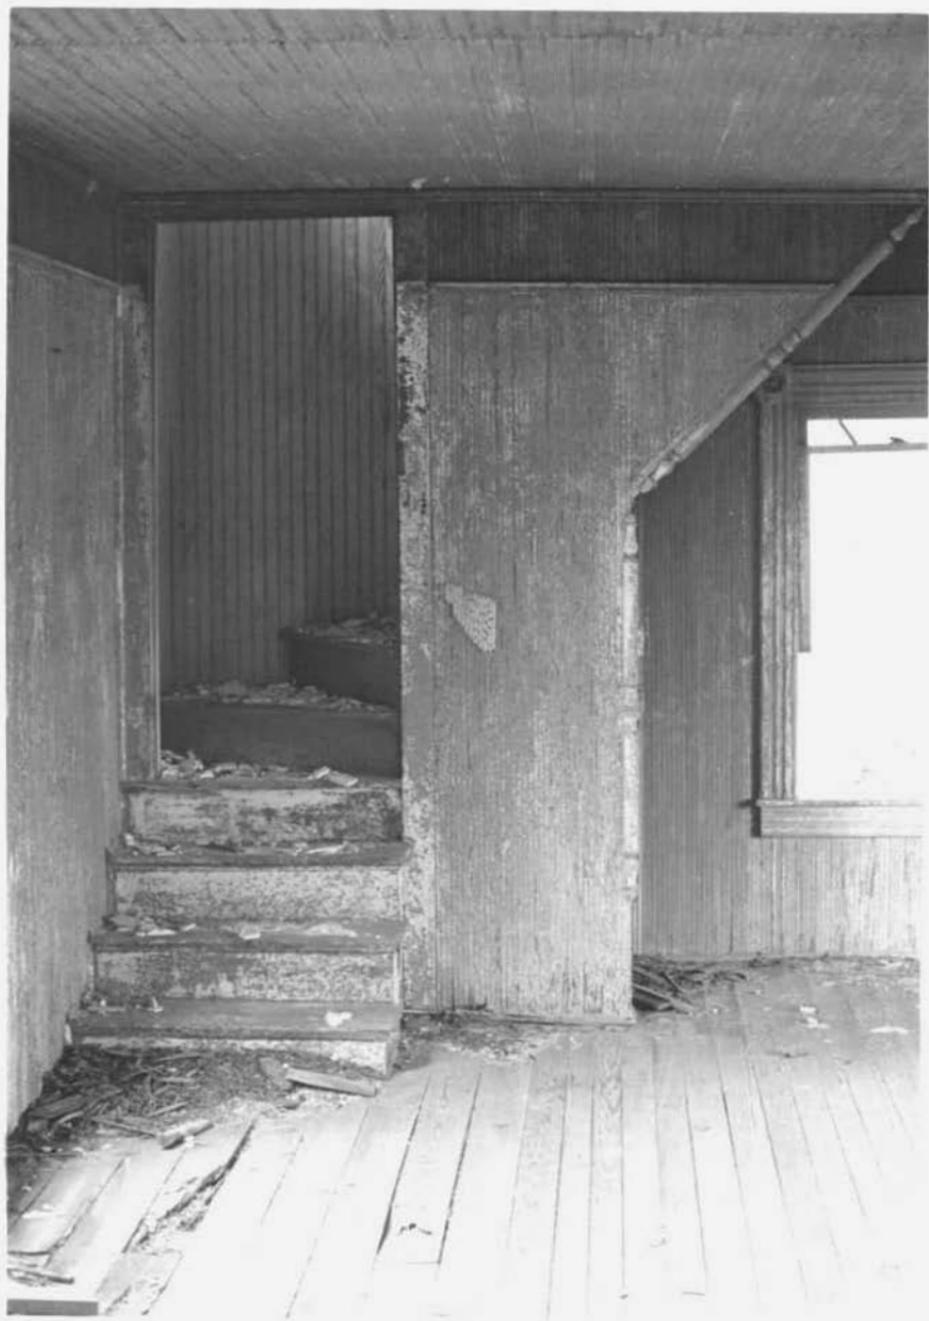
Rumbley Point Road House S-259
Near Marumscro, Somerset County
Kitchen Interior
4/85, Photographer, Paul Touart
Neg./MD. Historical Trust

The first floor of the service wing is one large rectangular room also sheathed with vertical beaded board. In the middle of the room, the brick stove stack rises through the ceiling and is encased with beaded board sheathing. An unusual decorative ceiling trim surrounds the stack. Fixed in the southeast corner is a built-in cupboard, and in the northeast corner the enclosed winder stair provides second floor access. The outside corners of the boxed stair are trimmed with turned spindles to

S-259
protect the corners from damage. The ceiling is also covered with beaded board. An unusual survival in this room is the paint scheme. White walls are contrasted with a narrow cornice and a bright yellow picture rail. The bulls-eye corner blocks are multi-colored.
