MARYLAND HISTORICAL TRUST
DETERMINATION OF ELIGIBILITY FORM

Property Name: Alfred Tull House Inventory Number: S-271
Address: East Side of Tulls Corner Road. Vicinity of Tulls Corner. Historic district: ___ yes no
City: Marion Zip Code: 21838 County: Somerset
USGS Quadrangle(s): Marion
Property Owner: Private Tax Account ID Number: Unknown
Tax Map Parcel Number(s): Unknown Tax Map Number: Unknown
Project: Proposed Tower Site: Marion, Somerset County, Maryland Agency: Maryland Dept. of Budget and Management
Agency Prepared By: A.D. Marble & Company
Preparer's Name: Stephanie Foell and Stacey Streett Date Prepared: 3/21/2005
Documentation is presented in: Proposed Tower Site: Marion, Somerset County, Maryland
Preparer's Eligibility Recommendation: ___ Eligibility recommended Eligibility not recommended
Criteria: ___ A ___ B ___ C ___ D Considerations: ___ A ___ B ___ C ___ D ___ E ___ F ___ G
Complete if the property is a contributing or non-contributing resource to a NR district/property:

The Alfred Tull House (S-271) is located on the east side of Tulls Corner Road, in the vicinity of Tulls Corner crossroads. The building faces west and it is oriented on a north-south axis. It wa

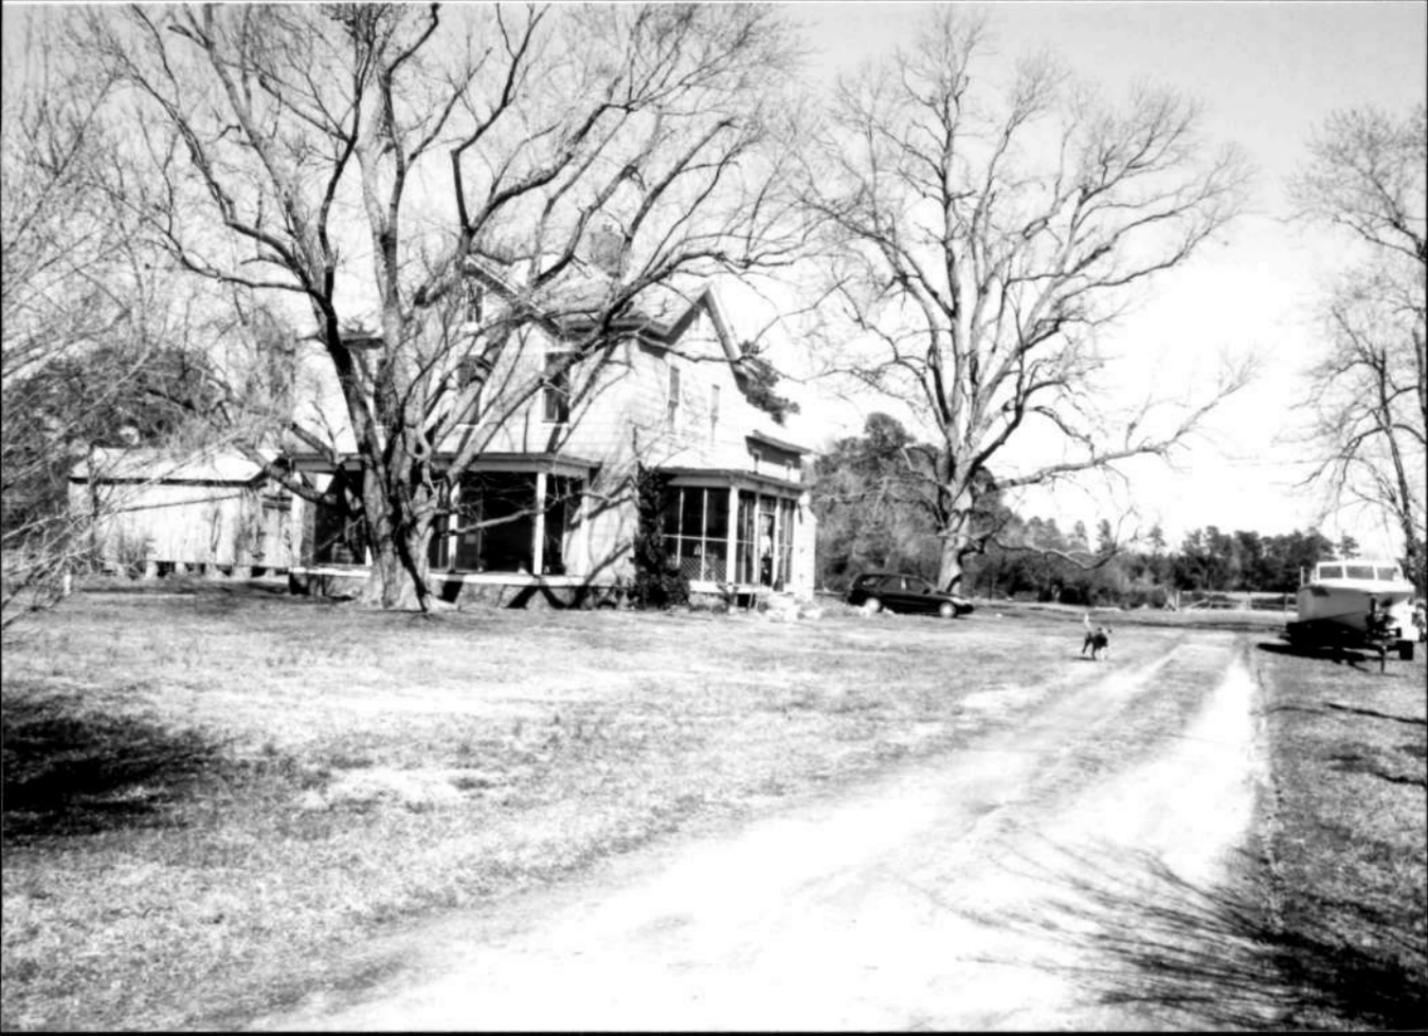
1/3

Overview of property, taken from east side of
Tulls Corner Rd.

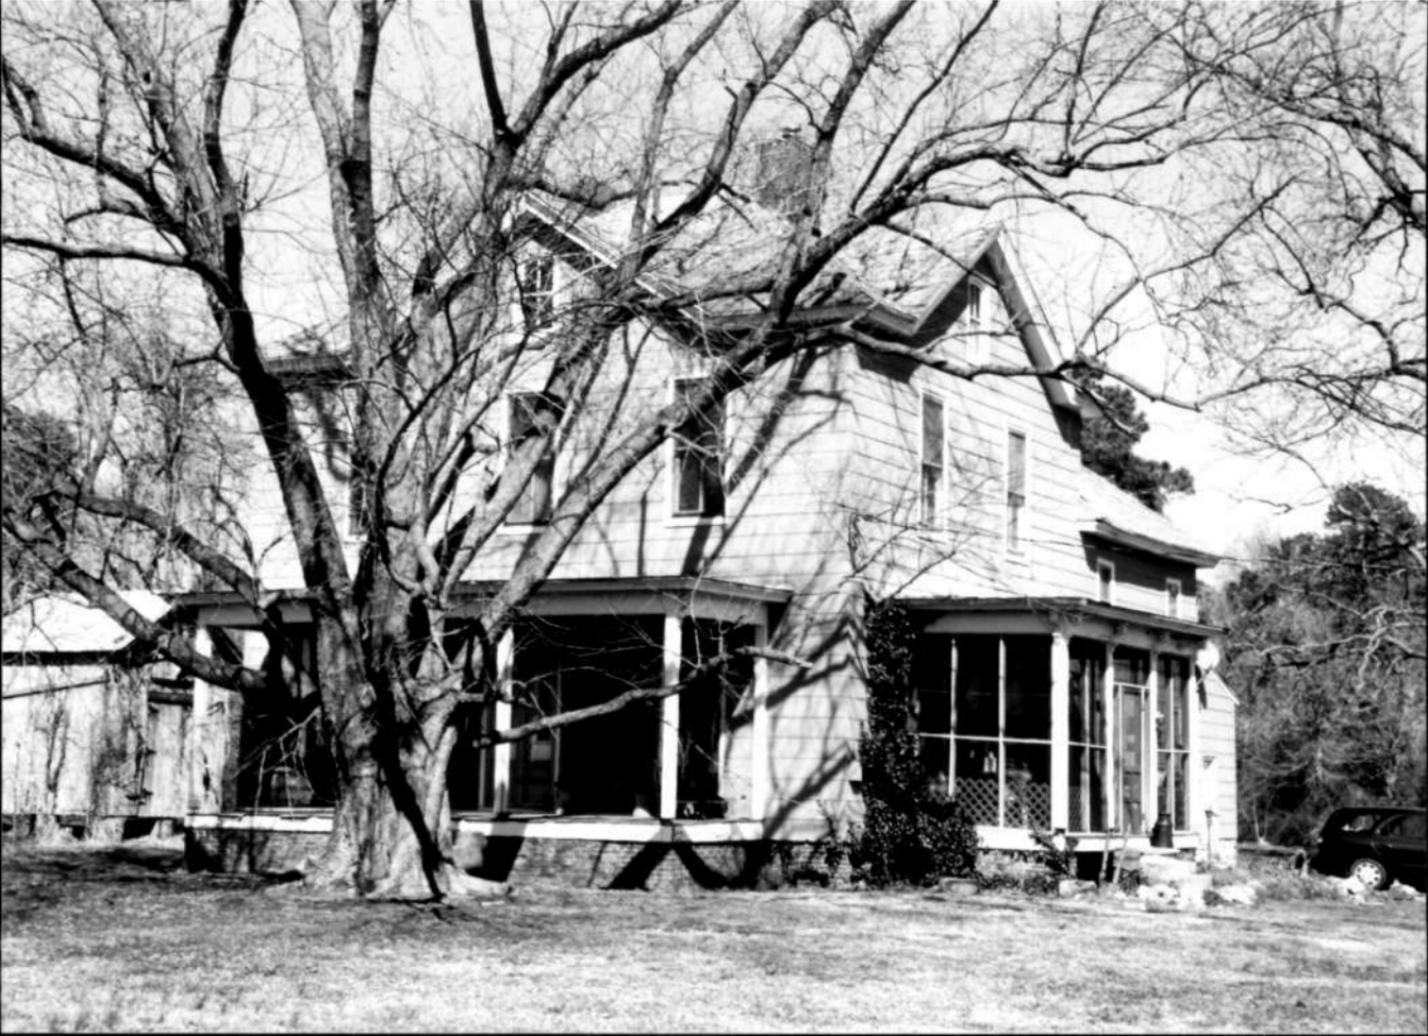
2/3

The appearance of the porches has been altered since the Alfred Tull House was first surveyed in 1987 (MIHP Form S-271). At that time, the craftsmanship of the decorative sawnwork and brackets was a prominent feature of the porches. The main entrance is in the center of the façade on the first story, and side entrances are located on the south elevation.

Southwest corner, view of porch from
east side of Tull's Corner Rd.

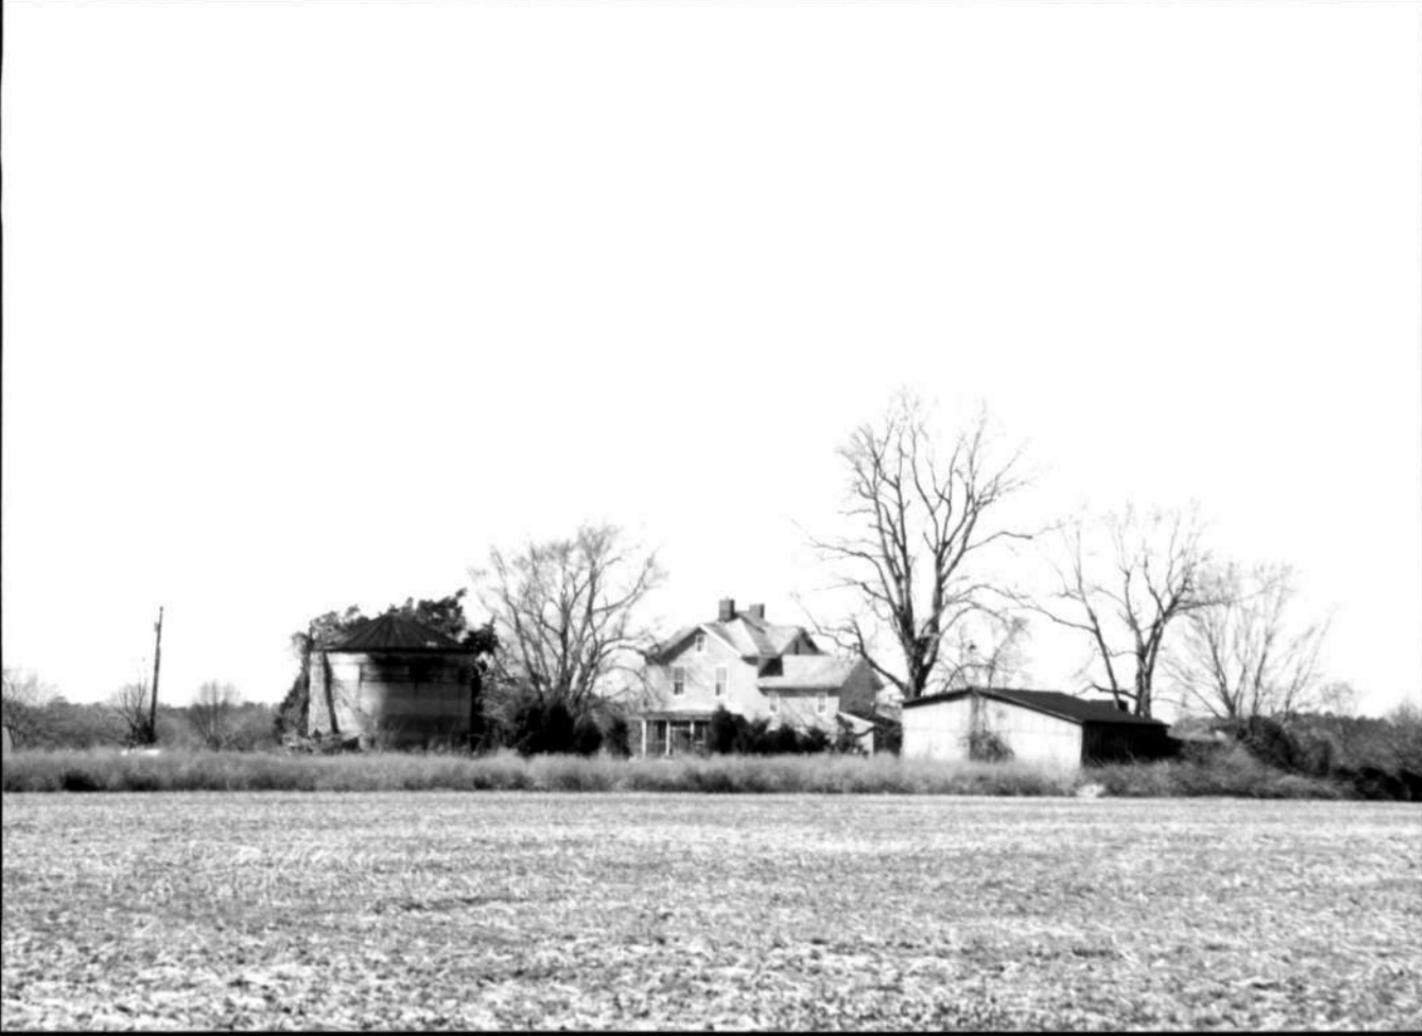
3/3

South elevation, taken from
the north side of Whittington Rd.

The south elevation is a two-bay facade with a side entrance squeezed between the two first floor windows. The second floor and attic are lighted by identical windows, and the same Victorian porch stretches across the first floor.

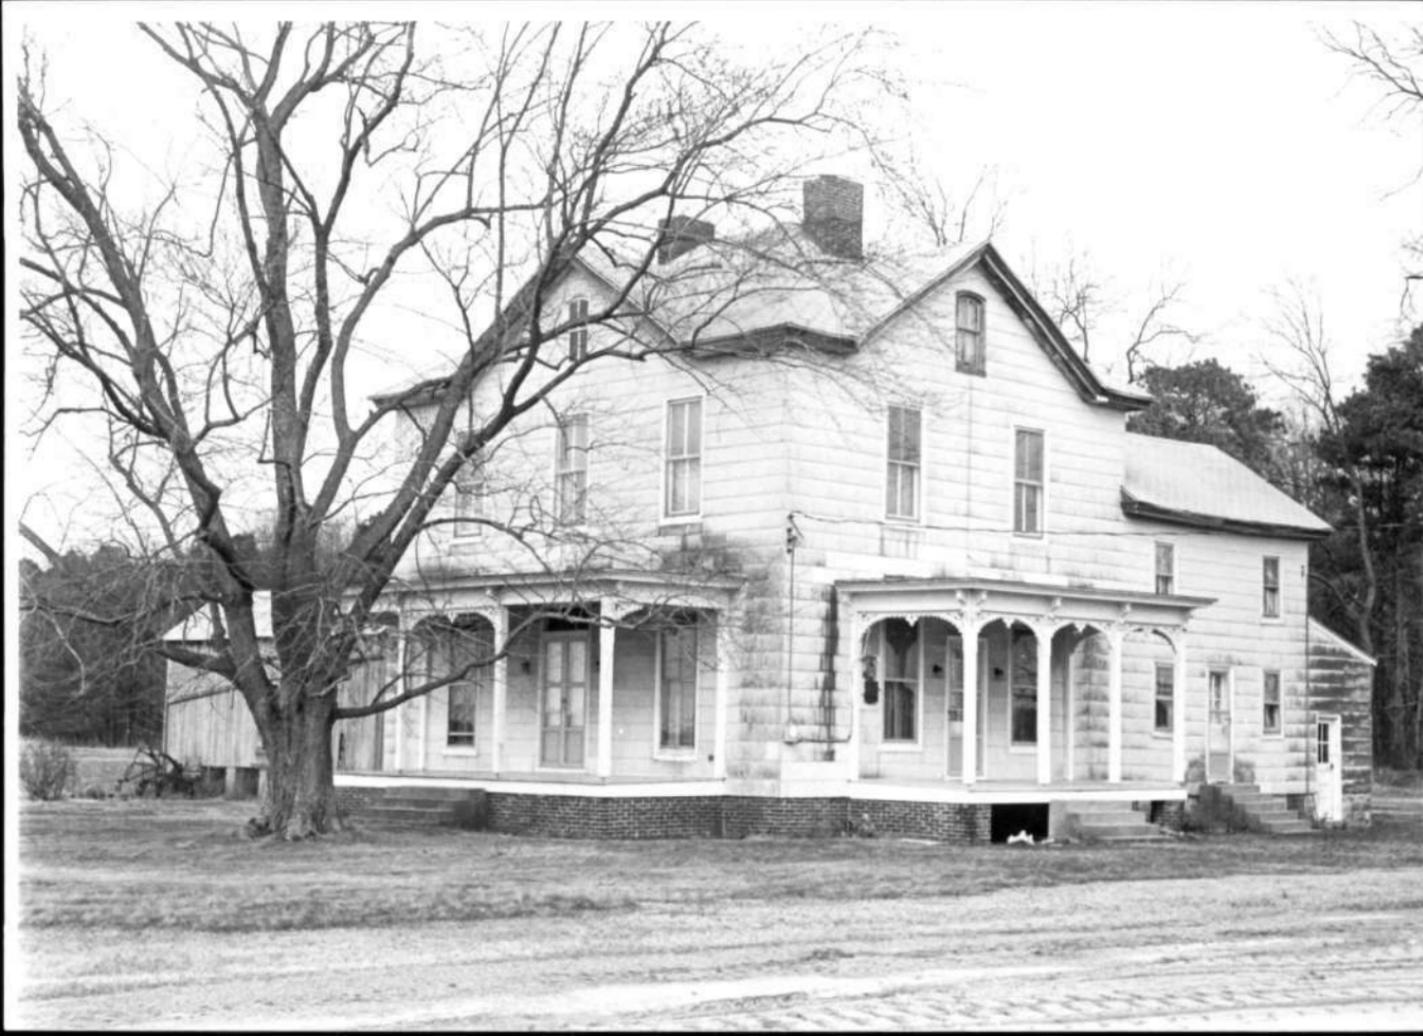
S-271

The west (main) elevation is a symmetrical three-bay facade with a center heavily molded double door topped by a two-light transom. The first and second floors are lighted by two over two sash windows, and the front gable is pierced by a two over two sash with a slightly arched header. The first floor is covered by a flat-roofed porch supported by chamfered posts and decorated with sawnwork and brackets. A pair of brick chimneys rises from the central portion of the house while flanking the stair hall.

Southwest Elevation

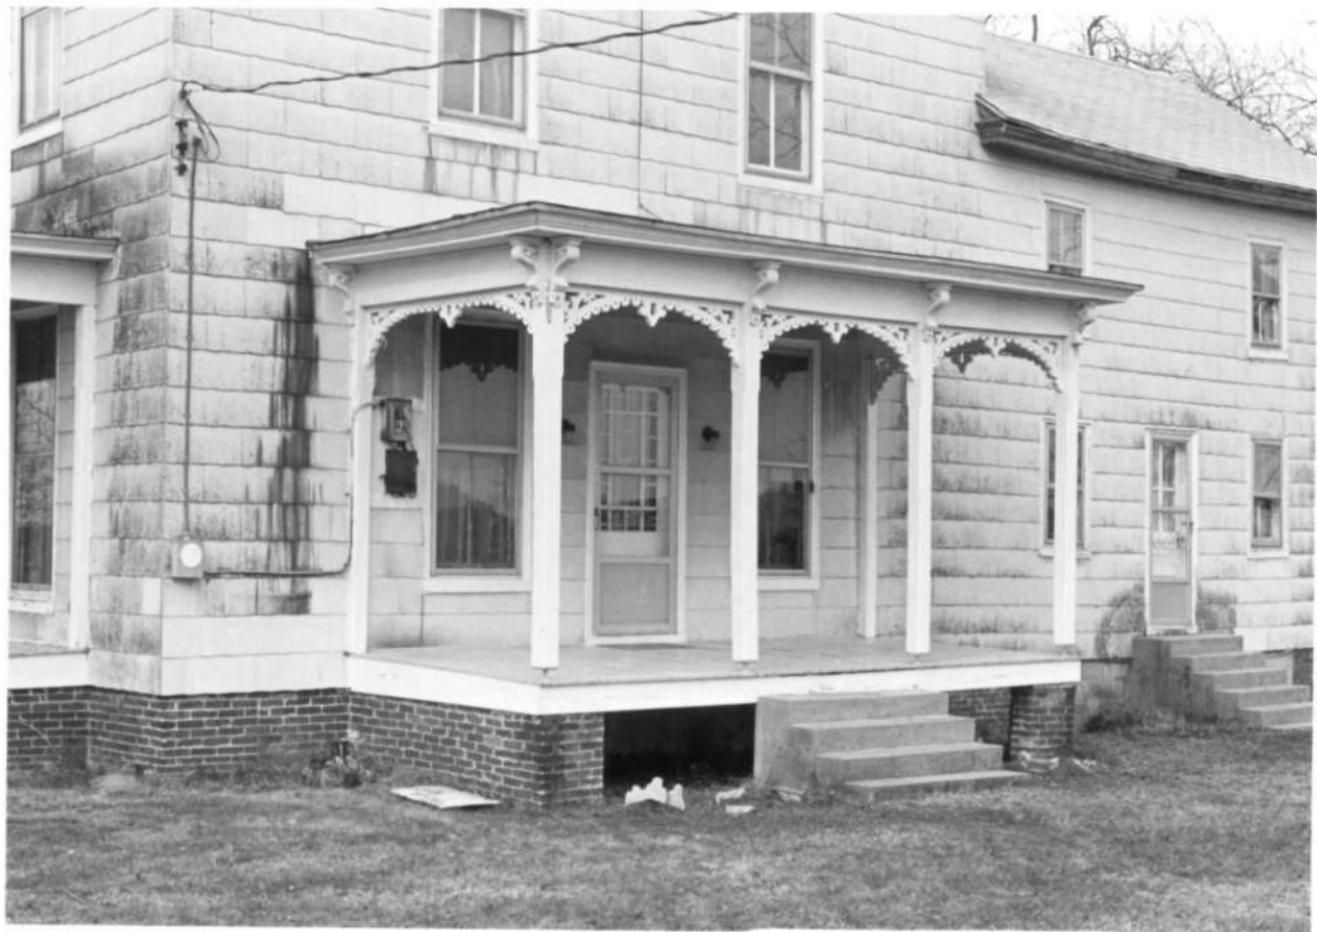
S-271

South Porch

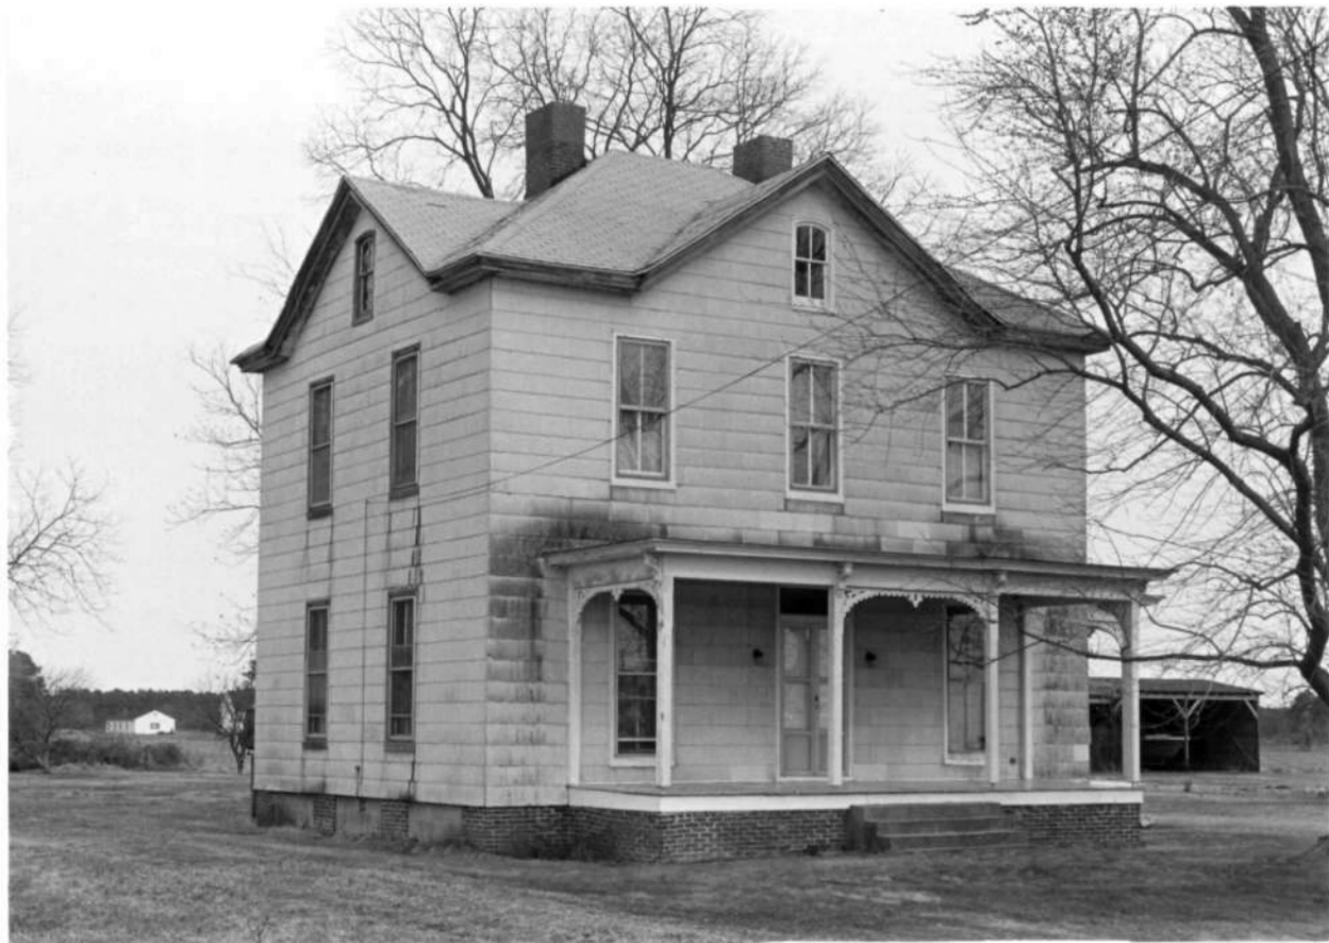
S-271

The north end of the main house has two 2/2 sash windows on each floor and a single 2/2 attic light with an arched header.

Northwest Elevation
