S-276
Old Whittington Farm
Marion vicinity
private

State Historic Sites Inventory Form

historic Old Whittington Farm

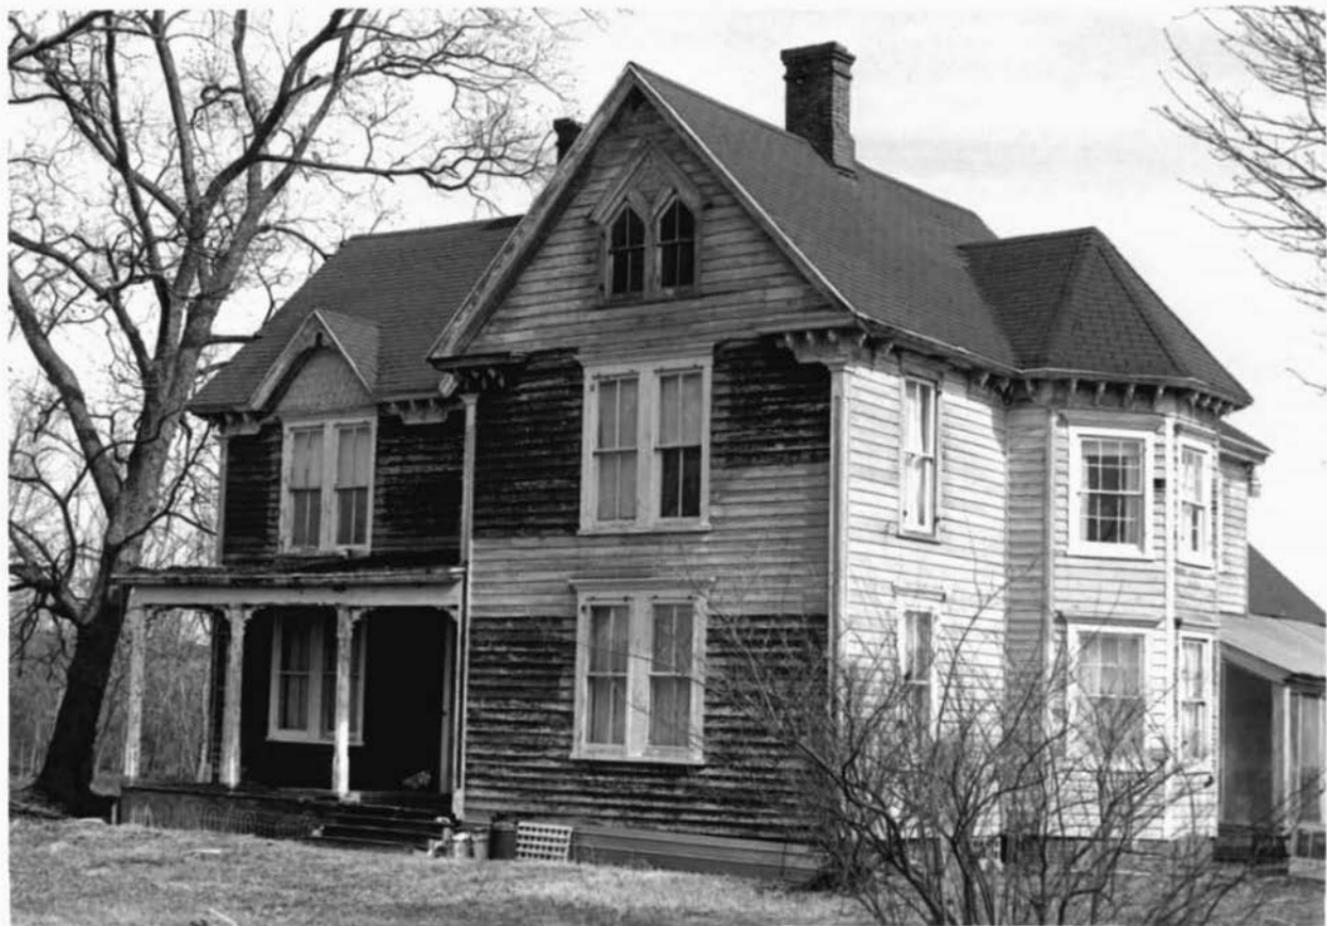
Old Whittington Farm S-276
Near St. Paul's Church, Somerset Co.
Southwest Elevation
4/85, Photographer, Paul Touart
Neg./MD. Historical Trust

The west (main) elevation is an asymmetrical three-bay facade with a recessed entrance wall. The front twelve-panel door is framed by a colored-glass multi-pane transom and colored glass sidelights. Raised panels are found below each sidelight. The adjacent (north) bay is filled with a paired 2/2 sash window, and the first floor is covered by a hip roofed porch. Chamfered posts are embellished with corner brackets.

The second floor is lighted by a paired window over the first floor pair and a single 2/2 sash over the entrance bay. Both windows have a gable roof covering that interrupts the cornice. The gable fronts are covered with fishscale shingles. Brackets trim the eaves, and corner pilasters mark the principal corners of the house.

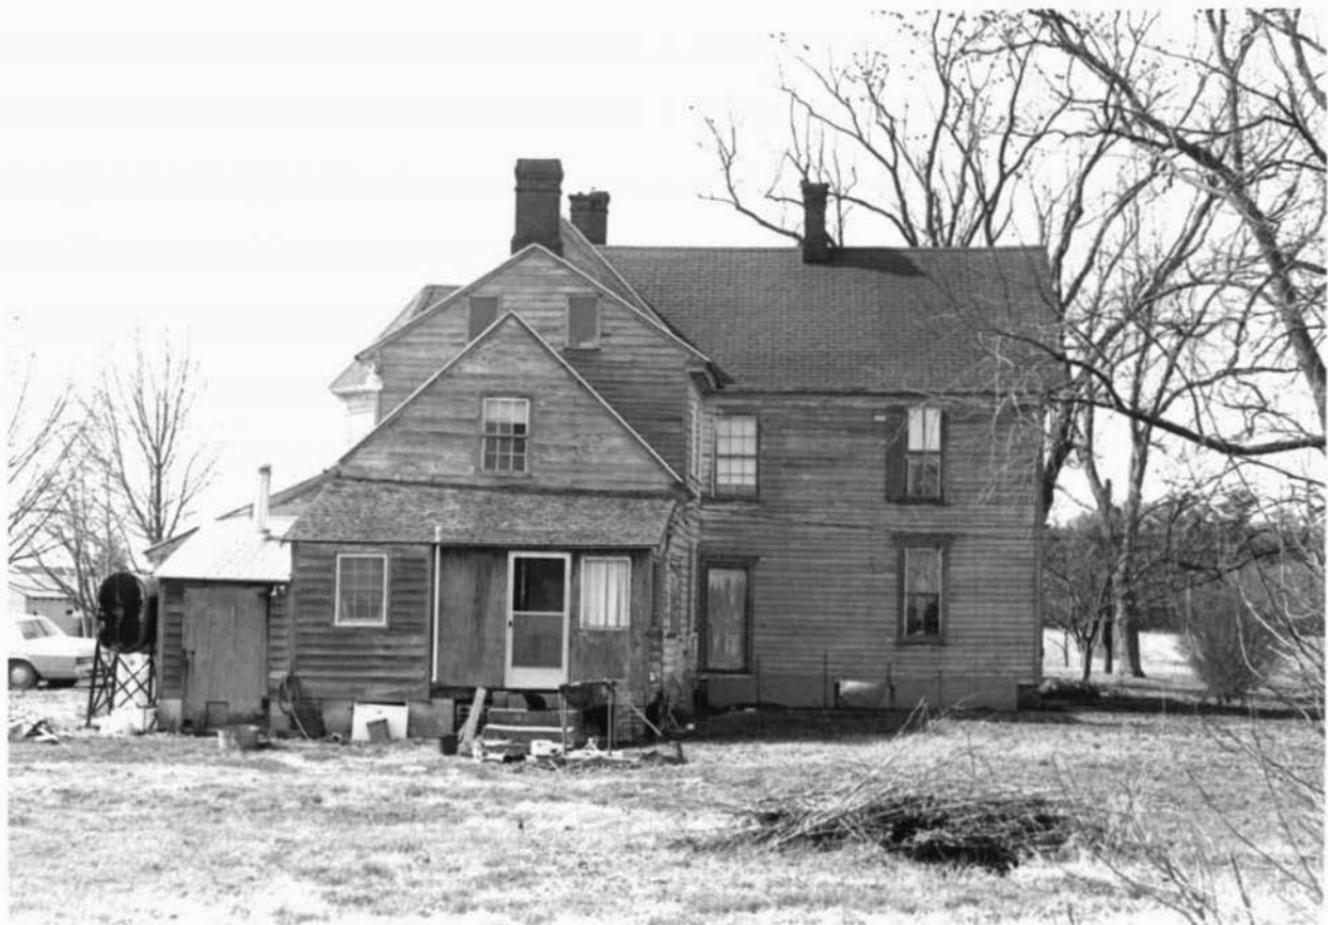
Old Whittington Farm S-276
Near St. Paul's Church, Somerset Co.
East Elevation
4/85, Photographer, Paul Touart
Neg./MD. Historical Trust

An interior end brick chimney rises from the gable. Stretching across the first floor is a single-story shed roofed porch that extends across the kitchen wing as well. The kitchen is also finished in a plain manner with a board soffit under the eave, flush gable ends and 6/6 sash windows. A board and batten door opens from the porch into the one-room plan kitchen. A shed roofed addition extends from the east end of the kitchen, and a 6/6 sash fills the upper gable.

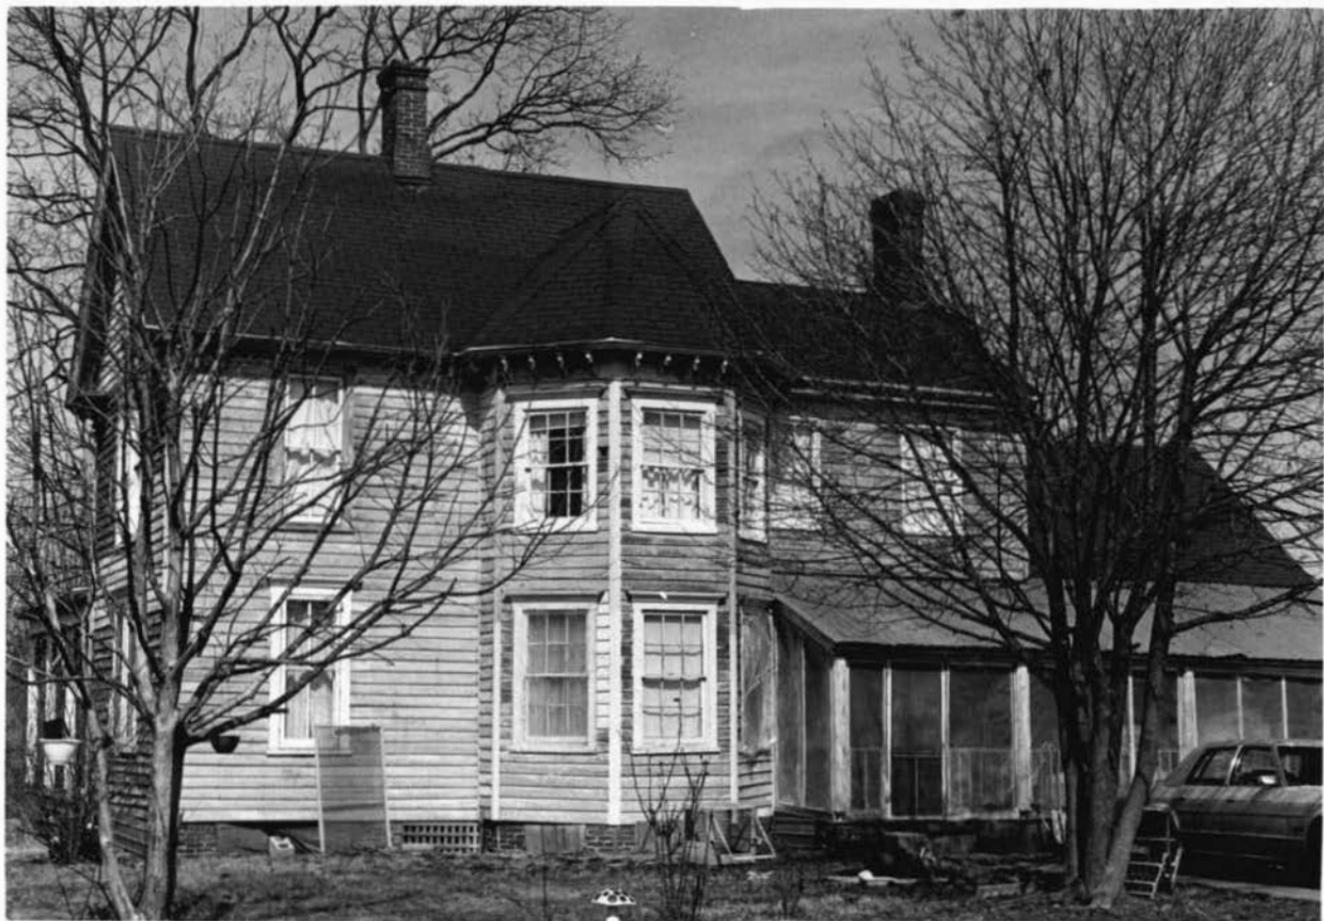
Old Whittington Farm S-276
Near St. Paul's Church, Somerset Co.
South Elevation
4/85, Photographer, Paul Touart
Neg./MD. Historical Trust

The south two-bay elevation of the front section is dominated by a two-story five-sided bay on the southeast corner. Three 6/6 sash windows pierce each floor of the bay, while 2/2 sash windows fill the west bays on each floor. Eave brackets continue around the south side of the house.

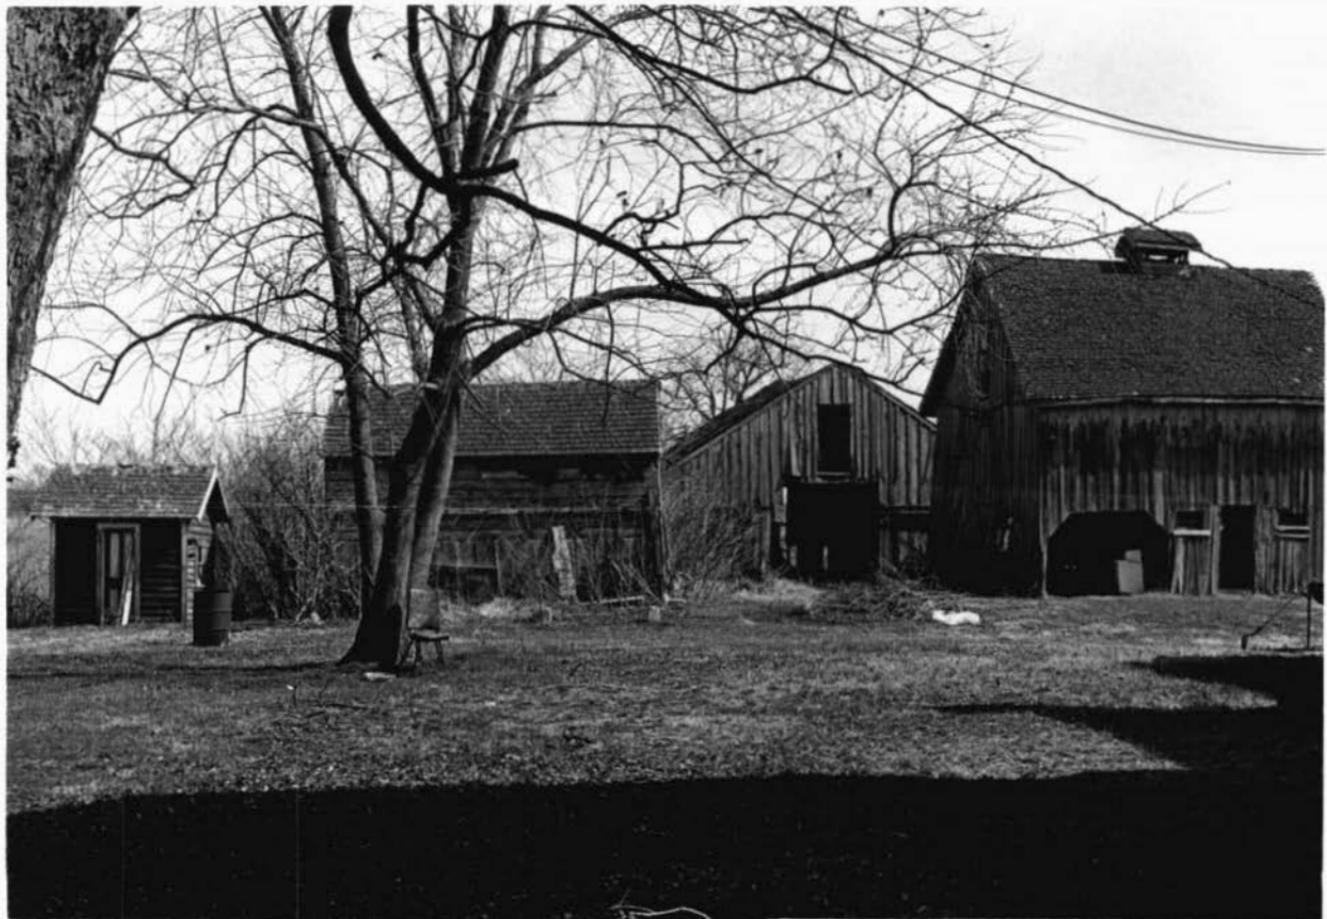
Old Whittington Farm S-276
Near St. Paul's Church, Somerset Co
Farmyard from west
4/85, Photographer, Paul Touart
Neg./MD. Historical Trust

Located north and east of the house is a small group of farm buildings. The oldest of the four structures are a mortise and tenon frame granary and a mortise and tenon frame corn crib. The gable front barn is sheathed with board and batten siding and covered by a medium pitched corrugated tin roof. The barn has a center drive-through with aisles to each side. A floor was formerly located in the center passage but has been removed. The mortise and tenon frame structure has cut-nails.

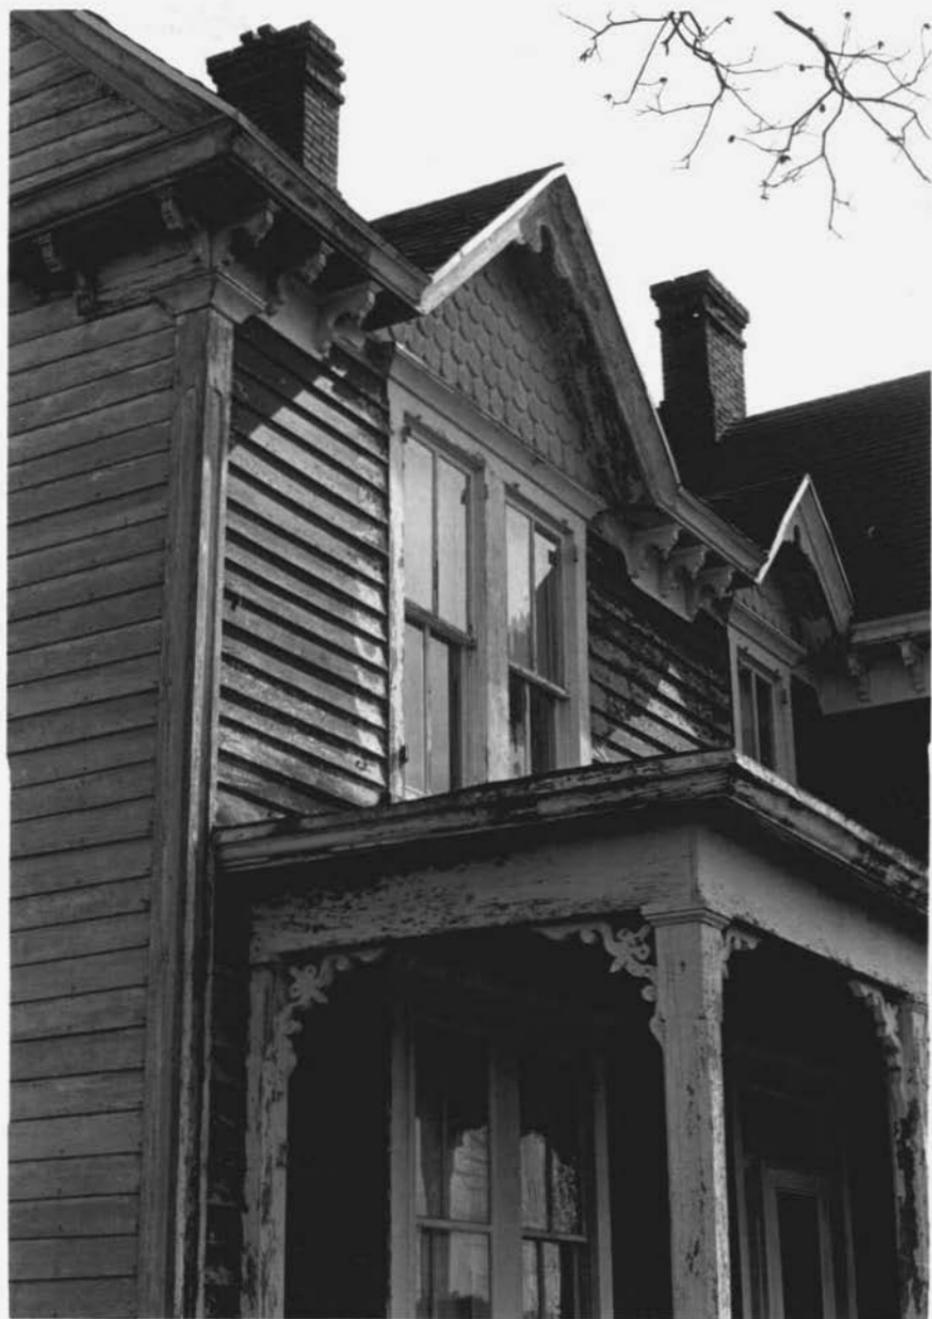
Old Whittington Farm S-276
Near St. Paul's Church, Somerset Co.
Eave Detail
4/85, Photographer, Paul Touart
Neg./MD. Historical Trust

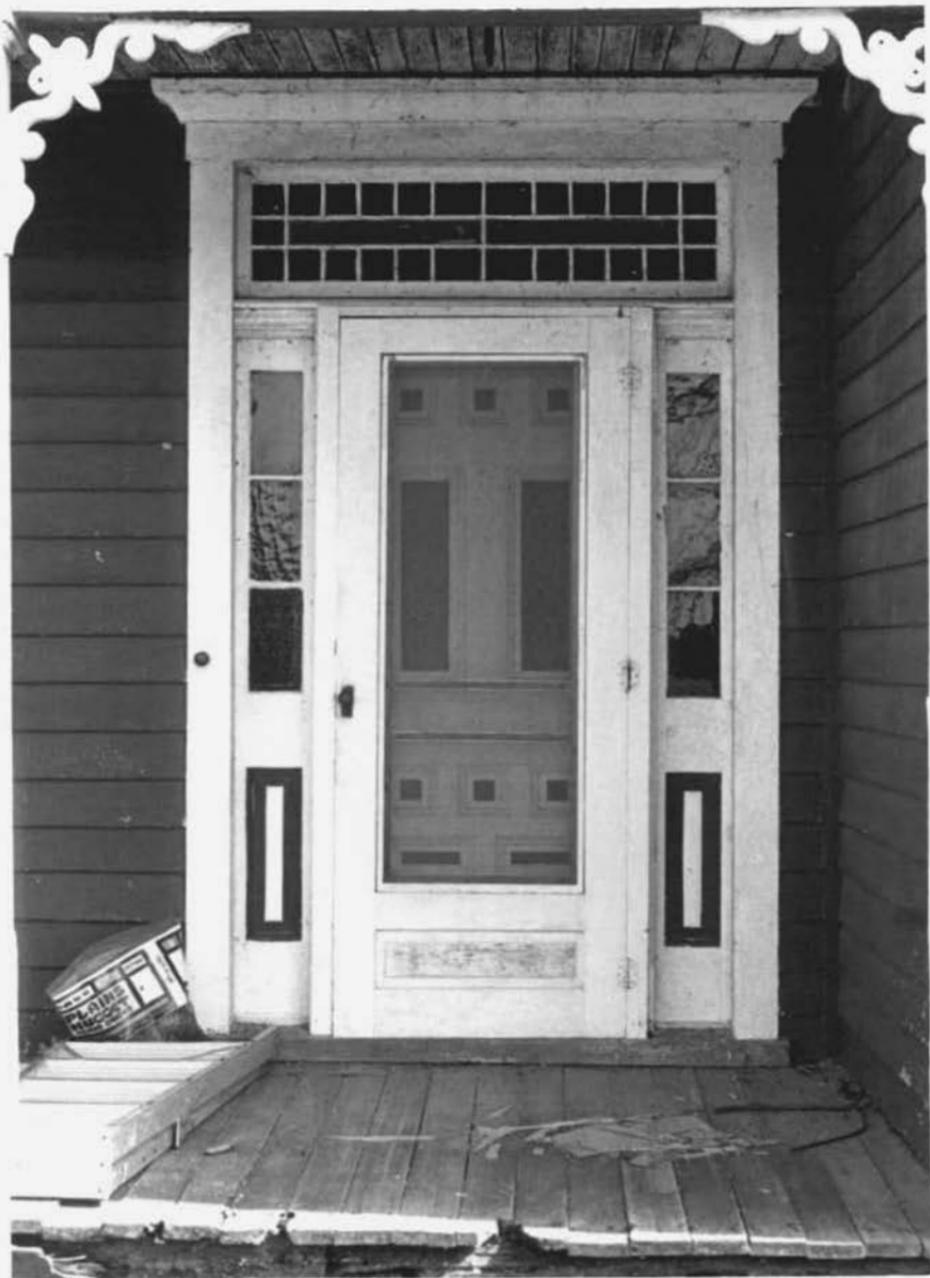
Old Whittington Farm S-276
Near St. Paul's Church, Somerset Co.
Entrance
4/85, Photographer, Paul Touart
Neg./MD. Historical Trust

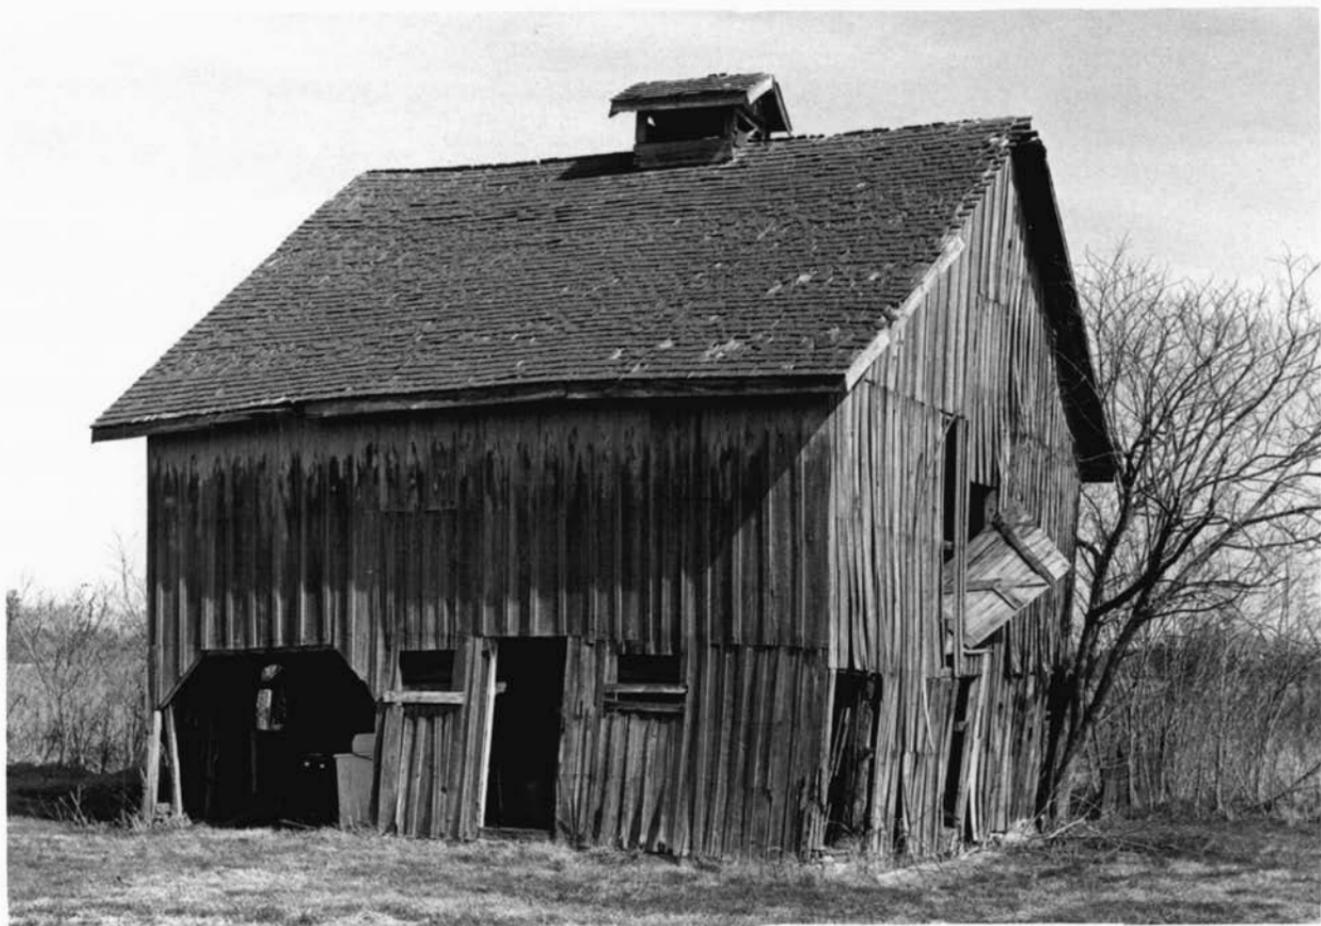
Old Whittington Farm S-276
Near St. Paul's Church, Somerset County
Southwest Elevation of Barn
3/84, Photographer, Paul Touart
Neg/Md. Historical Trust

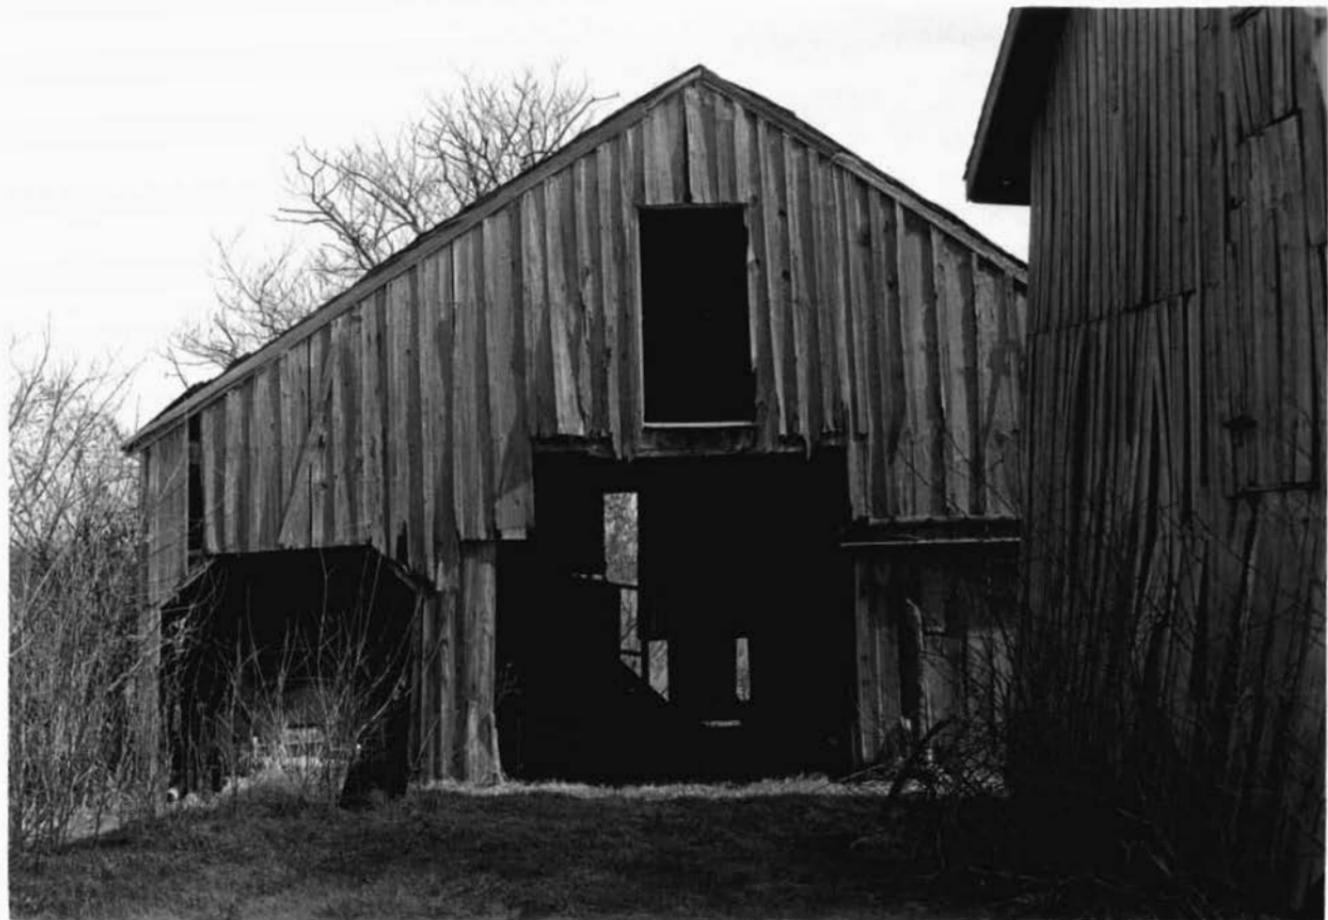
Old Whittington Farm S-276
Near St. Paul's Church, Somerset County
West Elevation of Barn
3/84, Photographer, Paul Touart
Neg./Md. Historical Trust

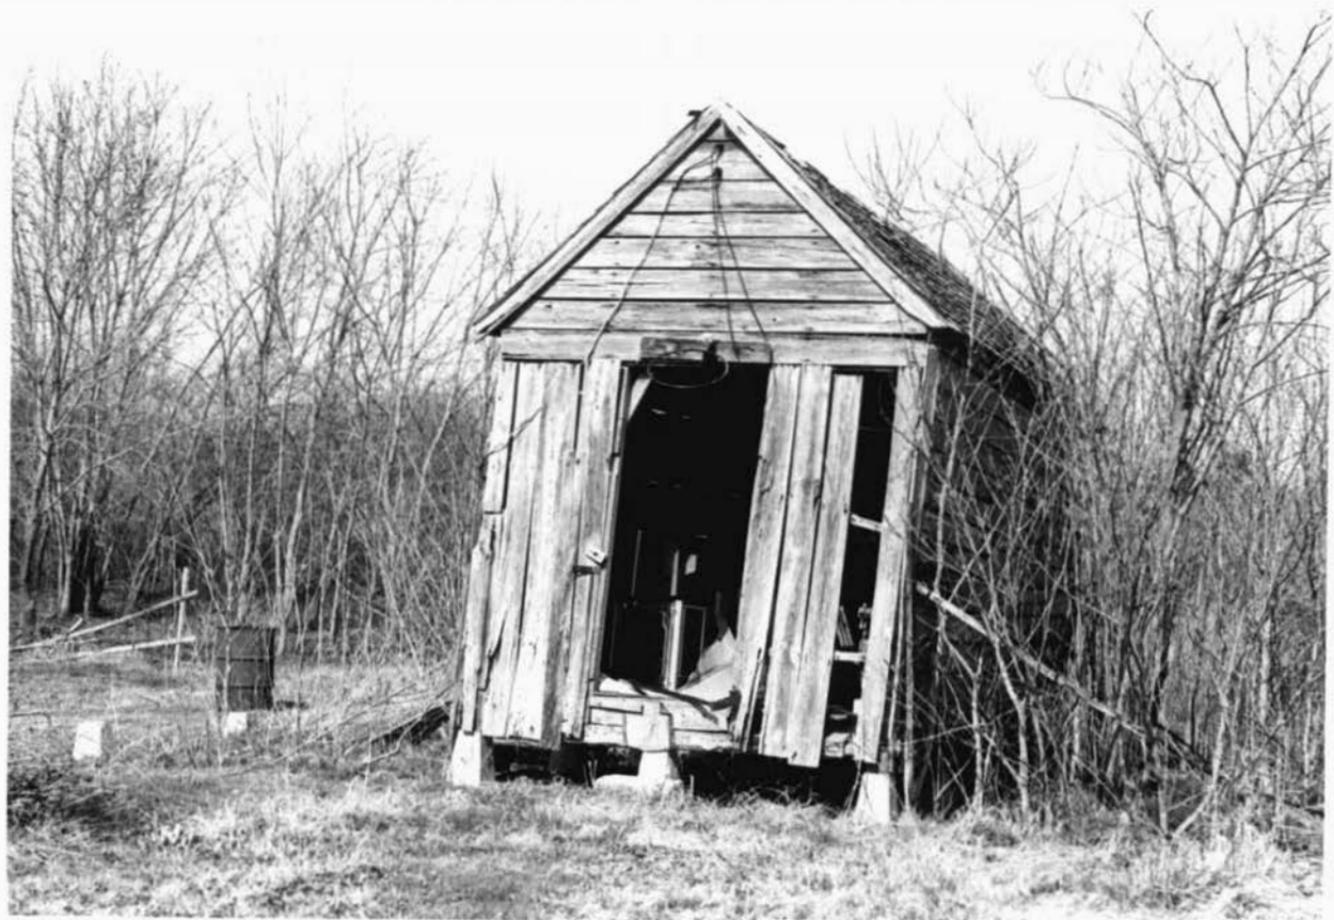
Old Whittington Farm S-276
Near St. Paul's Church, Somerset Co.
Corn Crib
4/85, Photographer, Paul Touart
Neg./MD. Historical Trust

The corn crib is a single-pen mortise and tenon frame structure with some pit-sawn horizontal slats in place. The structure is covered by a steeply pitched wood shingle roof supported by a common rafter system. The pear joint is of mortise and tenon pinned construction.
