S-279  
Old Bradshaw Place  
Marion vicinity  
private

# Maryland Historical Trust State Historic Sites Inventory Form

historic Old Bradshaw House

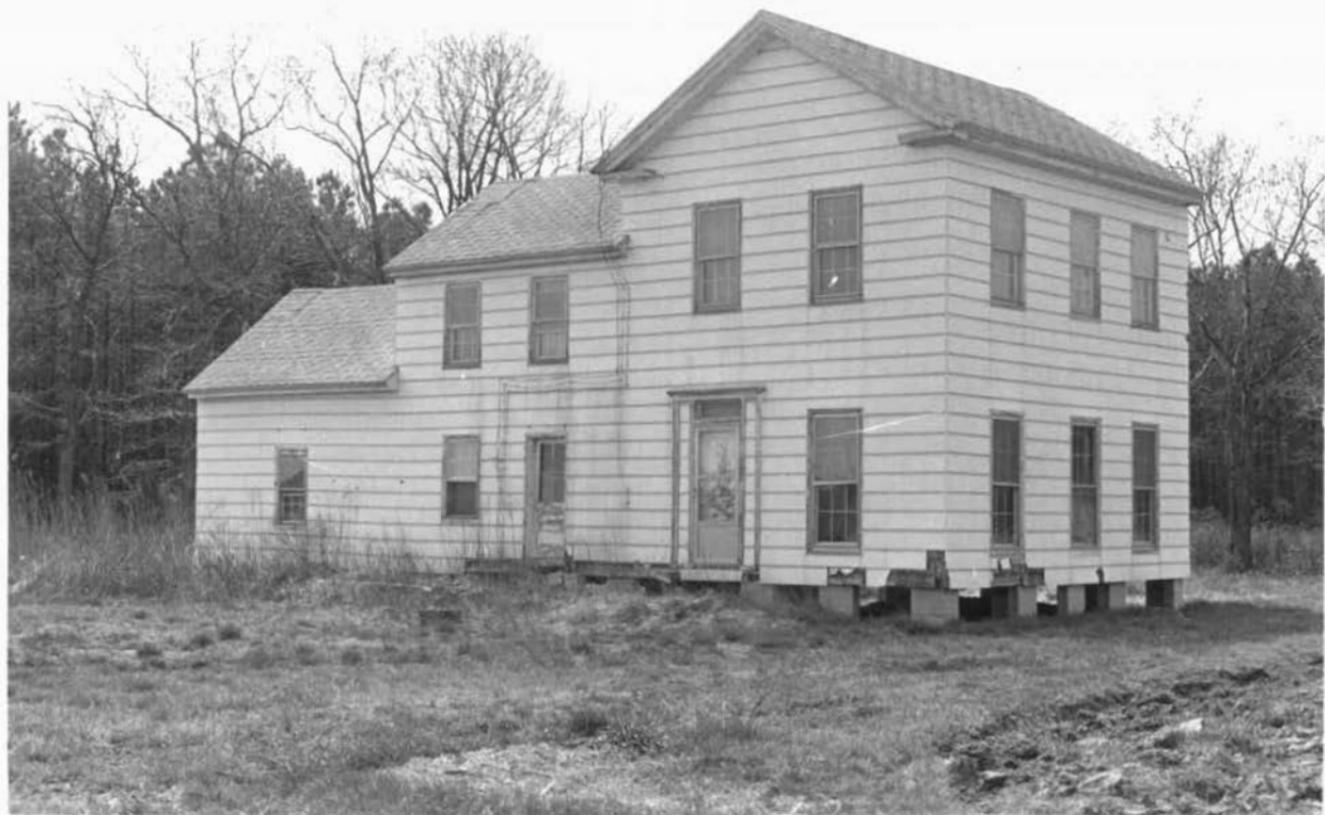
S-279

The main block is a gable-front structure laid out with a transverse hall and a parlor behind it. The two-bay principal elevation has a sidelighted front entrance with a heavily molded four-panel door. The sidelights have been covered, but the transom remains exposed. To the right is a six over six sash window, while the second floor is pierced by a pair of six over six sash windows. The shutters have been removed.

Old Bradshaw House  
Near Marion, Somerset County  
Northeast Elevation  
4/84, Paul Touart, Photographer  
Neg./MD Historical Trust
