S-281
William J. Coulbourn Farm
Hopewell vicinity
private

Maryland Historical Trust State Historic Sites Inventory Form

historic William J. Coulbourn Farm

Survey No. S-281

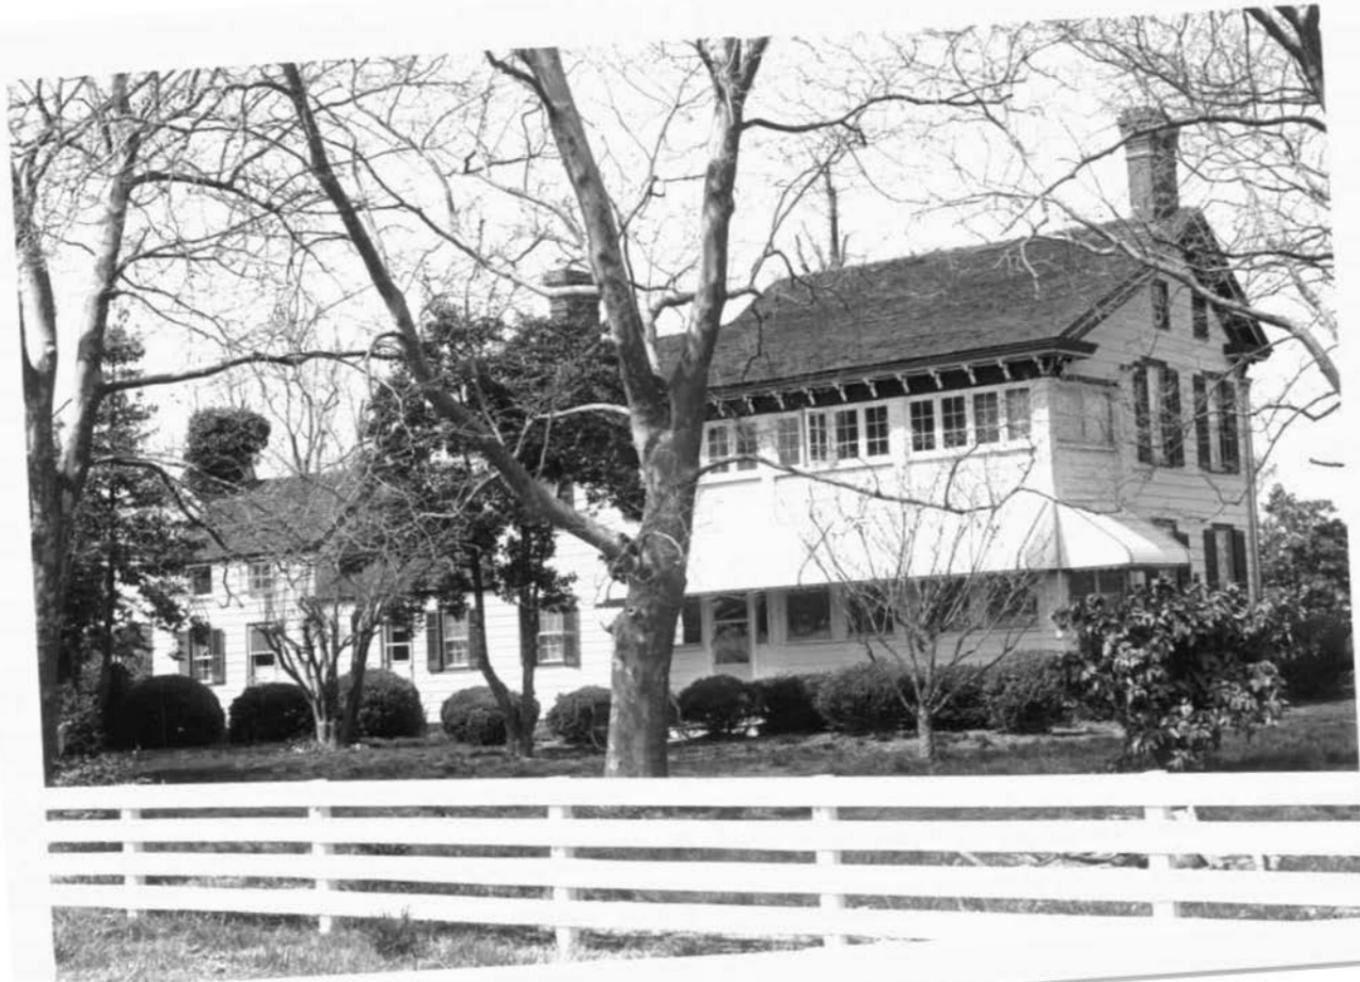
S-281

The east elevation is a nine-bay facade divided into four parts. The main block is three bays across, and it is covered by an enclosed two-story porch. The porch roof is a continuation of the main roof slope; the corners are marked with paneled pilasters, and the eaves are bracketed. The front wall of the house, now enclosed behind the porch wall, has an entrance in the south (left) bay. The paneled front door is topped by a criss-crossed muntin transom. Six over six sash windows fill the adjacent two bays. The second floor is divided into three bays with a second floor porch door in the south bay and two six over six sash to the north.

Near Marion, Somerset County
East Elevation

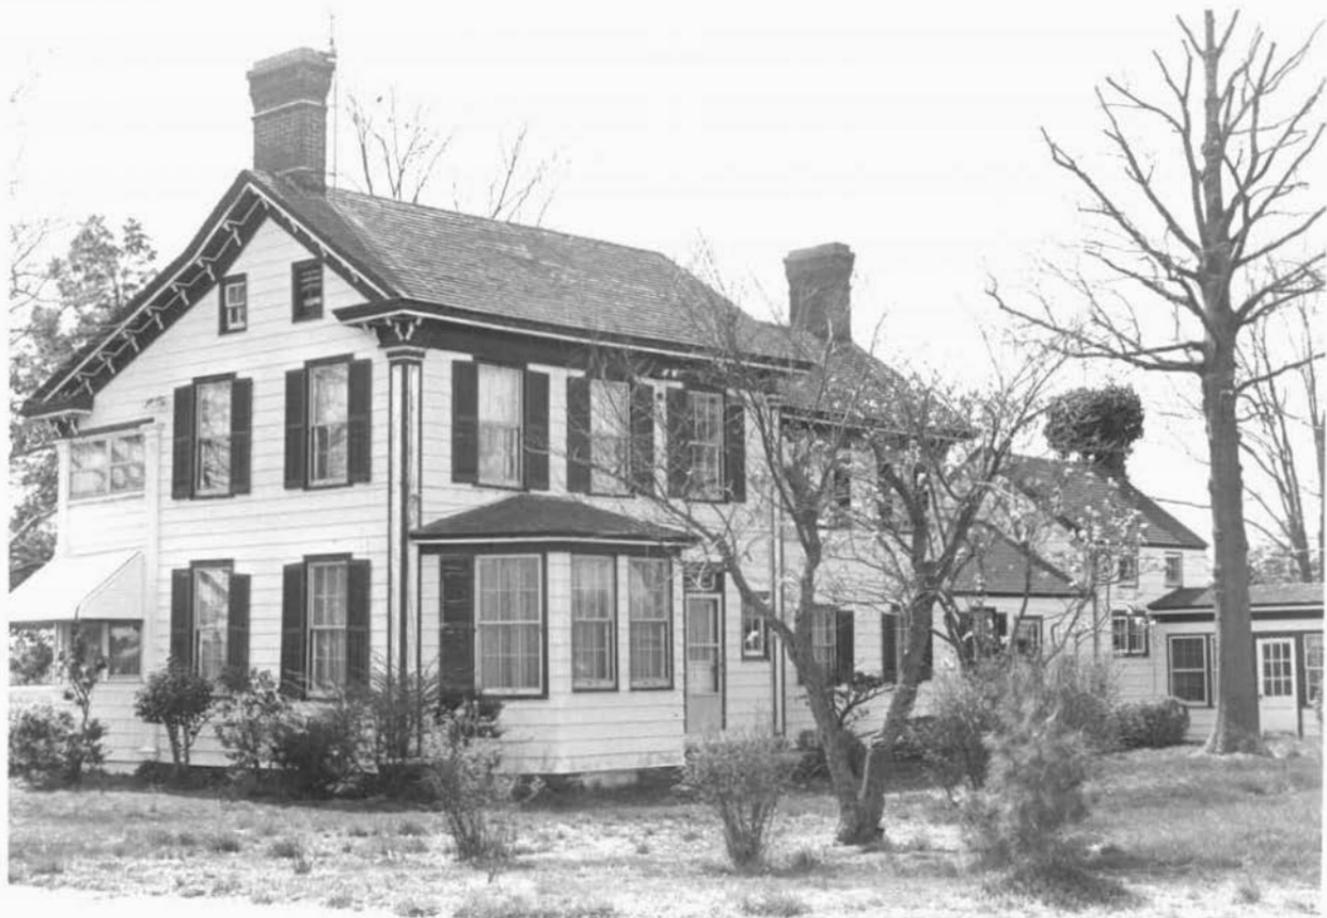
S-281

The north gable end of the main house is a symmetrical elevation with six over six sash on each floor flanked by louvered shutters. A pair of 2/2 attic sash flank the interior end brick chimney, which is finished with a corbelled cap.

The west (rear elevation has a three-sided bay window that lights the first floor with six over six sash windows. A back entrance to the hall has a partially glazed door and a criss-crossed muntin transom. A side six-pane window lights a small bath-room below the stair. The second floor is evenly divided into three bays with six over six sash windows and louvered shutters.

Coulbourn Farm
Near Marion, Somerset County
Northwest Elevation
Photographer-Paul Touart 4/85
Neg/Md. Hist. Trust
