S-300
Eastern Shore National Bank
Crisfield
public

Maryland Historical Trust State Historic Sites Inventory Form

historic Bank of Crisfield

and/or common Eastern Shore National Bank

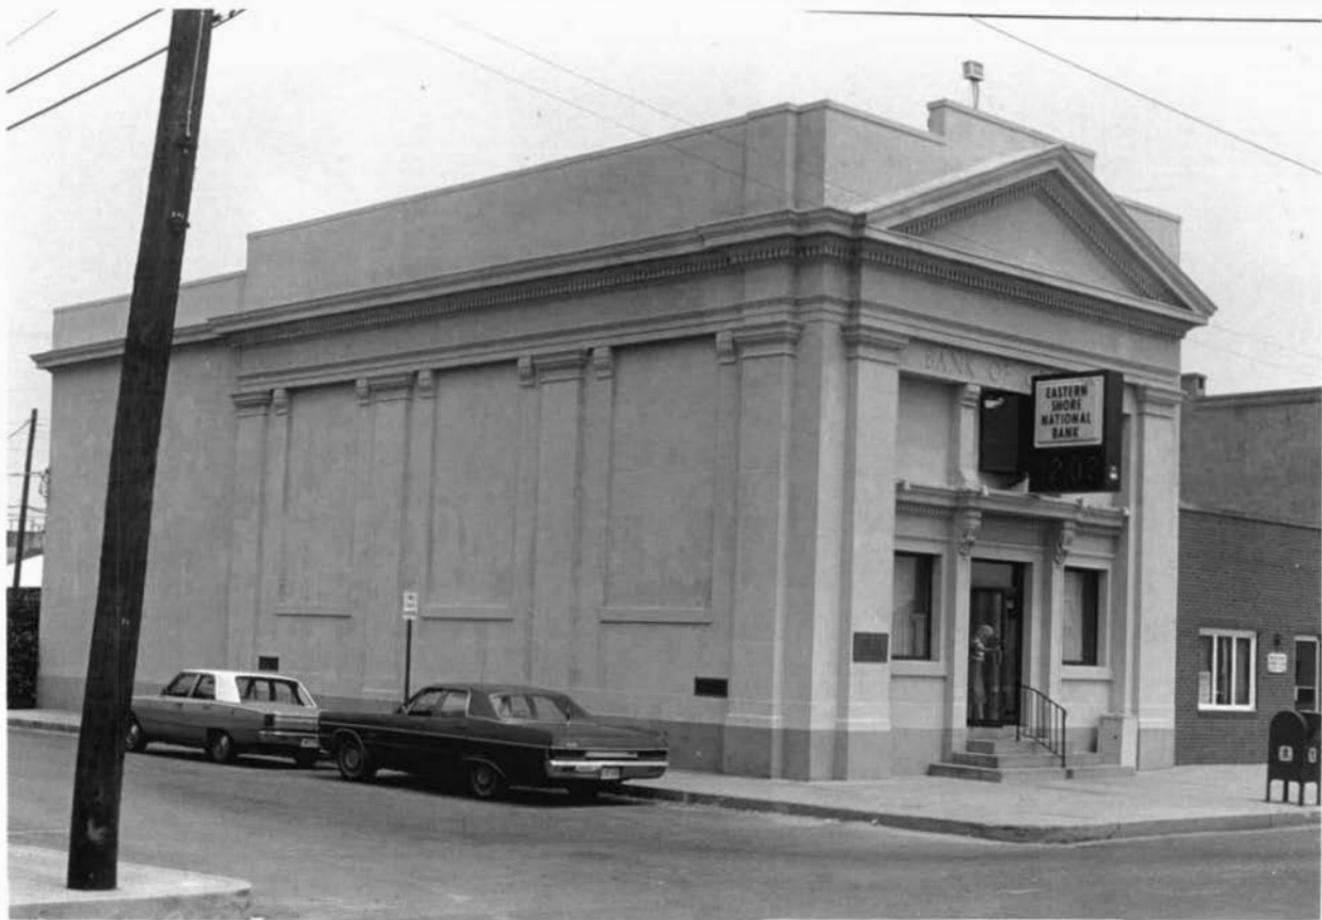
S-300

The southeast (main) facade is a classically inspired temple-front design with corner pilasters topped by a classical pediment. The Doric order pilasters frame the center door opening, which is elevated on a three-step granite platform. The door is flanked by paneled columns with acanthus leaf capitals, and to each side of the columns are single-pane windows. Atop the capitals, a molded cornice with a dentil row divides the entrance bay from the upper portion of the first floor which is now blocked up. This upper portion is divided into three sections and split by short, simply molded columns. A modern bank sign for "Eastern Shore National Bank" occupies the center bay. Engraved in the stone above this modern sign is the old name "Bank of Crisfield." The classical pediment follows a combination of Roman Doric pilasters and a Roman Ionic frieze. The dentil work under the cornice was continued within the pediment. The tympanum is plain. Rising above the pediment is a stepped parapet finished with a slightly projecting cap.

Bank of Crisfield, Downtown
Crisfield, Somerset County

Southeast Elevation

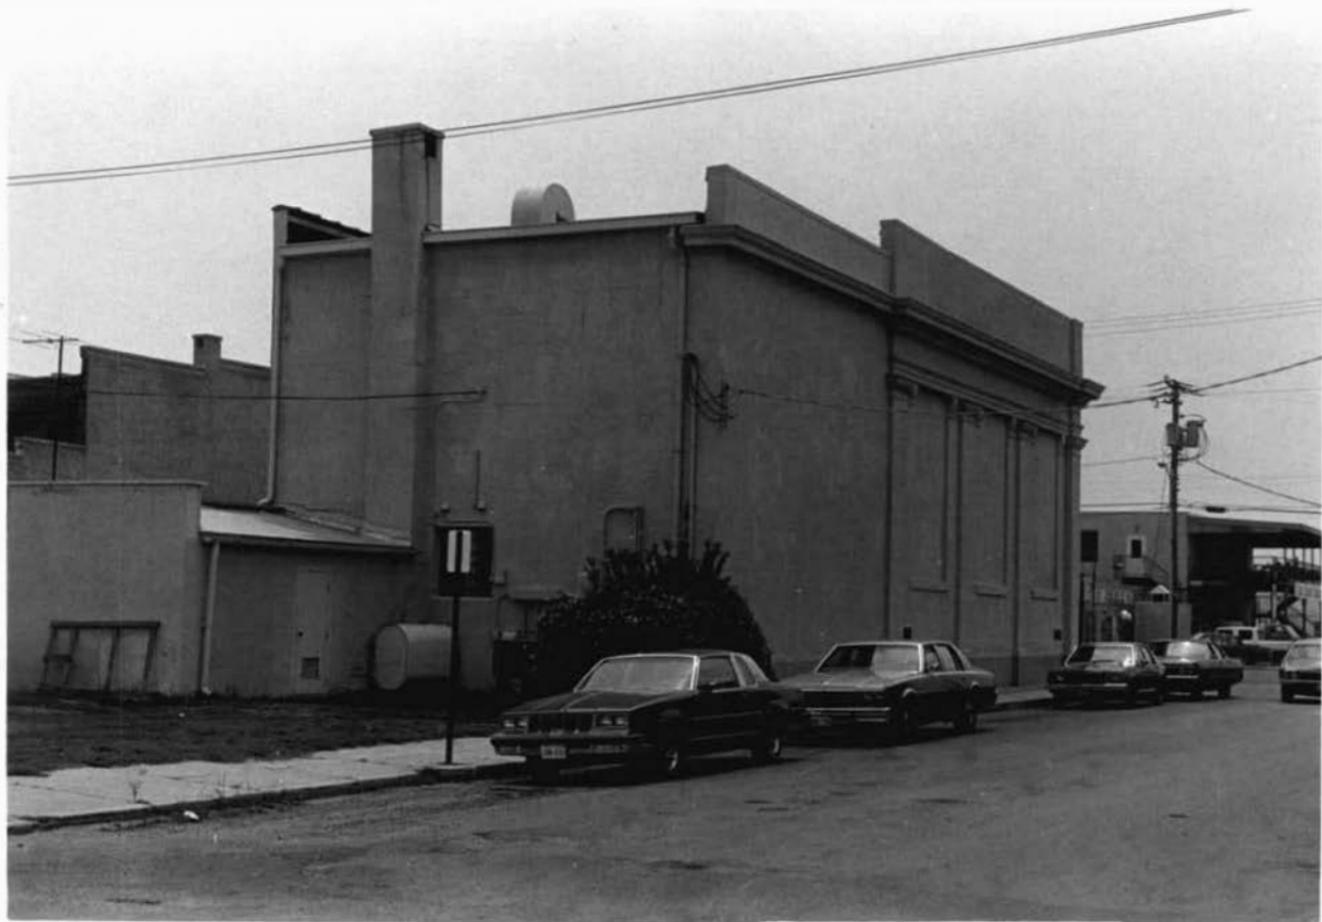
S-300

The southwest street elevation is a partially decorated facade divided into three principal bays. Four Doric pilasters separate three blind bays, while the Roman Ionic entablature extends around from the front. Attached to the main block is a simply finished rear bay which is a plain stuccoed wall joined visually to the front block by a continuation of the molded cornice. The parapet is slightly shorter than the main block.

Bank of Crisfield, Downtown
Crisfield, Somerset County
Southwest Elevation
7/85 Photographer - Paul Touart
Neg/Maryland Historical Trust

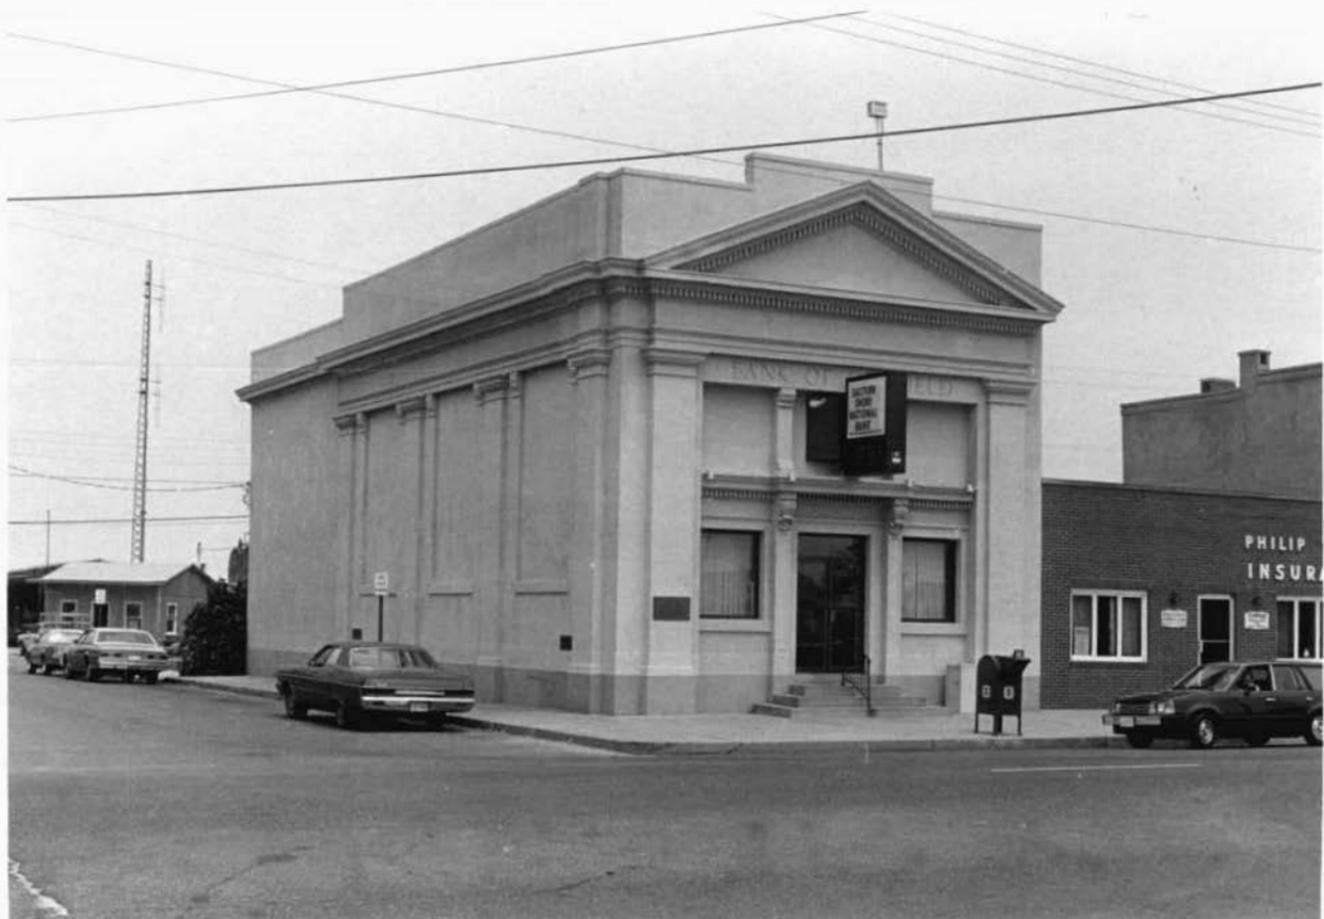
S-300

Bank of Crisfield, Downtown
Crisfield, Somerset County
Southeast Elevation
7/85 Photographer - Paul Touart
Neg/Maryland Historical Trust
