S-302  
Old Customs House and Post Office  
Crisfield  
Public

# Maryland Historical Trust State Historic Sites Inventory Form

historic Old Customs House and Post Office

Survey No. S-302

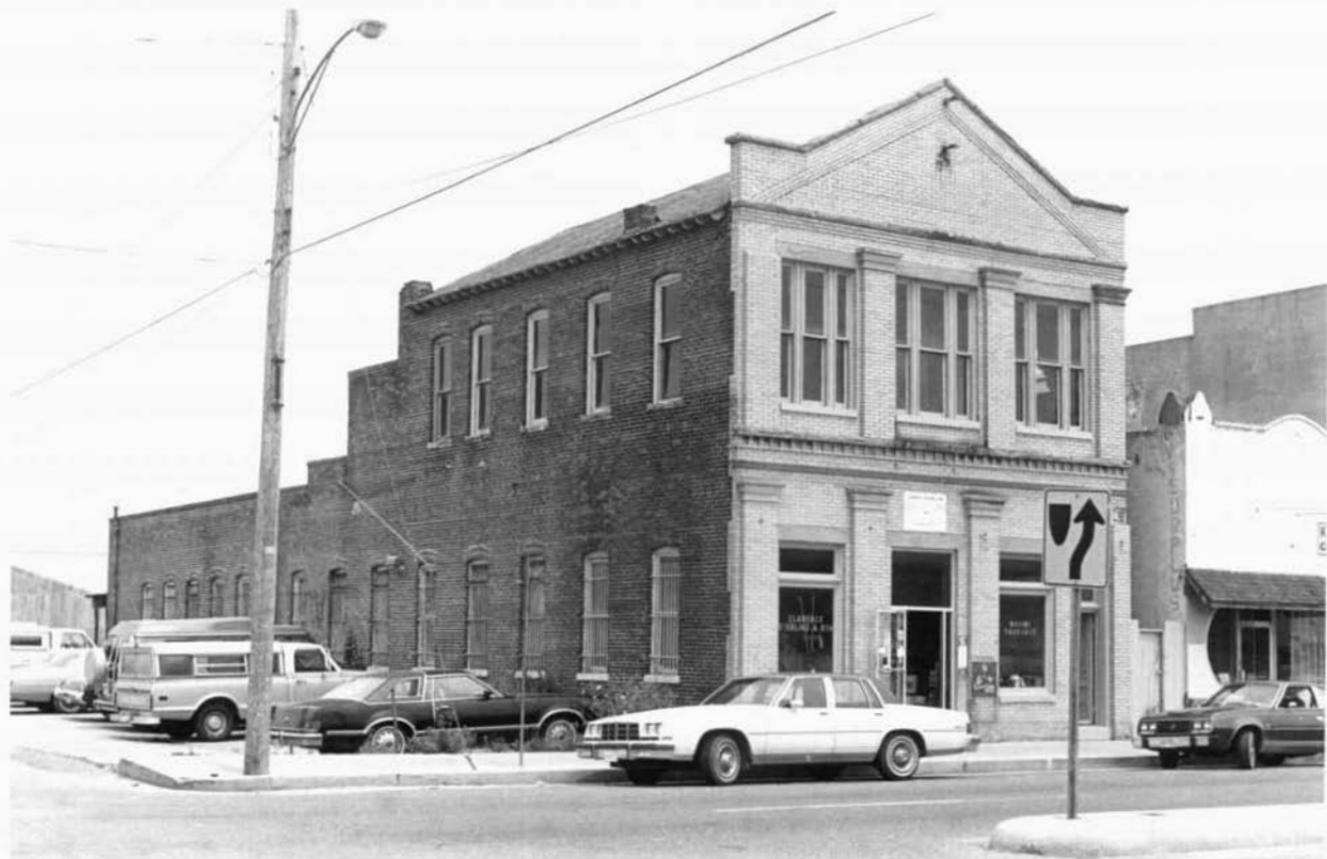
Old Customs House and Post Office S-302  
Crisfield, Somerset County  
Southeast Elevation  
7/85 Photographer - Paul Touart  
Neg/Maryland Historical Trust

The southeast (main) elevation is a three-bay facade divided by four brick pilasters on each floor. A modern glass door occupies the center bay, while the two adjacent bays have large glass display windows. Painted on each window is "Clarence Sterling and Son." Also located in the north bay is a side door entrance that leads to the second floor. Each window and door opening is topped by a plain limestone flat arch. The first and second floors are divided by a rusticated stone string course with a decorative row of brick dentils below. Rising from the string course are four identical pilasters that divide the second floor windows. Tri-partite single-pane sash windows are topped by smooth limestone lintels. Stretching across the base of the gable roof is a corbelled brick cornice and another rusticated limestone string course. The gabled parapet roof is highlighted by corbelled brick that parallels the rusticated limestone parapet capping.

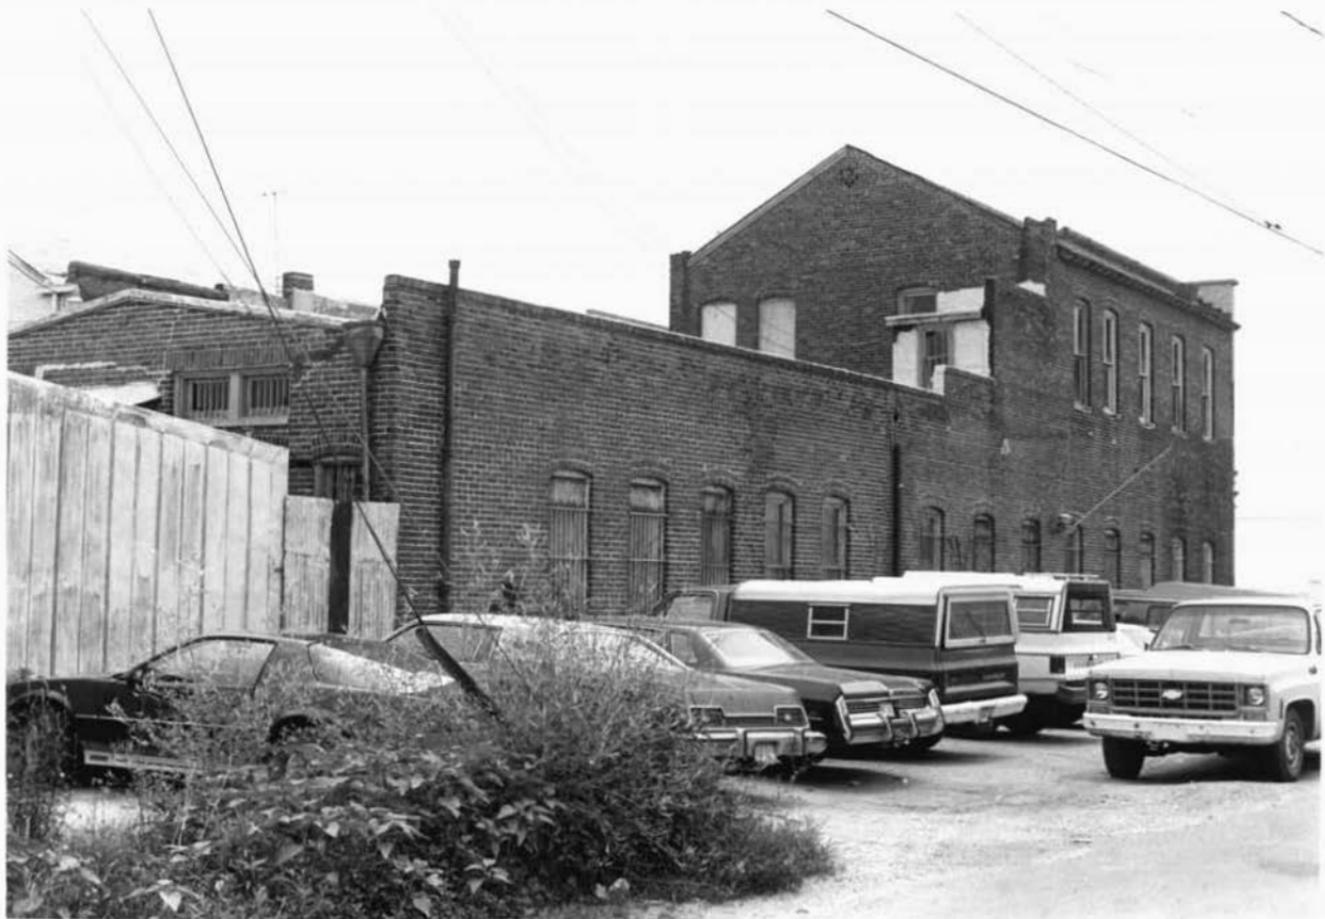
Old Customs House and Post Office    S-302  
Crisfield, Somerset County  
Southwest Elevation  
7/85    Photographer - Paul Touart  
Neg/Maryland Historical Trust

The southwest side of the main block is evenly divided into five bays marked by single pane sash windows with segmental brick arches. The sills are of rusticated stone and iron grills cover the first floor windows. Round butt rafter feet peak out below the slate roof, and a partially demolished brick stove stack rises from the southwest side and the southwest corner.
