S-307
United States Post Office
Crisfield
public

Maryland Historical Trust State Historic Sites Inventory Form

and/or common Crisfield Post Office

Survey No. S-307

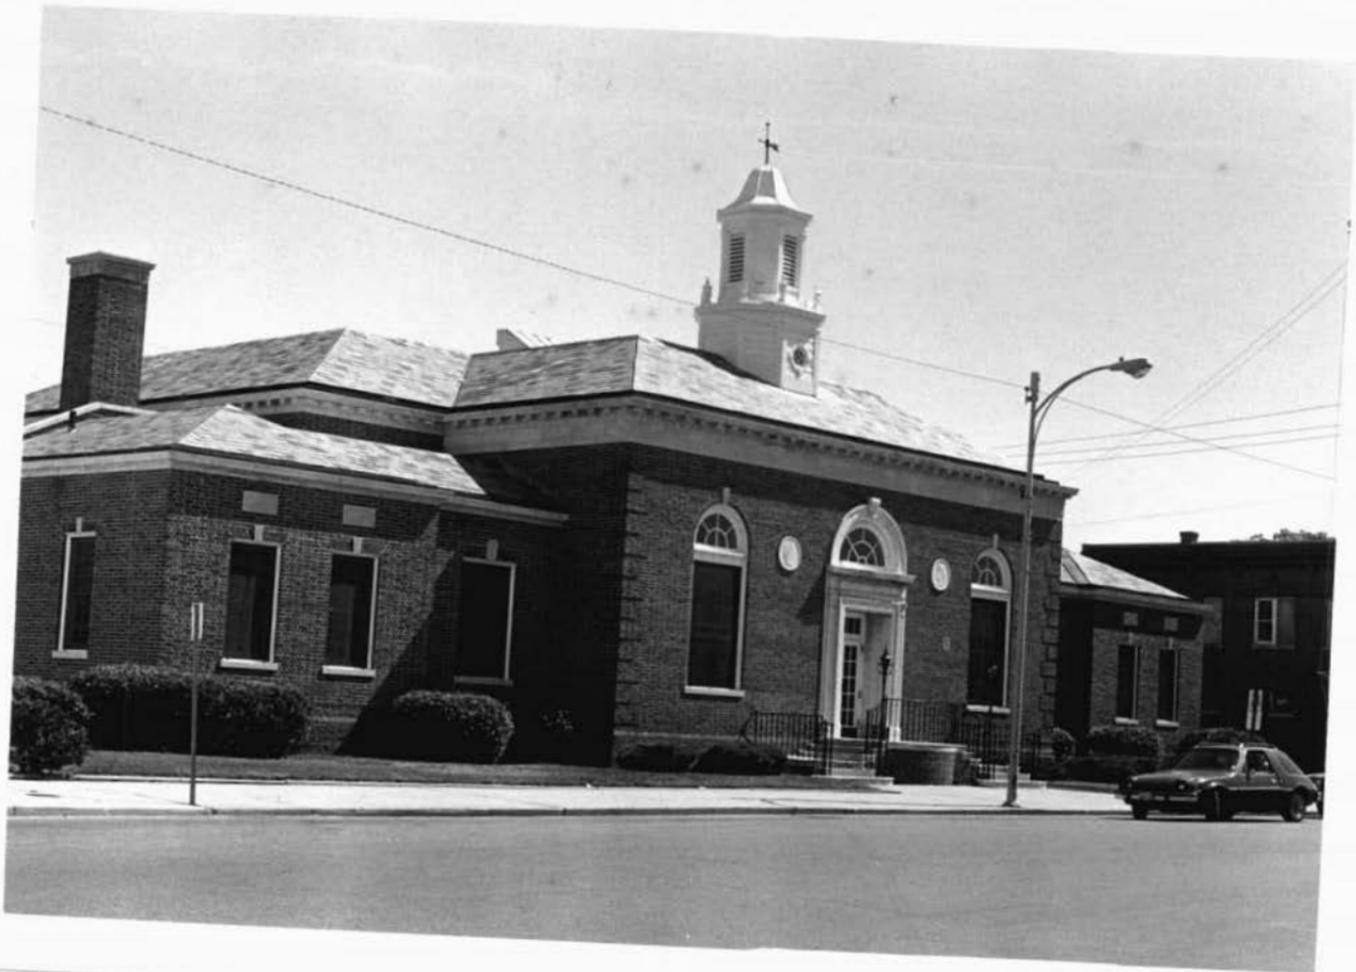
S-307

Crisfield Post Office
Crisfield, Somerset County
Southwest Elevation
7/85 Photographer - Paul Touart
Neg/Maryland Historical Trust

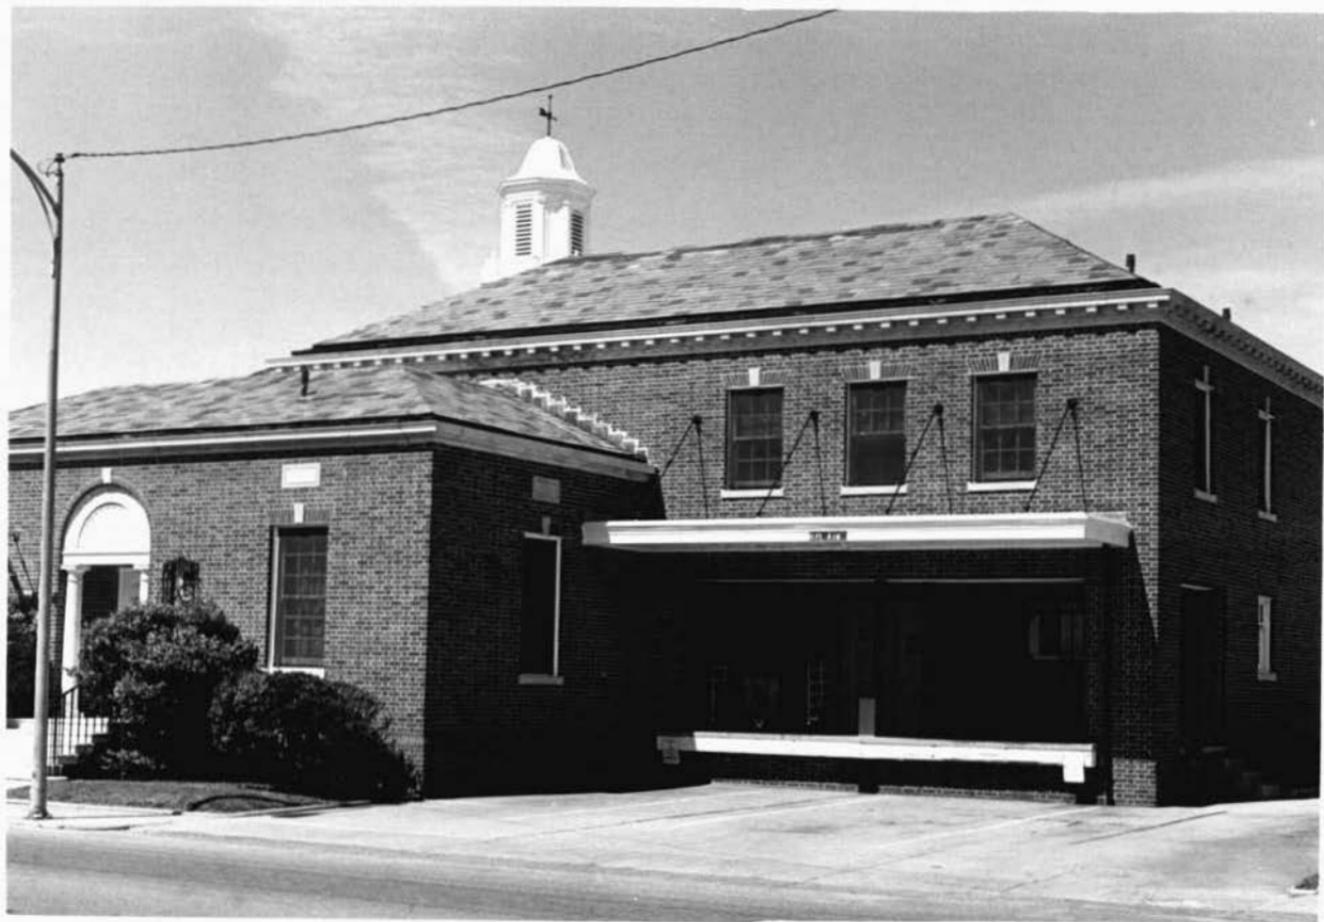
S-307

The east side elevation of the wing is a basically symmetrical facade with a center entrance and flanking nine over nine sash windows finished in the same manner as the south windows. The center side entrance is entered at the top of a flight of six marble steps and within a slightly recessed alcove. Tuscan columns flank the six-panel door and support a solid arched fan-shaped panel. The round arch is interrupted by a small keystone. Positioned directly to the north (right) of the door is a small grilled window opening. The molded cornice stretches across at the base of the roof, and it is finished with an intricate Greek key bed molding. Directly behind the east wing is the post office loading platform which fills the first floor space. The second floor is pierced by three 9/9 sash windows.

Crisfield Post Office
Crisfield, Somerset County
East Elevation
7/85 Photographer - Paul Touart
Neg/Maryland Historical Trust

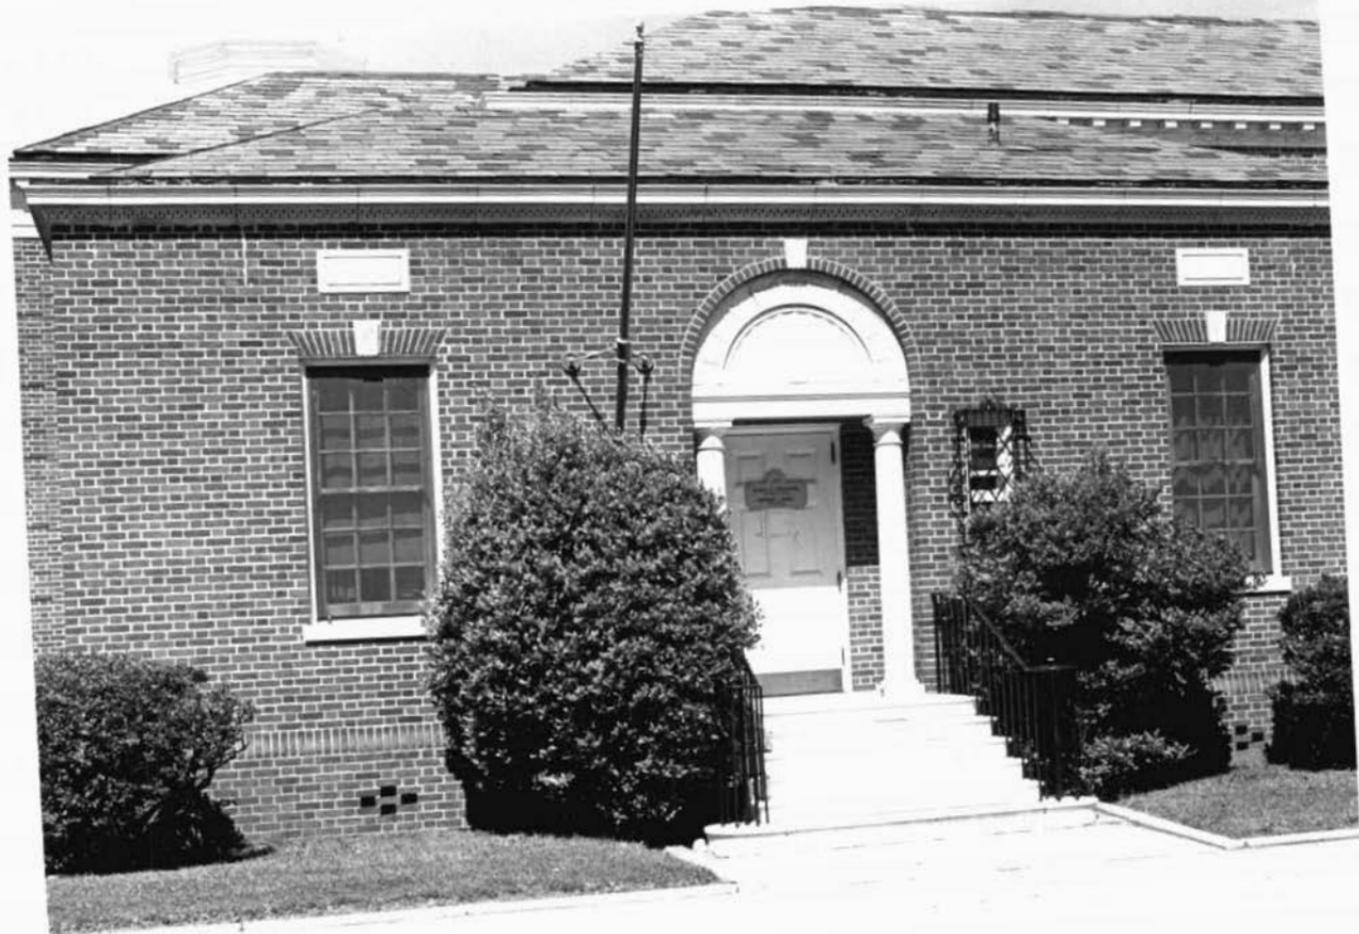
S-307

Crisfield Post Office
Crisfield, Somerset County
East Door
7/85 Photographer - Paul Touart
Neg/Maryland Historical Trust

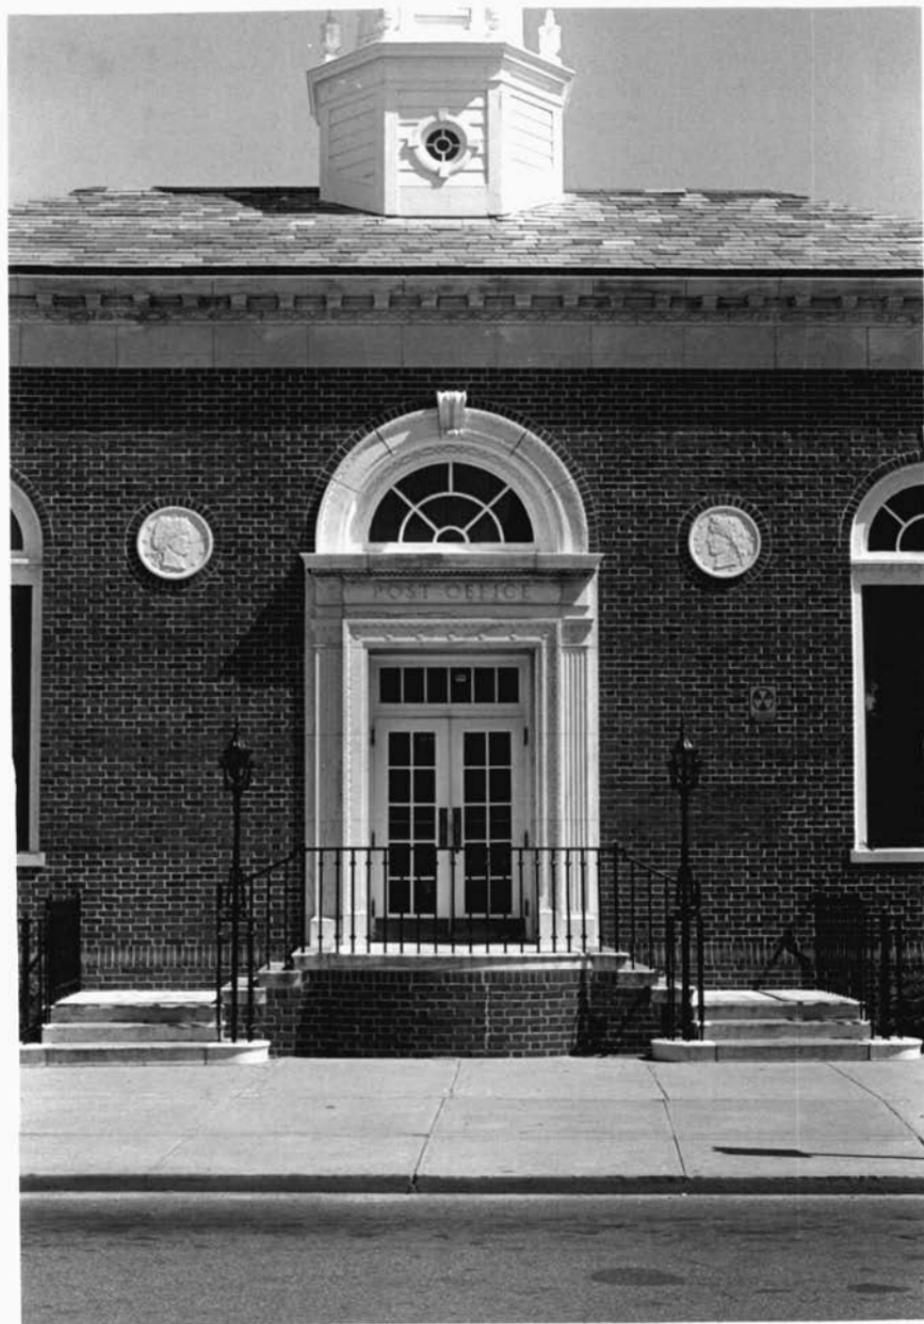
S-307

The south (main) facade of the center block is a symmetrical elevation with a classically inspired entrance and flanking nine over nine sash windows. The front door is situated on a raised platform with access provided by a twin stair of marble steps surrounded by iron railings. The double-door entrance is topped by a six-light transom and framed by a classical entablature with an arched fanlight. The decorated ovolo molded door surround is flanked by fluted pilasters which support a cushion frieze and broken cornice. The cushion frieze is inscribed, "Post Office". Above the cornice is an arched fanlight with a molded surround interrupted by a scrolled keystone. The wall space to each side of the entrance is marked by a round medallion with a relief sculpture of a classical profile. The flanking nine over nine sash windows are topped by arched fanlights. A limestone keystone is centered within the round brick arch.

Crisfield Post Office
Crisfield, Somerset County
Front Door
7/85 Photographer - Paul Touart
Neg/Maryland Historical Trust
