S-324

Maryland Historical Trust State Historic Sites Inventory Form

historic Albert Sterling House

street & number 23 West Main Street not for publication

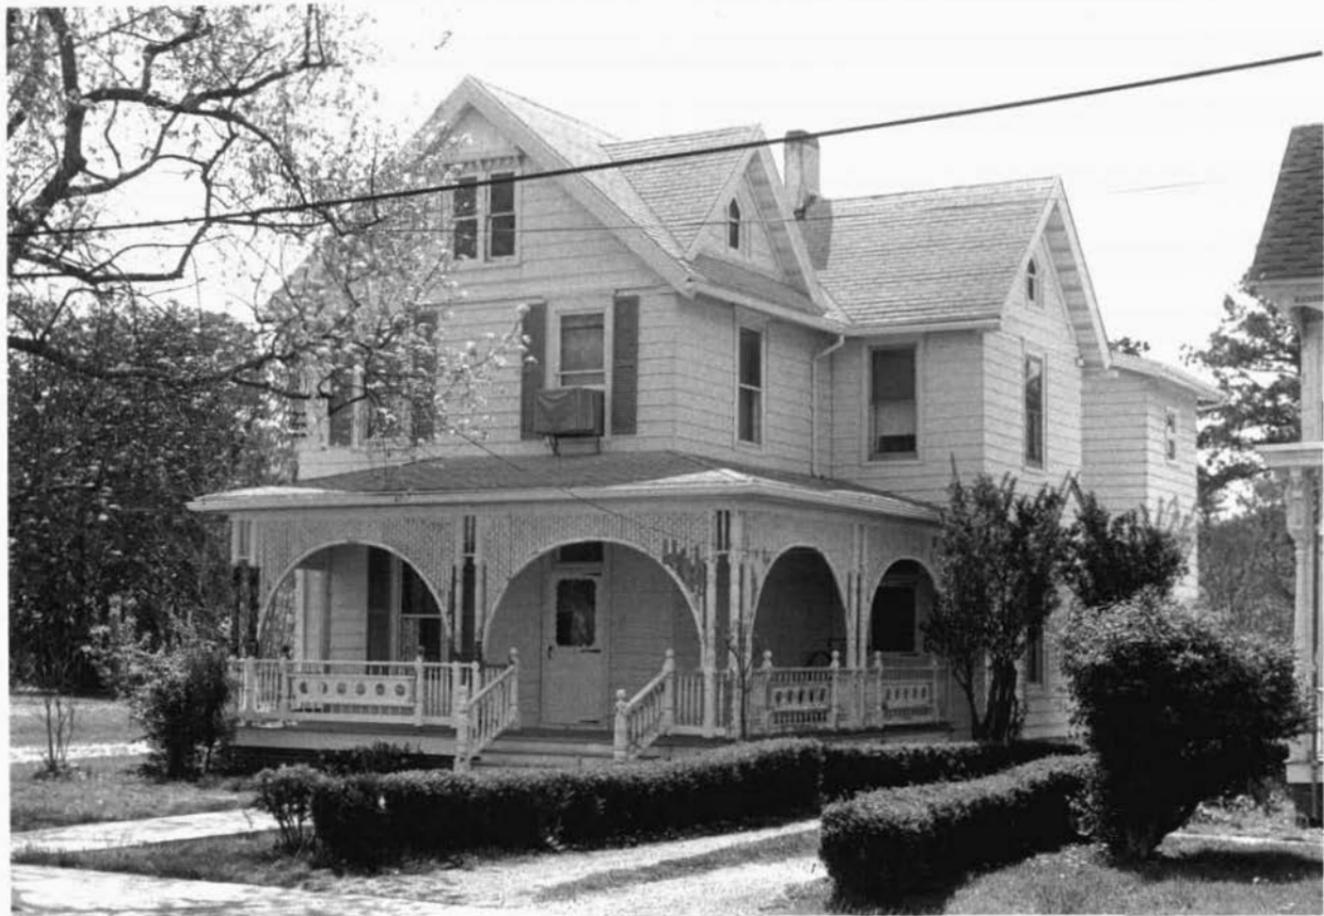
Albert Sterling House
Crisfield, Somerset County
North Elevation
7/85, Photographer, Paul Touart
Neg/Md. Historical Trust

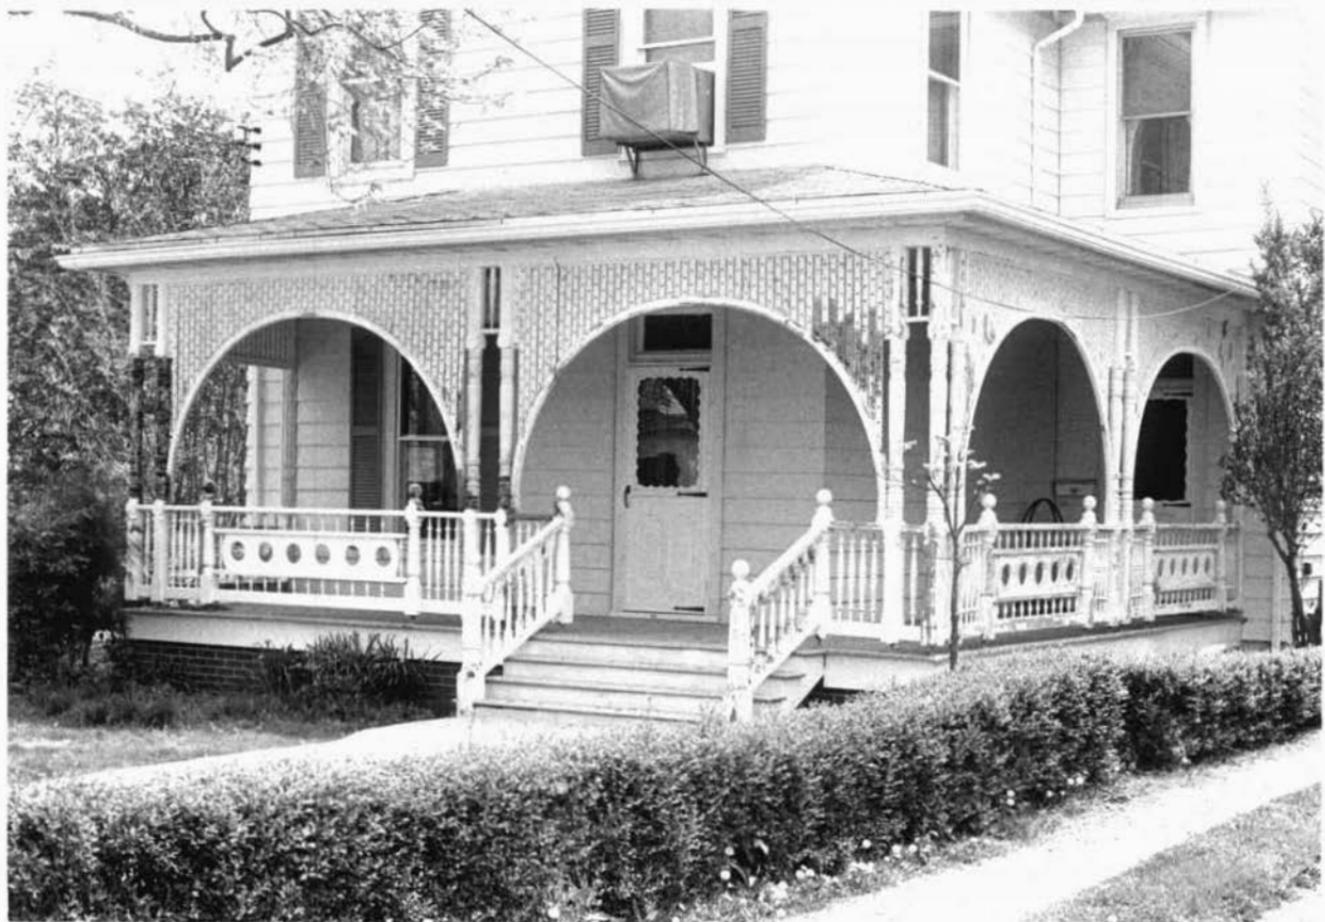
Albert Sterling House
Crisfield, Somerset County
North Elevation
7/85 Photographer - Paul Touart
Neg/Maryland Historical Trust

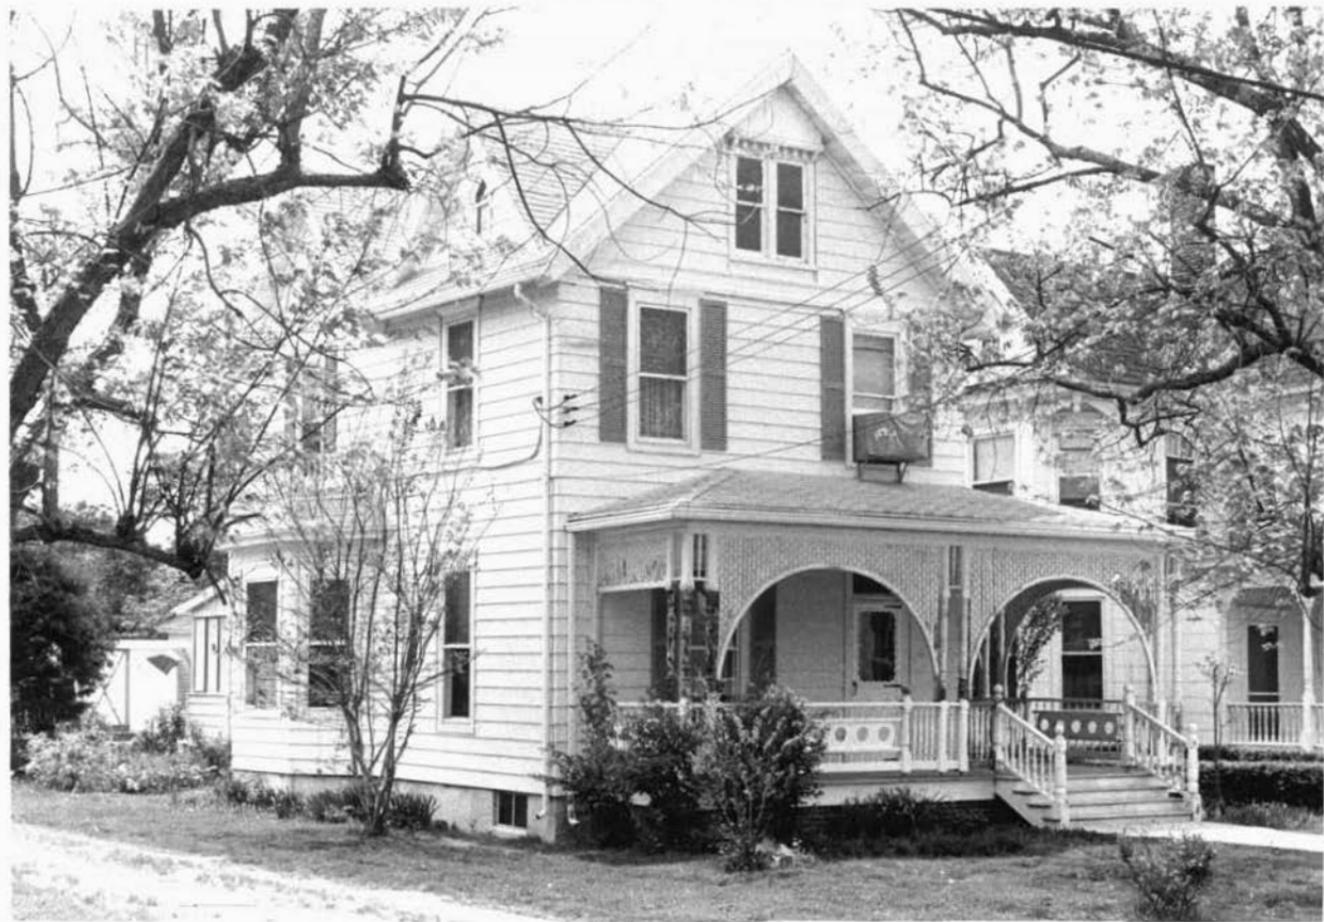
Albert Sterling House
Crisfield, Somerset County
North Elevation
7/85, Photographer, Paul Touart
Neg/Md. Historical Trust
