S-325
McCready House
Crisfield
private

c. 1870

Maryland Historical Trust State Historic Sites Inventory Form

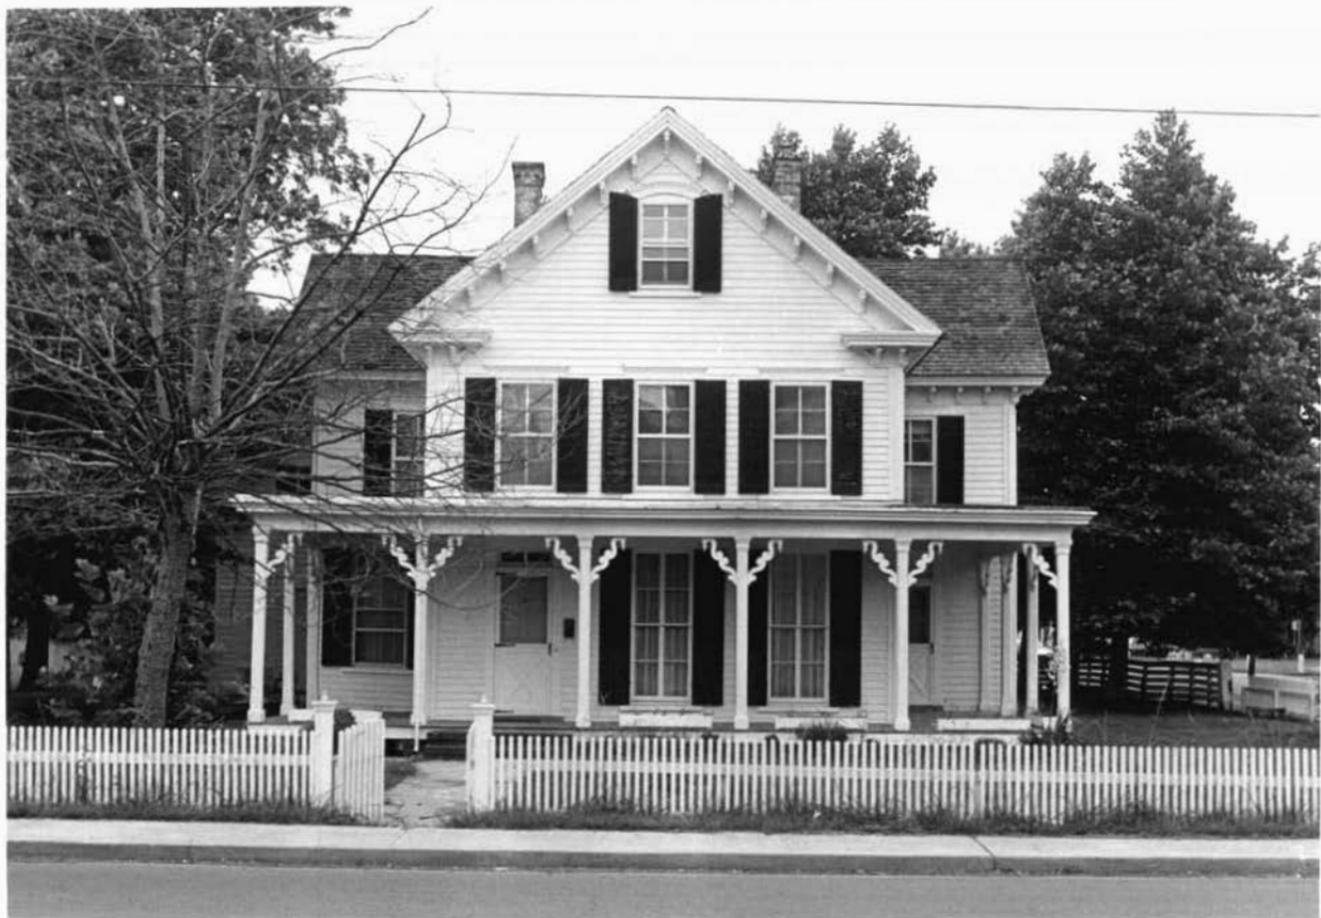
South Elevation

The south (main) facade of the tee-plan is a gable-front elevation of three bays. The entrance is located in the left (west) bay with a heavily molded four-panel door. The adjacent window openings have four over four sash that stretch from the floor to the ceiling and are flanked by louvered shutters. The first floor is covered by a wraparound porch of chamfered posts and snake-curved corner brackets. A side porch entrance opens into the rear section from the east end. The second floor of the main elevation is marked by three evenly spaced four over four sash windows with louvered shutters, while the upper gable is pierced by a single four over two sash with an arched header and corresponding arched shutters.

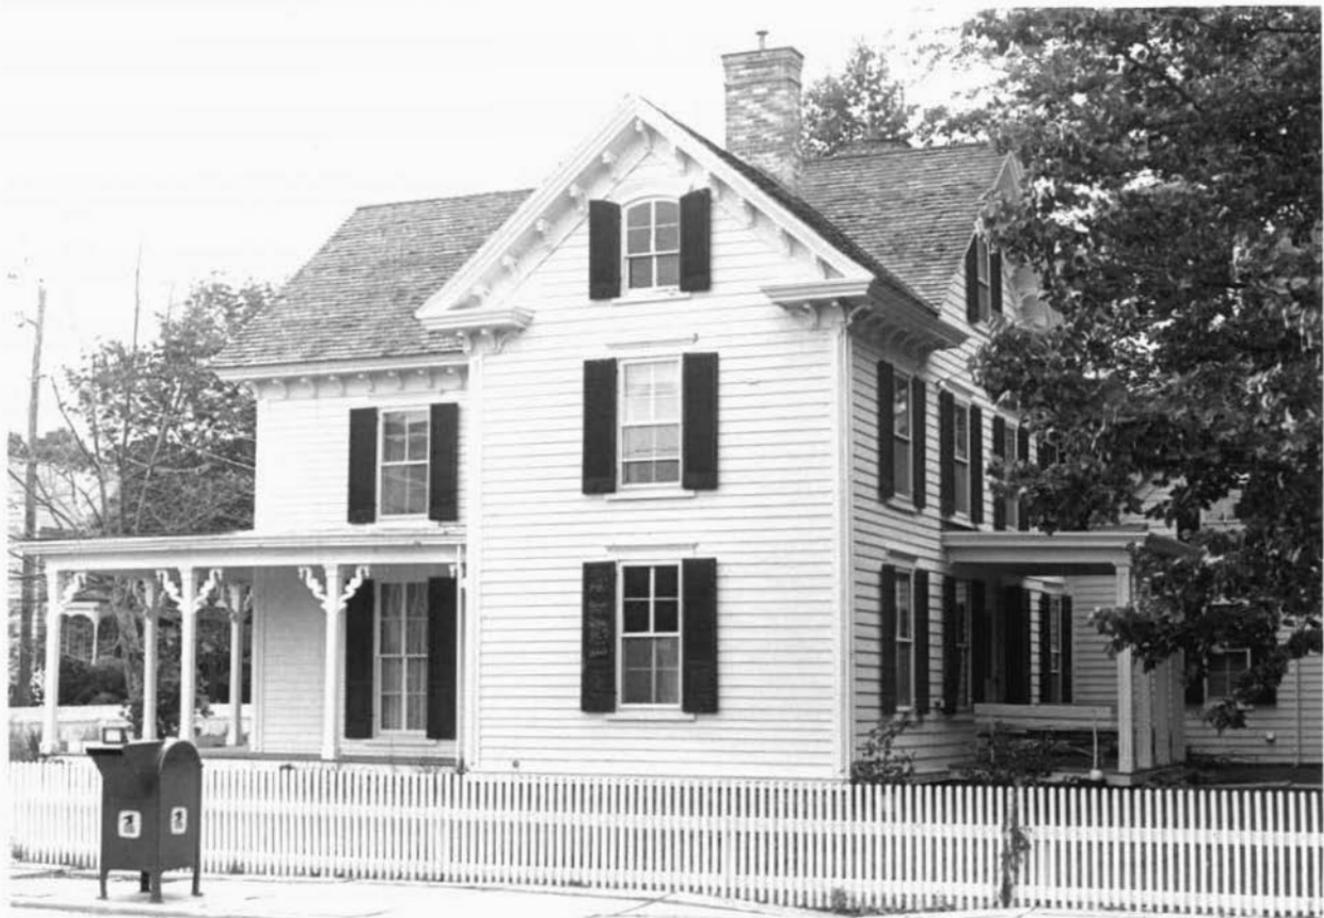
East Elevation

The east and west side elevations are essentially the same. The uneven facade of the tee-plan is pierced by a combination of four over four or two over two sash windows. The east gable end of the rear section has a single four over four sash on the first and second floors and a single four over two sash that lights the attic.
