S-340
Cedar Lane Farm
Princess Anne vicinity
private

c. 1870

Survey No. S-340

Maryland Historical Trust State Historic Sites Inventory Form

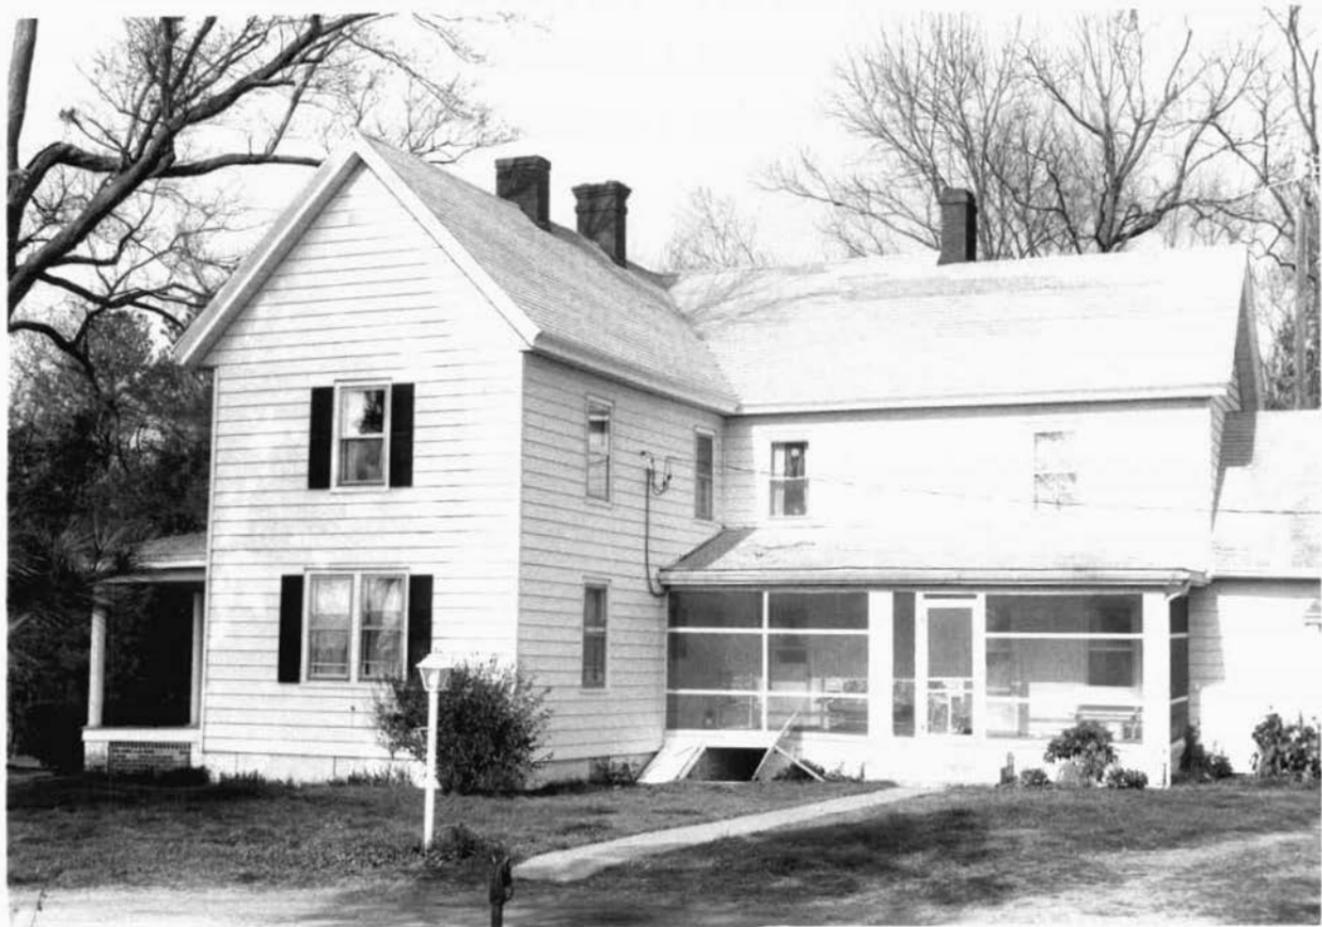
South Elevation

Standing at the end of a long farm lane bordered by mature cedar trees is a third quarter of the nineteenth-century frame farmhouse that is supported by a brick pier foundation and is sheathed with aluminum siding. The steeply pitched roof has extended eaves and an exterior layer of asphalt shingles. Attached to the back of the house is a two-story, two-bay service wing.

The south gable end has a paired single-pane sash window on the first floor and a single sash window on the second floor.
