S-350
W.J. Shockley Farm
Princess Anne vicinity
private

Maryland Historical Trust State Historic Sites Inventory Form

historic W. J. Shockley Farm - Woolford Farm

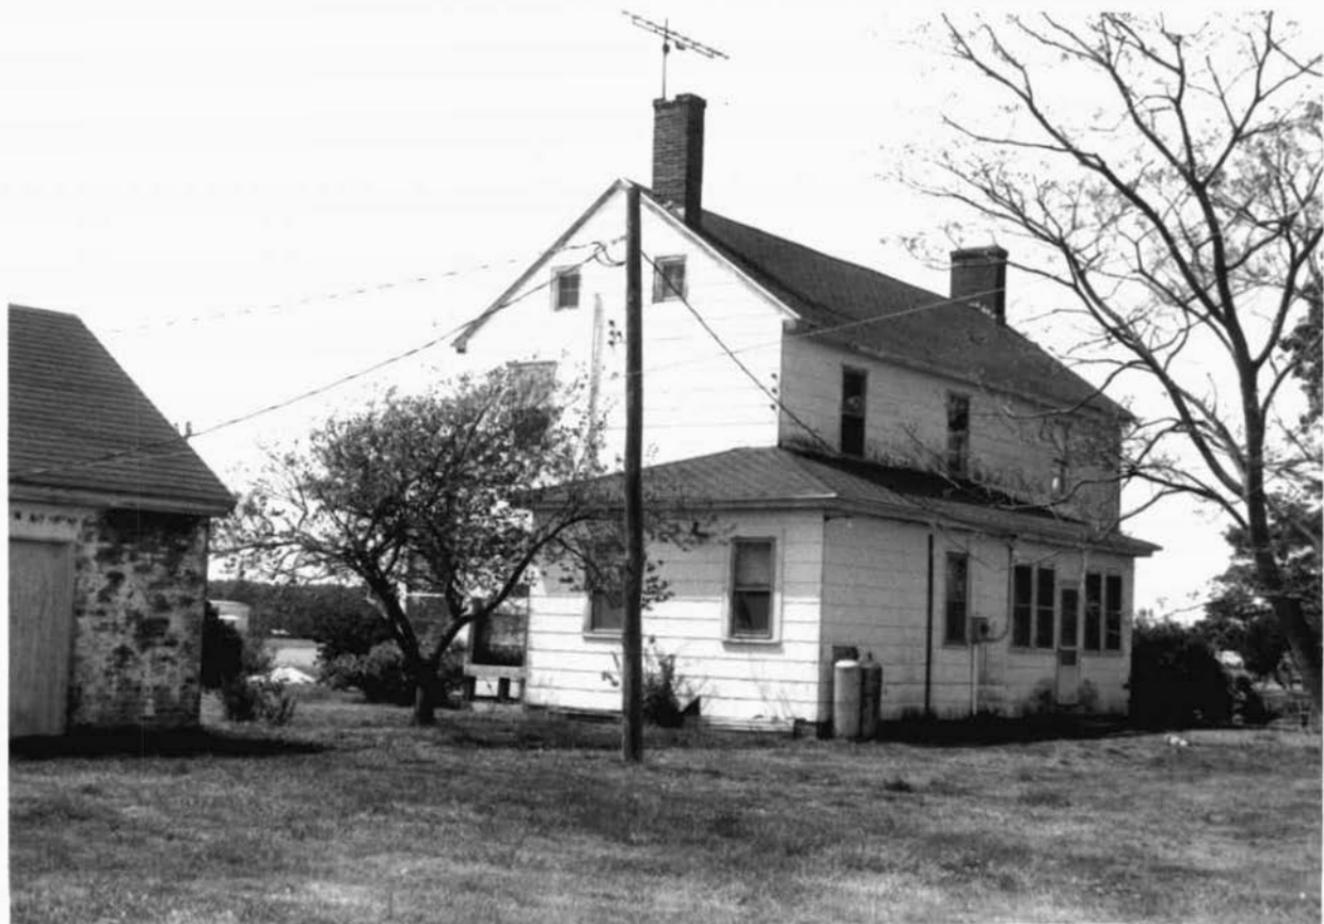
W.C. Shockley Farm S-350
Princess Anne vicinity, Somerset Co., Md.
Southeast Elevation
4/86, Paul Touart, Photographer
Neg./Md. Historical Trust

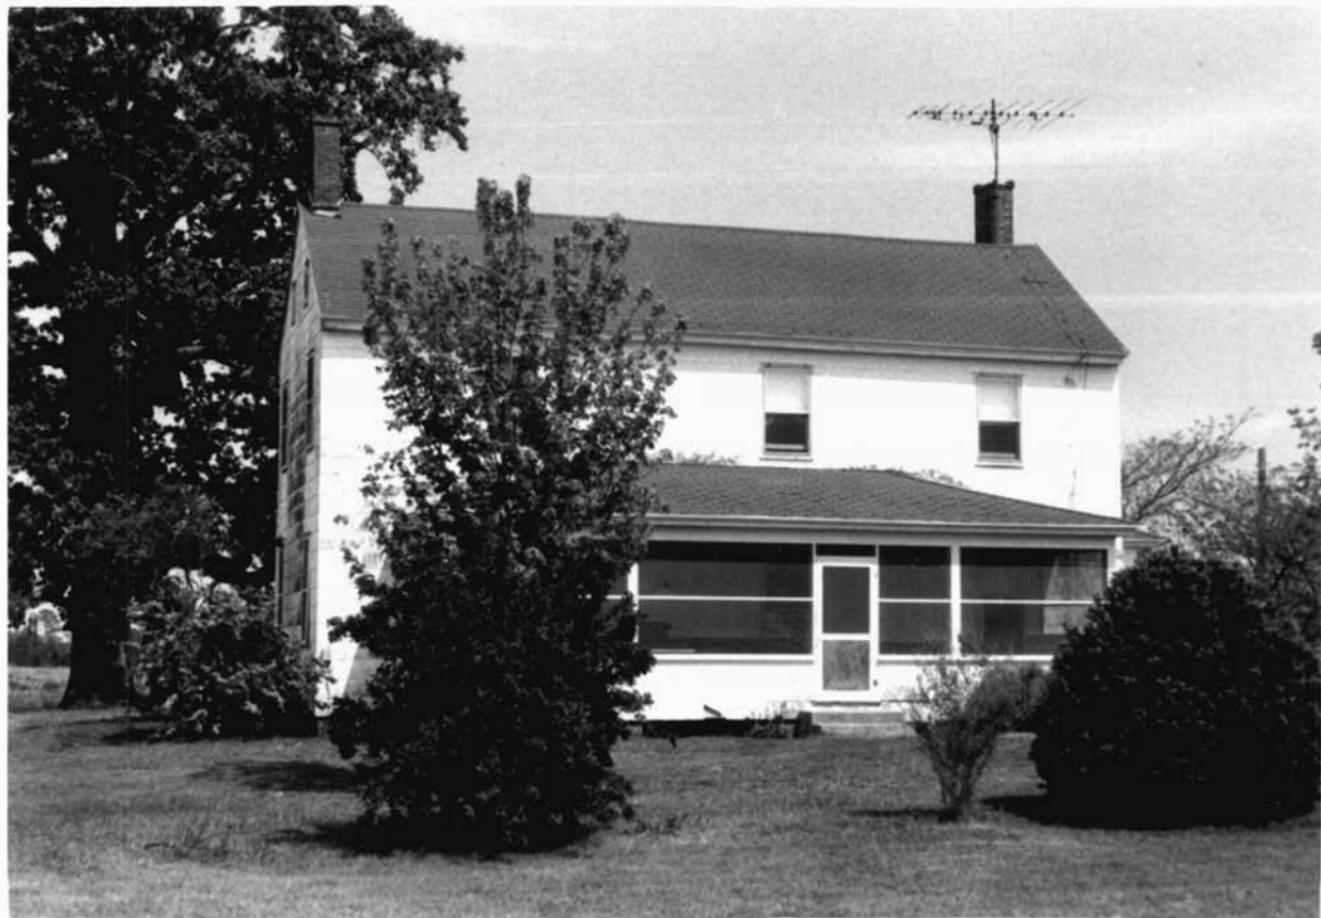
The west (main) elevation is a slightly asymmetrical three-bay facade covered on the first floor by a hip roof screened-in porch. The front door is a replacement as are the flanking single-pane sash windows. A former resident described the old nine-over-six sash windows. The second floor is lighted by three single-pane sash as well.

W.C. Shockley Farm S-350
Princess Anne vicinity, Somerset Co., Md.
West Elevation
4/86, Paul Touart, Photographer
Neg./Md. Historical Trust

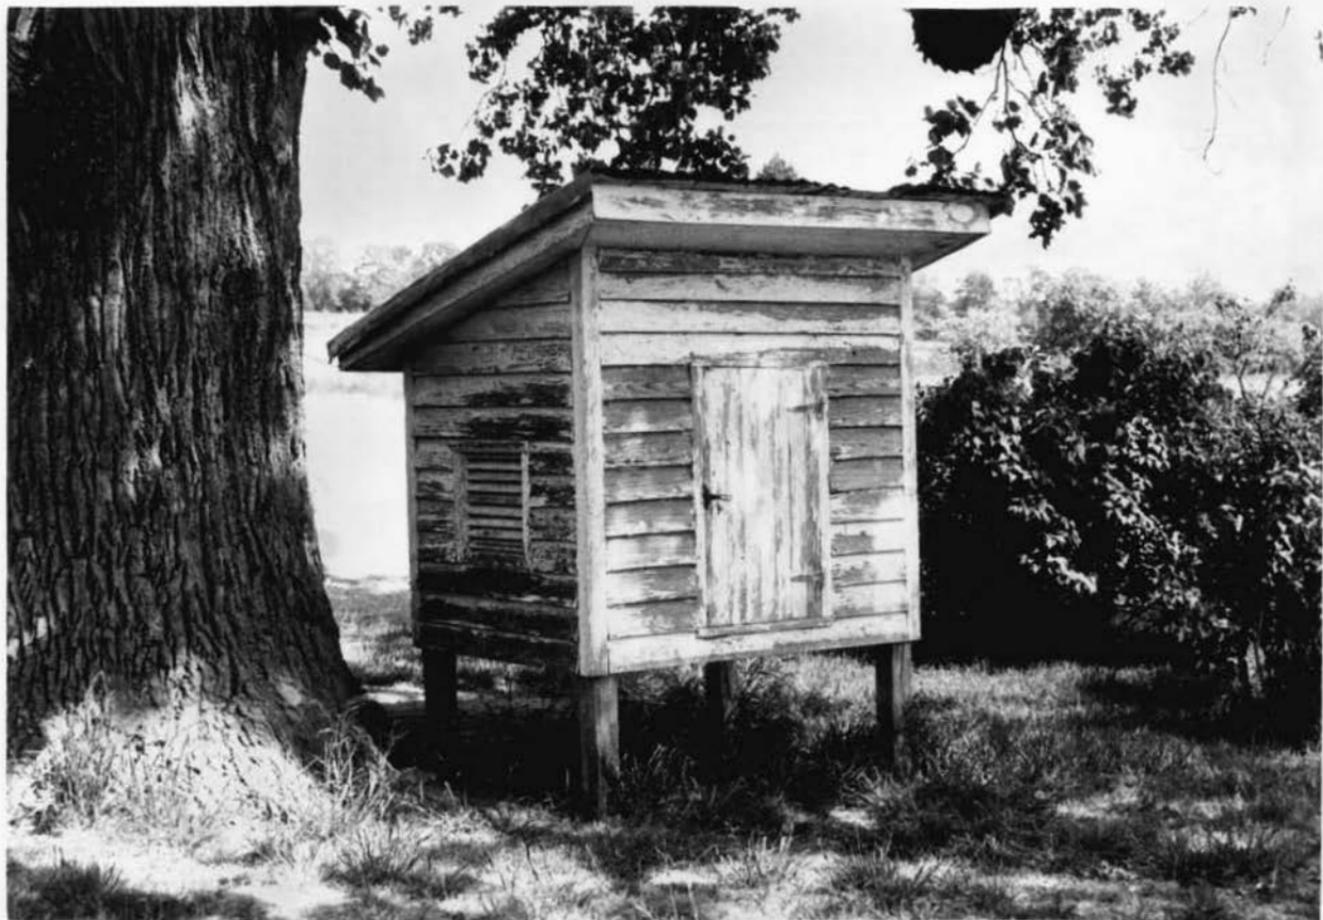
West Elevation of Dairy

Also standing behind the house is a small stilted dairy covered with a shed roof. The four walls are sheathed with weatherboards and pierced with a board door on the west side and louvered openings on the north and south.

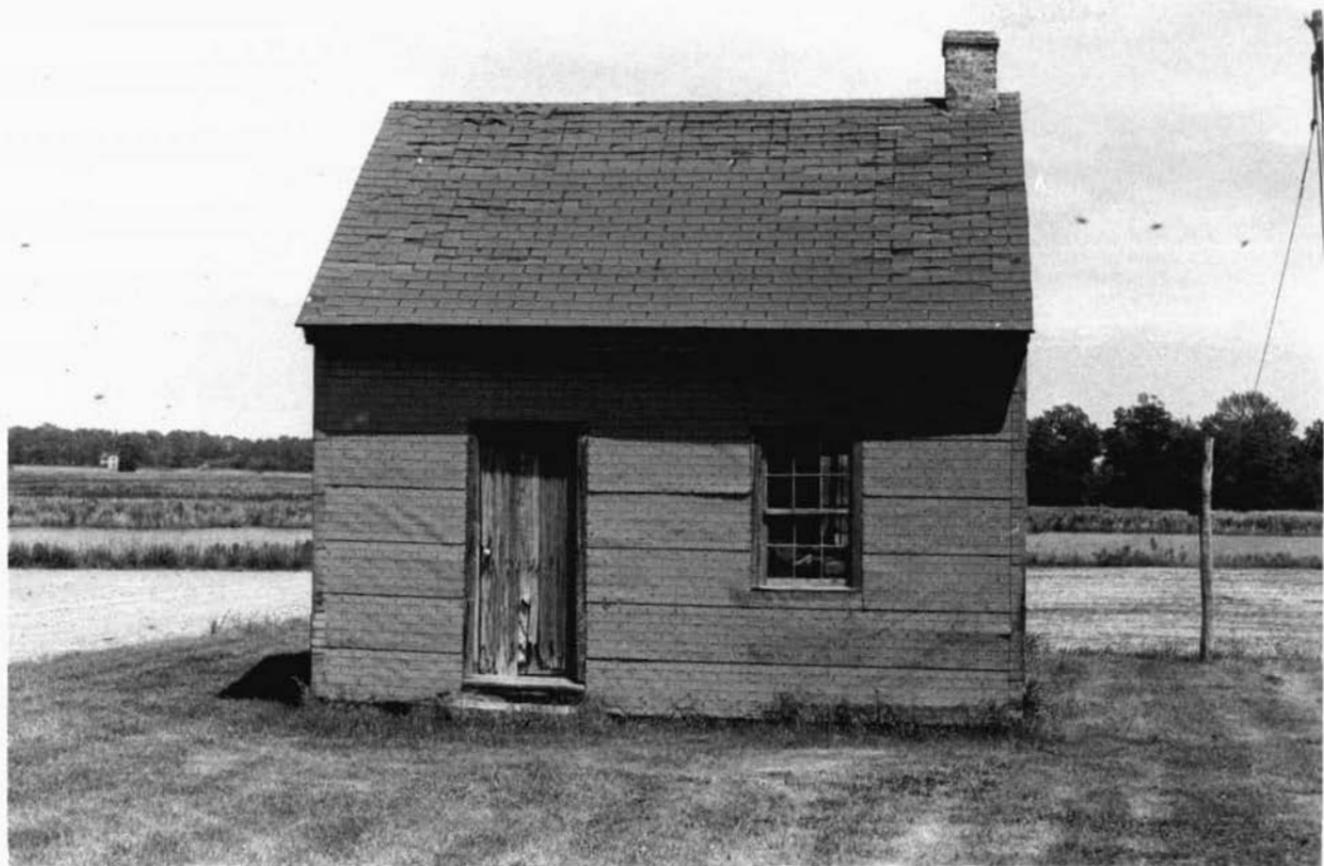
Standing southeast of the dwelling is the old single-story kitchen which was formerly attached to the house by a single-story colonnade. The kitchen, now used as a storage building, is a single-story, two-bay one-room plan frame structure covered with asphalt tile sheets that imitate brick. A board and batten door is located in the left bay, while a six-over-six sash window fills the right bay. The gable roof is covered with asphalt shingles, and the cornice is plain. A small brick stack rises from the south gable end in lieu of the former brick stack.

W.C. Shockley Farm S-350
Princess Anne vicinity, Somerset Co., Md.
West Elevation of Old Kitchen
4/86, Paul Touart, Photographer
Neg./Md. Historical Trust

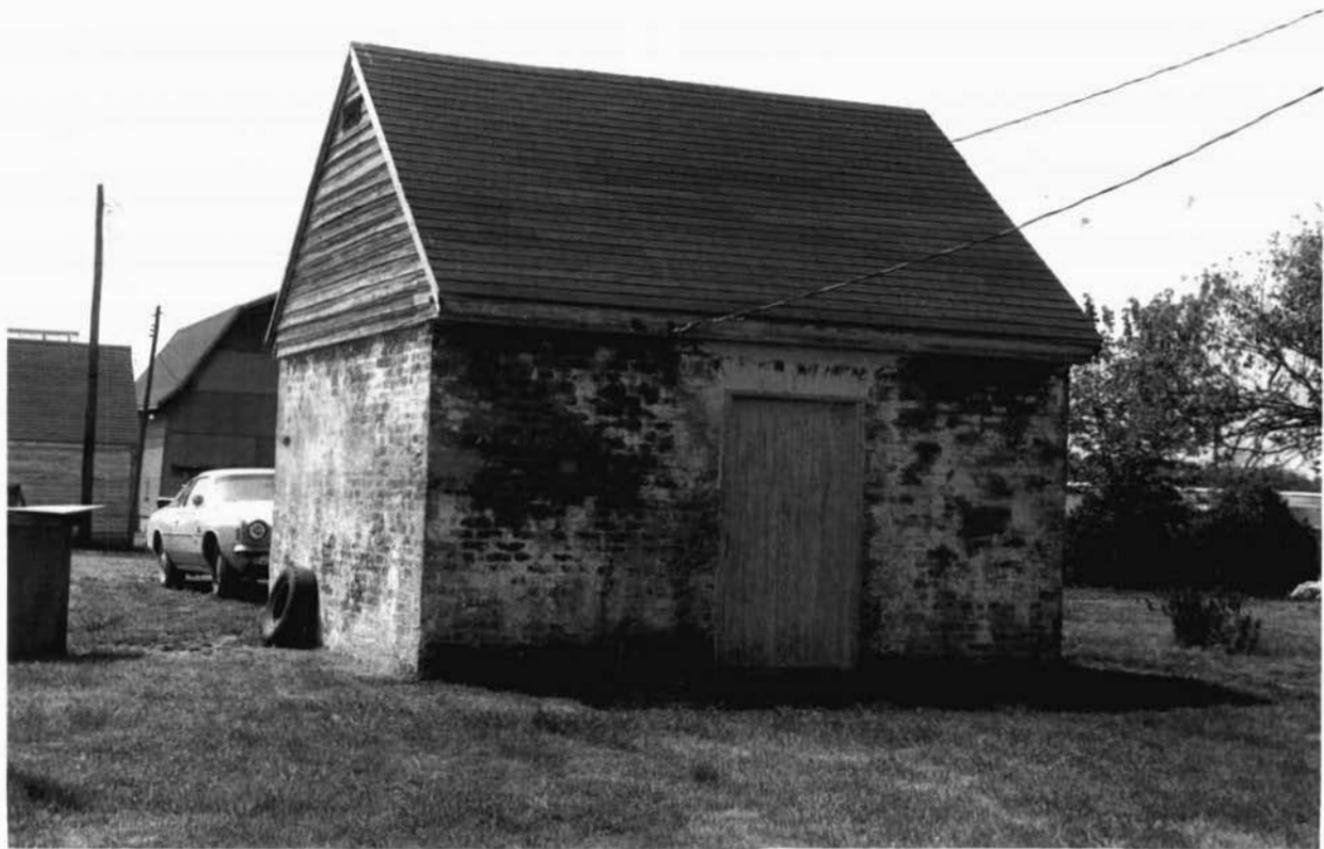
East Elevation of Smokehouse

Located near the kitchen is a common bond brick smokehouse. Four common bond brick walls retain remnants of stucco and whitewash. Due to the various sizes of bricks and the relative frequency of glazed bricks it appears that many were salvaged from a former building. The gable ends are studded and covered with weatherboards. The roof is sheathed with asphalt shingles. The only opening in the rectangular structure is the door on the east side which is topped by a jack arch.
