S-358
Bozman-Fitzgerald House
Venton vicinity
private

Maryland Historical Trust State Historic Sites Inventory Form

Bozman-Fitzgerald House Description

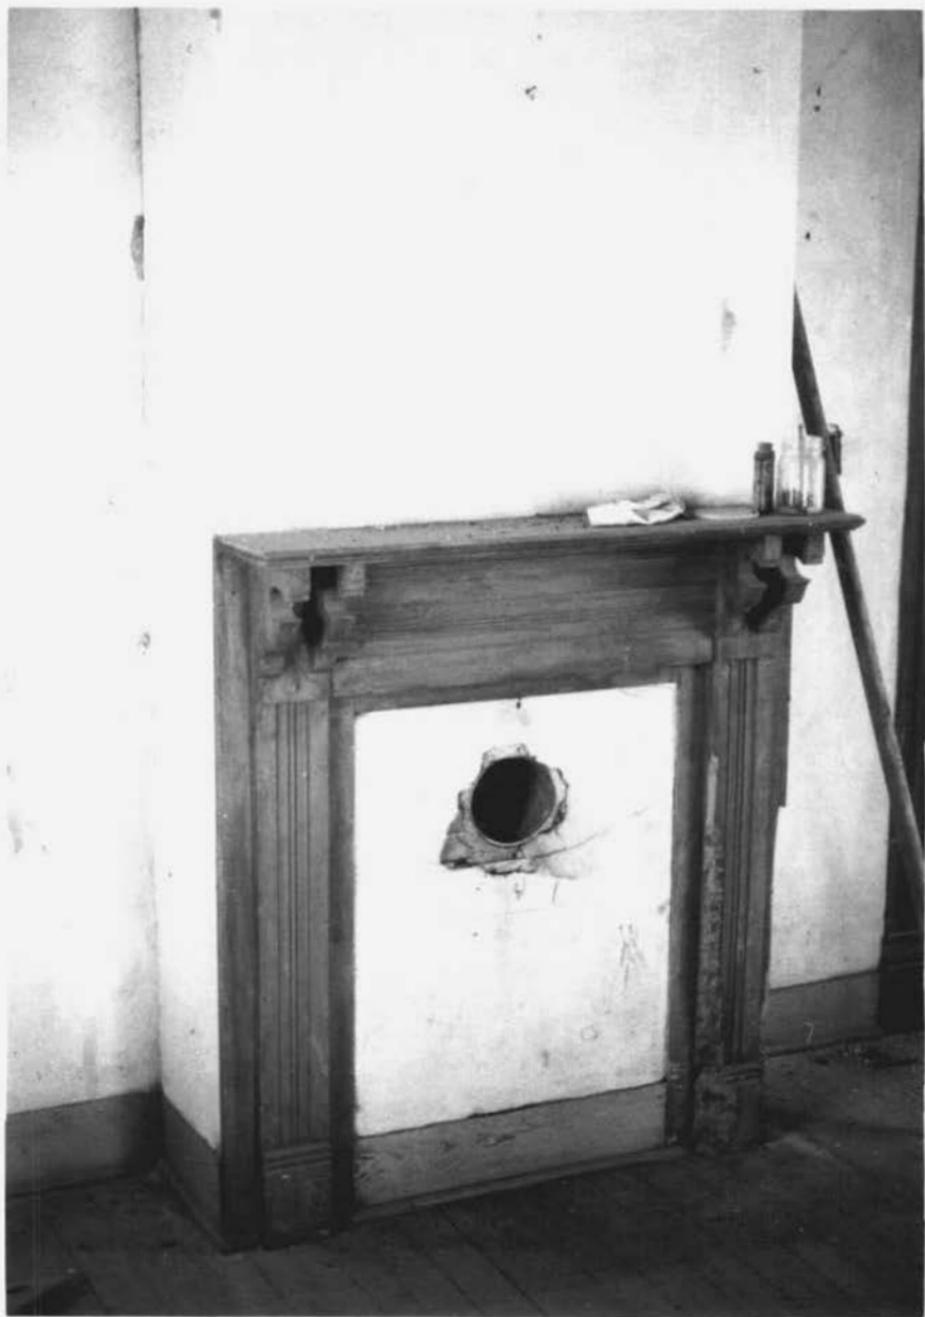
S-358

Bozman-Fitzgerald House
Venton Vicinity, Somerset Co. Md.
Mantel
6/86, Paul Touart, Photographer
Neg/Md. Historical Trust

The interiors of the house retain large portions of the turn of the century woodwork; however, the center stair has been vandalized and the turned newel post, balusters and handrail have been removed. The stringer retains its Victorian decoration, and narrow beaded boards sheathe the triangular space below. Shallow four-panel doors are framed by molded surrounds with bulls-eye blocks. The west room retains its period mantel as well as paneled window aprons and simply molded baseboards. The turn of the century plaster remains intact as well. The east room is finished in a similar manner with a late Victorian mantel, plaster walls, and ogee molded baseboards.

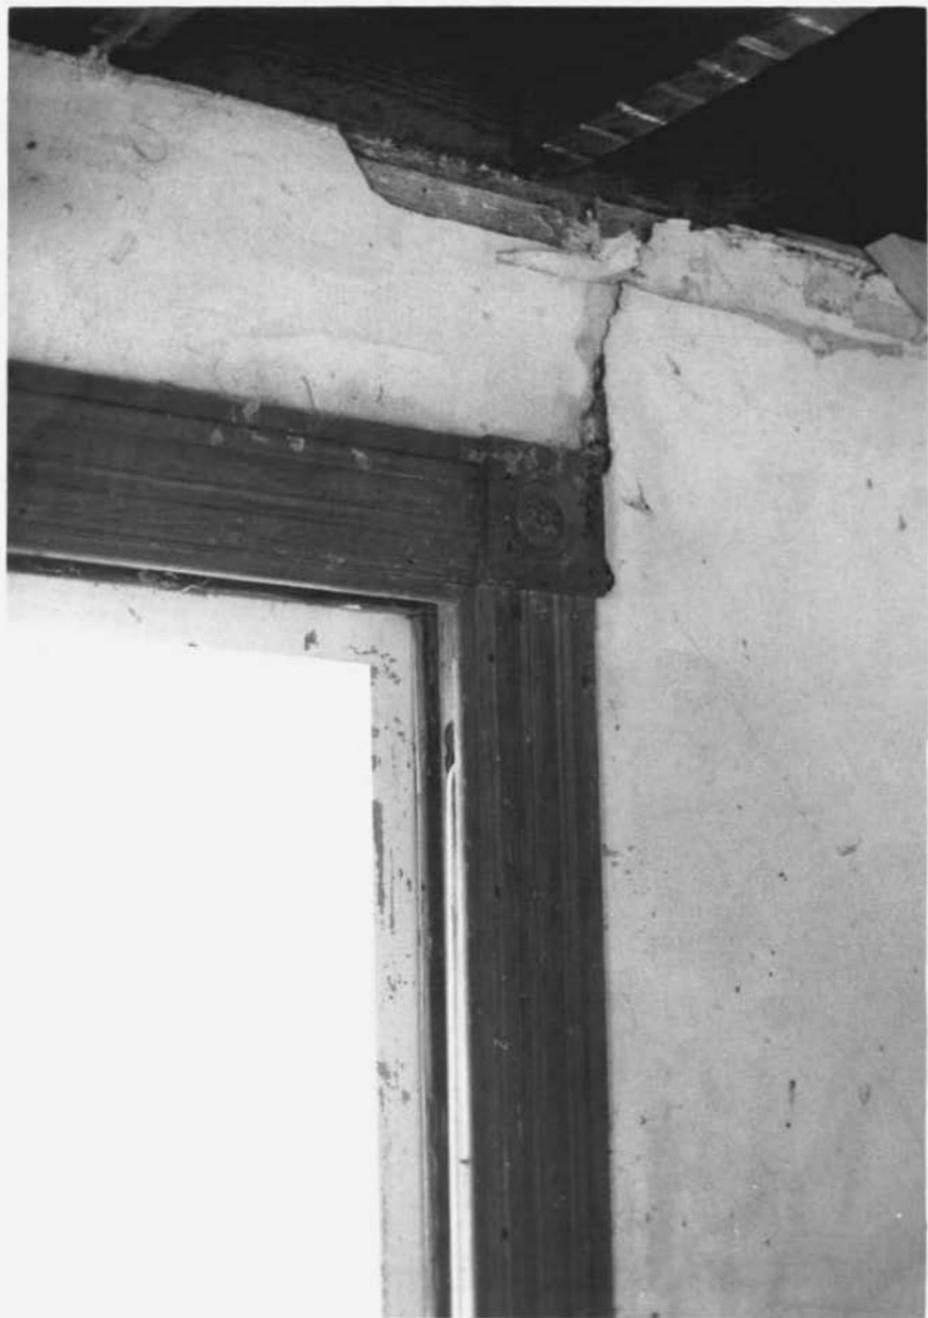
Bozman-Fitzgerald House S-358

Interior window trim

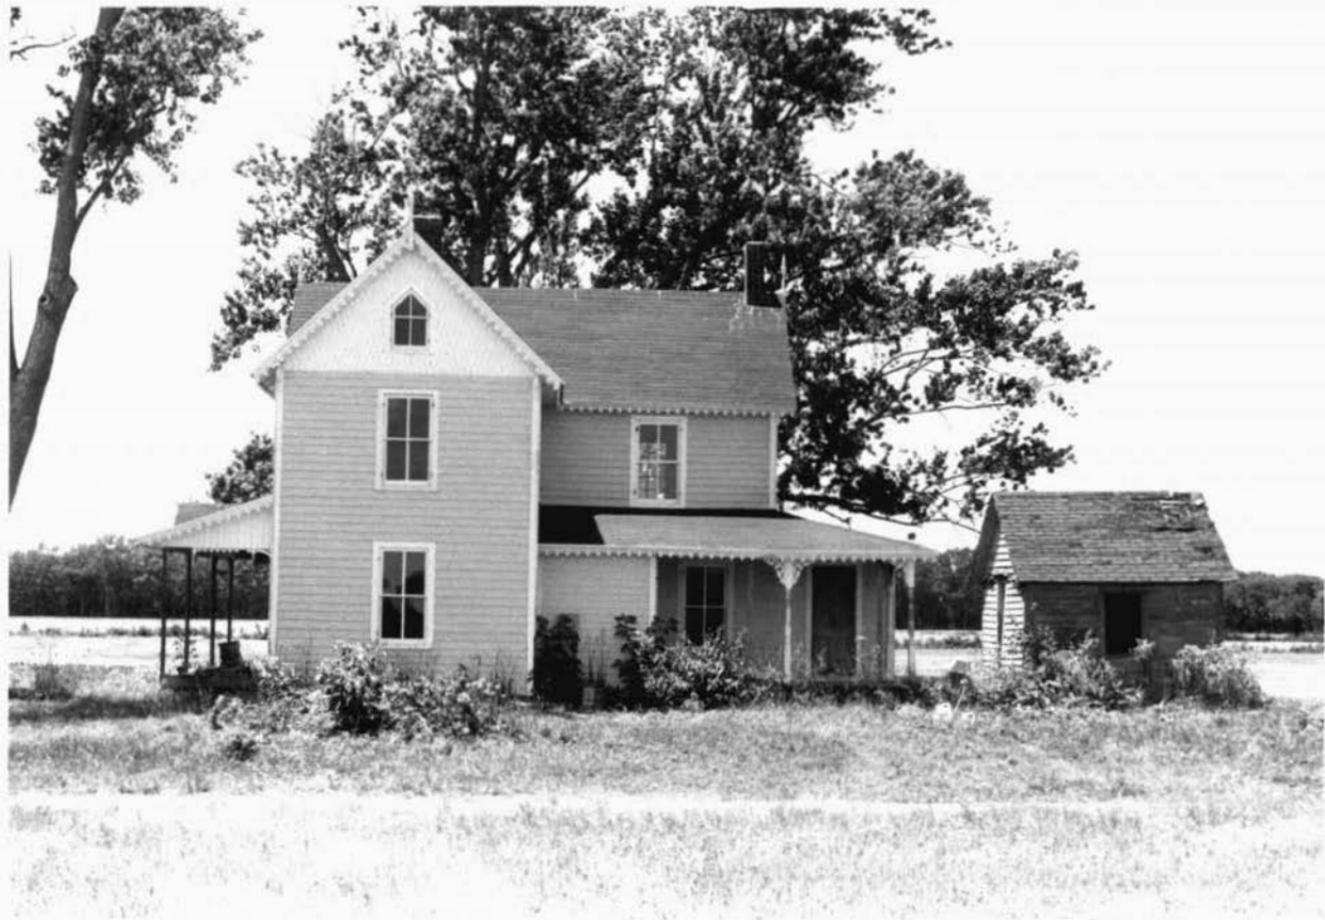
S-358

Bozman-Fitzgerald House
Venton vicinity, Somerset Co. Md.
East Elevation
6/86, Paul Touart, Photographer
Neg/Md. Historical Trust

The east and west gable ends are essentially alike with a single two-over-two sash window on each floor, and a pointed arch attic window is surrounded by a field of fish-scale shingles. Wooden finials rise from each roof peak.

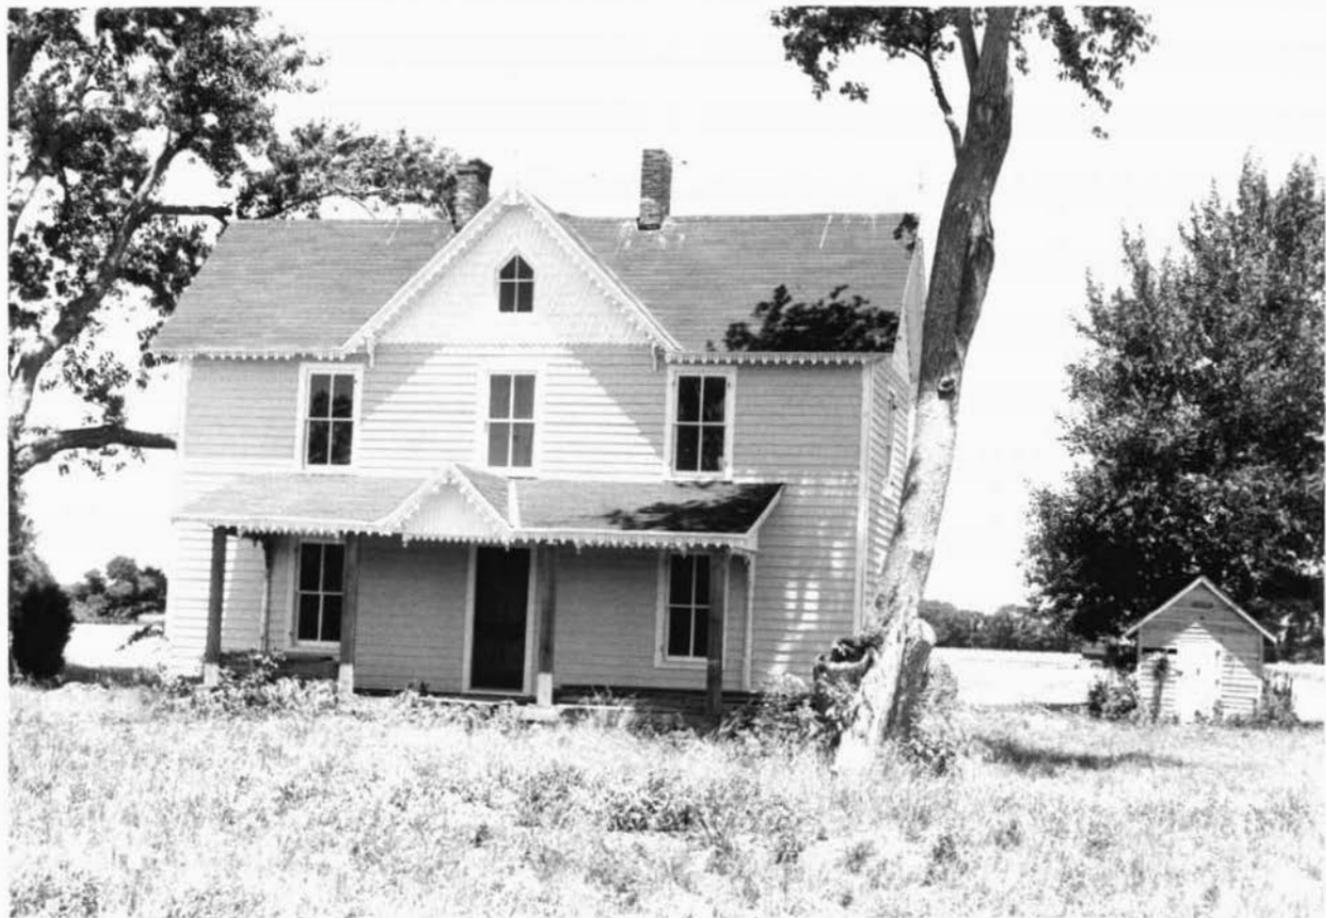
S-358

Bozman-Fitzgerald House
Venton Vicinity, Somerset Co. Md.
South Elevation
6/86, Paul Touart, Photographer
Neg/Md. Historical Trust

The south (main) elevation is a two-story, three-bay facade with a center entrance and flanking two-over-two sash windows. A shed roof porch distinguished with a center gable and decorative eave trim shelters the first floor openings. The turned porch posts have been removed temporarily while the porch floor is being rebuilt. A four-panel door with shallow raised panels remains in place. The second floor is lighted by three evenly spaced two-over-two sash windows, and the cross gable has a pointed arch two-over-two sash window. The eaves to the house are trimmed with decorative sawtooth edging, and the gable front is sheathed with fishscale shingles. Narrow brick stove stacks rise from the center of the house on either side of the passage.
