S-42
Myrtle Grove
Oriole vicinity
private

Maryland Historical Trust State Historic Sites Inventory Form

historic Dr. Hyland House

and/or common Mrytle Grove

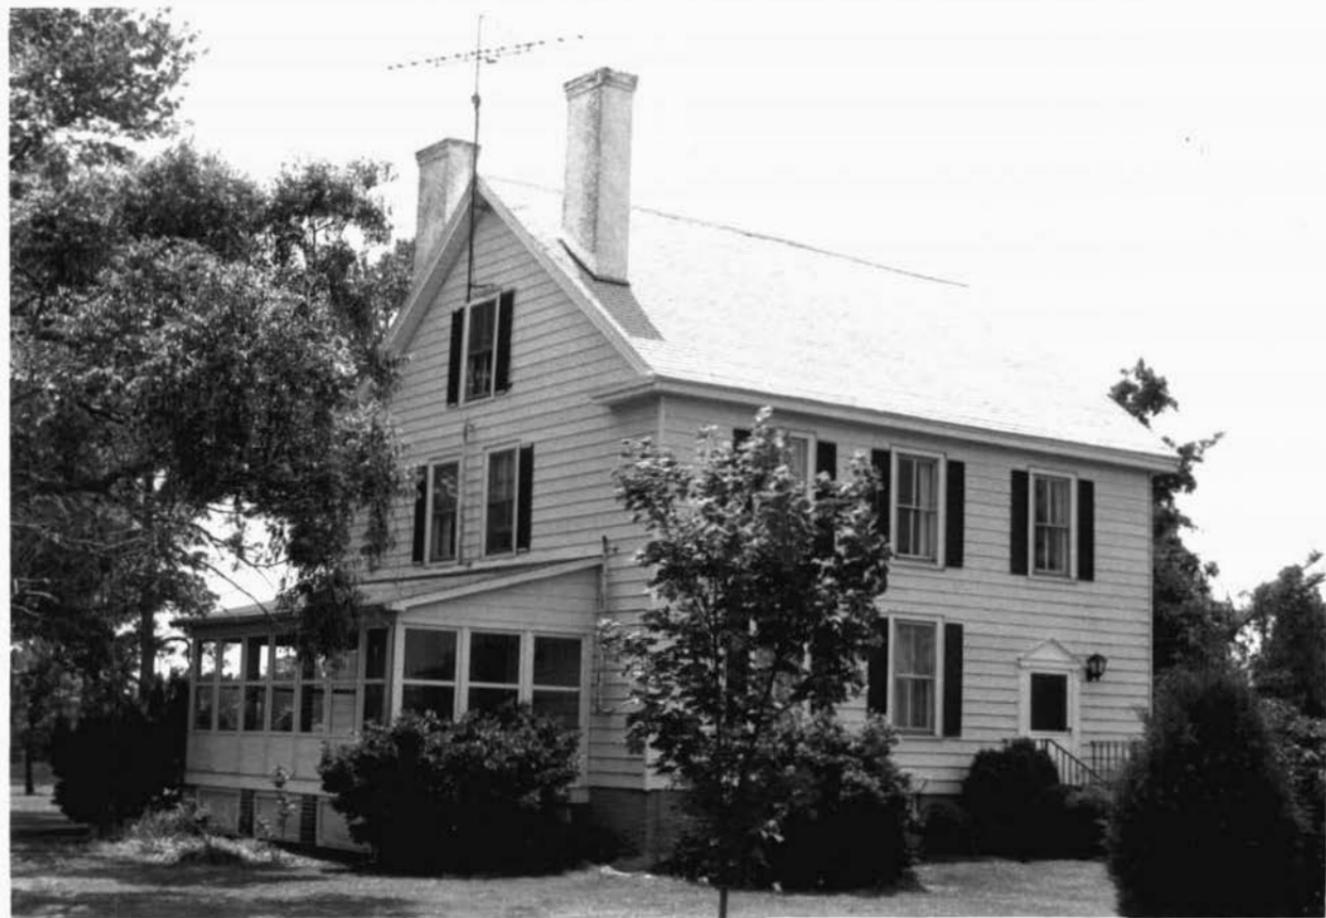
North Elevation

The north (back) side of the main house is an uneven wall surface. Three bays with a west side entrance define the main block, while two additional bays are stepped in from the principal wall surface. The rear entrance is trimmed with a modern Colonial surround, and two-over-two sash windows light the first and second floors. In addition, two diamond cross-sectioned grilled openings pierce the foundation wall.

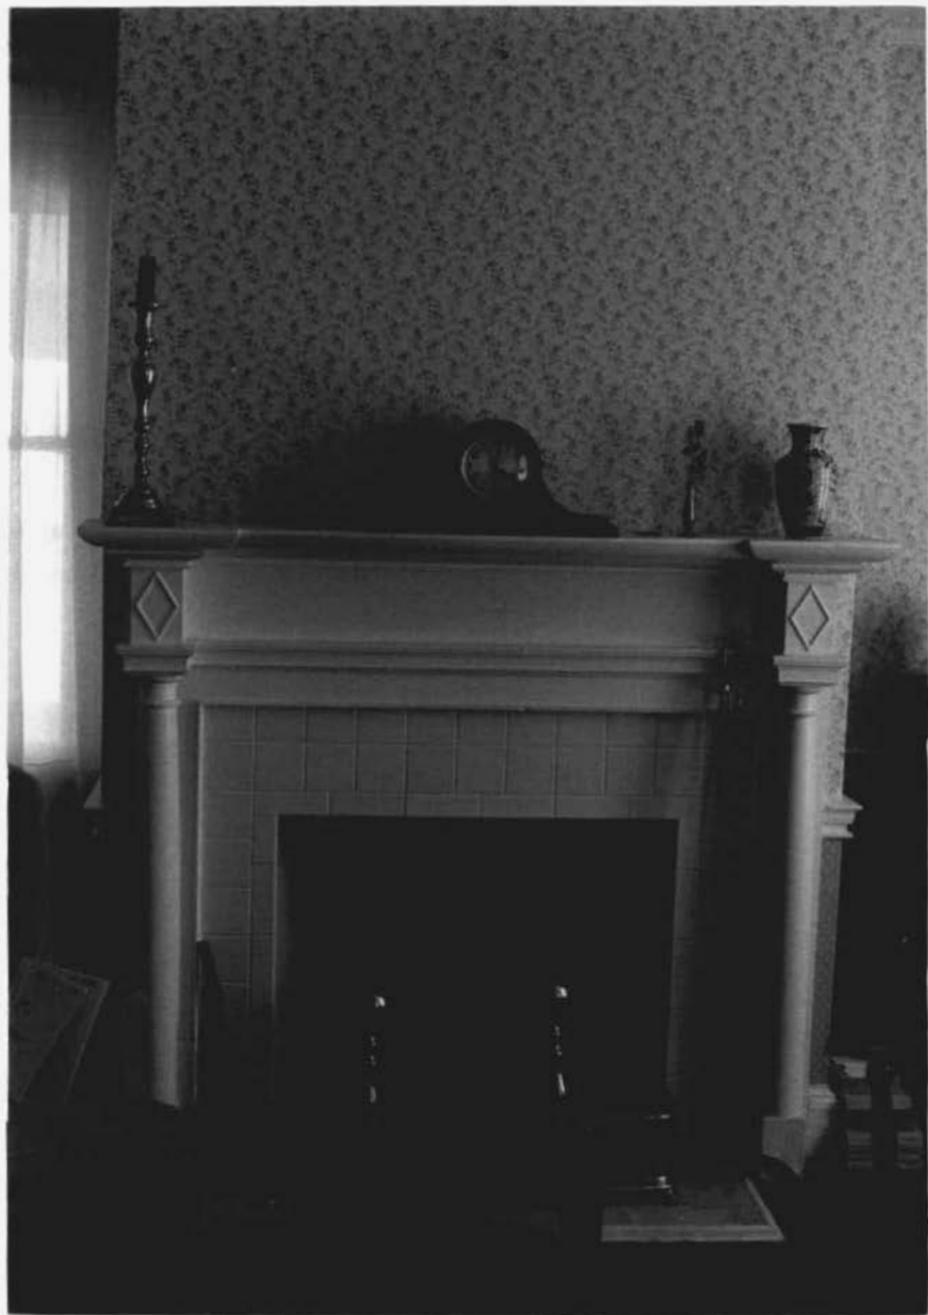
Myrtle Grove S-42
Oriole vicinity, Somerset Co., Md.
Mantel - Parlor
5/86, Paul Touart, Photographer
Neg./Md. Historical Trust

From the hall access is provided to the two principal first floor rooms through slightly raised eight-panel doors, which are framed by thumb molded surrounds. Each doorway has paneled reveals. Both first floor rooms retain early nineteenth-century chair rail, baseboards, and mantels. The mantels in both rooms follow Greek Revival style designs with semi-detached Tuscan columns that support protruding frieze blocks and stepped and broken shelves. The frieze blocks in the south room have a diamond design. Joining the two rooms are large ten-panel double doors framed by fluted surrounds with bullseye corner blocks. The niche to the left of the mantel in the north room (dining room) is filled with an eight-panel door closet.

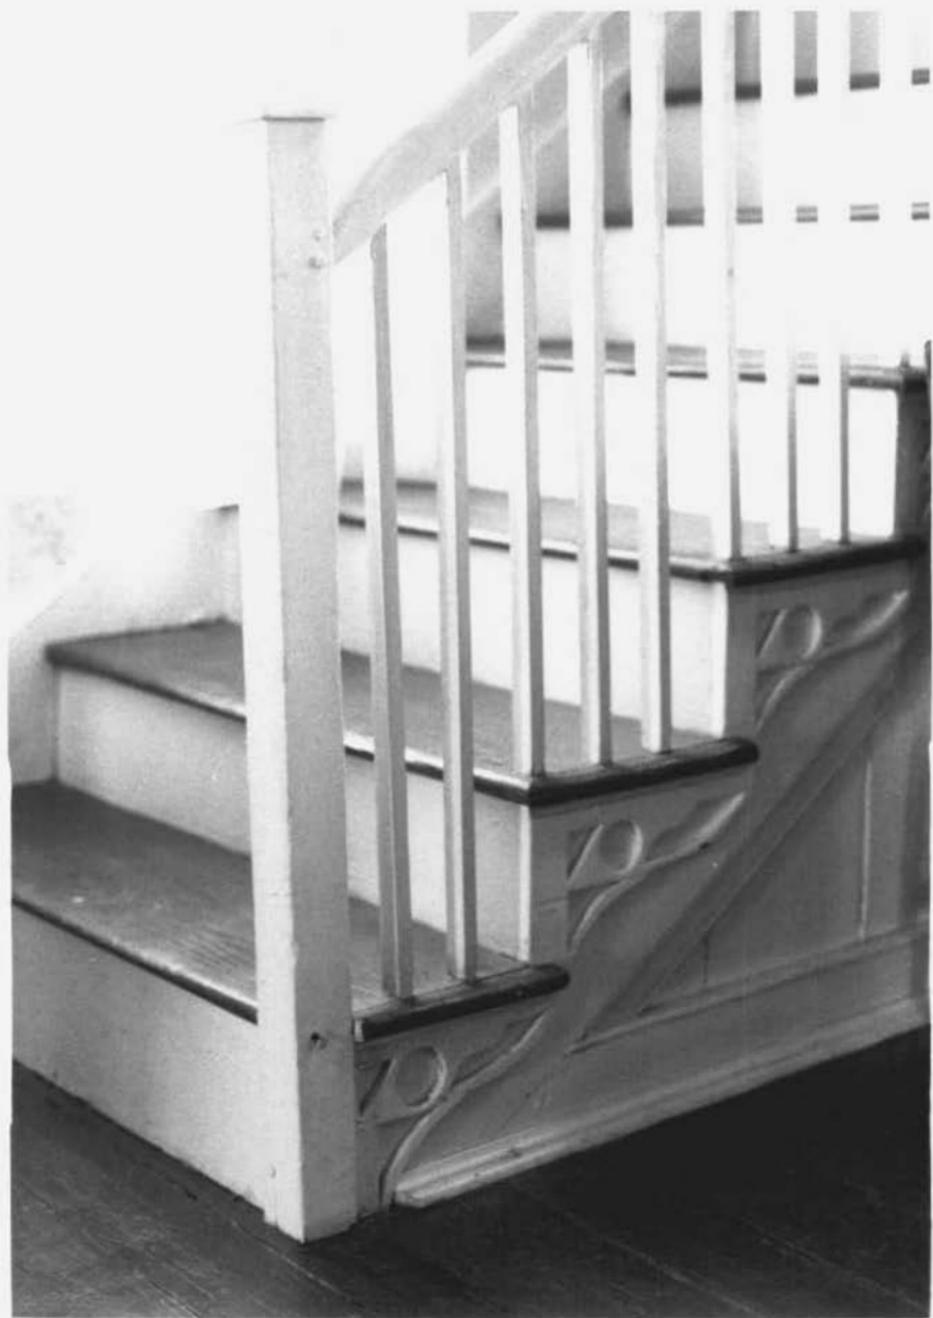
Myrtle Grove S-42
Oriole vicinity, Somerset Co., Md.
Stair
5/86, Paul Touart, Photographer
Neg./Md. Historical Trust

The side hall contains a Federal style stair that rises in an open flight to the attic in the northwest corner. A square newel post and three rectangular balusters to each tread support an oval profile handrail. The stringer is decorated with an unconventional stepped pattern, and the triangular area below the stringer is finished with vertical beaded boards. The stair rises in three flights to the attic.
