**MARYLAND HISTORICAL TRUST
DETERMINATION OF ELIGIBILITY FORM**

Property Name: Stuckey Farm Inventory Number: S-519
 Address: 6402 George Riggin Road City: Westover Zip Code: 21871-3764
 County: Somerset USGS Topographic Map: Kingston
 Owner: Susan G. Stuckey & Donald L. Green Trust, same address Is the property being evaluated a district? yes
 Tax Parcel Number: 0064 Tax Map Number: 0059 Tax Account ID Number: 03-041832
 Project: Great Bay Wind Energy Center Agency: _____
 Site visit by MHT Staff: X no yes Name: _____ Date: _____
 Is the property located within a historic district? yes X no

Great Bay Wind Energy Center
Somerset County - Maryland

Historic Resources Assessment
February 2014

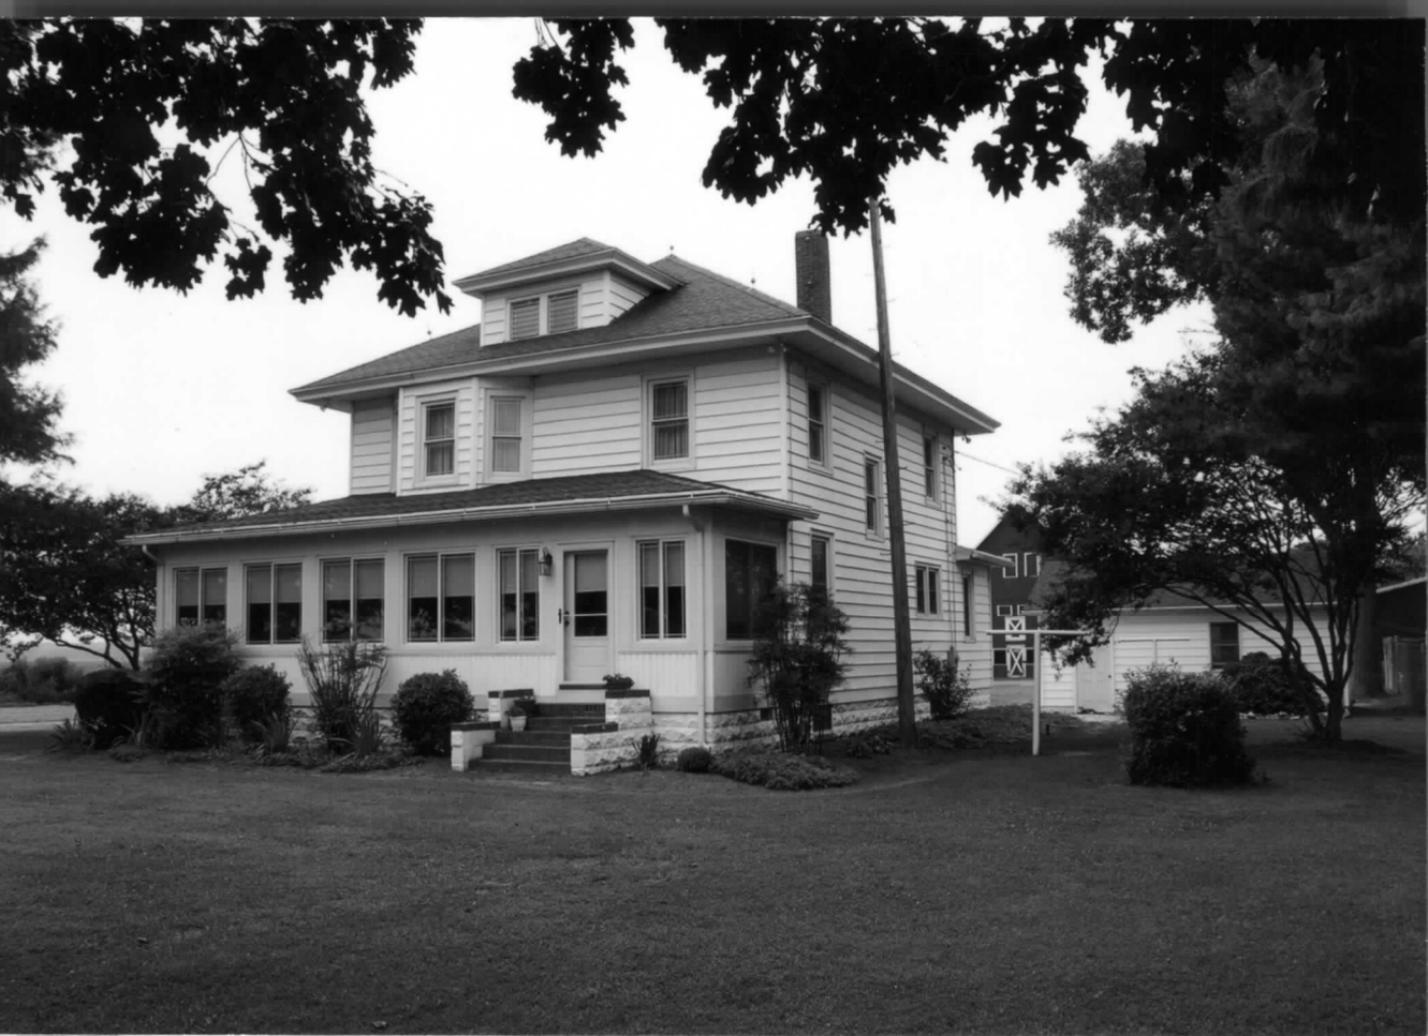
PHOTO # 1/14

The house is two bays wide and two bays deep, with aluminum-sided walls, and a hipped roof clad in asphalt shingles. The house is situated atop a raised poured concrete block foundation. An enclosed wraparound porch is located on the first story of the east (street) and south facades. An entry door is located at the north end of the east façade, and another at the west end of the entry porch. A hipped roof dormer with paired, louvered windows is located on the roof of the east façade. Fenestration is irregular on all facades of the house, generally comprised of one-over-one sash windows. The porch displays paired, sliding sash windows. A canted window bay is located on the south window on the second story of the east façade. A full-story canted bay is located on the west end of the south façade of the house. The west façade displays a one-story enclosed porch addition with offset entry and low-pitched roof clad in asphalt shingles.

VIEW SW TOWARD NORTH & EAST FACADES OF HOUSE

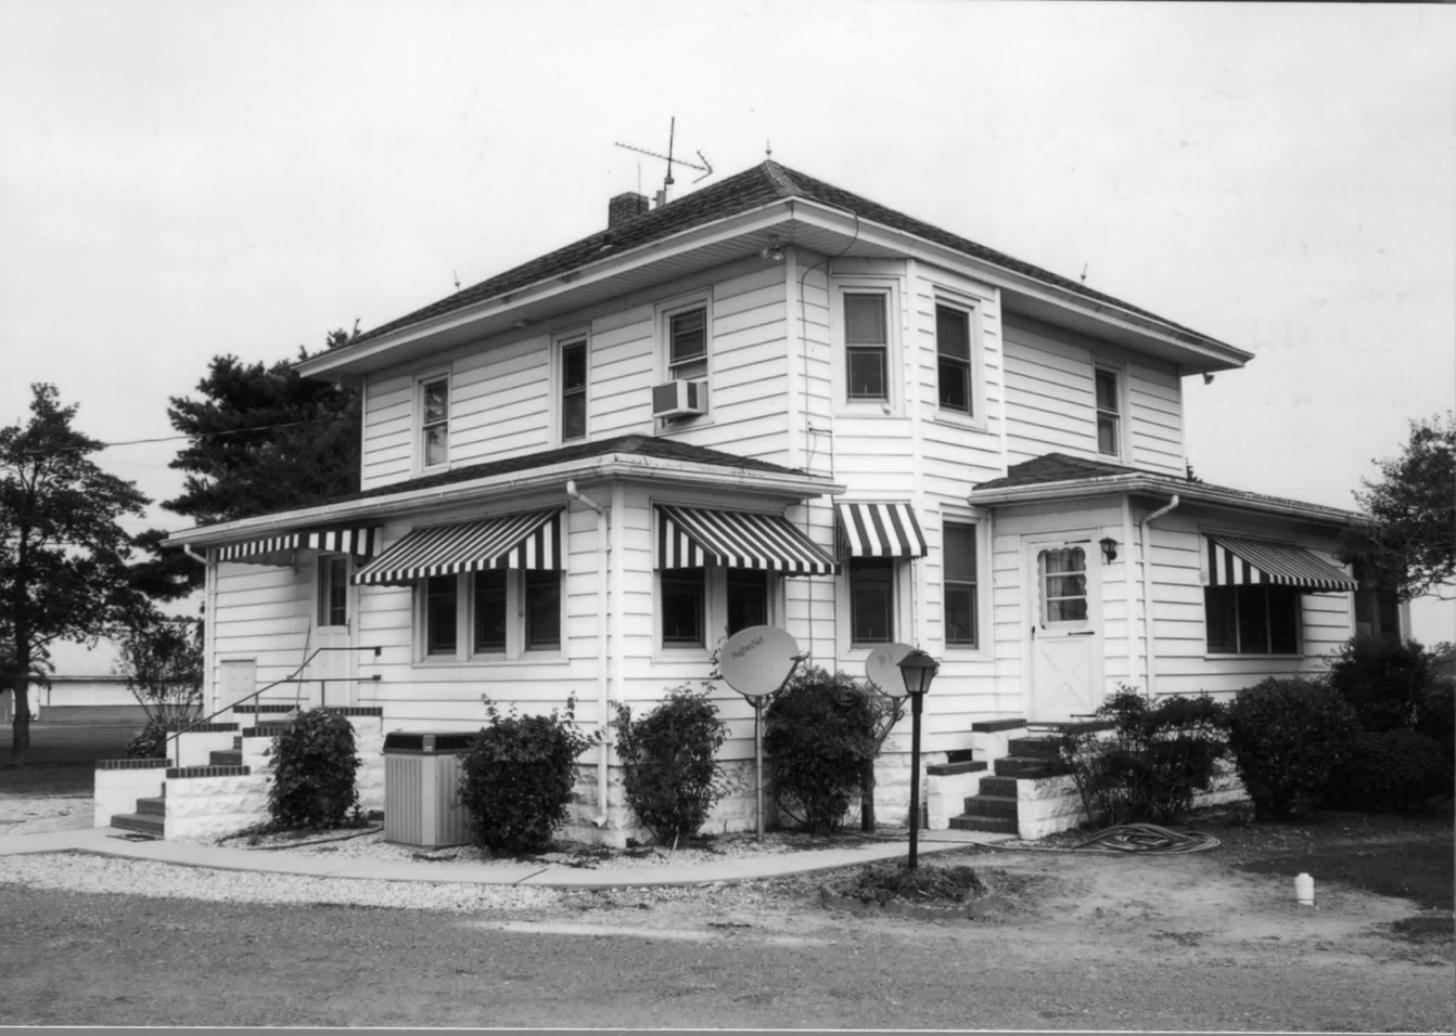
PHOTO # 2/14

VIEW NW TOWARDS SOUTH & EAST FACADES OF HOUSE

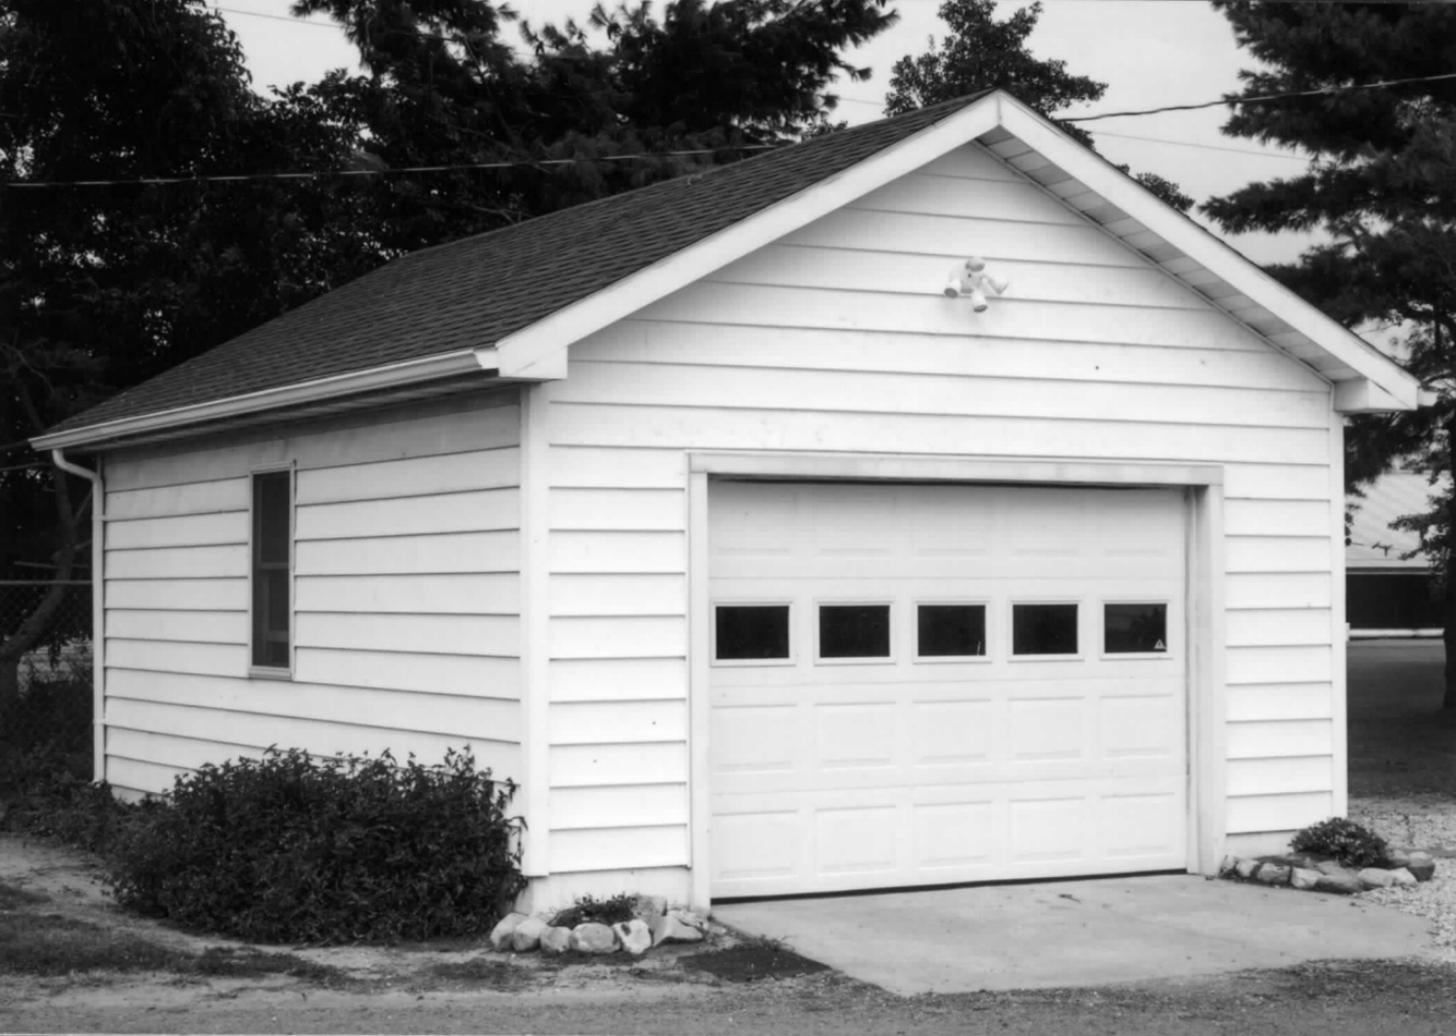
8/28/2013
DIGITAL FILE at MO SHPO
VIEW NE TOWARDS AUTO GARAGE
PHOTO #3 | 14

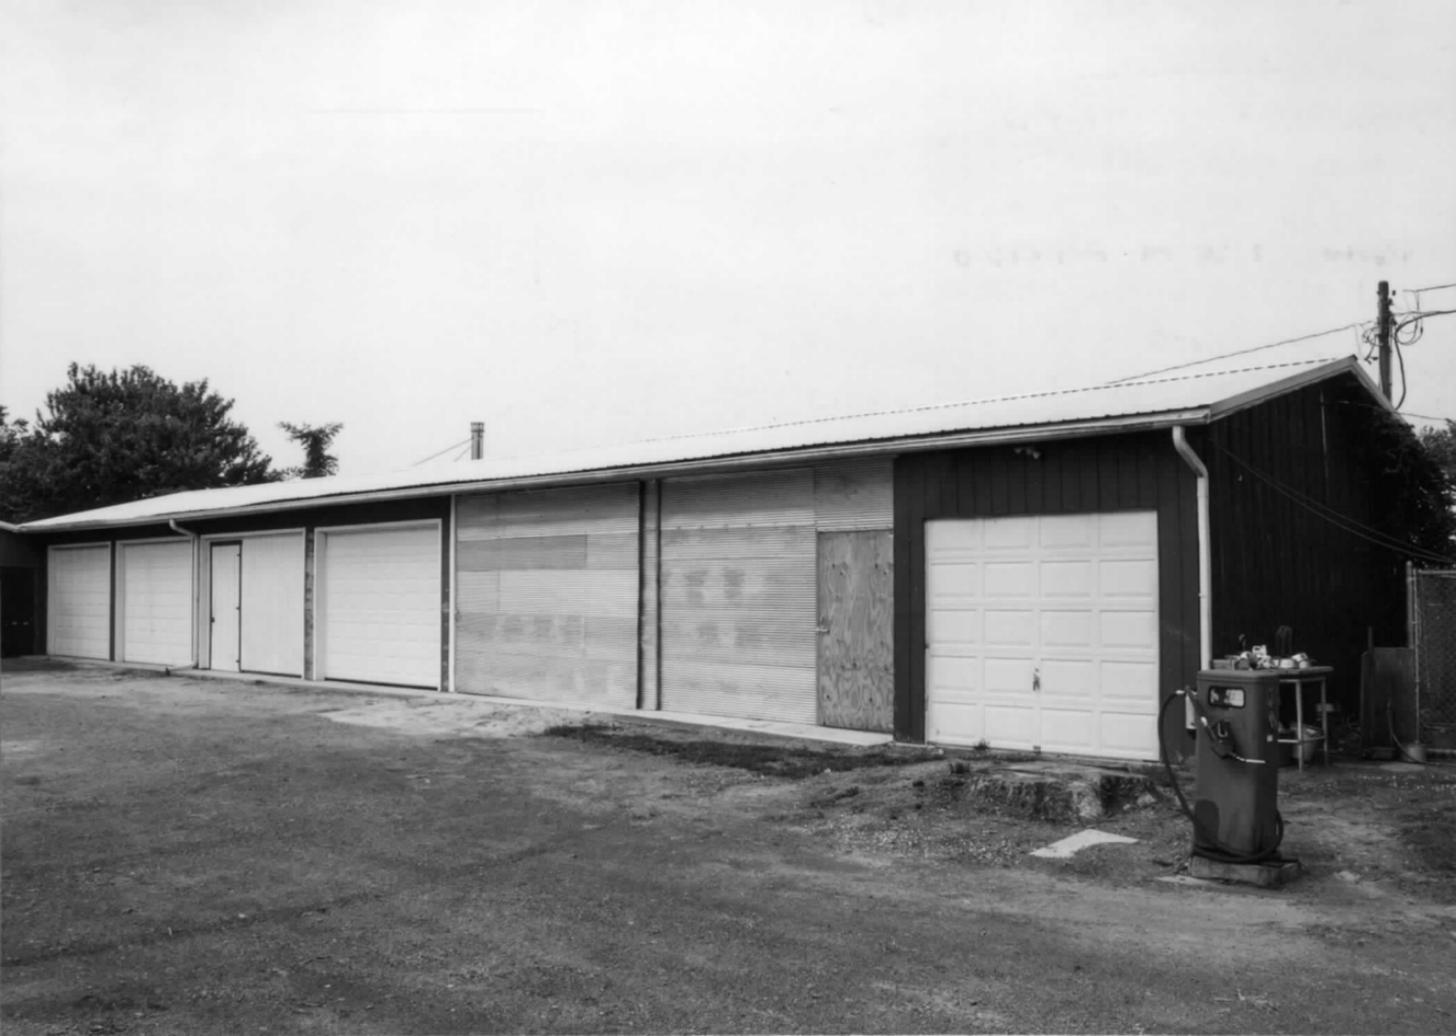
PHOTO #4 | 14

The granary is extended on its north side by a shed roofed addition that served as a workshop. The shed roof of the workshop covers a wall of board-and-batten siding. The workshop joins the granary to a one-story, seven-bay garage. Its walls are clad in plywood and aluminum sheeting. It is topped by a low-pitched, side-gable roof clad in metal. A free-standing mid-twentieth century, single-story, gable-front, single-bay frame garage covered with aluminum siding and a medium pitched gable roof clad in asphalt shingles is located east of the seven-bay garage, directly behind the house.

VIEW NW toward SEVEN BAY GARAGE

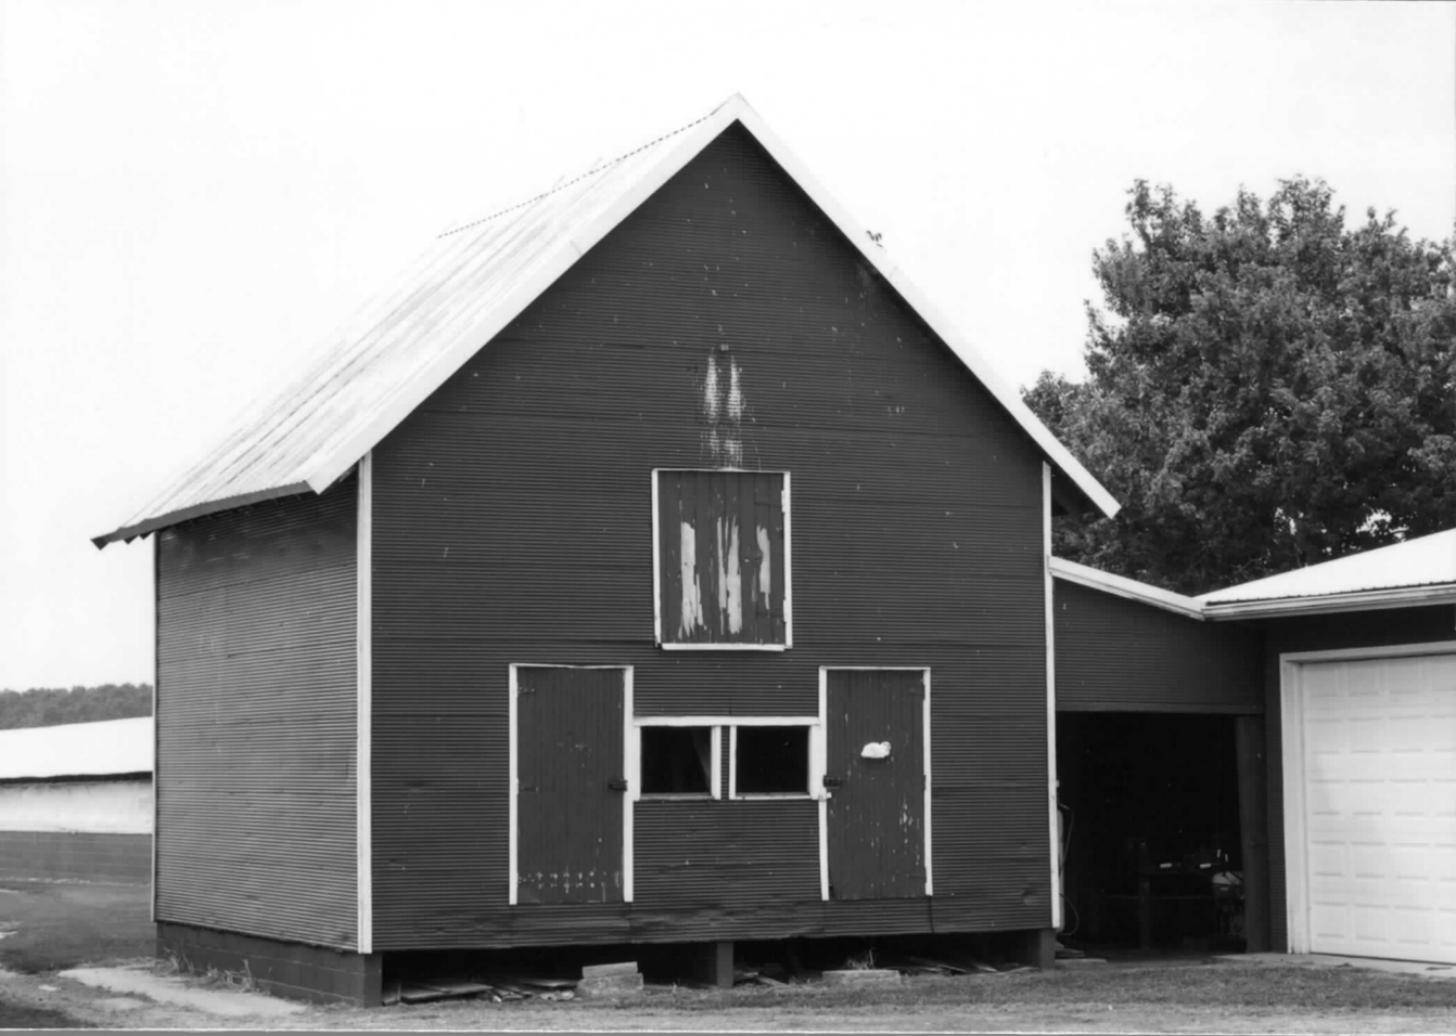
PHOTO #5 | 14

A bi-level frame granary dating from the early twentieth century stands to the north of the hay barn. Supported on concrete block foundation, the exterior is clad with corrugated metal, and the steeply pitched gable front roof is covered with corrugated metal. The edge of the roof has extended eaves with open soffits. The east (main) elevation of the granary is pierced by a pair of door openings fitted with board doors. There are two small, boarded over window openings between the two doors. Another board door centered in the gable end provides access to the granary loft. The granary interior is floored with narrow tongue-and-groove boards, and the side walls are covered partially by a tongue-and-groove board knee wall.

VIEW WNW TOWARD FORMER GRANARY

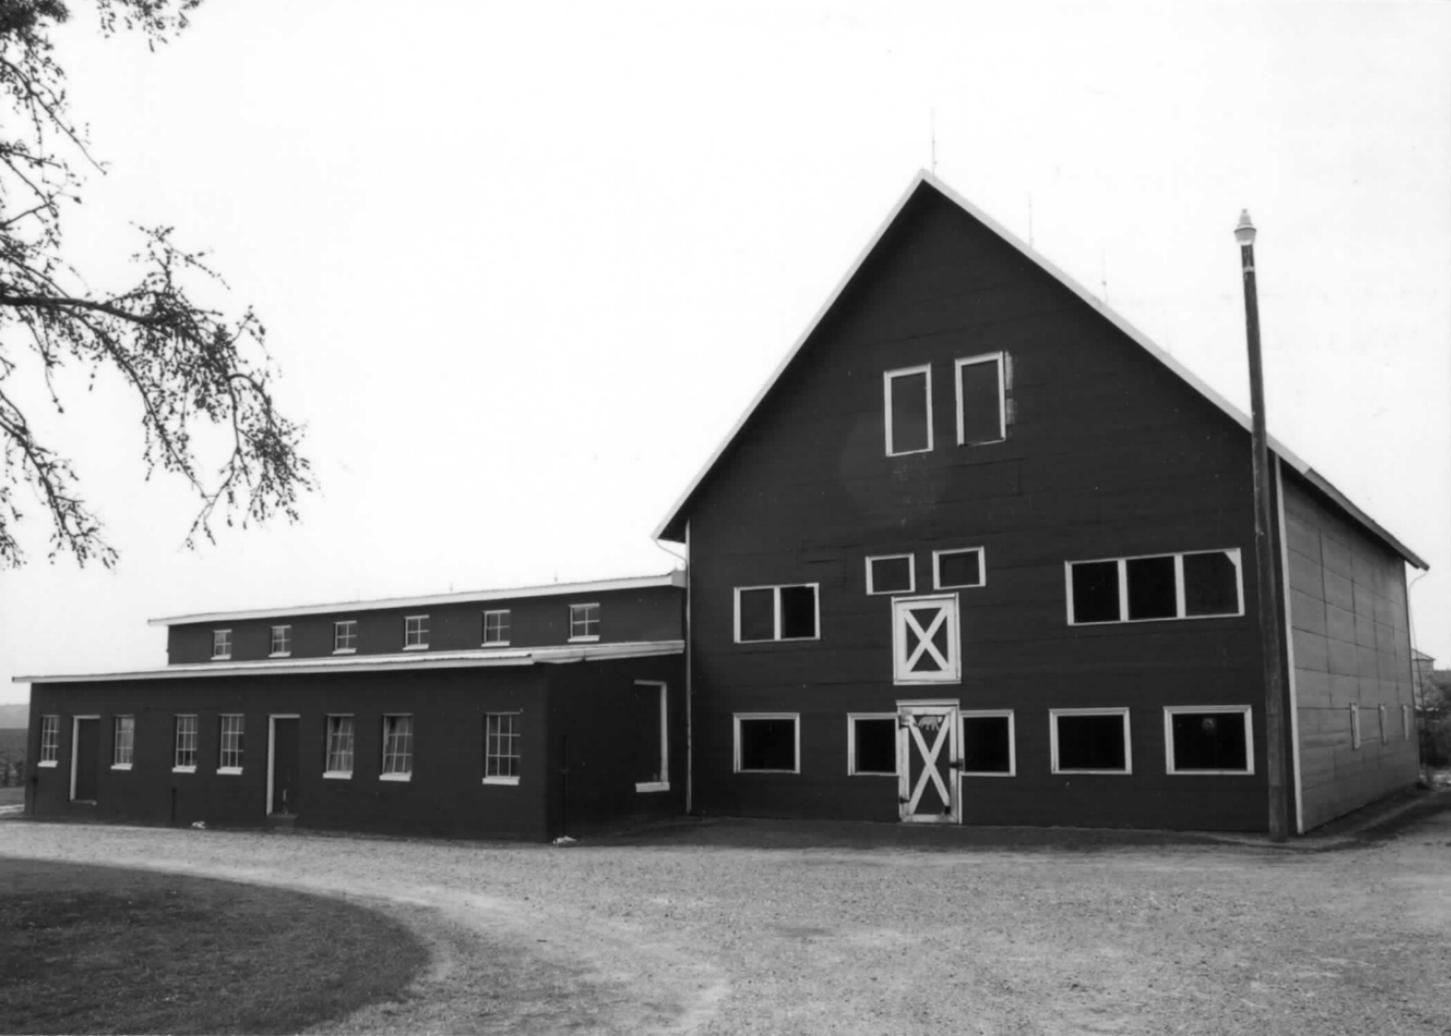
PHOTO # 6/14

A farm complex of early-to-late-twentieth century frame buildings is located west of the house, and is dominated by a large two-story frame hay barn constructed circa 1910. Currently supported on a poured concrete foundation, the braced frame skeleton of the barn, assembled with wire nails, is sheathed with vertical boards covered with corrugated metal. The barn is covered by a steeply-pitched gable-front roof covered with corrugated metal as well. An early twentieth century lightning rod system remains on the roof. The east (main) elevation is defined by an asymmetrical arrangement of boarded over window openings. A center door provides access to the ground floor, and the rectangular, boarded up window openings are located to each side. Another door provides access to the loft, which is also marked by boarded over window openings. A pair of boarded over access doors pierce the east gable end. The edge of the roof is finished with extended eaves and open soffits.

A one-and-a-half story concrete block wing dating from the second quarter of the twentieth century, initially built for hogs, extends from the south side of the hay barn. Distinctive to the concrete block addition are rounded outer corners and rounded corners on each of the metal nine-pane window openings. The concrete block addition has a monitor-type roof pierced by a series of six four-pane windows. The concrete block wing covers the south side of the hay barn, while the other two sides to the north and west are defined by boarded up window openings. The interior of the early twentieth century barn has a center aisle flanked by square posts that support beams that underpin the second floor joists. The interior first story framing retains a coat of whitewash. A reused Federal-era six-panel door is located on the second floor of the barn.

VIEW WSW TOWARD FORMER HAY BARN & WING

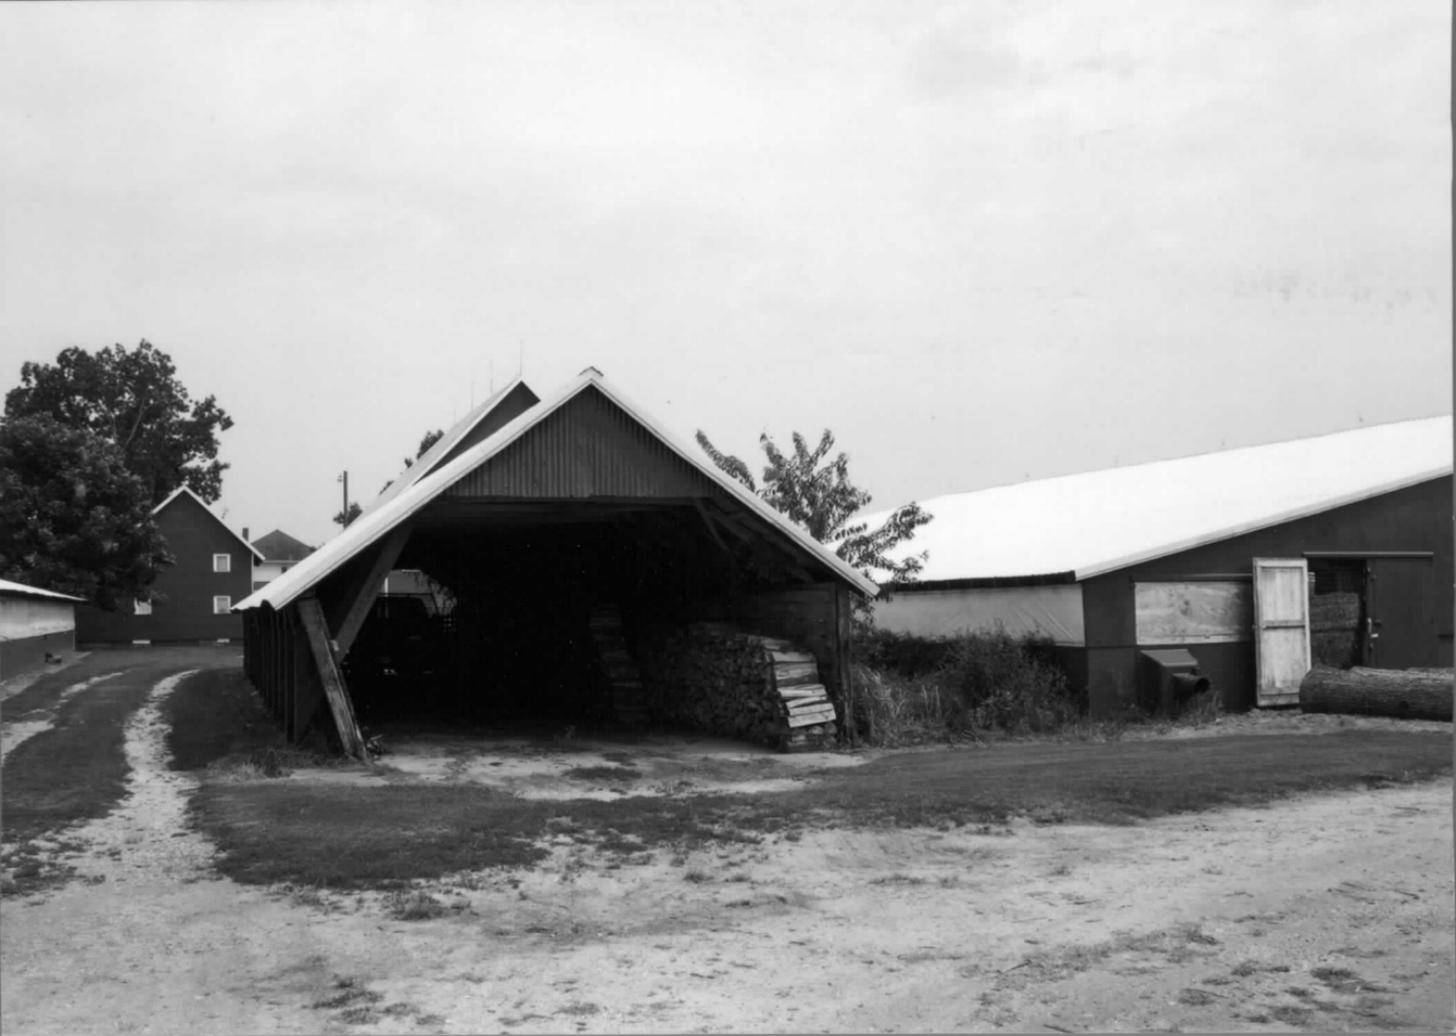
PHOTO # 8/14

VIEW E TOWARD FRAME WOOD SHED

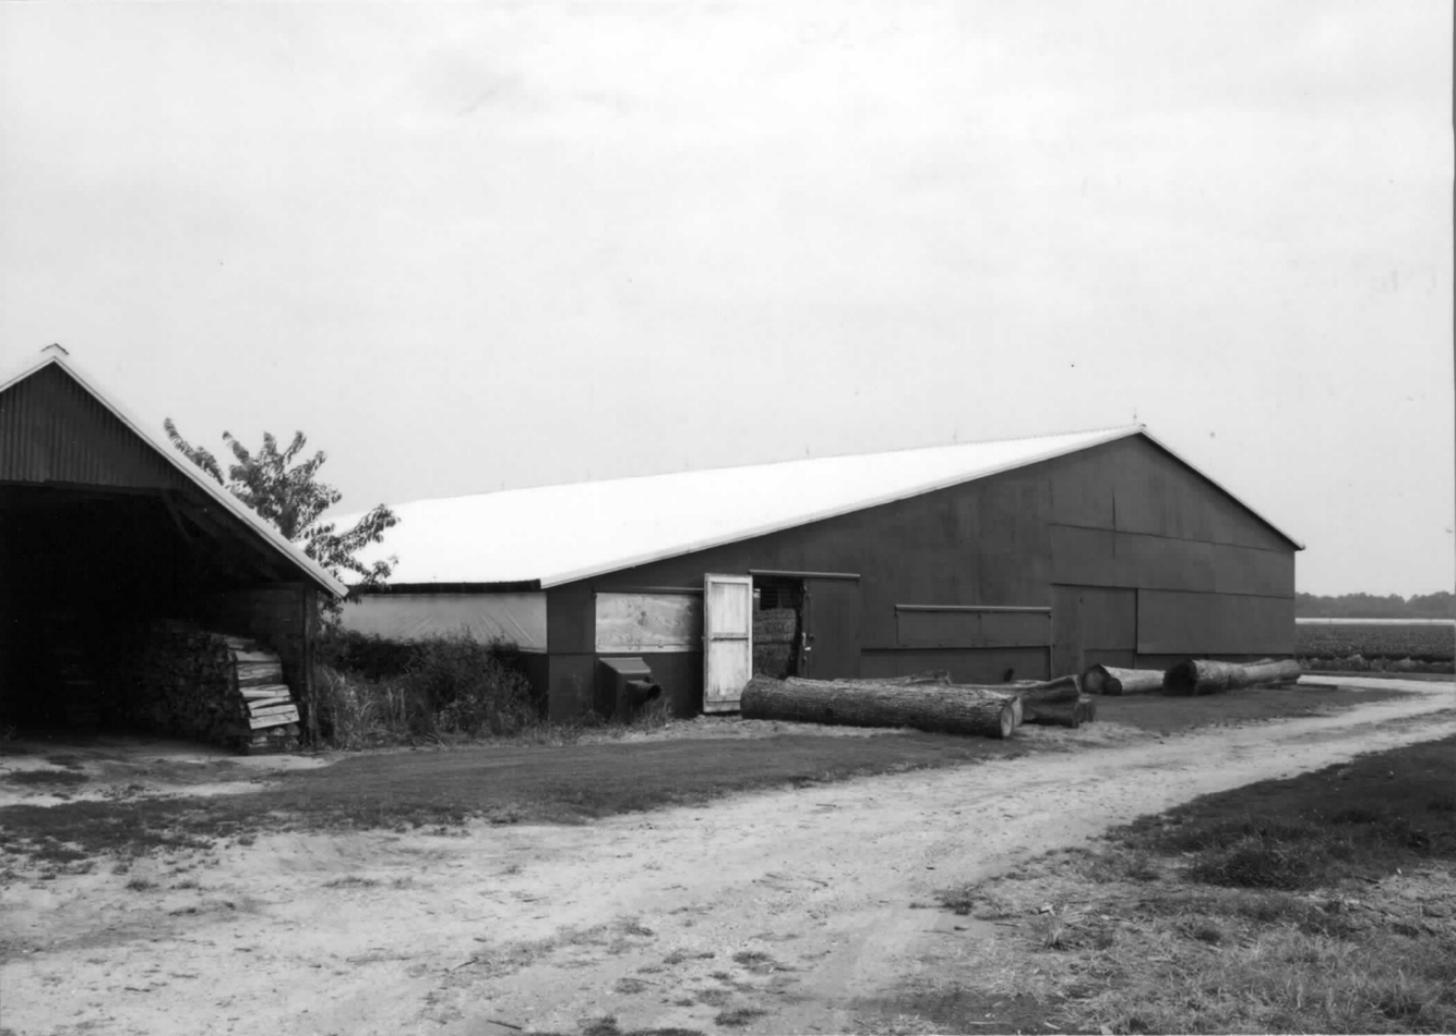
PHOTO #9/14

VIEW SW TOWARD IMPLEMENT SHED & TRACTOR BARN

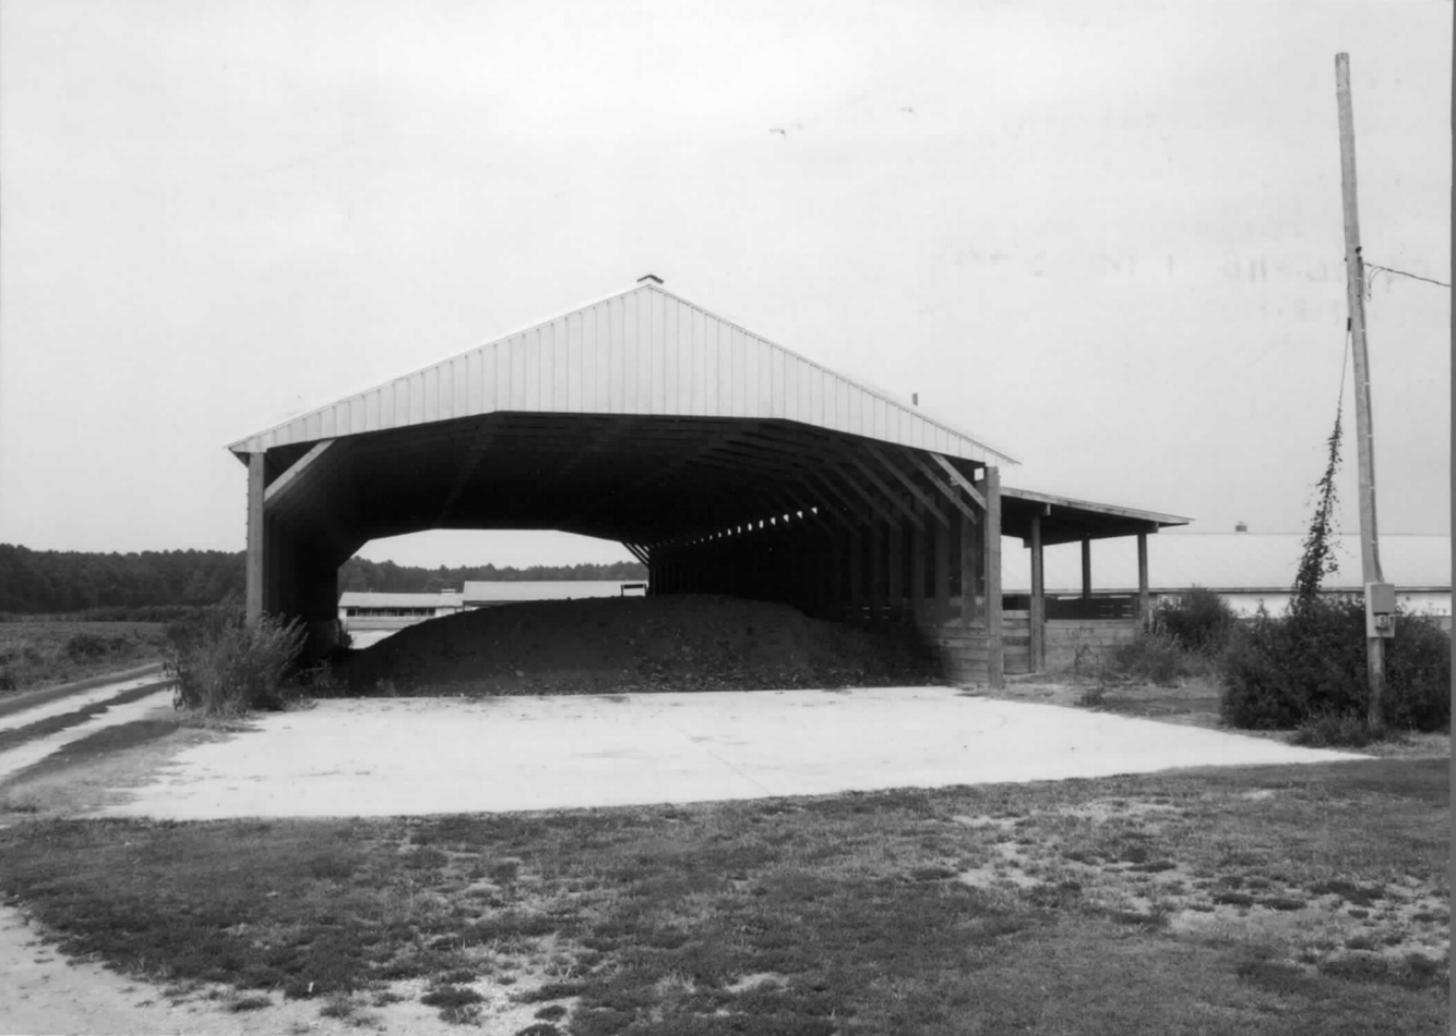
PHOTO #10 | 14

A series of three, long, metal-clad chicken houses built during the mid-to-late twentieth century (1958, 1960 and 1991) is located north of the mid-twentieth century hog house. A large, gable-roofed manure shed with an open front facing south is located to the west of the hog house. Other buildings in the farm complex built during the late twentieth century include: a gable-roofed wood house erected with ground set posts, featuring open front and rear walls and covered by a medium pitched gable roof; a long implement storage building built atop a poured concrete slab and supported on stout poles, located south of the wood house; and an open-fronted wagon shed covered with a metal-clad roof. Two corrugated metal silos of mid-to-late twentieth century construction are located to the west of the pole shed.

VIEW NINE TOWARD MANURE SHED
