MARYLAND HISTORICAL TRUST  
DETERMINATION OF ELIGIBILITY FORM

Property Name: Rosedale Manor Inventory Number: SM-101  
Address: Greenwell State Park City: Hollywood Zip Code: 20636  
County: Saint Marys USGS Topographic Map: Hollywood  
Owner: State of Maryland Is the property being evaluated a district?  yes  no  
Tax Parcel Number: \_\_\_\_\_ Tax Map Number: \_\_\_\_\_ Tax Account ID Number: \_\_\_\_\_  
Project: ADA Renovations Agency: DNR  
Site visit by MHT staff:  no  yes Name: Tania Tully Date: 12/11/2002  
Is the property is located within a historic district?  yes  no

National Register of Historic Places  
Registration Form

historic name ROSEDALE

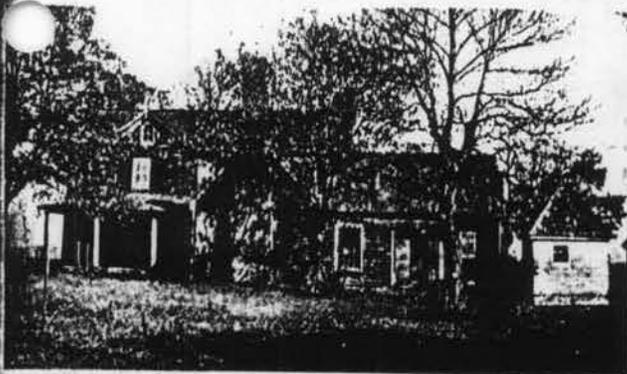
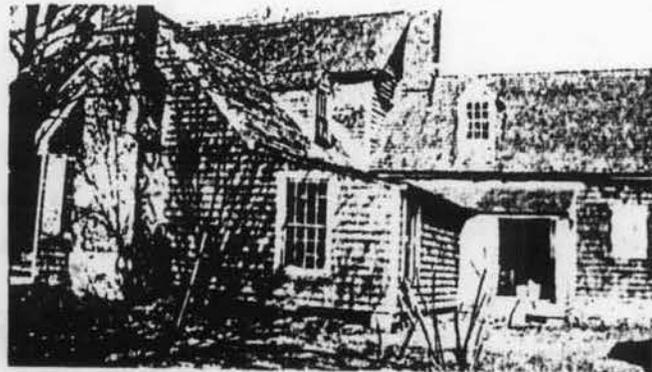
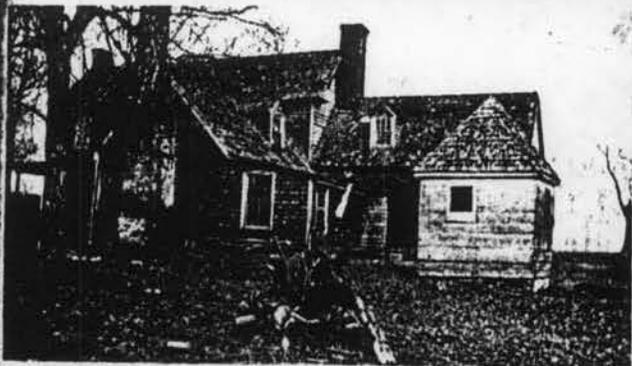
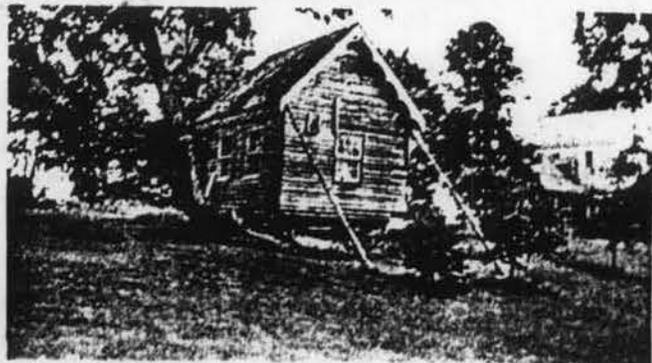
Rosedale In 1941

A series of exterior photographs of the main house at Rosedale taken in 1941 before rehabilitation and alterations commenced depict a building of significantly different architecture from that which exists today. These photographs, all of which are views taken from the south, show the house to have been a rectangular, two-story, frame structure built on a northwest-southeast axis and with a brick chimney at each end of its gable roof. These are the only similarities between the house as it existed and the house one sees today.

The 1941 photographs record convincing physical evidence that the original house - the central core of the present structure - was likely built in two stages, beginning as a two-story, side-passage dwelling with an exterior chimney at its southeast end that was subsequently enlarged by a two-story extension of its northwest elevation, the latter

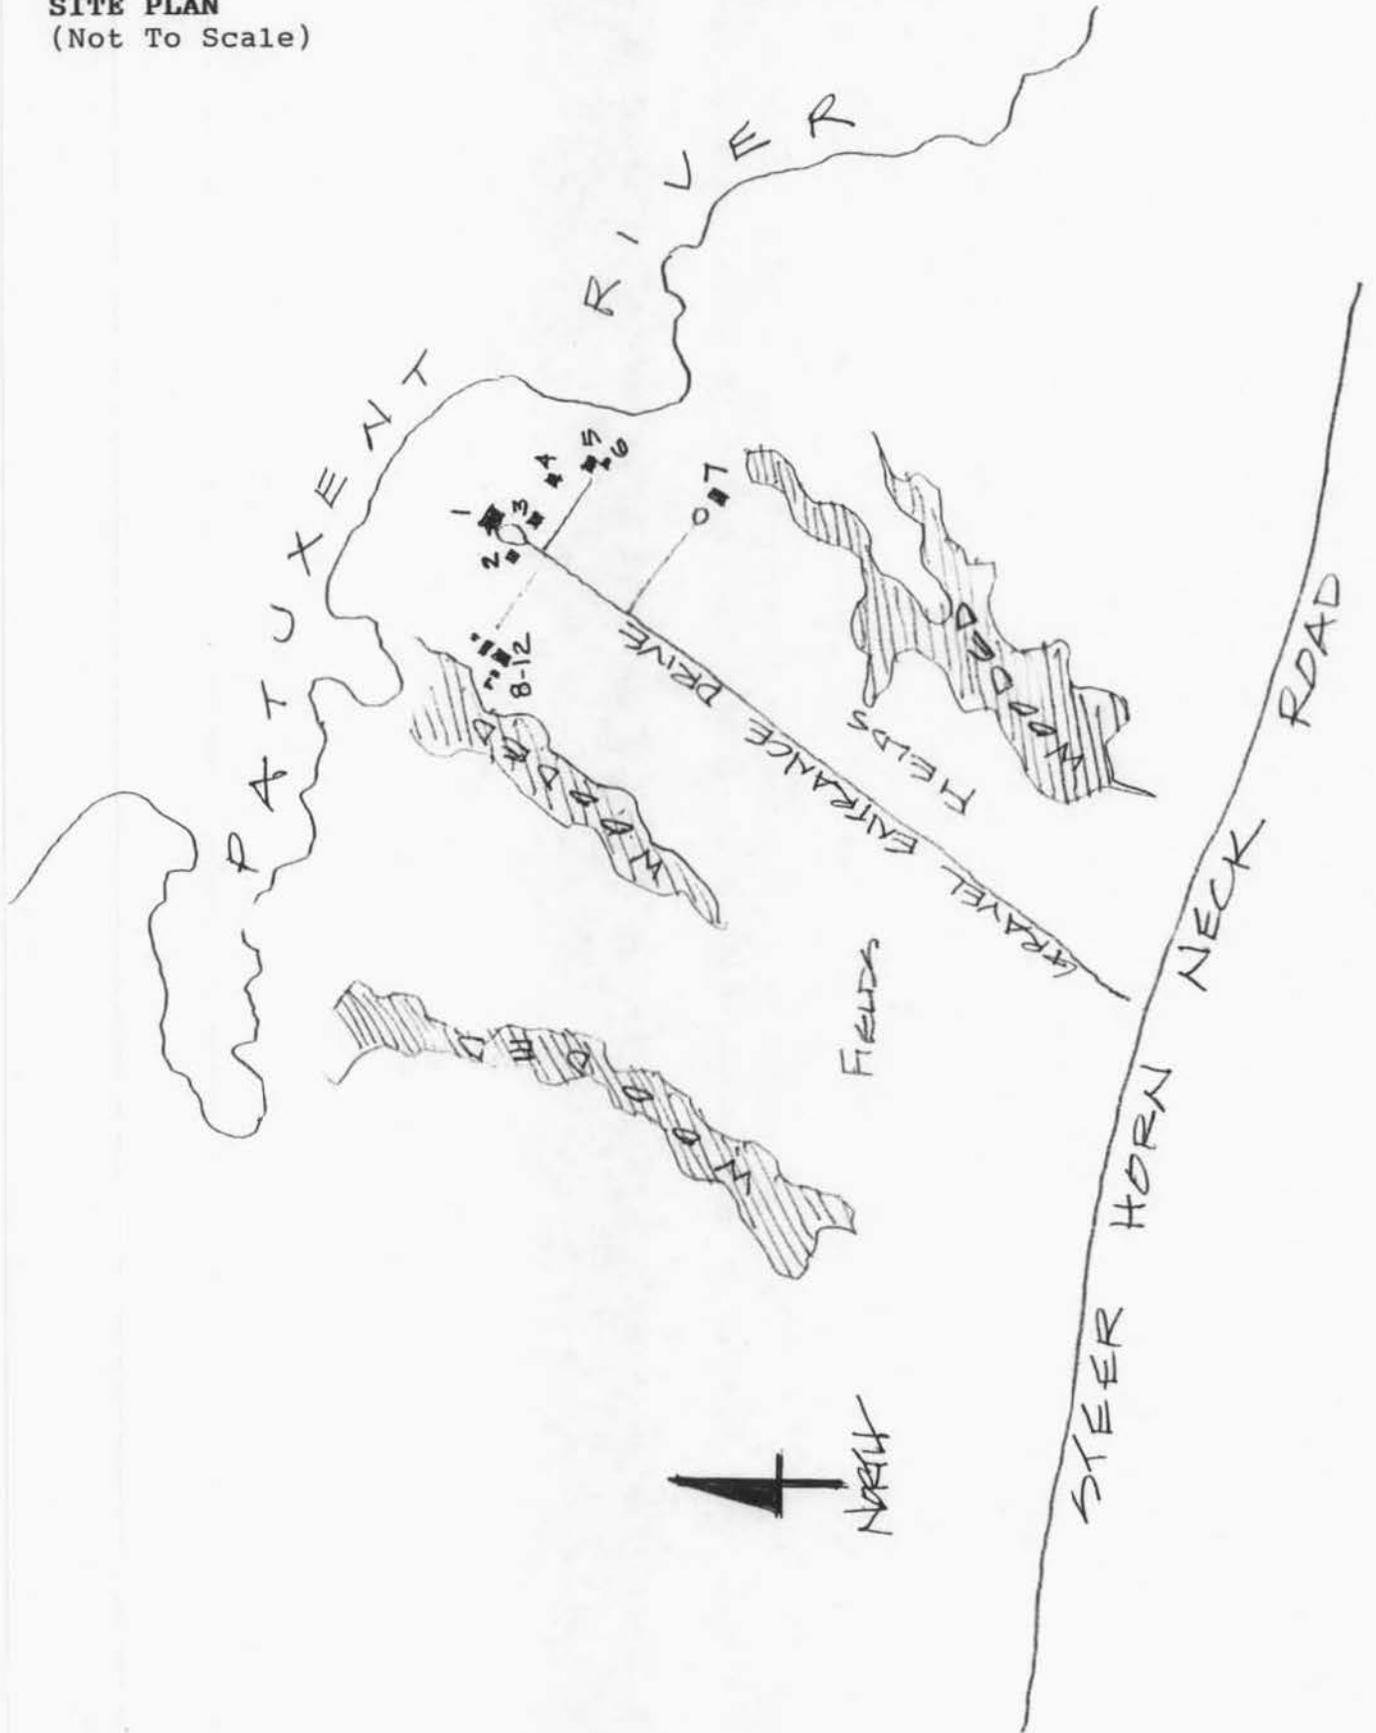
SITE PLAN  
(Not To Scale)

The following describes each of the standing structures on the Rosedale property. The descriptions, which are keyed to the accompanying site plan, include the present and pre-1941 appearance of each building.

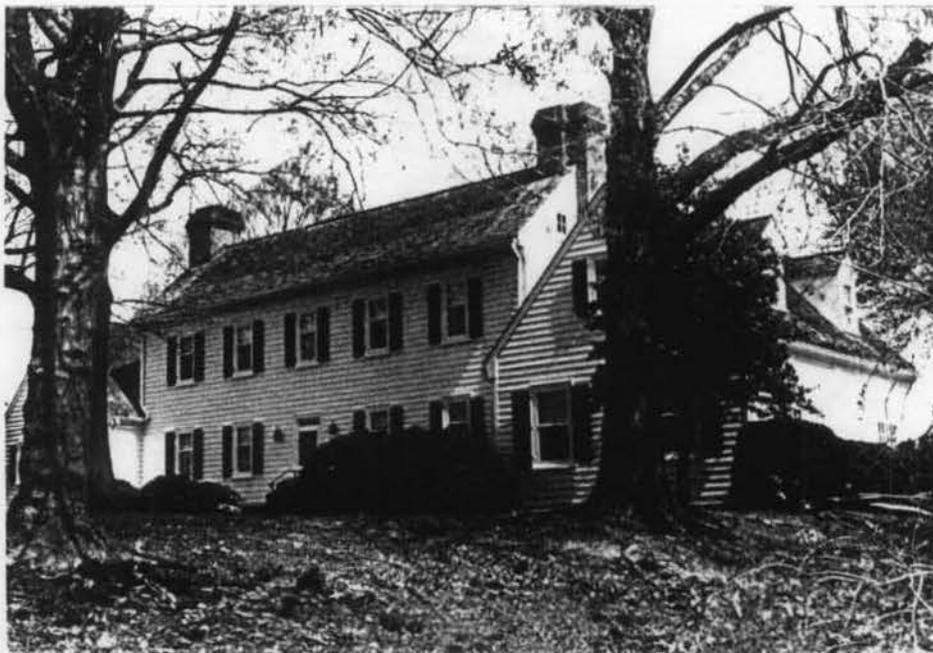
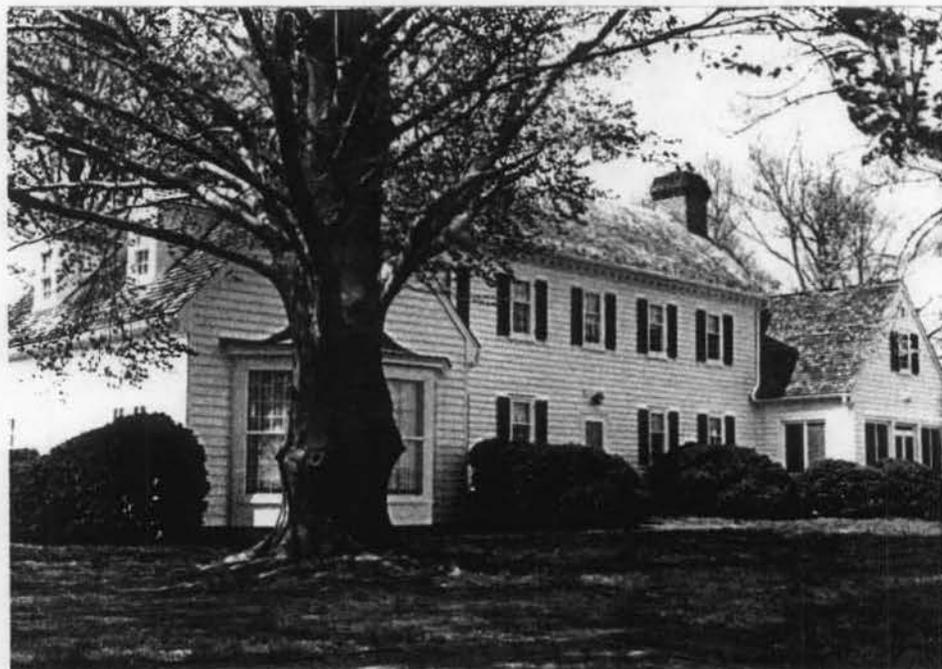
TOP: View of main house (1) from southeast.  
BOTTOM: View of main house from northeast.

Situated on a promontory affording broad vistas of the Patuxent River, the principal residence on the Rosedale property is a three-part frame structure composed of a two-story, five-bay, gable-roofed central block flanked by matching one-story wings. The wings, set at a right angle to the main block, project forward of the front and rear elevations of the latter, giving the house an "H"-shaped plan. The approach facade of the central block features a transomed door flanked by two six-over-nine pane sash windows, with five evenly spaced windows of matching sash above. The same door location and fenestration pattern is repeated on the opposite side of the house, the only difference being that there is no transom over the door. This portion of the building features brick foundation walls, lapped beaded siding and wood roof singles. The eaves are trimmed with modillion blocks and there is a large, "T"-shaped, brick chimney stack at each end of the roof ridge. All of the windows are fitted with louvered blinds.

The flanking wings have matching fenestration on their southwest (approach) ends but differ on the other elevations. The northwest wing, which houses kitchen-service spaces at the first-floor level, is not as "formal" in external appearance as the southeast wing, the latter having two double-leafed French doors in its southeast wall, two gable-fronted dormers above these, and a wide, bow-shaped window at its northeast end. The northwest wing has a door and smaller windows in its northwest elevation and an enclosed porch at its northeast end. Like the main block, the wings are clad with beaded siding and have wood shingled roofs.

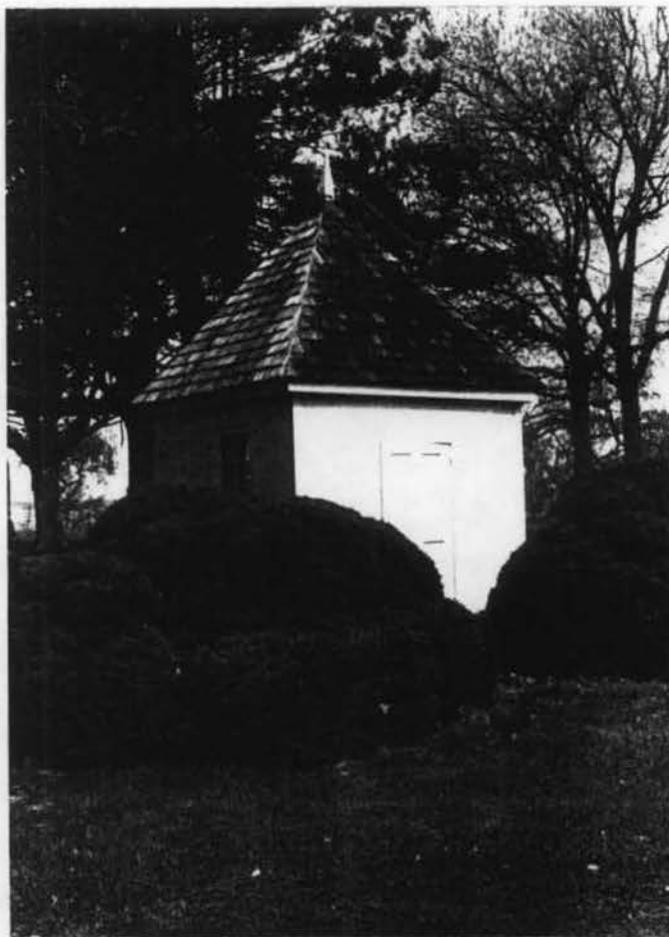
View of garden house (2) from south.

Measuring 8'-3" on a side, this is a small wood-framed structure with a pyramid roof. The exterior walls are sheathed with wide, horizontal, flush boards. Some of this siding, notably on the upper parts of the side and rear walls, is original, while other boards are twentieth-century replacements. The roof is sheathed with wood shingles. There is a simple boxed eave cornice with beaded fascia and a narrow crown molding, all of a profile typical of the 1830s and 1840s. A four-panel door with reproduction hardware is centered in the southeast elevation. The building stands on continuous, common-bond brick foundations.

The interior of the garden house features a brick tiled floor, plastered walls and ceiling, and simple trimwork. All of these finishes are twentieth century. The building's wall framing is completely sealed within modern finishes; the roof rafters, visible from a small trap door in the ceiling, are sawn and appear to be mid nineteenth century while the shingle nailers are of more recent vintage.

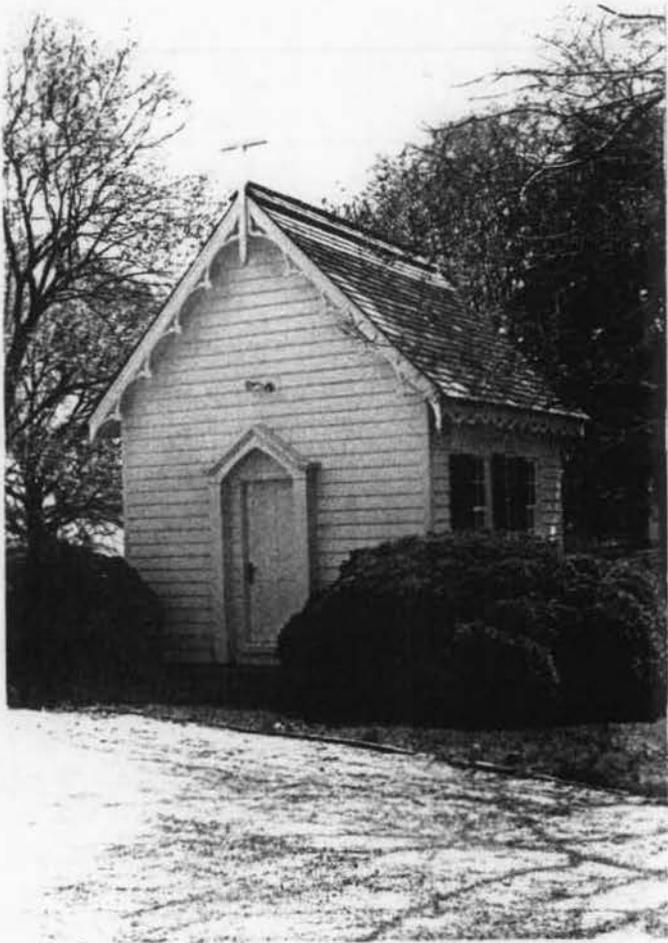
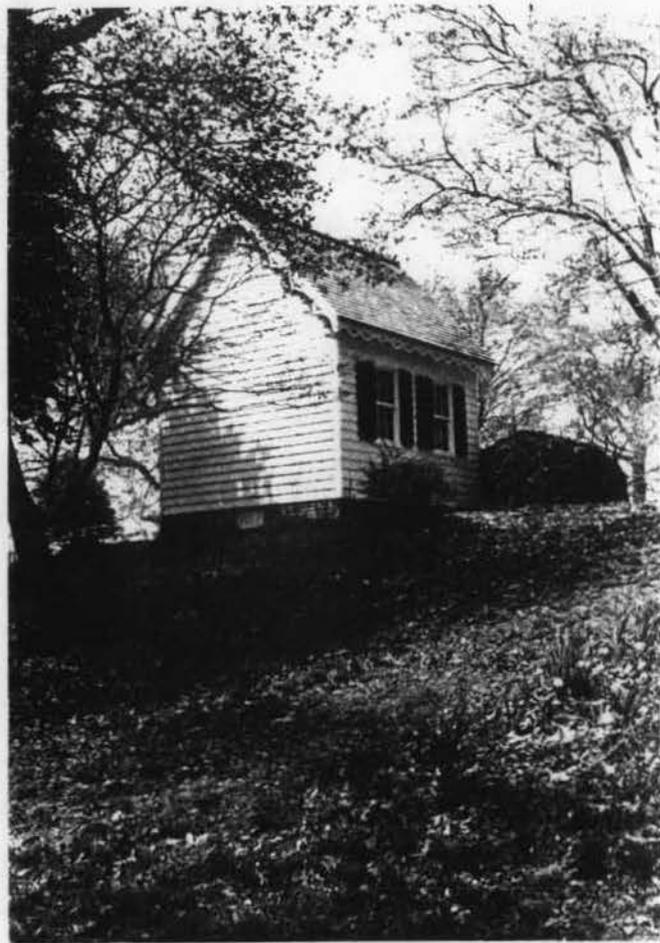
LEFT: View of chapel (3) from south. RIGHT: View of chapel from north.

located to the right (southeast) side of the beginning of the circular drive fronting the house, and directly opposite the drive from the garden house (2), the chapel is a one-story, 14x16-foot, gable-roofed frame structure whose northwest-southeast axis parallels that of the main house (1). The entrance door is centered in the northwest end within a slightly projecting, vaguely Gothic-style enframingent. There are two sash windows in each side wall, all with louvered shutters. The building stands on common-bond brick foundations, the exterior walls are clad with lapped siding and the roof is wood shingled. The most notable exterior feature of the building are pierced and scalloped fascia boards ornamenting the overhanging eaves of all four elevations. The pattern of cutouts and scallops of the two end elevations are similar to but do not precisely match that of the side elevations. Additionally, the boards of the northwest (front) elevation have trefoil-shaped drops between the scallops and at their bottom ends. This same elevation features a wooden cross with a carved, pendant-shaped base affixed to the apex of the gable. With the exception of the ornamental fascia boards, all of the building's exterior finishes are twentieth century.

The chapel's interior contains a single room with a vaulted ceiling. The walls have wainscoting of wide, vertical, beaded boards below the line of the window sills. The remaining wall areas and the ceiling are plastered. The floors are random width boards surface nailed with wire nails. An altar at the southeast end of the room

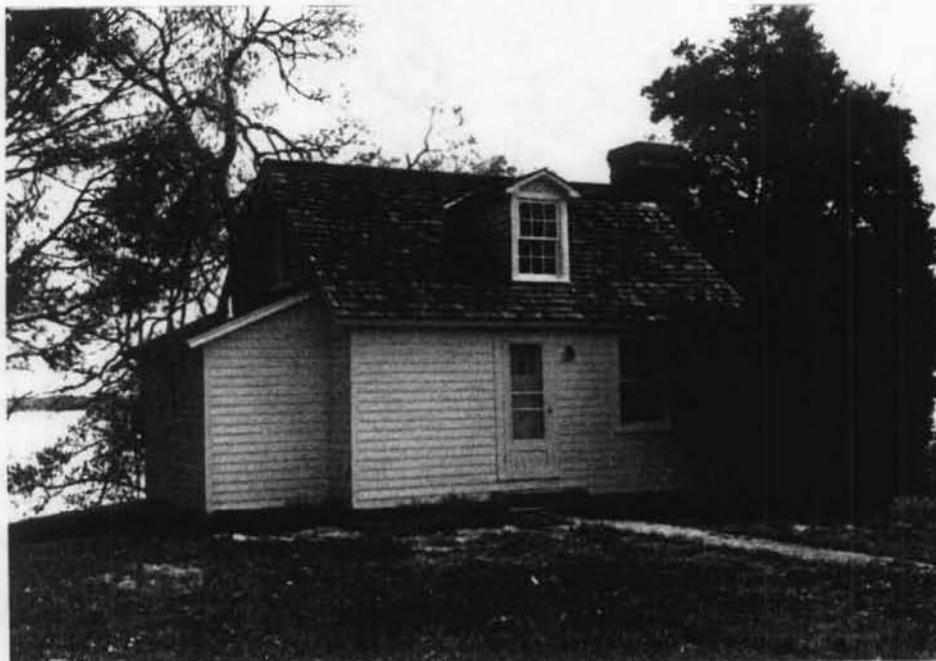
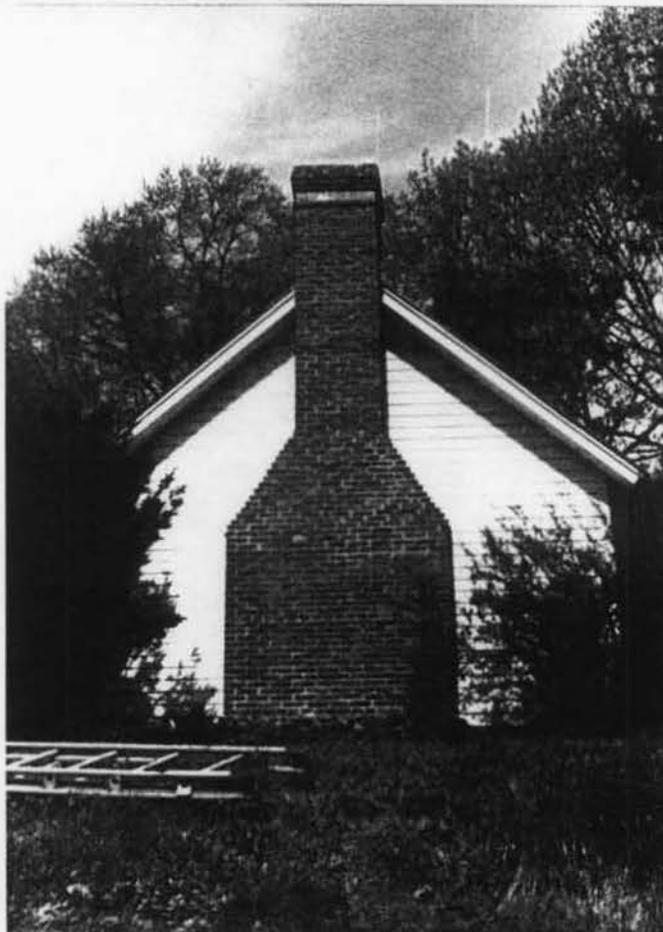
TOP: View of guest house (4) from south.  
BOTTOM: View of guest house from southeast.

Perched on a knoll a short distance southeast and across a ravine from the main house (1), the guest house is a small, two-bay frame structure whose gable roof follows a northwest-southeast axis. There is a shed-roofed wing at the northwest end, a single, gable-fronted dormer on each side of the roof, and a massive exterior chimney with stepped shoulders at the southeast end. Both the building and the chimney are underpinned with foundations composed of fossilized river marl and shells, a building material sometimes found in historic building foundations along the lower Potomac and Patuxent rivers. These foundations do not appear to date earlier than the twentieth century, though may have been constructed using material salvaged from another building. All of the exterior finishes of the buildings, including sash and doors, lapped siding and wood roof shingles are twentieth century.

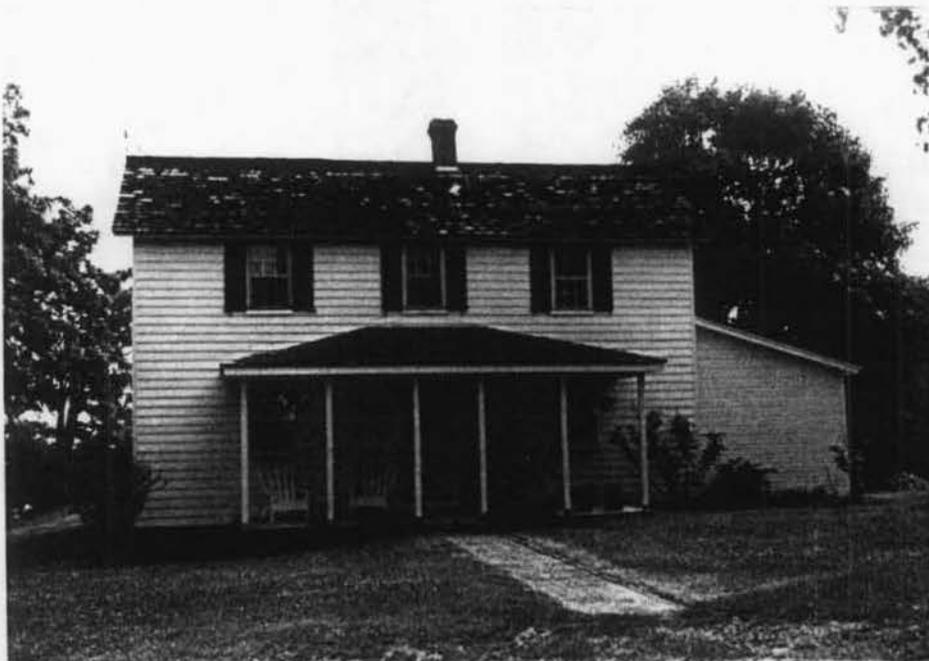
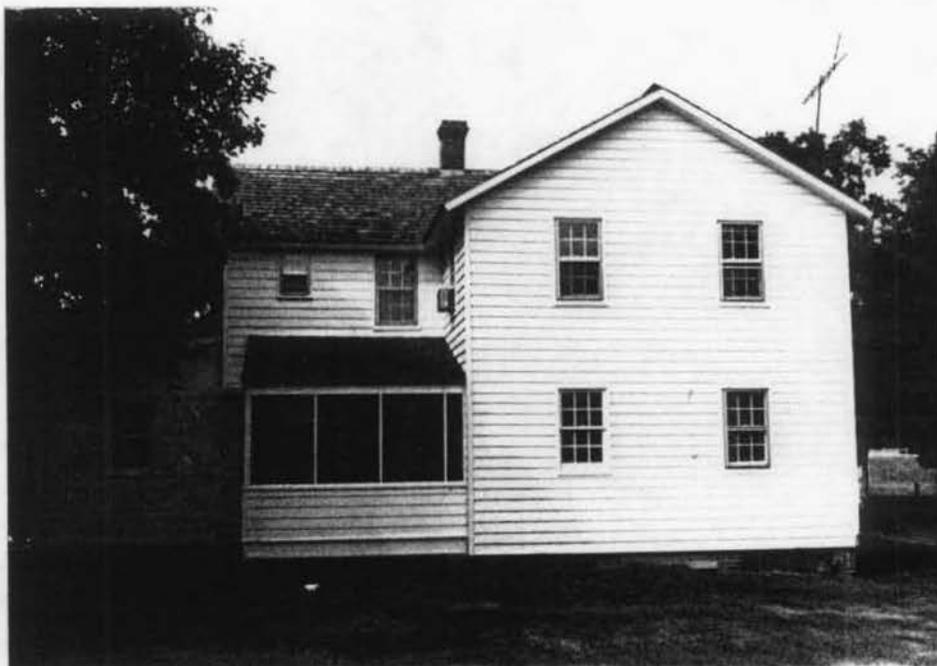
TOP: View of tenant house (5) from southwest.  
BOTTOM: View of tenant house from northeast.

Built on the same axis as the main residence, this is a two-story, ell-shaped frame dwelling with lapped siding and a wood-shingled roof. The southeast, front elevation is three bays wide at both floor levels with the centered entrance door and two flanking windows sheltered by a hip-roofed porch. The northeast, rear wing is also two stories high but only one bay wide on a side and two bays wide at the end. The wing covers about half the rear elevation of the main portion of the house. Between the southeast side of the wing and the southeast end of the house is a shed-roofed screened porch. The wing appears to have been an addition to the main block, though it may be contemporary with it. A more modern shed-roofed addition stands at the southeast end of the main block. All of the exterior of the building appears to have been recently refurbished. Access to the interior was not gained.

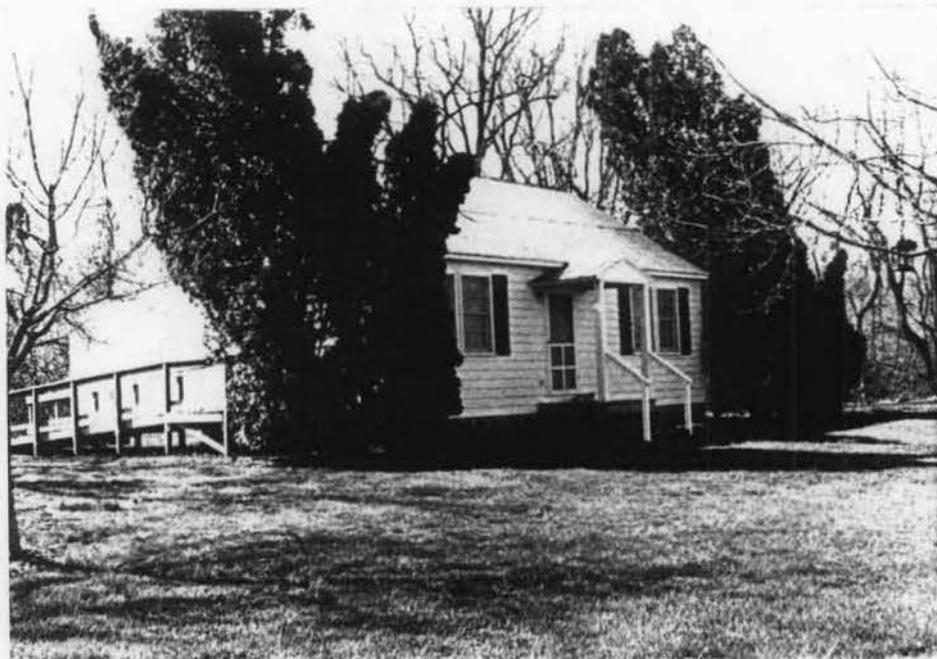
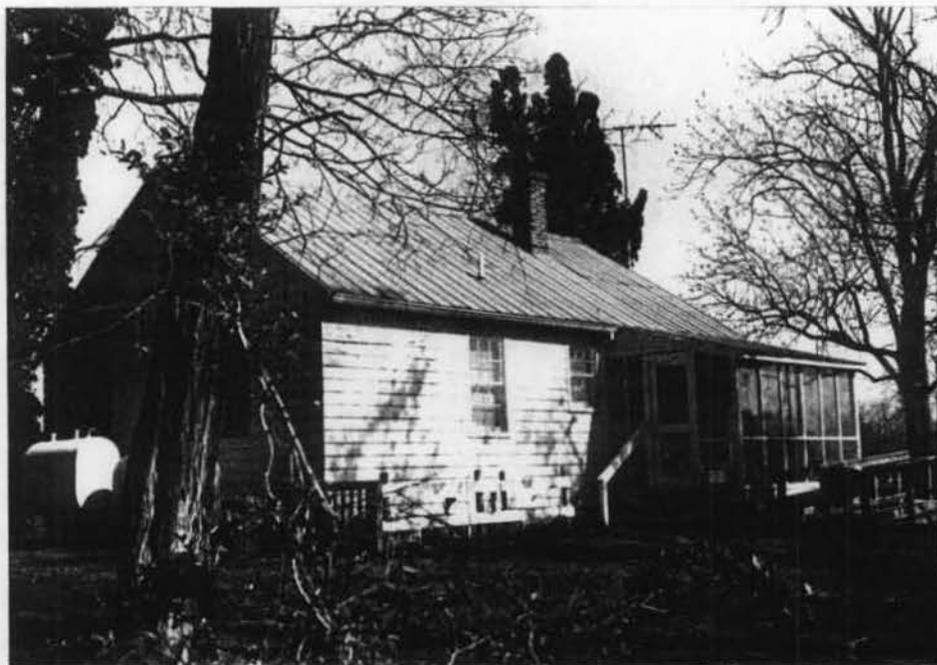
TOP: View of tenant house ("Francis Knott House" 7) from north. BOTTOM: View of tenant house from south.

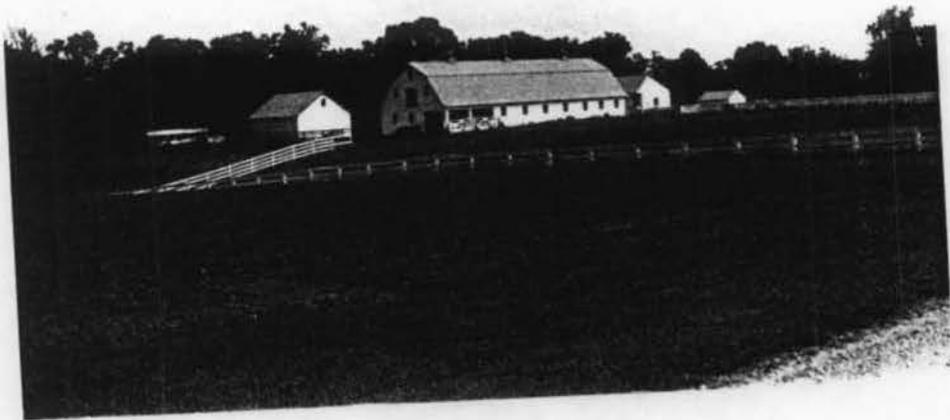
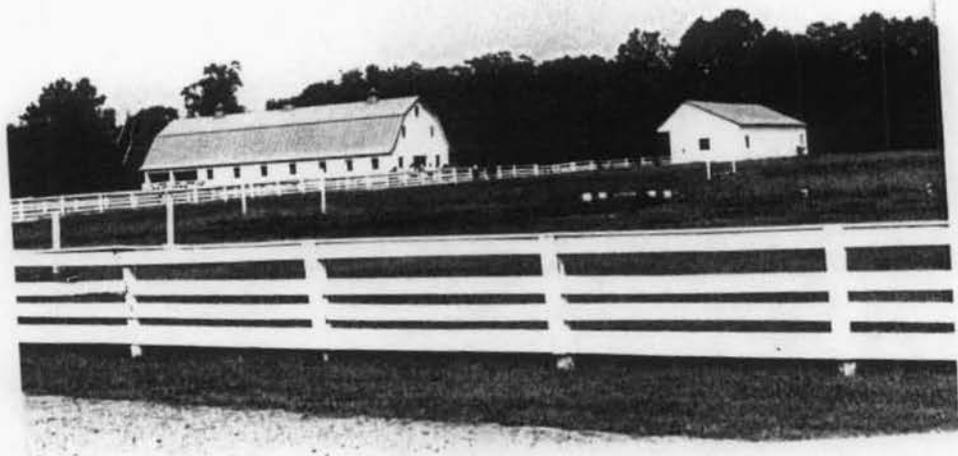
TOP: View of barn complex (8-12) from southeast.  
BOTTOM: View of barn complex from northeast.

This is a small grouping of farm buildings that includes a large, gambrel-roofed, masonry block and frame livestock barn, a shed row for horses, a large corncrib, and two small sheds. The buildings, all of which are painted white and in good repair, were constructed between about the late 1940s or early 1950s and 1971. The complex is visible from the entrance drive near the approach to the house but separated from the road and house complex by board-fenced paddocks and pastures.

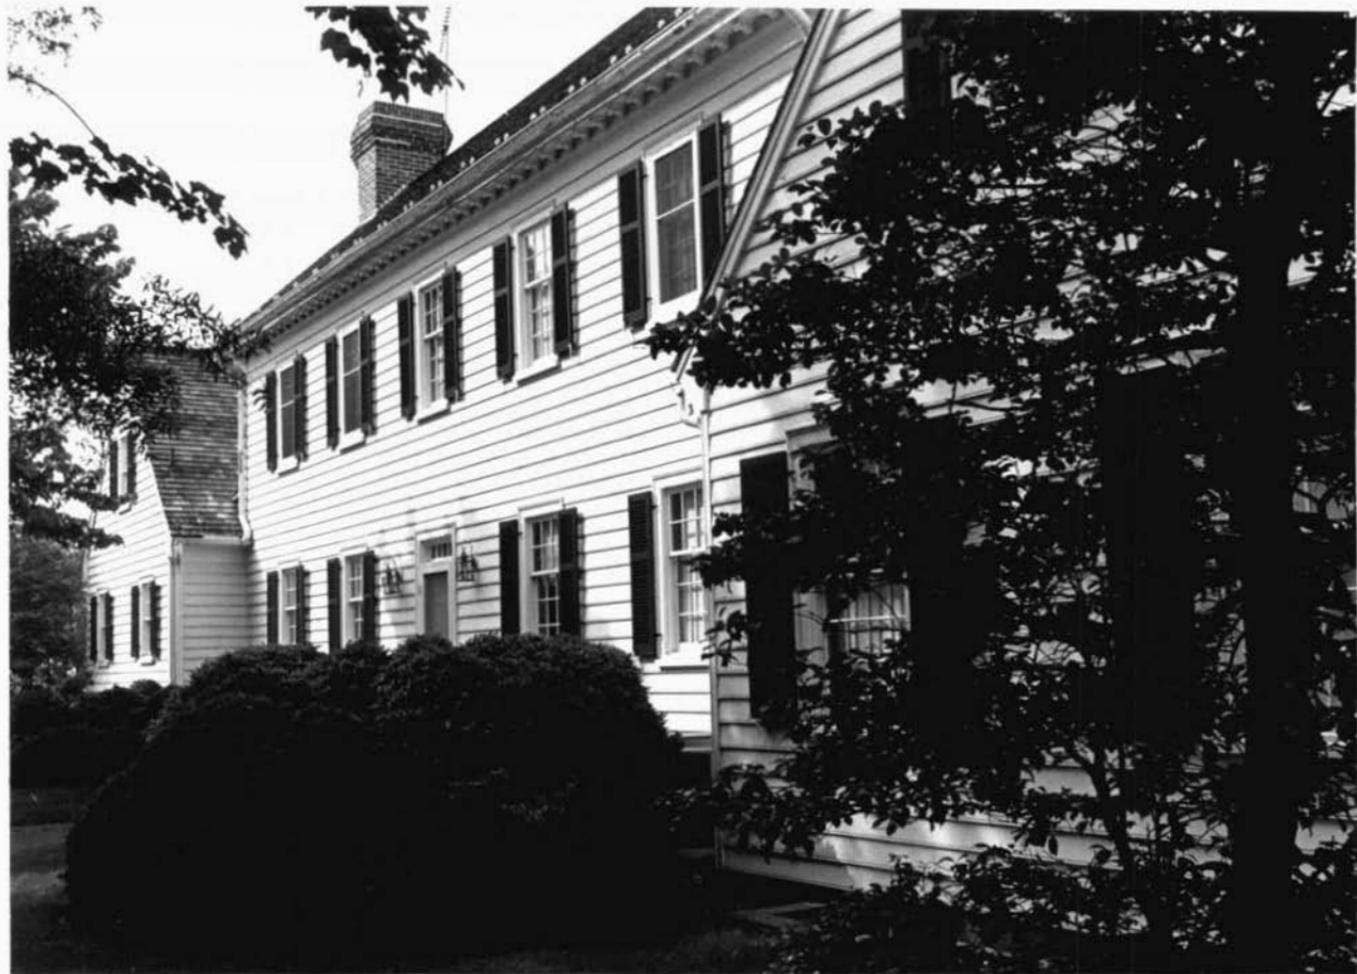
SM-101

Rosedale on the Patuxent  
Greenwell State Park  
c. 1830  
north facade  
E. Coxe 6/79

Rosedale is a two-story, five-bay frame structure with interior end chimneys which has been enlarged by 1940's additions on the gable ends. The entire structure is now sheathed in modern wood siding with each window shuttered; original window surrounds have been obscured by the installation of storm windows over the 6/9 double hung sash. A denticulate cornice remains in good repair; the north entrance door is surmounted by a five light transom.

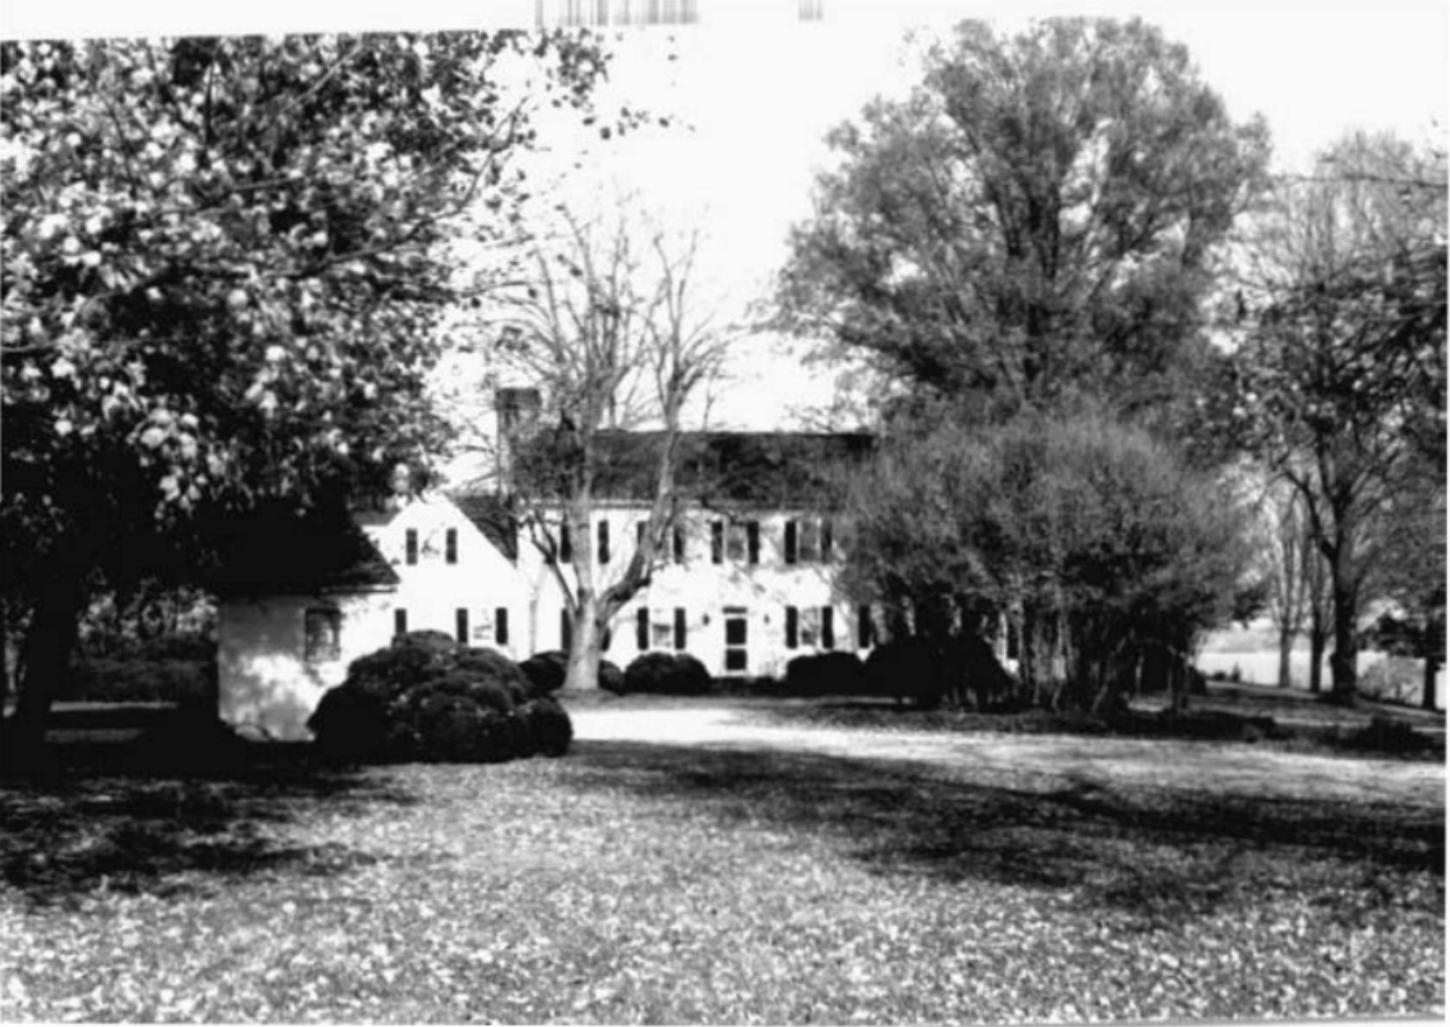
1/17

MAIN HSE., FROM SW

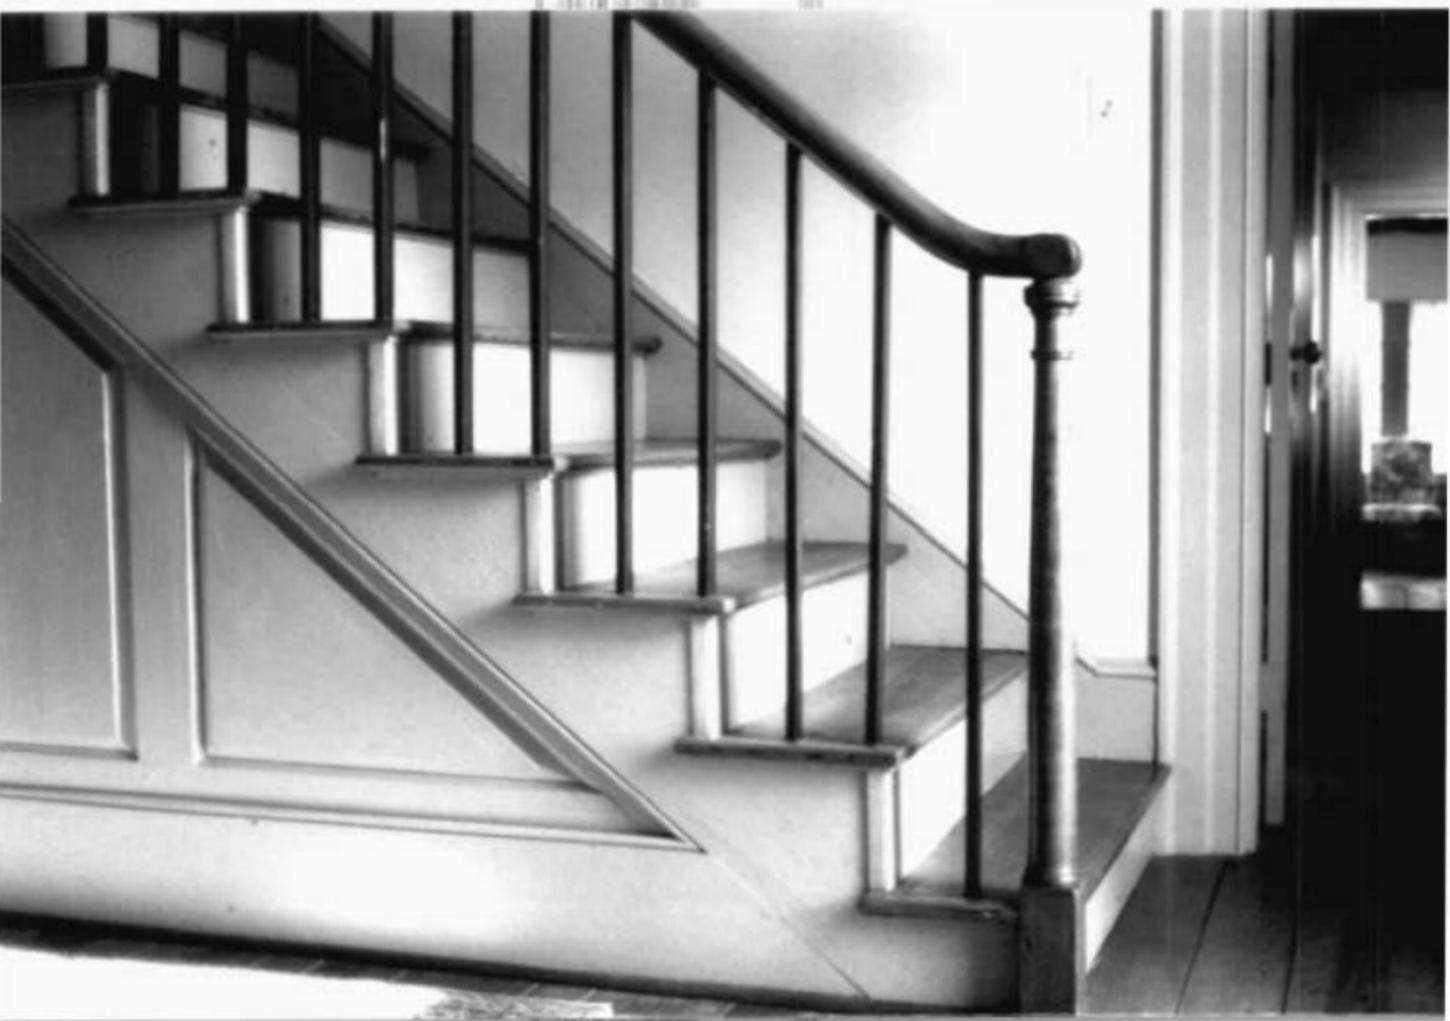
3/17

MAIN HSE., STAIR DETAIL, 1ST FLOOR

The first-floor room arrangement of the main block consists of a central stair hall flanked by two rooms: a dining room to the left and a small sitting room to the right. The stair rises in two flights to a small second-floor hallway flanked by two bedrooms. A narrow, enclosed stair in the north corner of the hall provides access to a commodious but unfinished attic.

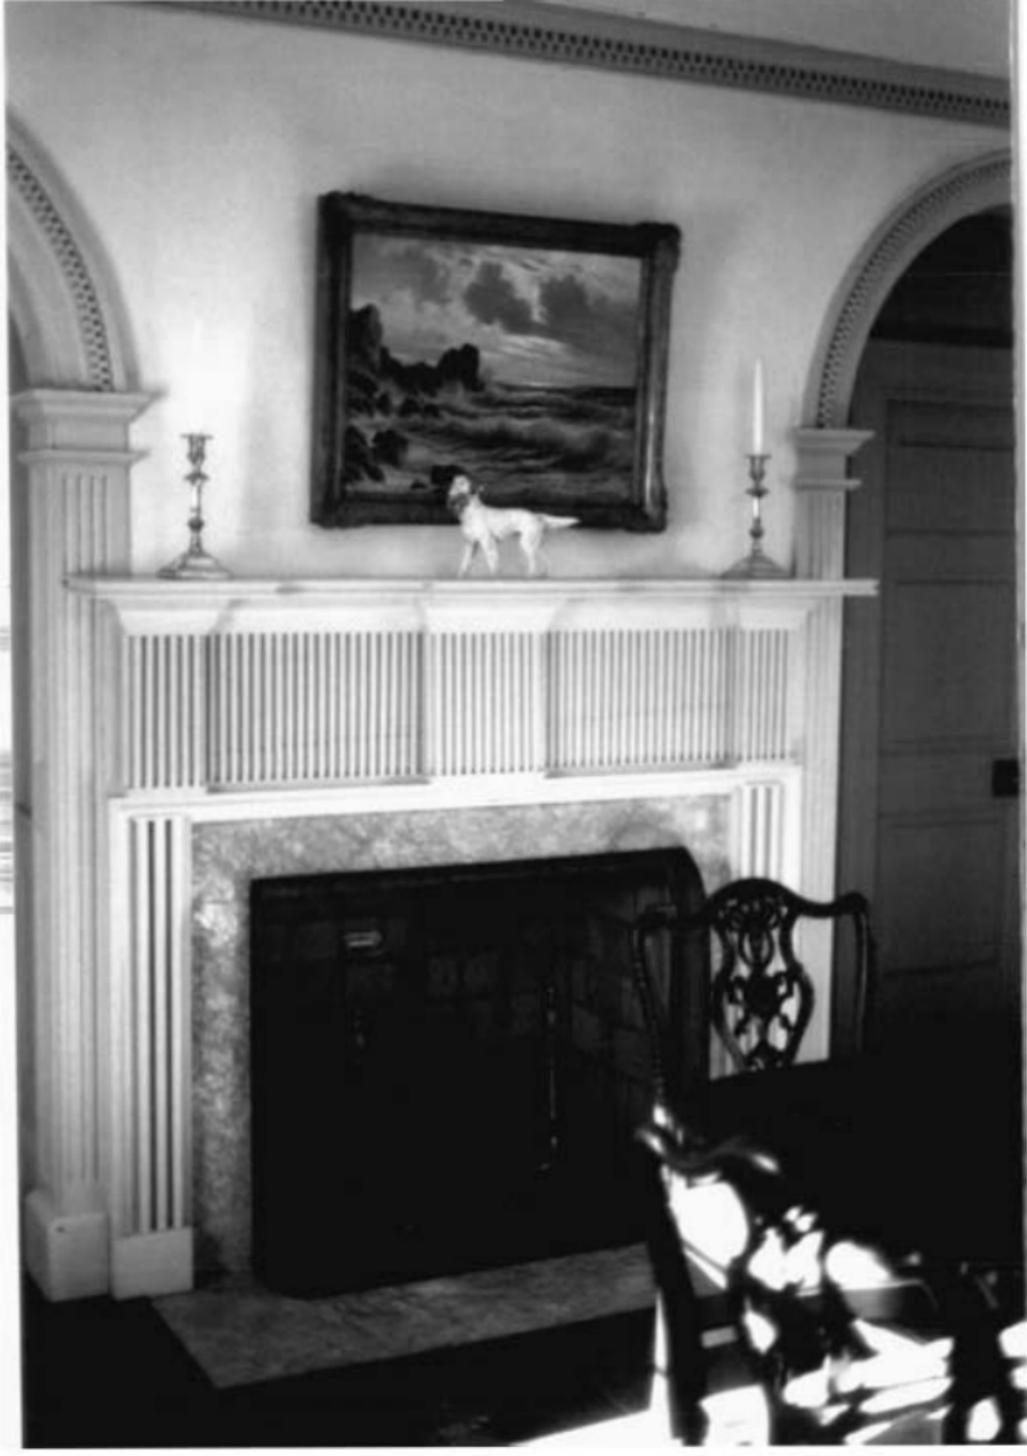
4/17

MAIN HSE., DINING RM MANTEL

The most formal room in this portion of the house is the present dining room where two arched doorways trimmed with fluted pilasters, fretwork and keystones flank a marble-faced fireplace framed by a mantel featuring series of narrow colonettes on both the pilasters and

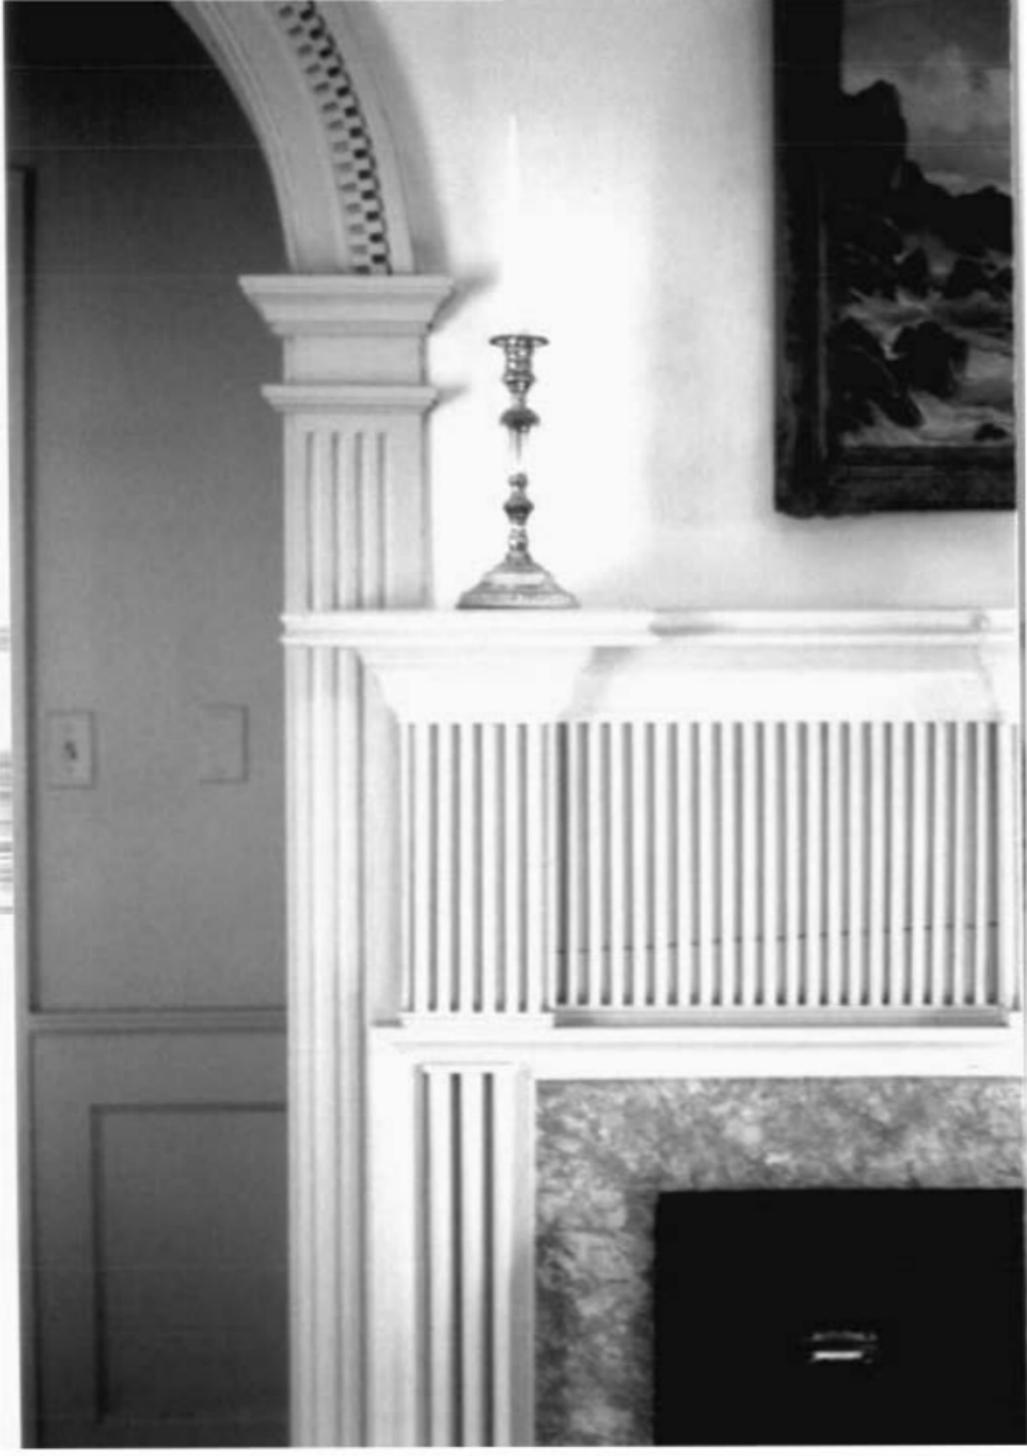
5/17

MAIN HSE., DINING RM. MANTEL DBT.

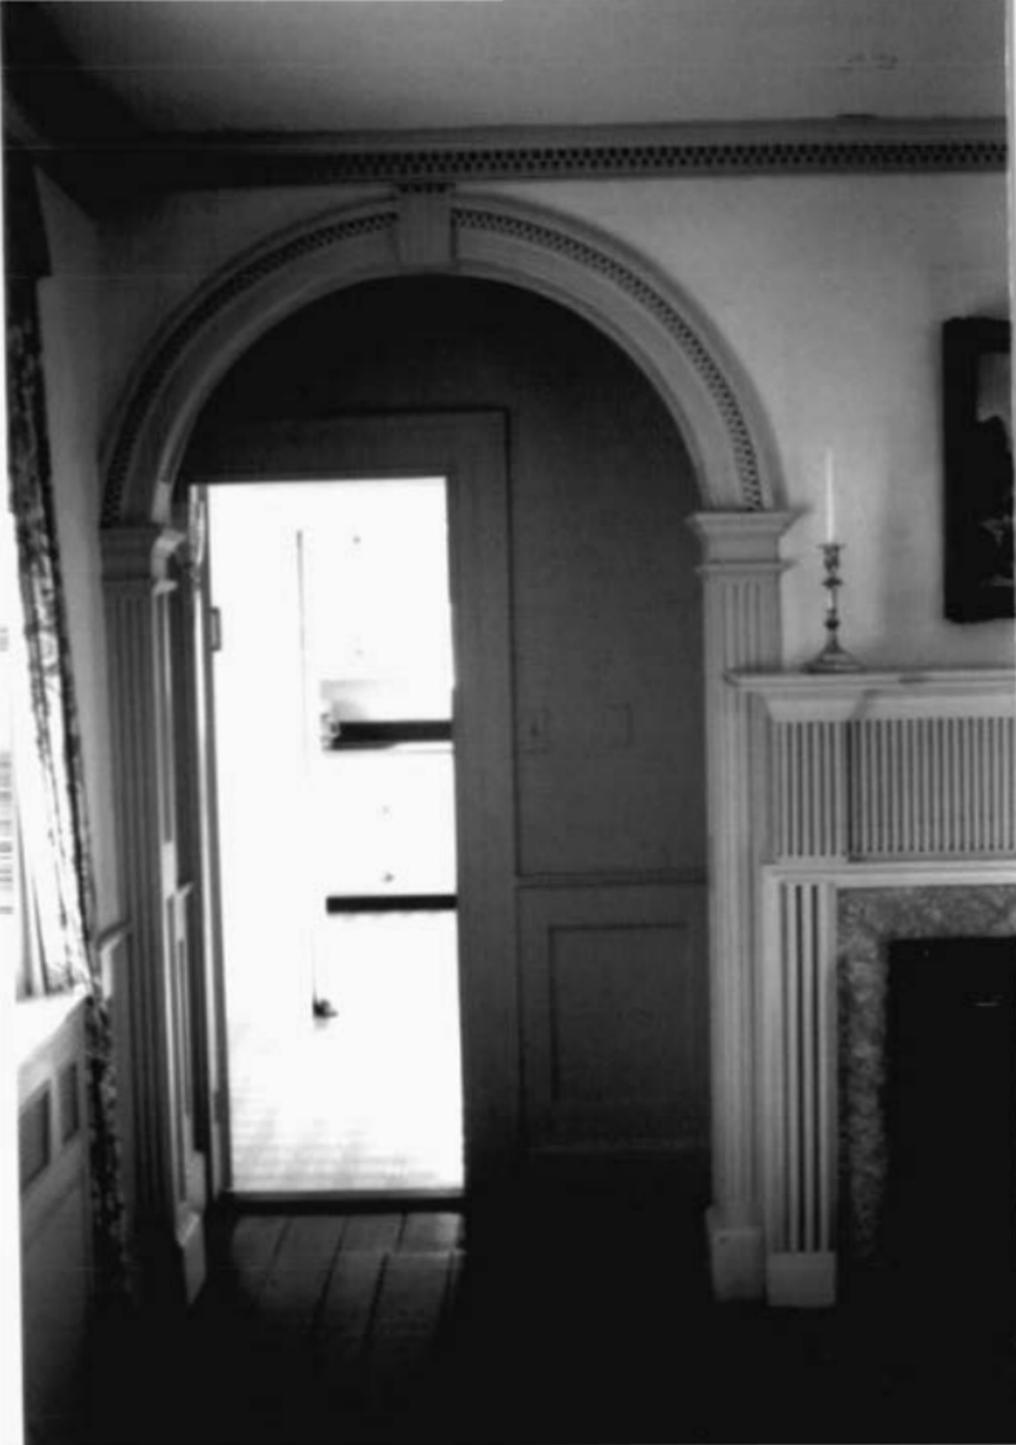
6/17

~~MAIN~~ HSE., DINING RM., ARCH
