MARYLAND HISTORICAL TRUST  
DETERMINATION OF ELIGIBILITY FORM

Property Name: Rosedale Manor Inventory Number: SM-101  
Address: Greenwell State Park City: Hollywood Zip Code: 20636  
County: Saint Marys USGS Topographic Map: Hollywood  
Owner: State of Maryland Is the property being evaluated a district?  yes  no  
Tax Parcel Number: \_\_\_\_\_ Tax Map Number: \_\_\_\_\_ Tax Account ID Number: \_\_\_\_\_  
Project: ADA Renovations Agency: DNR  
Site visit by MHT staff:  no  yes Name: Tania Tully Date: 12/11/2002  
Is the property is located within a historic district?  yes  no

National Register of Historic Places  
Registration Form

historic name ROSEDALE

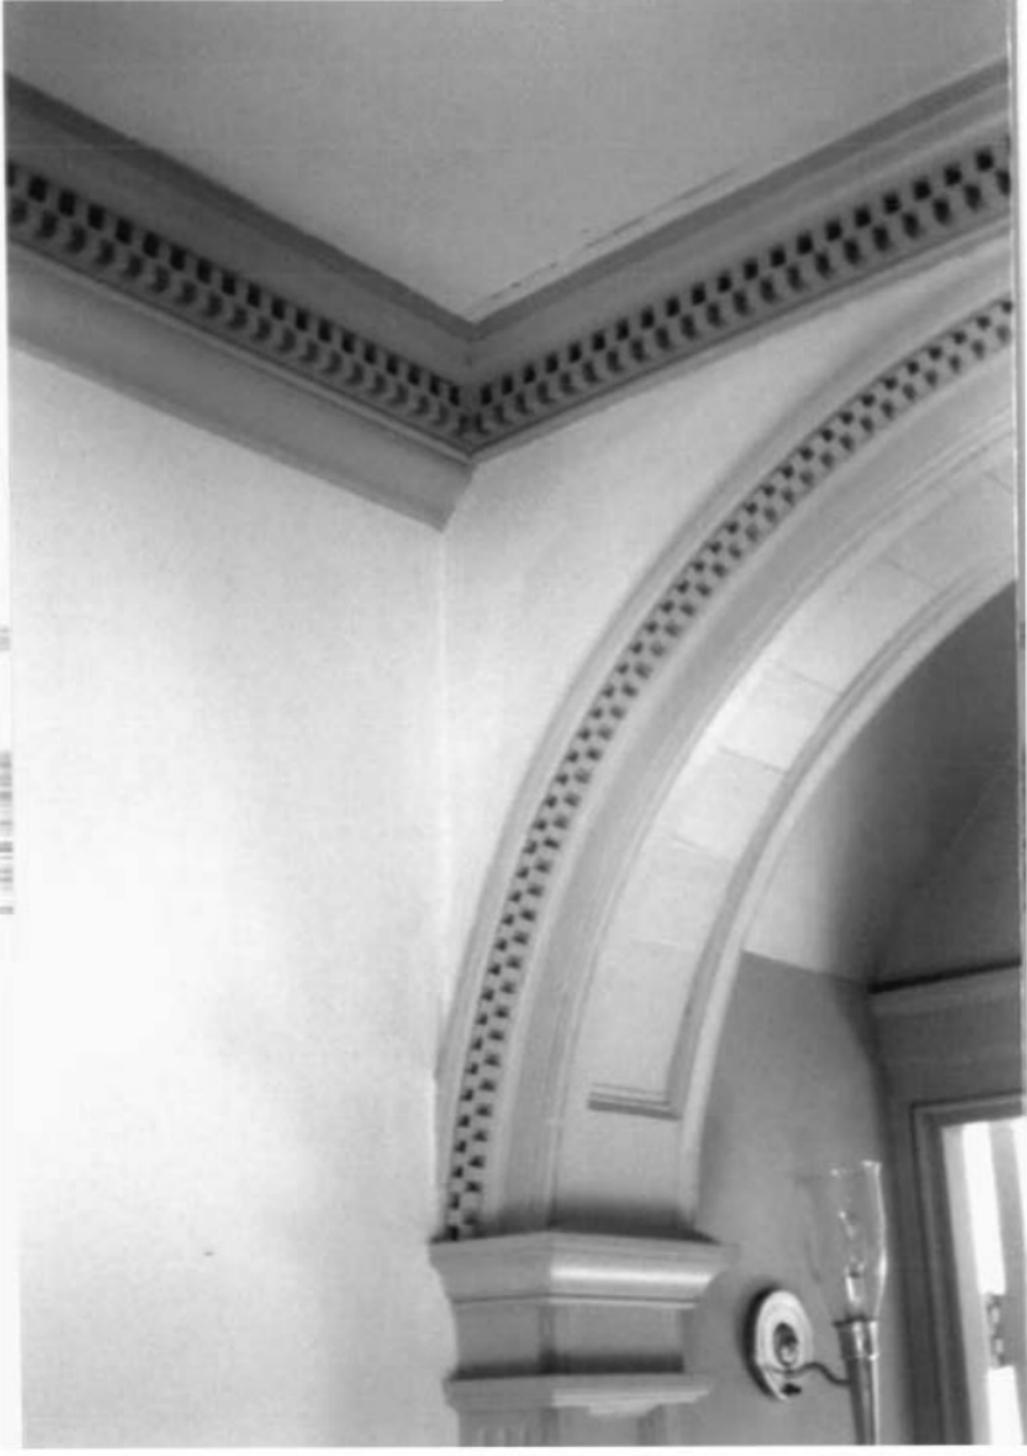
7/17

MAIN HSE., DIN. RM., ARCH DETAIL

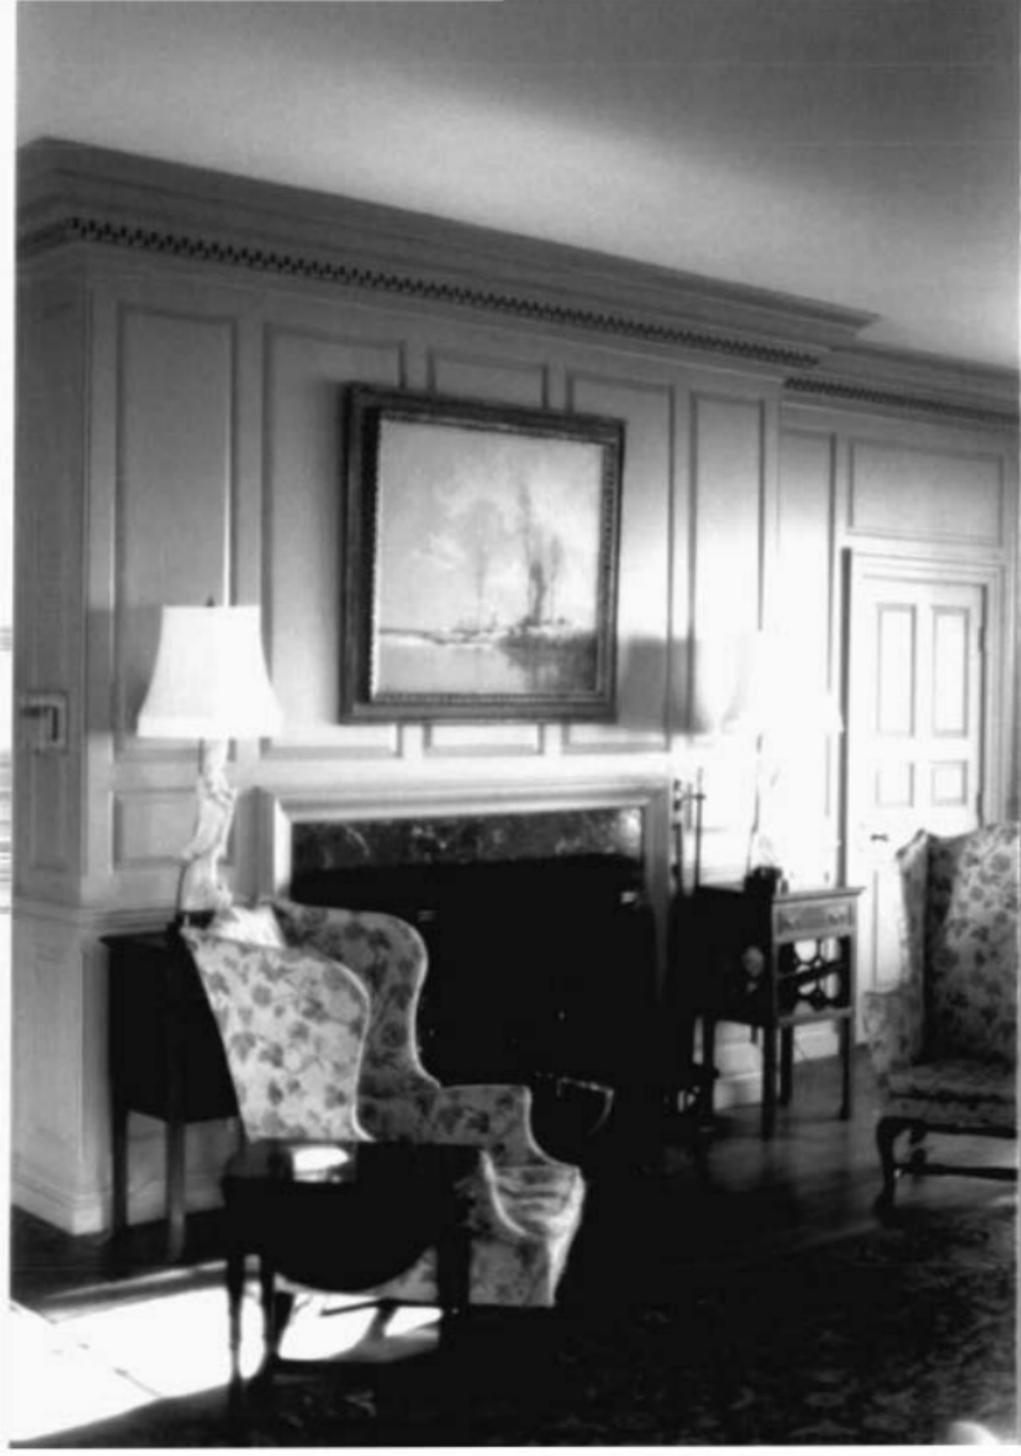
8/17

MAIN HSE., FPL. WALL, SE WIND

The southern room contains the same fenestration but its fireplace wall is treated more simply: the high frieze this time is a plain field articulated only by the slightly projecting center and corner blocks which are gougework triglyphs. The mantels' treatment of the two upstairs chambers is identical to this surround. What once were cabinets flanking this first floor southern room fireplace **have been** reworked to form doorways into the new addition. Also replaced are the doors to the two first floor chambers, now double doors with new hardware.

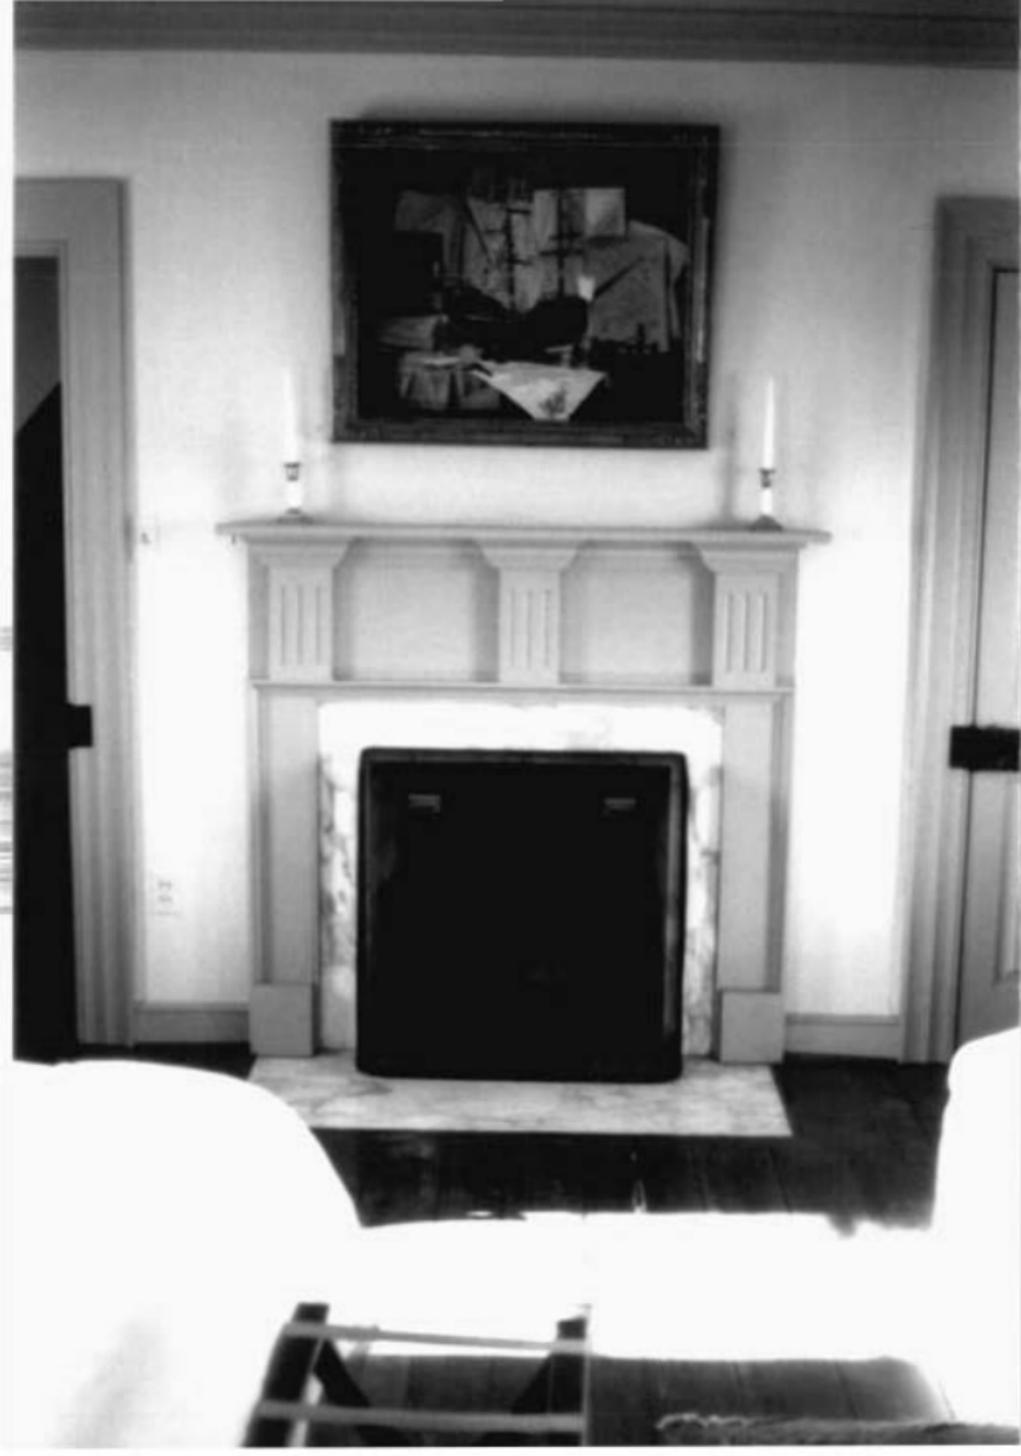
11/17

MAIN HSE., MANTEL, 2ND FL. NW BDR.

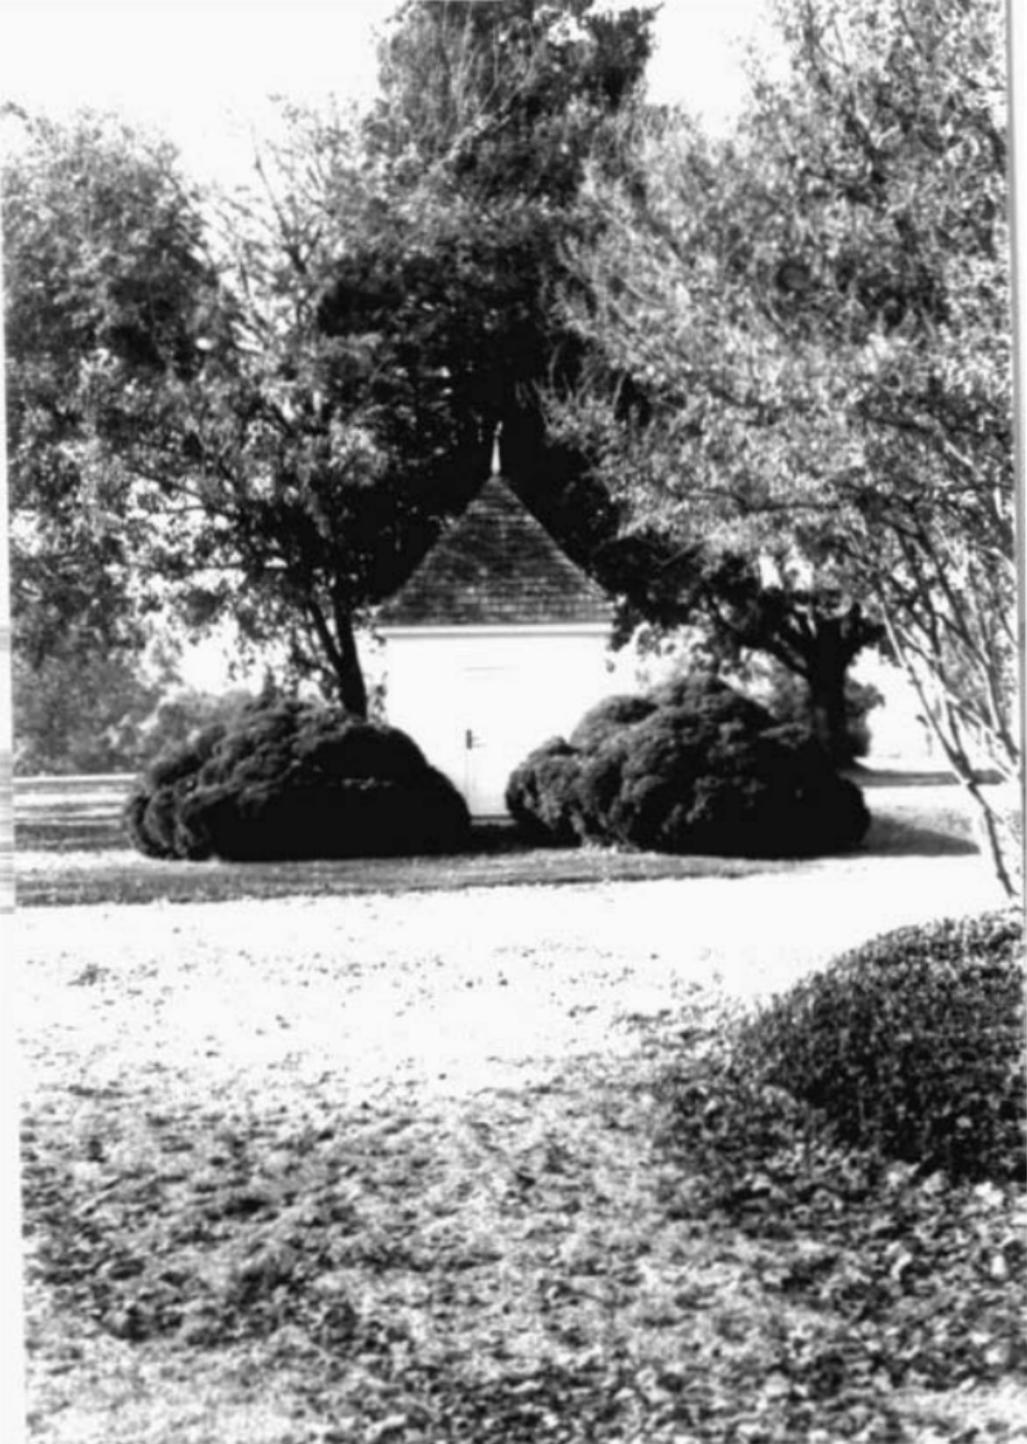
12/17

GARDEN HSE., FROM E-SE

Measuring 8'-3" on a side, this is a small wood-framed structure with a pyramid roof. The exterior walls are sheathed with wide, horizontal, flush boards. Some of this siding, notably on the upper parts of the side and rear walls, is original, while other boards are twentieth-century replacements. The roof is sheathed with wood shingles. There is a simple boxed eave cornice with beaded fascia and a narrow crown molding, all of a profile typical of the 1830s and 1840s. A four-panel door with reproduction hardware is centered in the southeast elevation. The building stands on continuous, common-bond brick foundations.

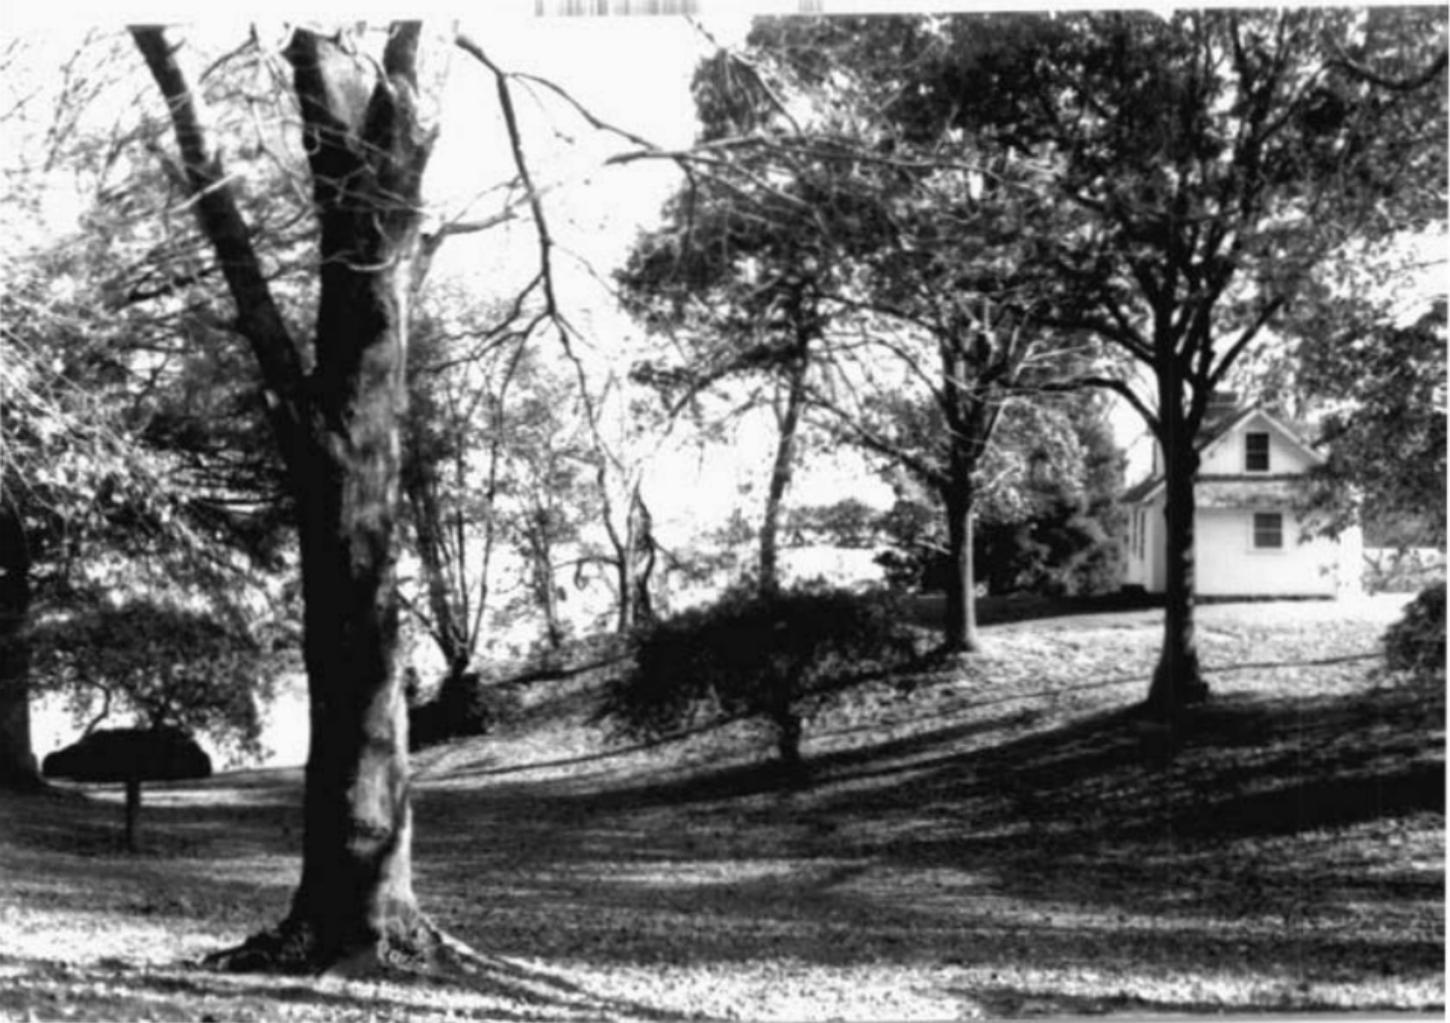
15/17

VIEW TWD. GUEST HSE FROM MAIN HSE.

Perched on a knoll a short distance southeast and across a ravine from the main house (1), the guest house is a small, two-bay frame structure whose gable roof follows a northwest-southeast axis. There is a shed-roofed wing at the northwest end, a single, gable-fronted dormer on each side of the roof, and a massive exterior chimney with stepped shoulders at the southeast end. Both the building and the chimney are underpinned with foundations composed of fossilized river marl and shells, a building material sometimes found in historic building foundations along the lower Potomac and Patuxent rivers. These foundations do not appear to date earlier than the twentieth century, though may have been constructed using material salvaged from another building. All of the exterior finishes of the buildings, including sash and doors, lapped siding and wood roof shingles are twentieth century.

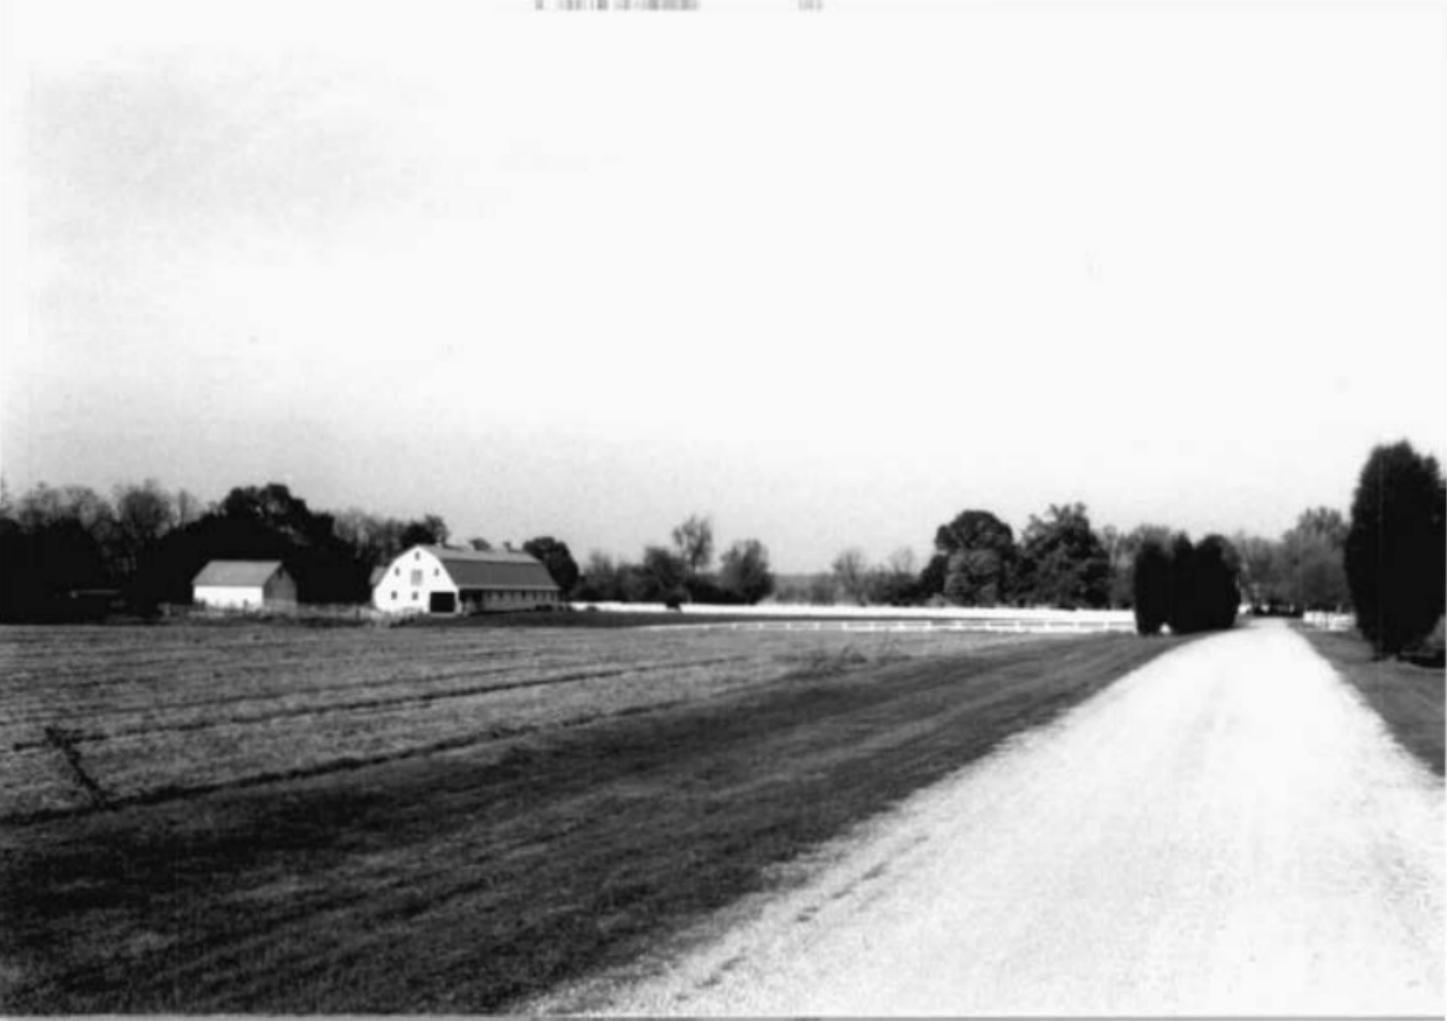
17/17

VIEW OF BARN COMPLEX FROM APPROACH  
DRIVE (HSE. TO RIGHT)

This is a small grouping of farm buildings that includes a large, gambrel-roofed, masonry block and frame livestock barn, a shed row for horses, a large corncrib, and two small sheds. The buildings, all of which are painted white and in good repair, were constructed between about the late 1940s or early 1950s and 1971. The complex is visible from the entrance drive near the approach to the house but separated from the road and house complex by board-fenced paddocks and pastures.

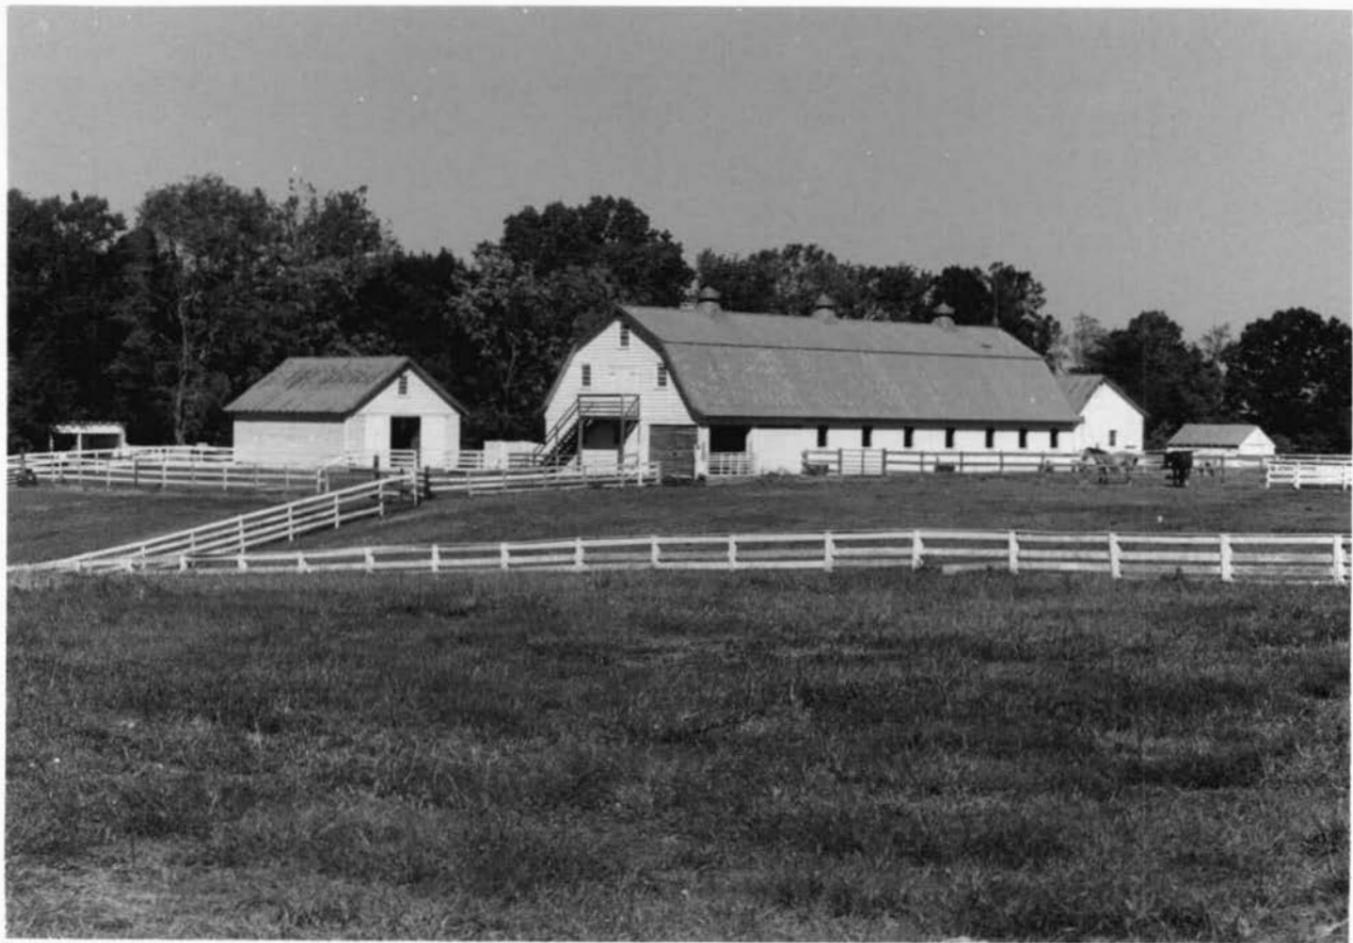
2 of 4

Barns - S + W elevations

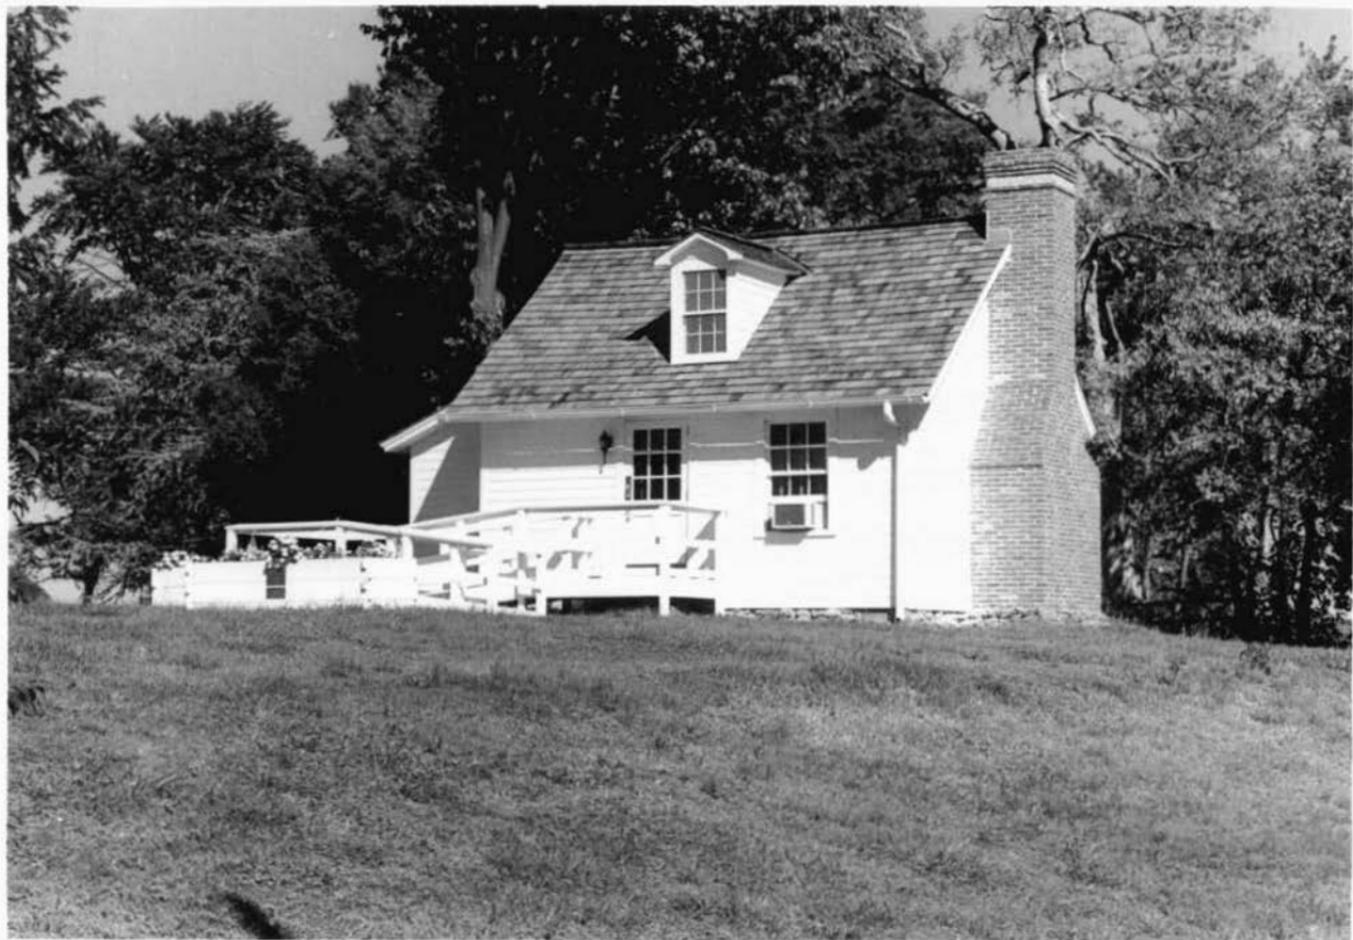
3 of 4

Outbuilding - St E elevations
